City of Marion

# Coastal Climate Change Adaptation Study

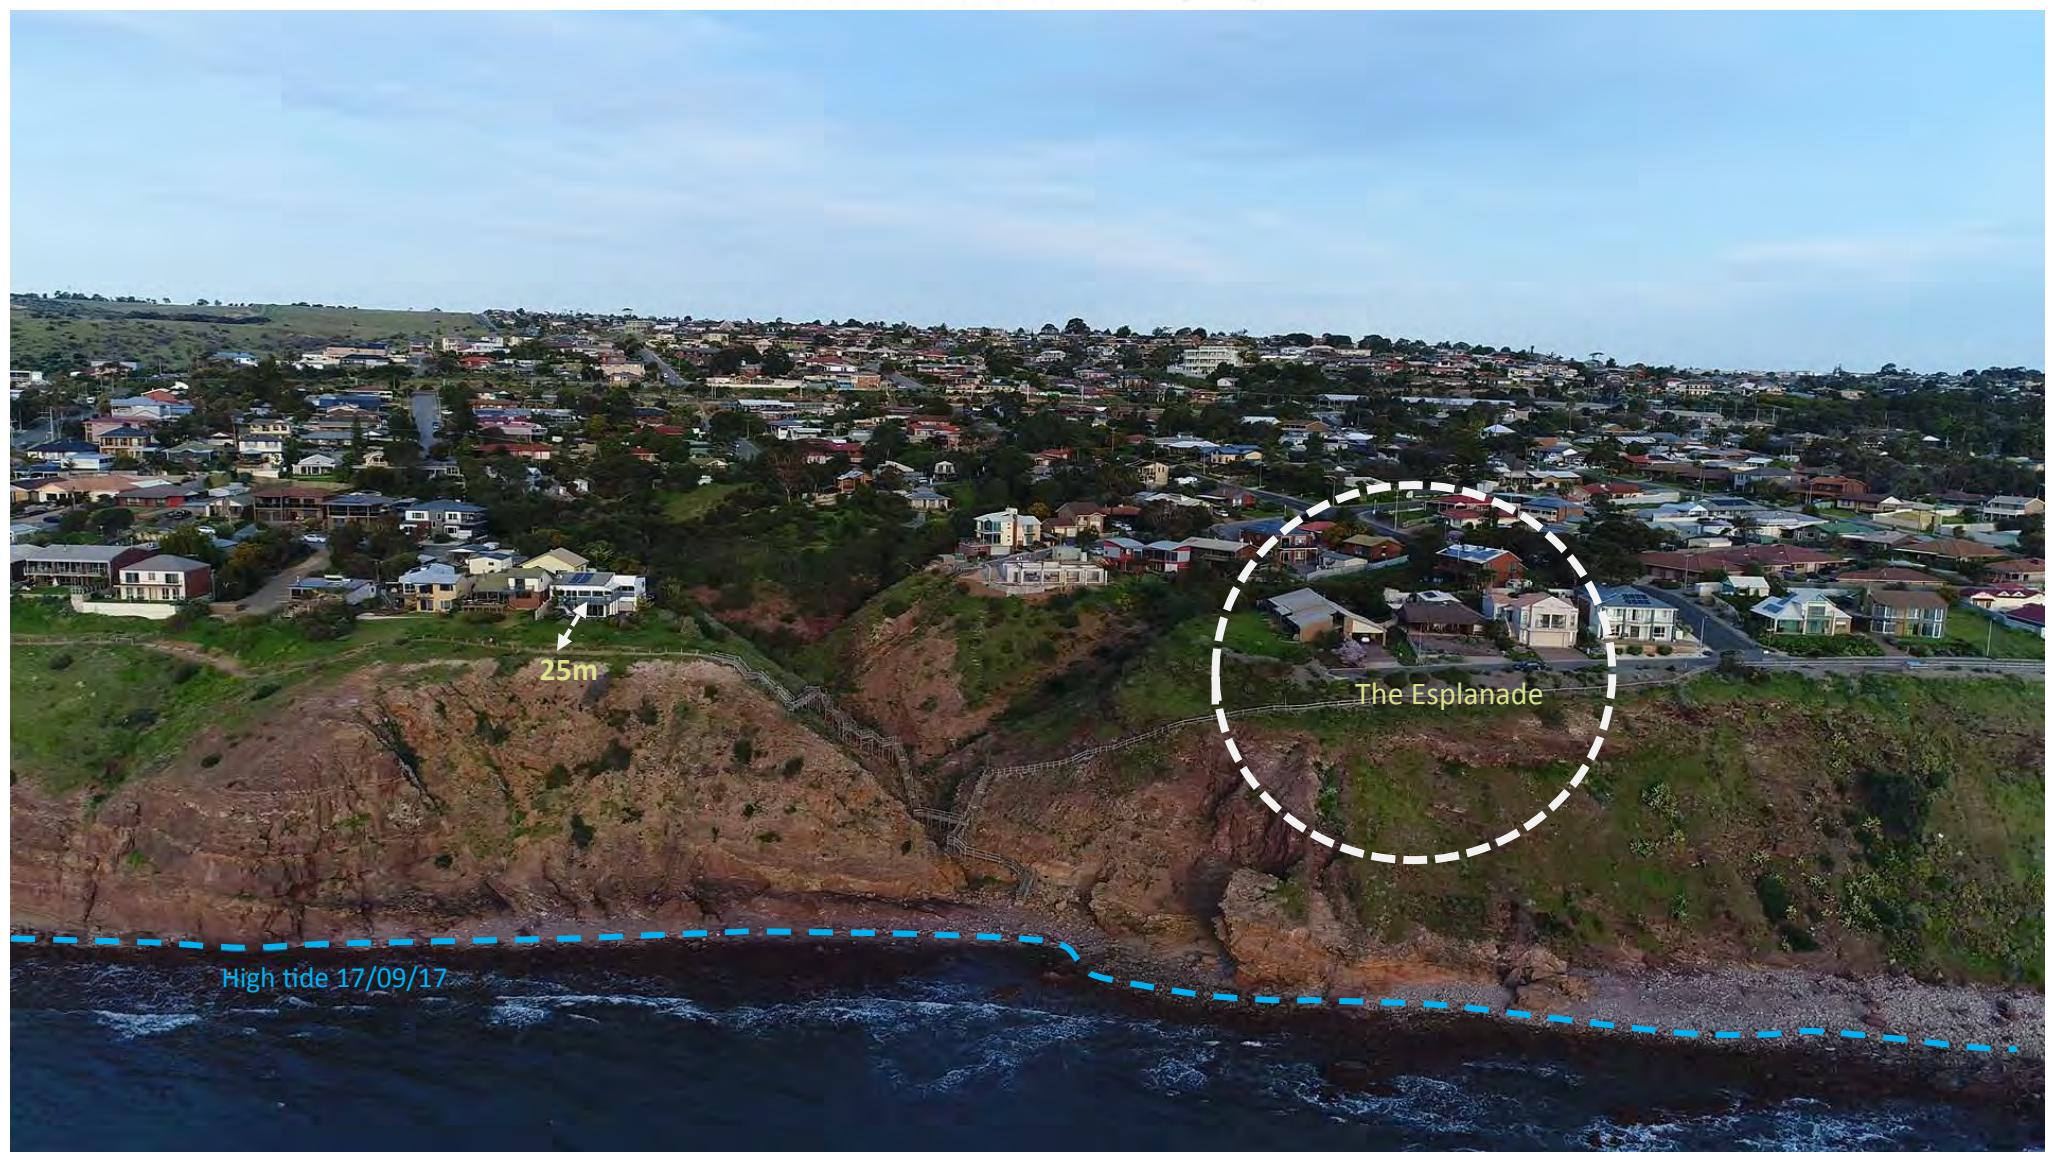
## Cell 2: Hallett Cliffs (2:4)

High tide was 2.03CD (high tides can be 2.30 to 2.50). It is likely that some sections of this cliff base is receiving constant wave action. The Esplanade Road is set back only a couple of metres from the top of the escarpment. Houses are set back about 15m. (See hotspot assessment below for The Esplanade)

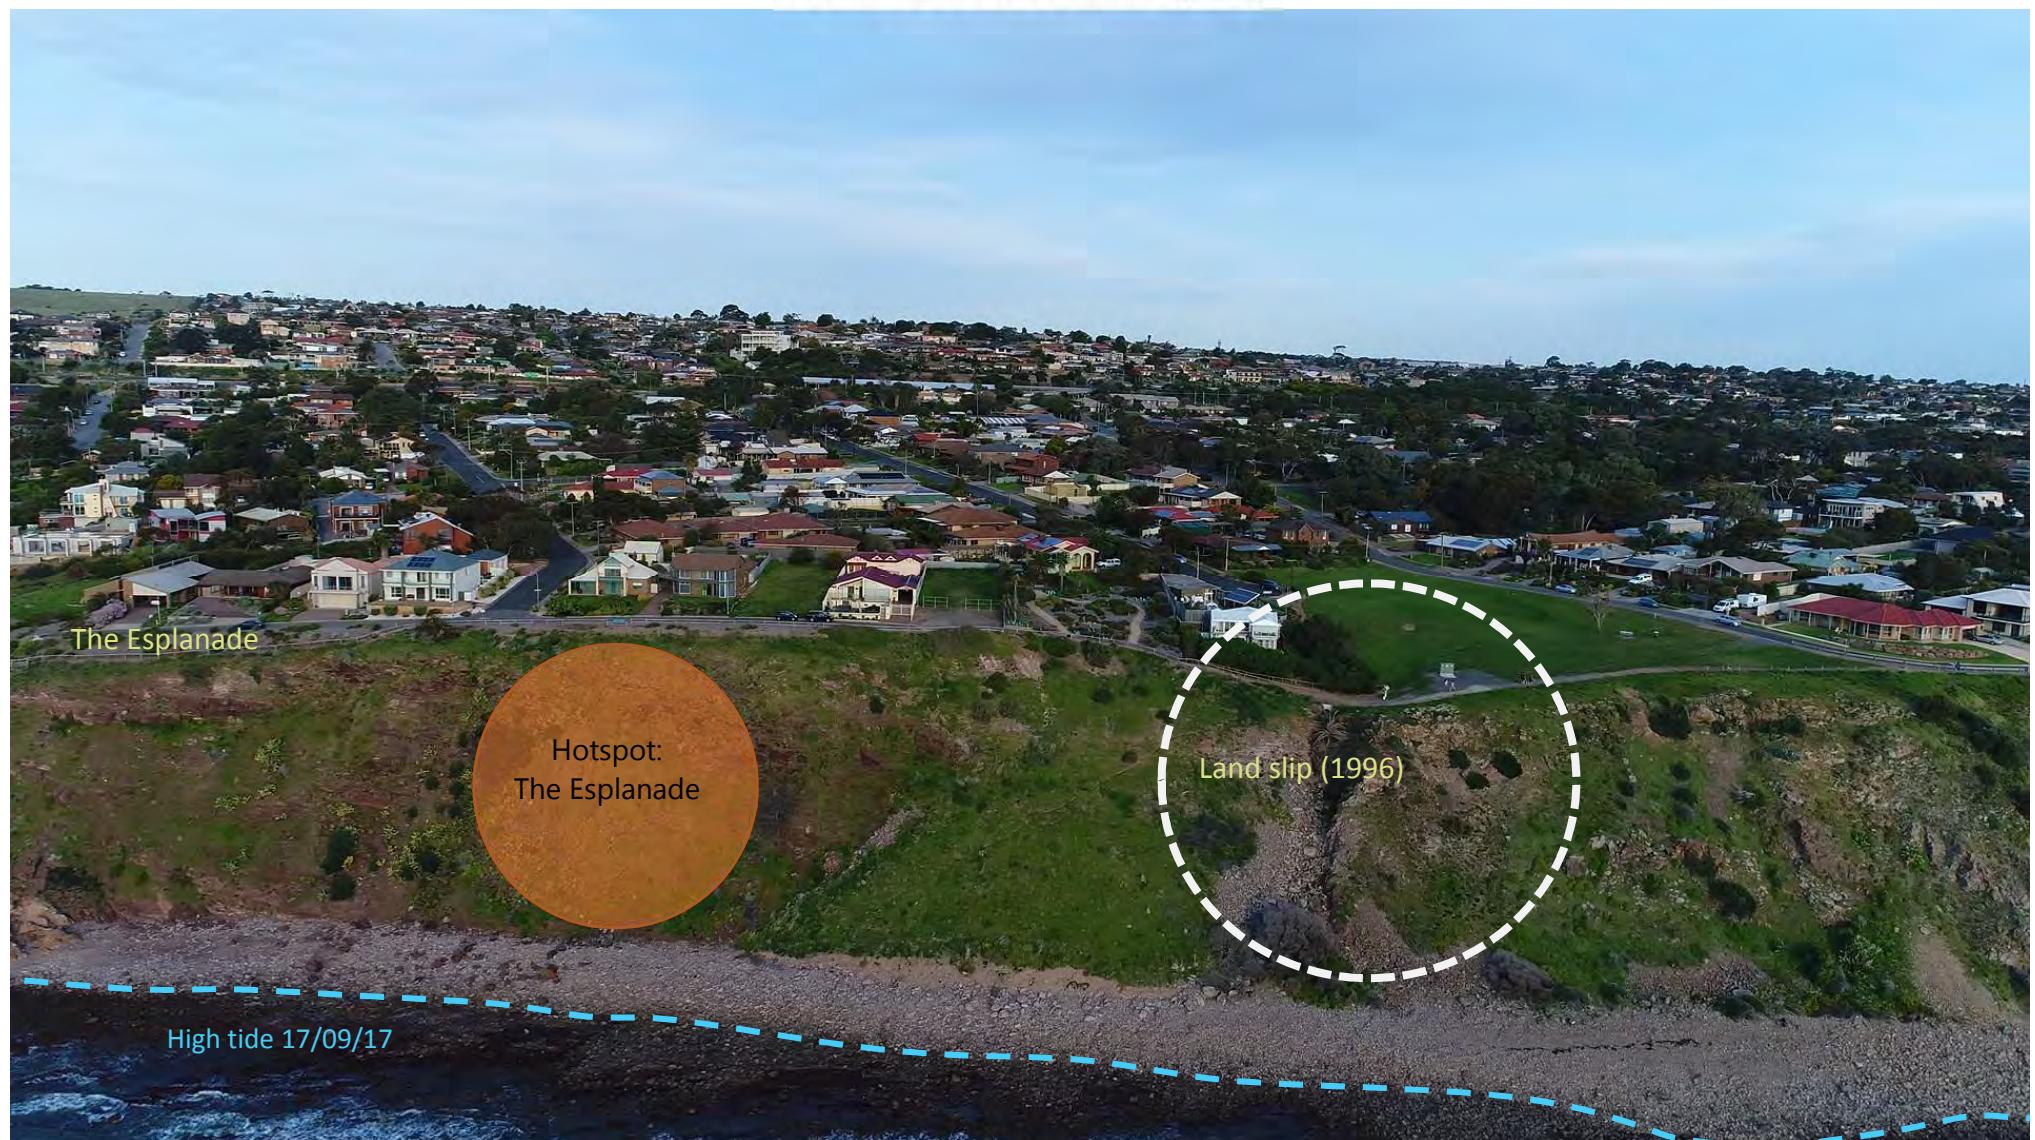
## Cell 2: Hallett Cliffs (2:5)

High tide was 2.03CD (high tides can be 2.30 to 2.50). The Esplanade Road is set back only a couple of metres from the top of the escarpment. Houses are set back about 15m. A landslip occurred in this location in 1996-1997 and the cliff was subsequently collapsed to decrease the slope of the escarpment. Fortunately, this area does not appear to be receiving constant wave action at the base. (See hotspot risk assessment)

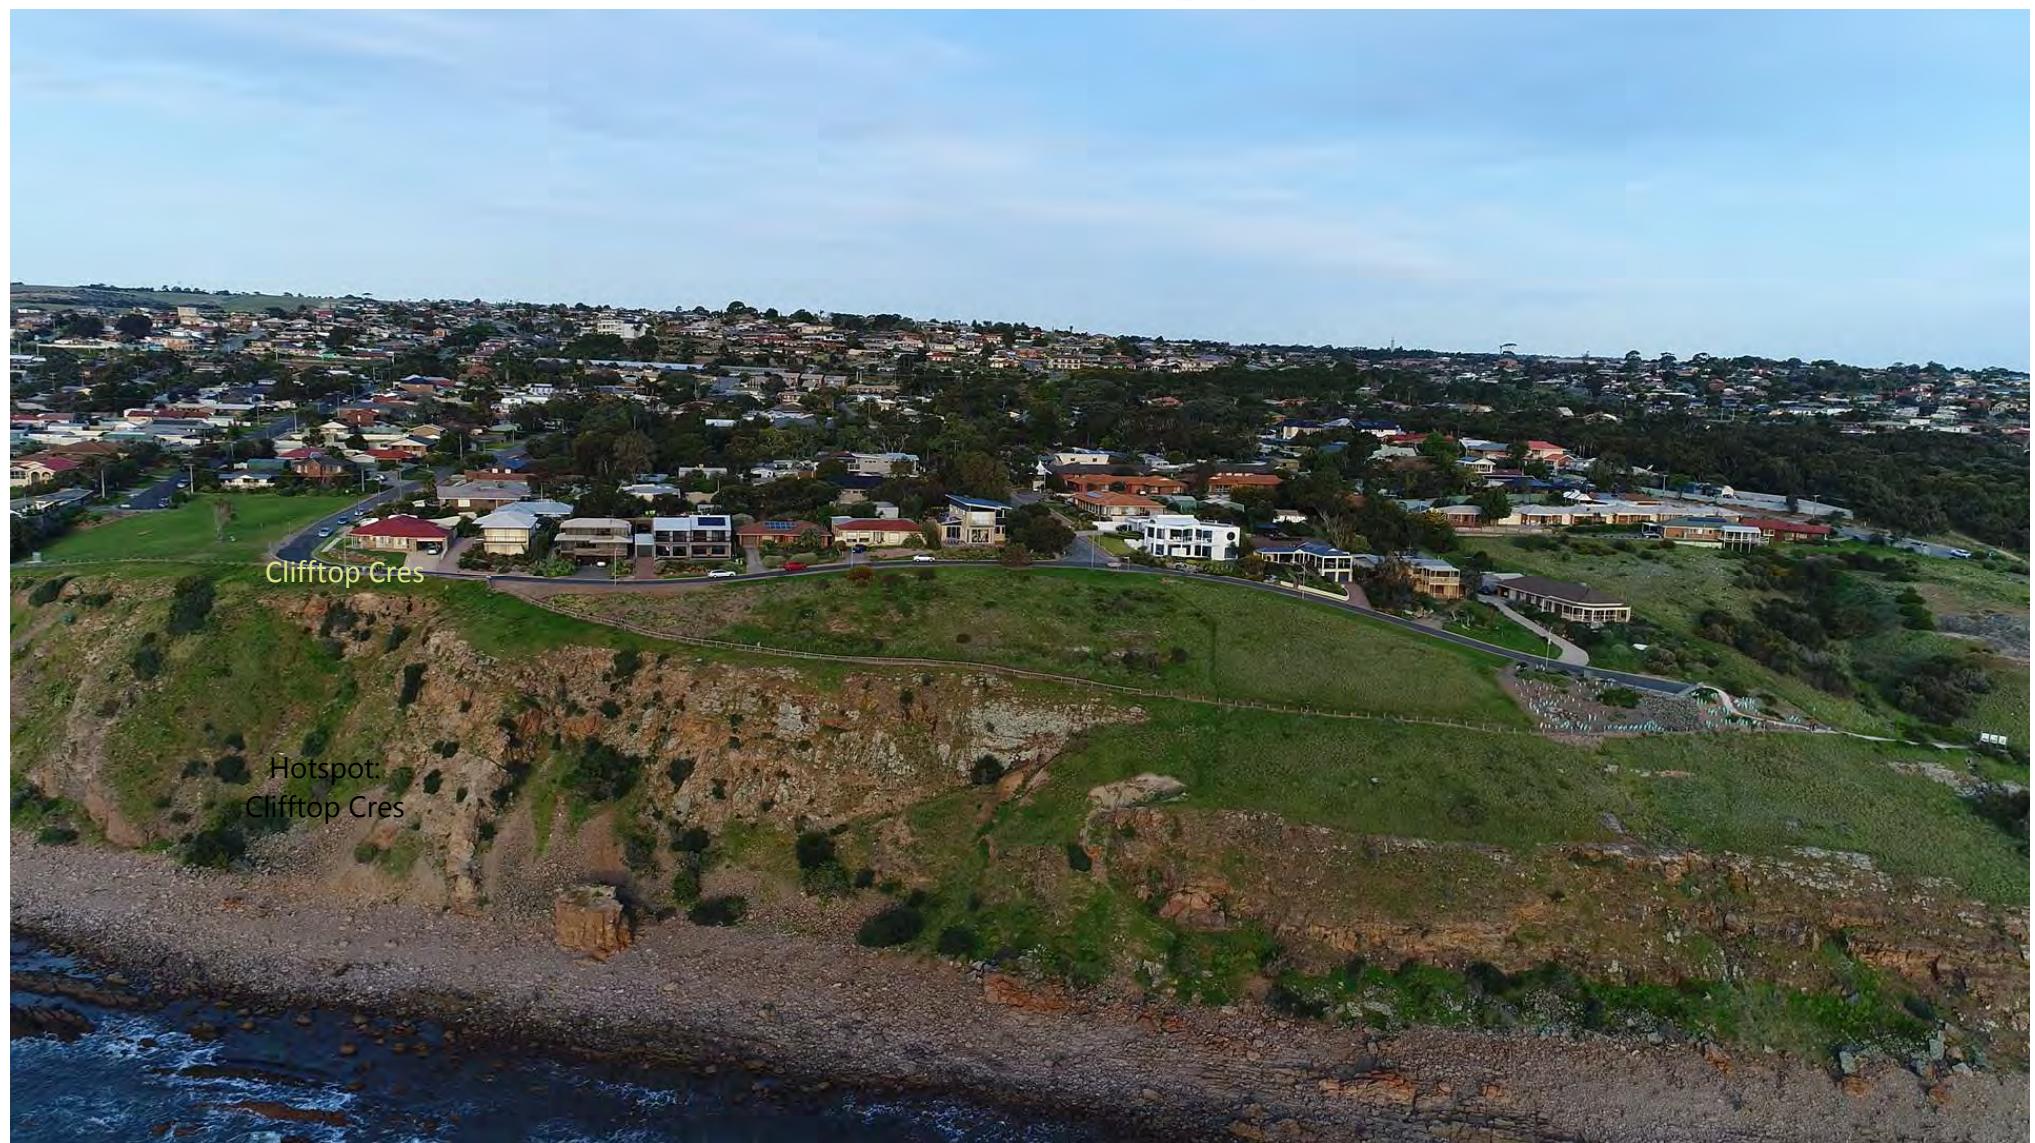
## Cell 2: Hallett Cliffs (2:6)

Clifftop Road is set back only five metres from the top of the escarpment. Two houses near the corner are set back about 15m from the clifftop. The remainder of the houses on Clifftop Cres are set back in excess of 30m. The base of the cliff in this area does not appear to be receiving constant wave action. High tide was 2.03CD (high tides can be 2.30 to 2.50). (See hotspot risk assessment below)

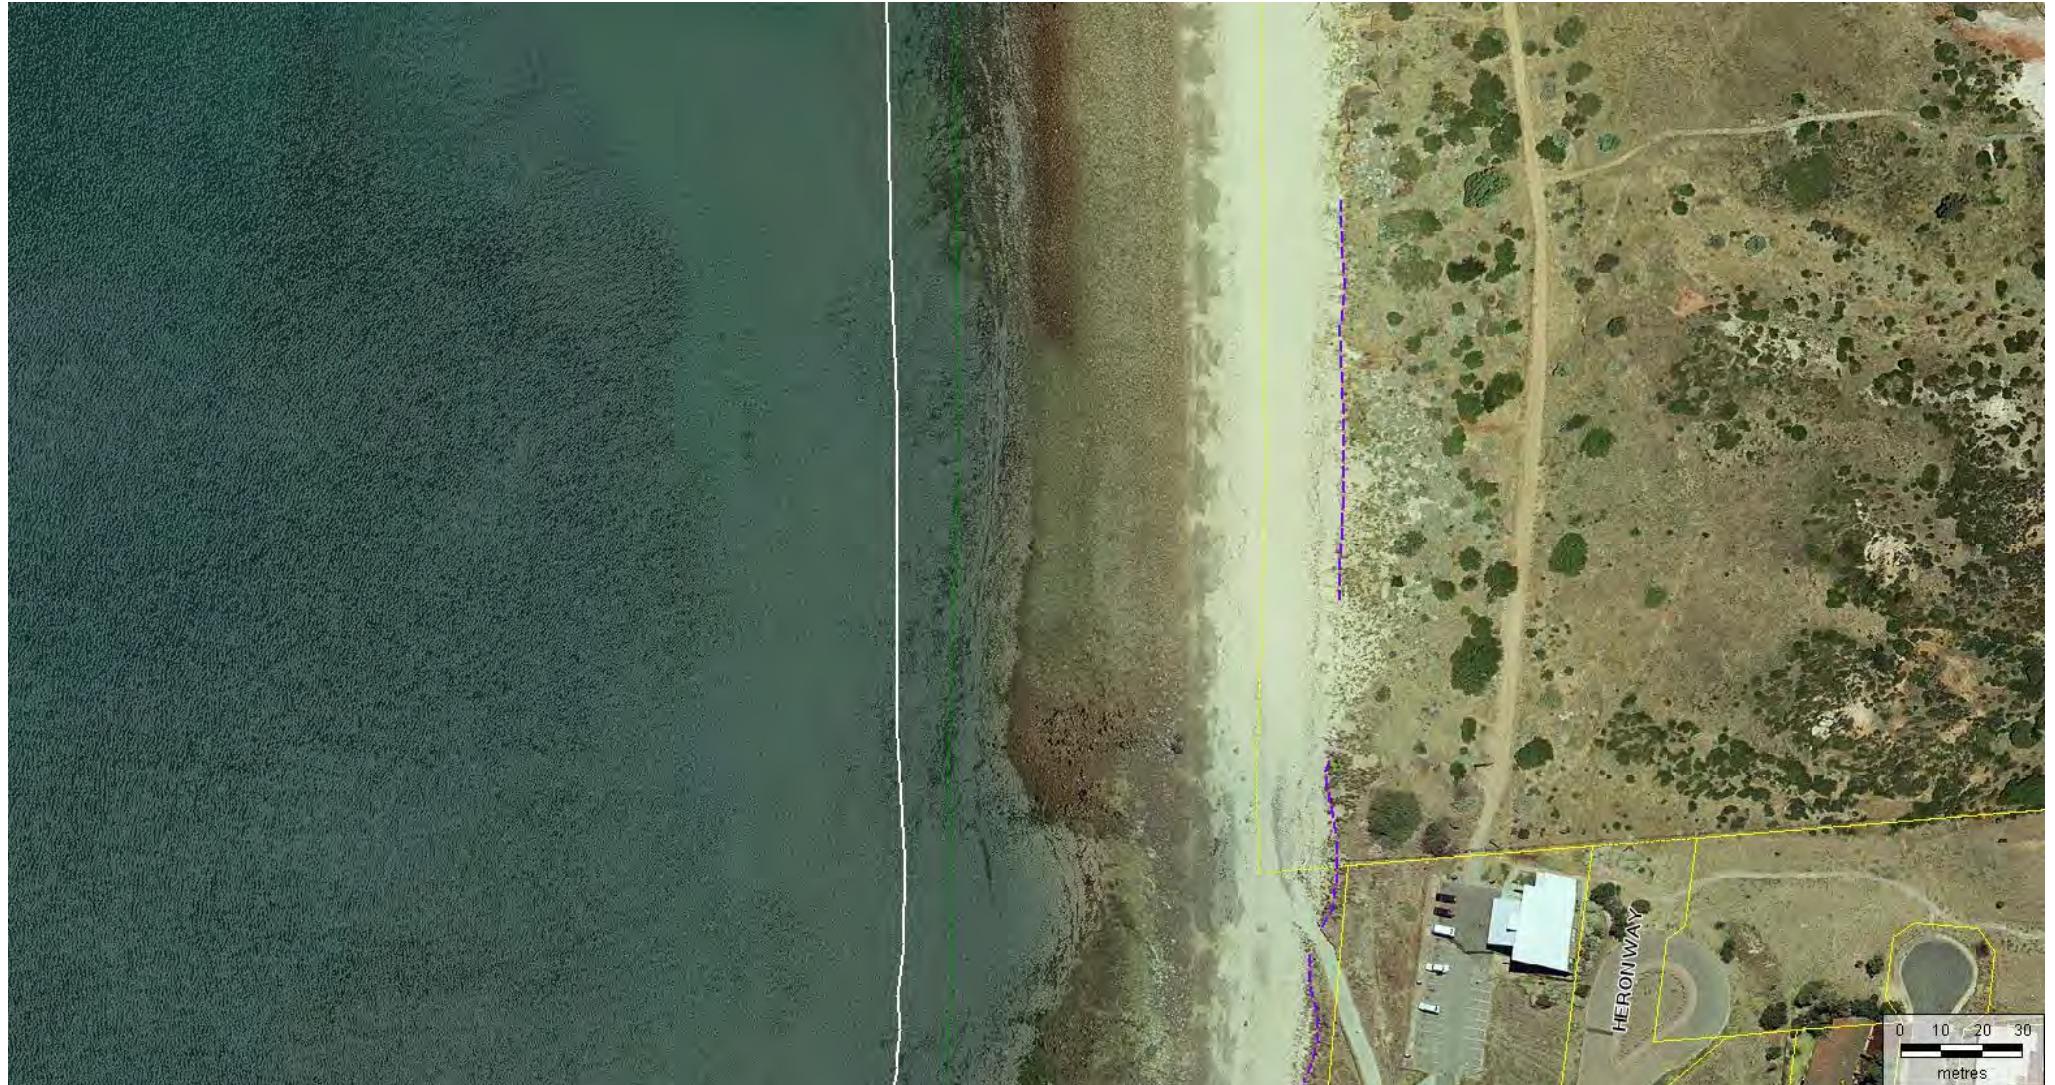
**Hallett Beach 3:2**  
**Erosion assessment**  
Event: 2017  
Risk: Shoreline recession  
Date: 12 May 2018

Some minor recession of the vegetation line at the base of the dunes is noted in places (1-2 m)

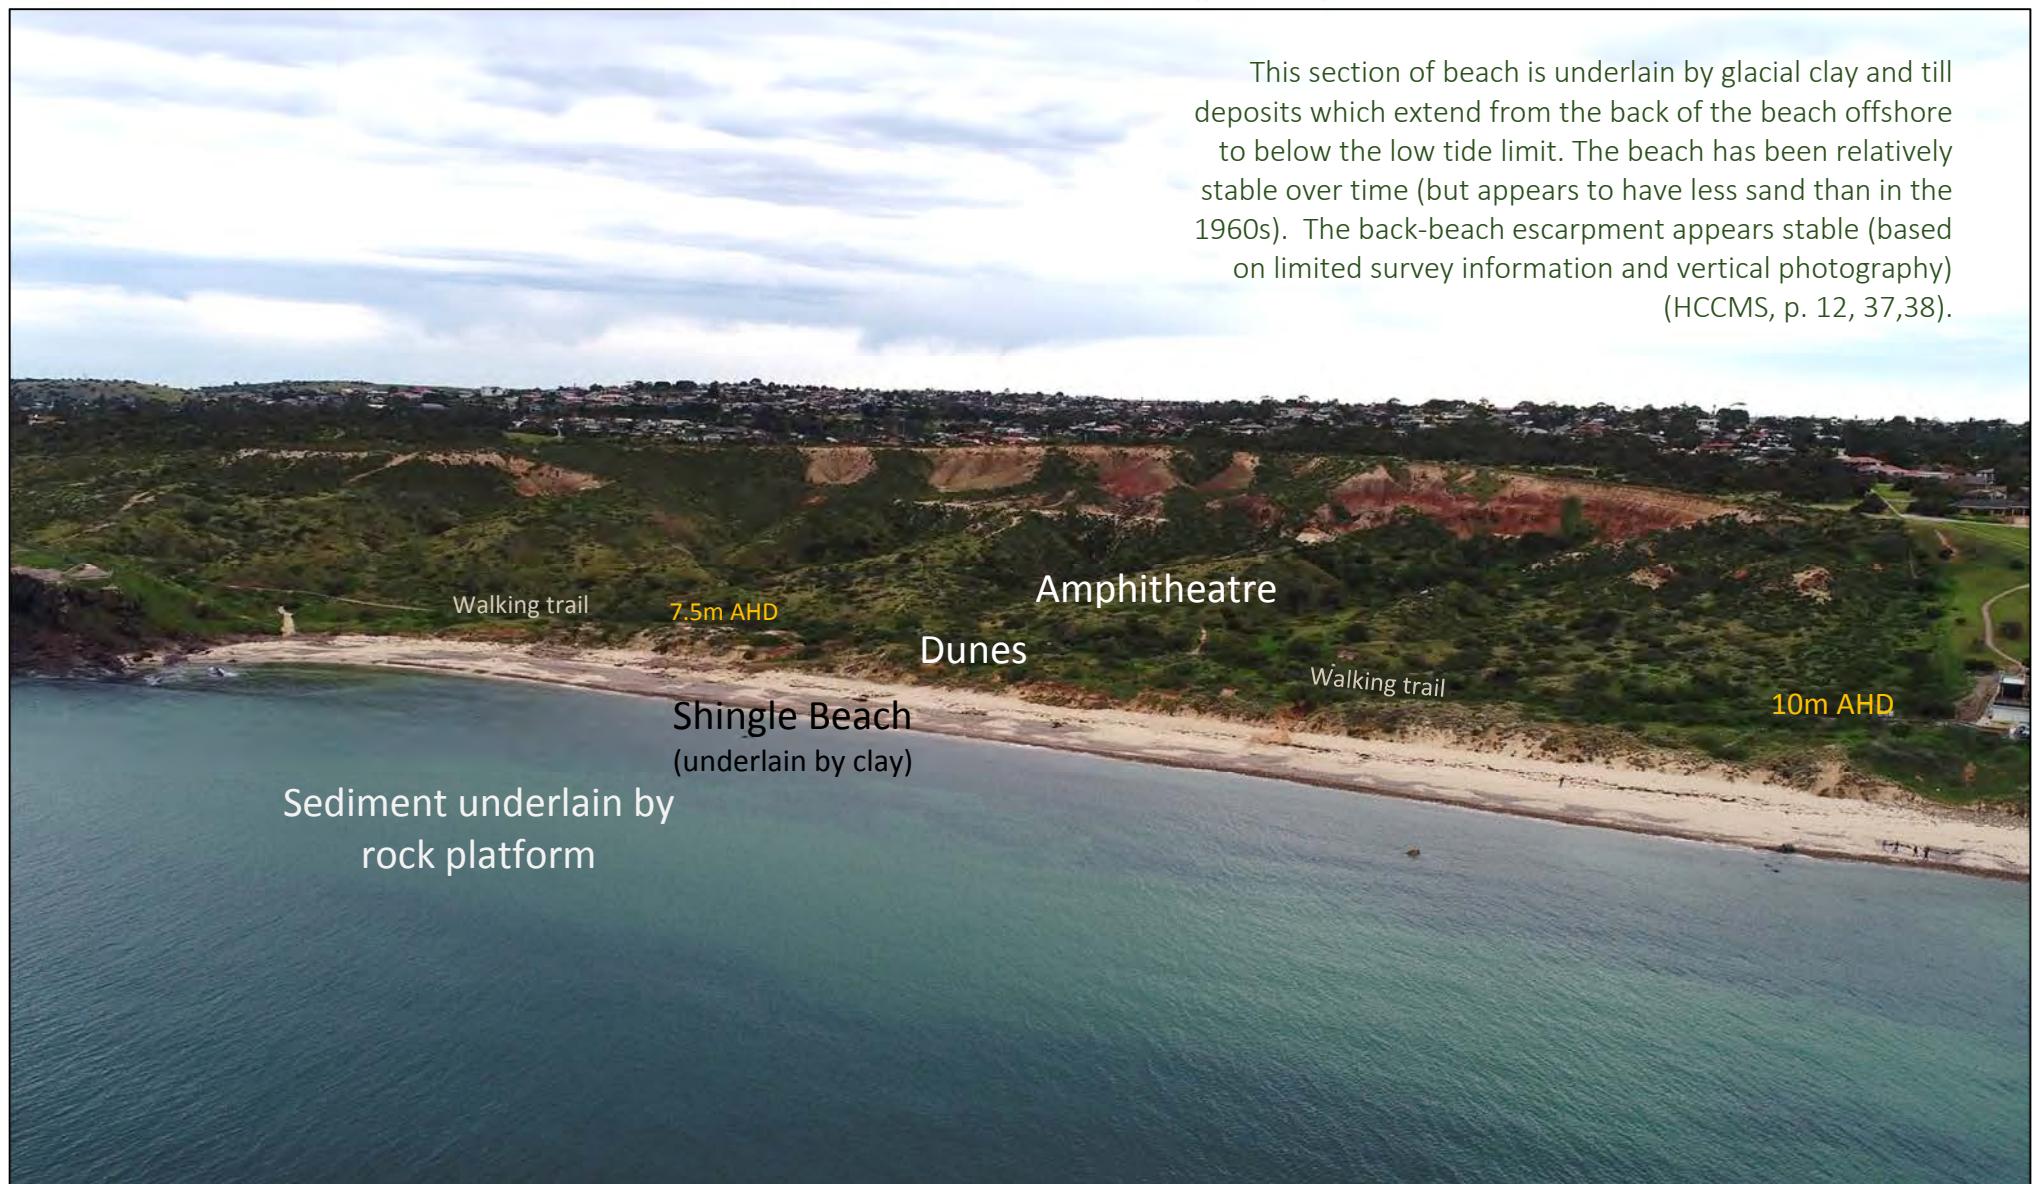
## Section 3: Hallett Beach (north)

Stormwater drains from the amphitheatre to the beach (nil water from urban environments). Storm water is compromising the dunes in three places. Combined with higher storm surges, the dunes are likely to degrade more quickly and impact the walking trail behind.

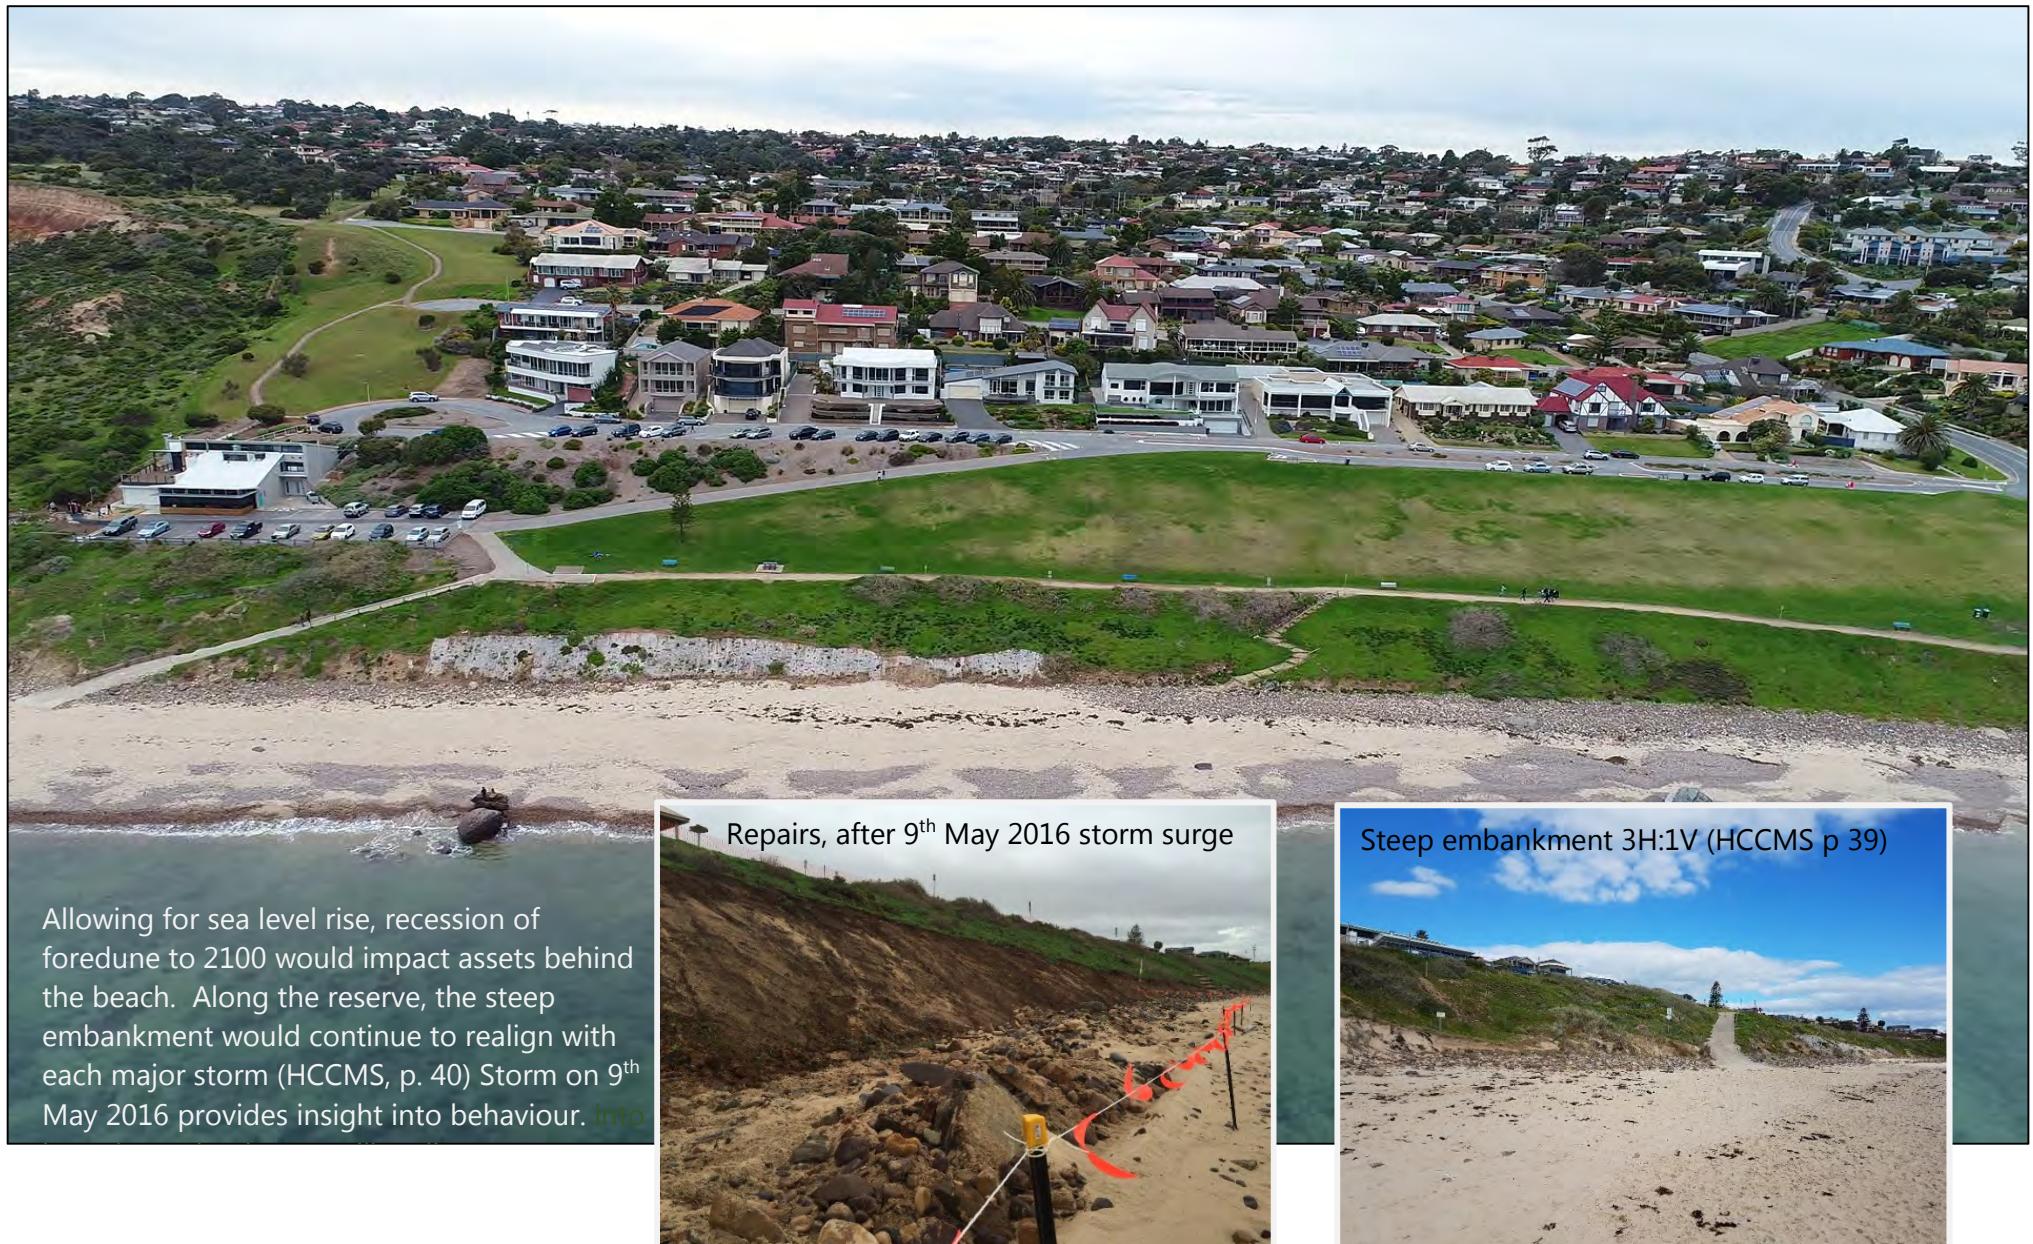
Allowing for sea level rise, recession of foredune to 2100 would impact assets behind the beach. Along the reserve, the steep embankment would continue to realign with each major storm (HCCMS, p. 40) Storm on 9<sup>th</sup> May 2016 provides insight into behaviour. [into](#)

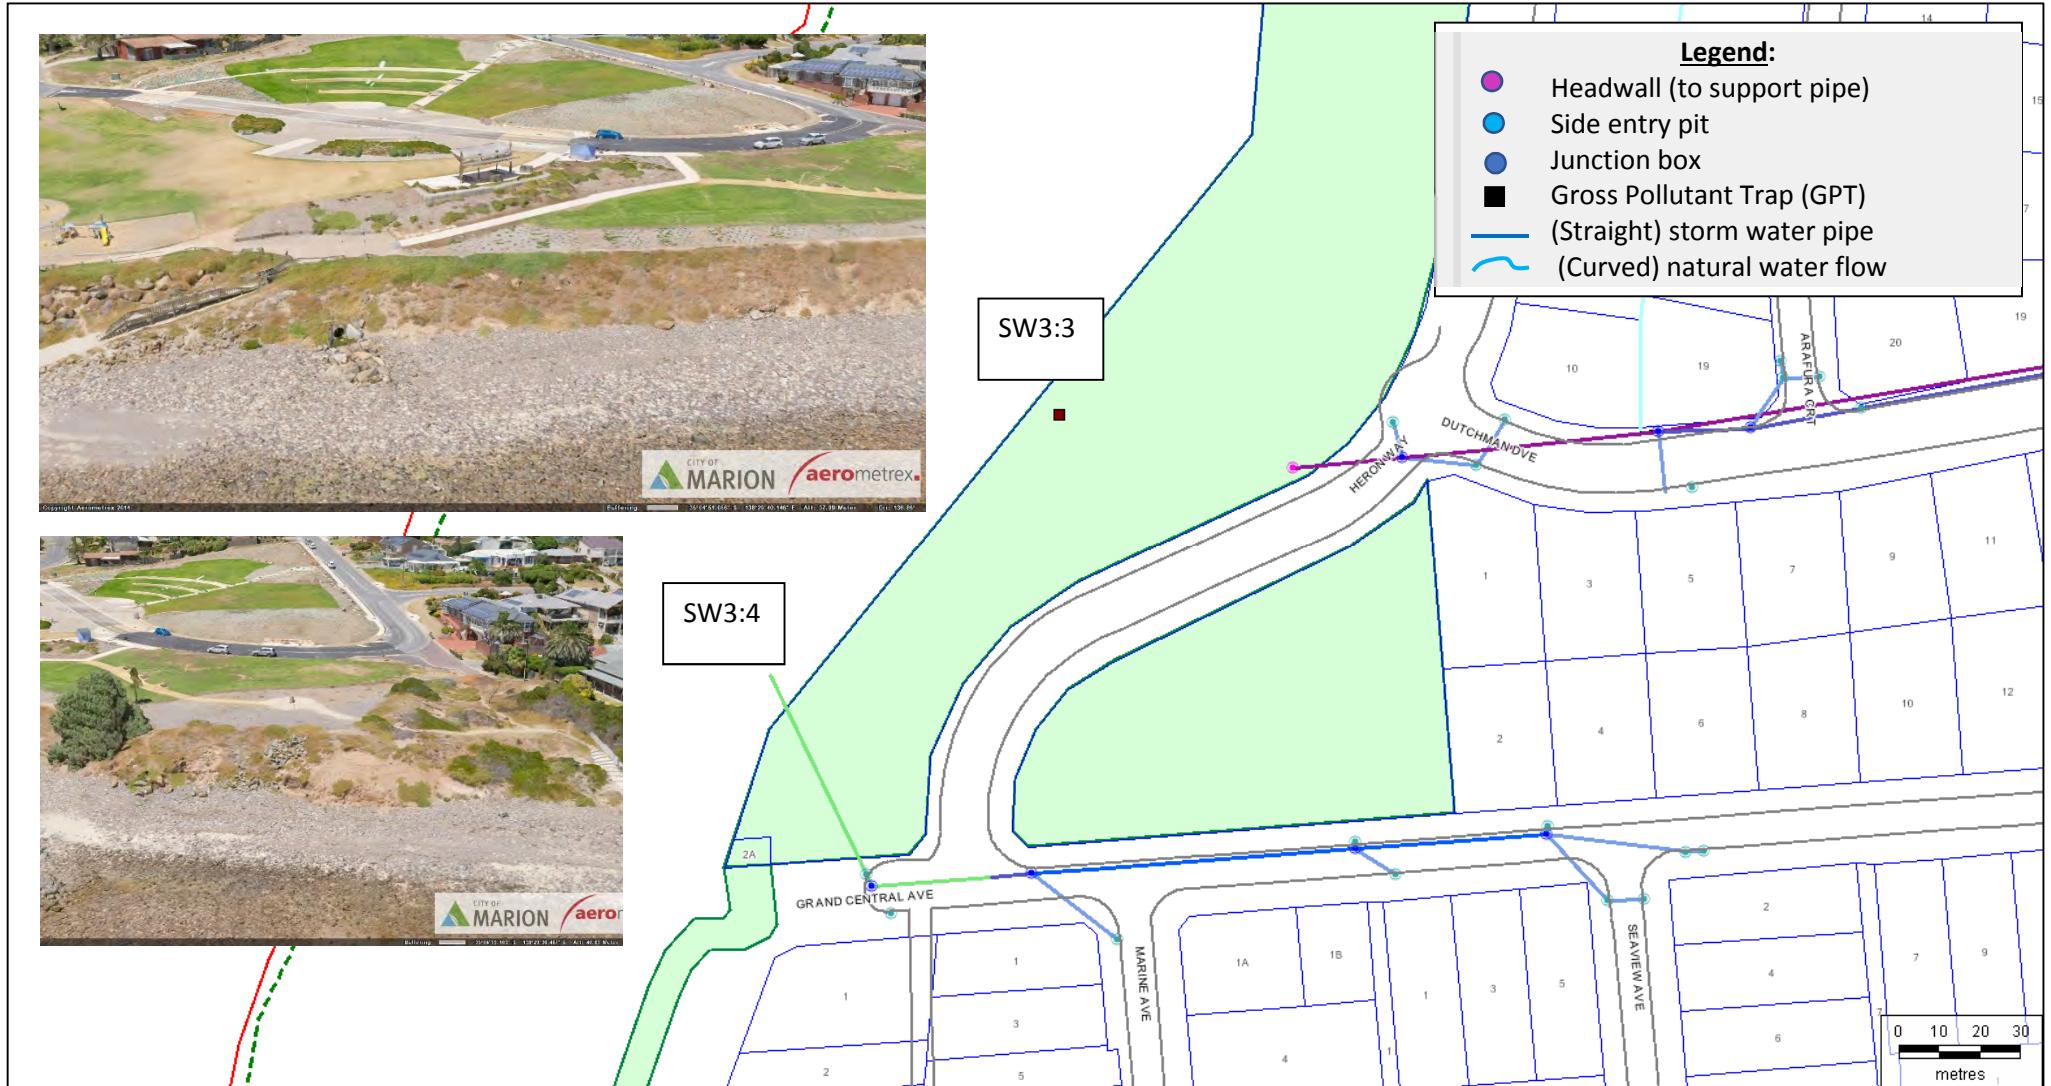
#### Hallett Beach 3:4 Erosion assessment

SW3:3 GPT installed at 'pink dot'. Headwall to ocean outfall. Some evidence of erosion on beach (rocks installed to limit erosion)  
SW3.4 Southpoint (2012) recommended GPT to be installed. CoM not yet installed (unsure of priority) (MW...can't locate outfall...in rock area?)

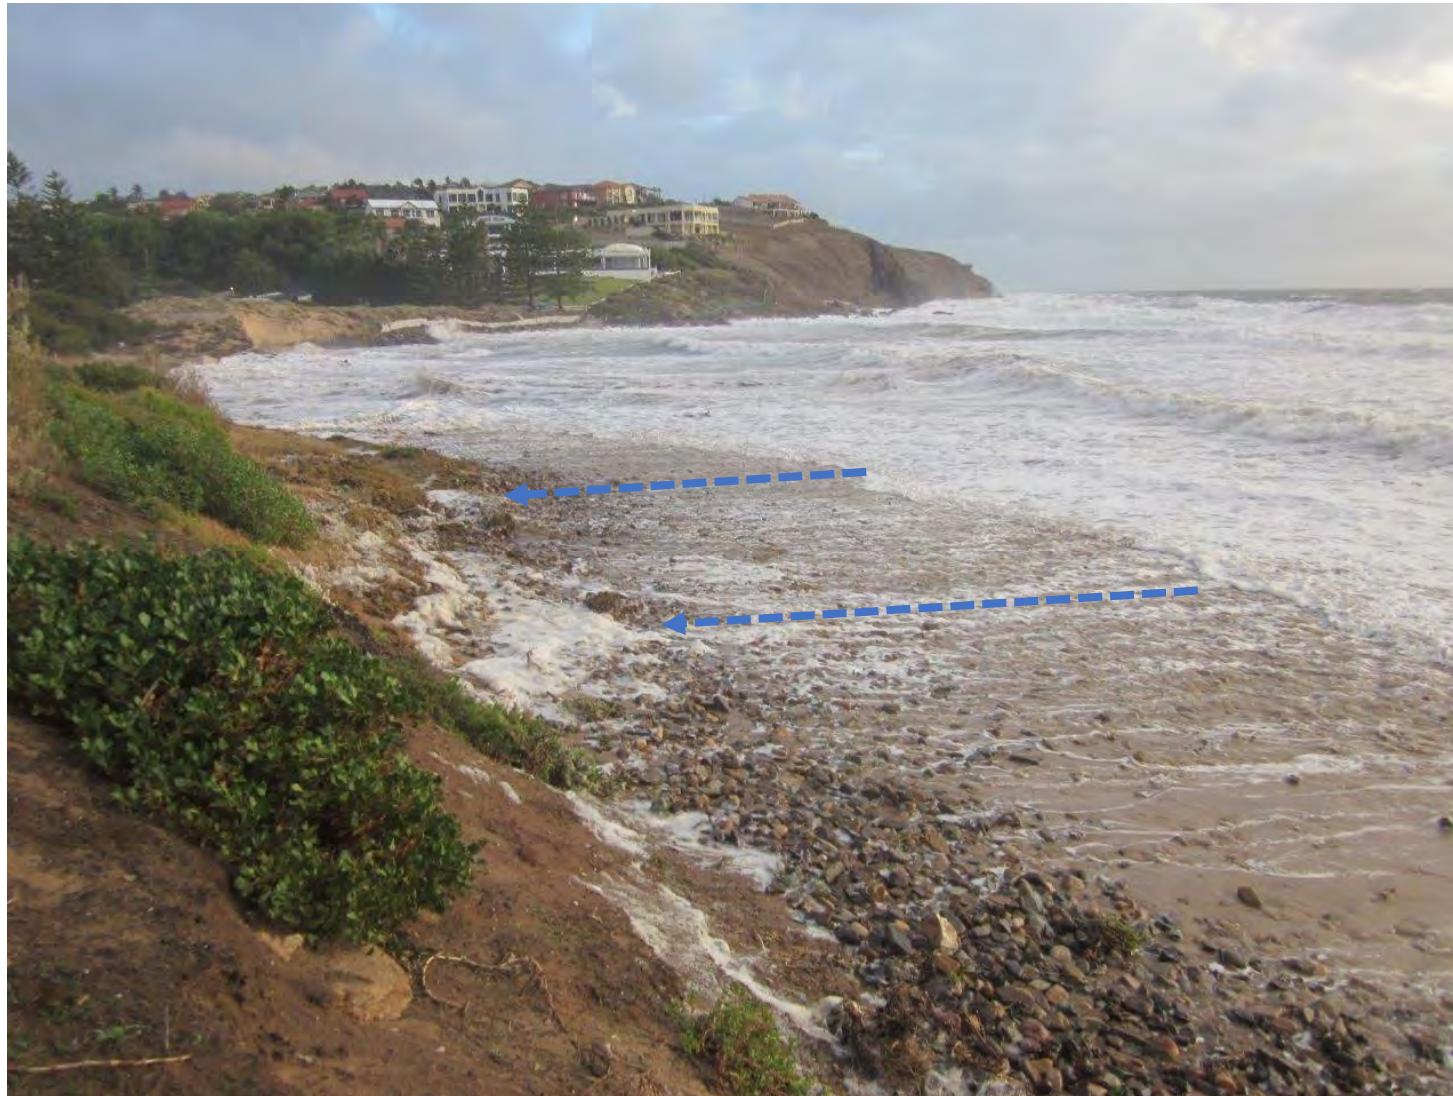
#### Field River 4:1 Historical Event

Photographs taken by Damian Landrigan at observed height of the storm, approximately between 17:50 and 18:15 (although colour in sky suggests it may have been slightly earlier). (Photographs used with permission). The pattern in the photograph above is effectively reproduced with a storm surge and wave height of 2.43m AHD, with wave run-up elevating the storm tide further up the beach.

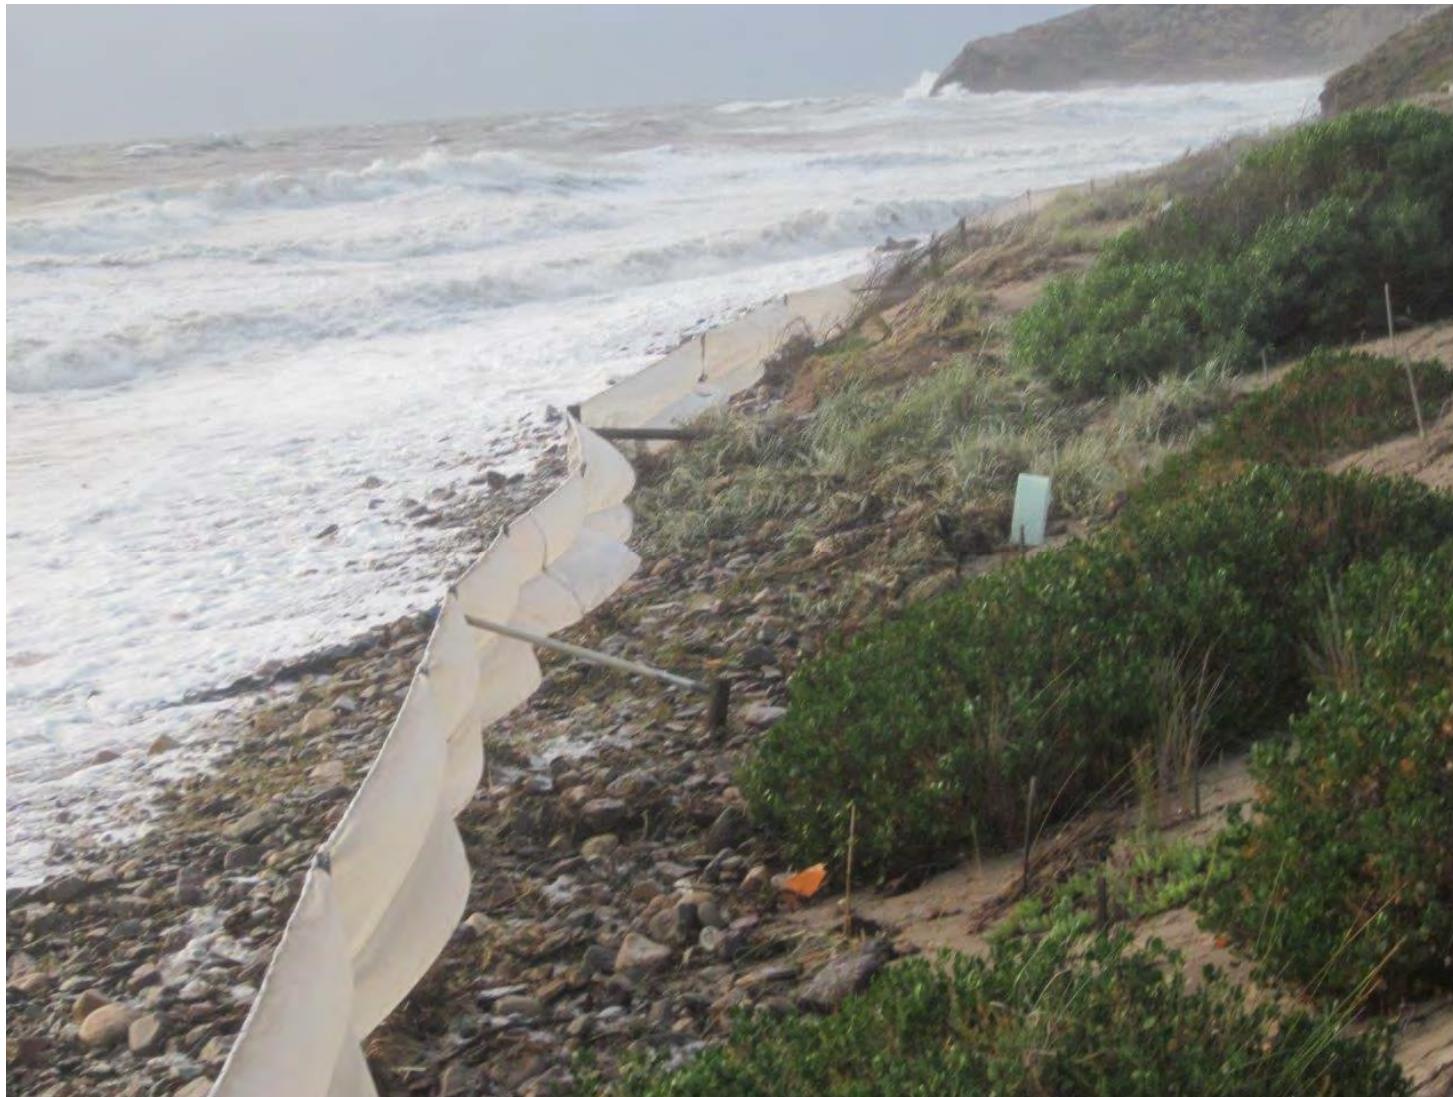
#### Field River 4:1 Historical Event

Photographs taken by Damian Landrigan at observed height of the storm, approximately between 17:50 and 18:15 (although colour in sky suggests it may have been slightly earlier). (Photographs used with permission). The pattern in the photograph above is effectively reproduced with a storm surge and wave height of 2.43m AHD, with wave run-up elevating the storm tide further up the beach.

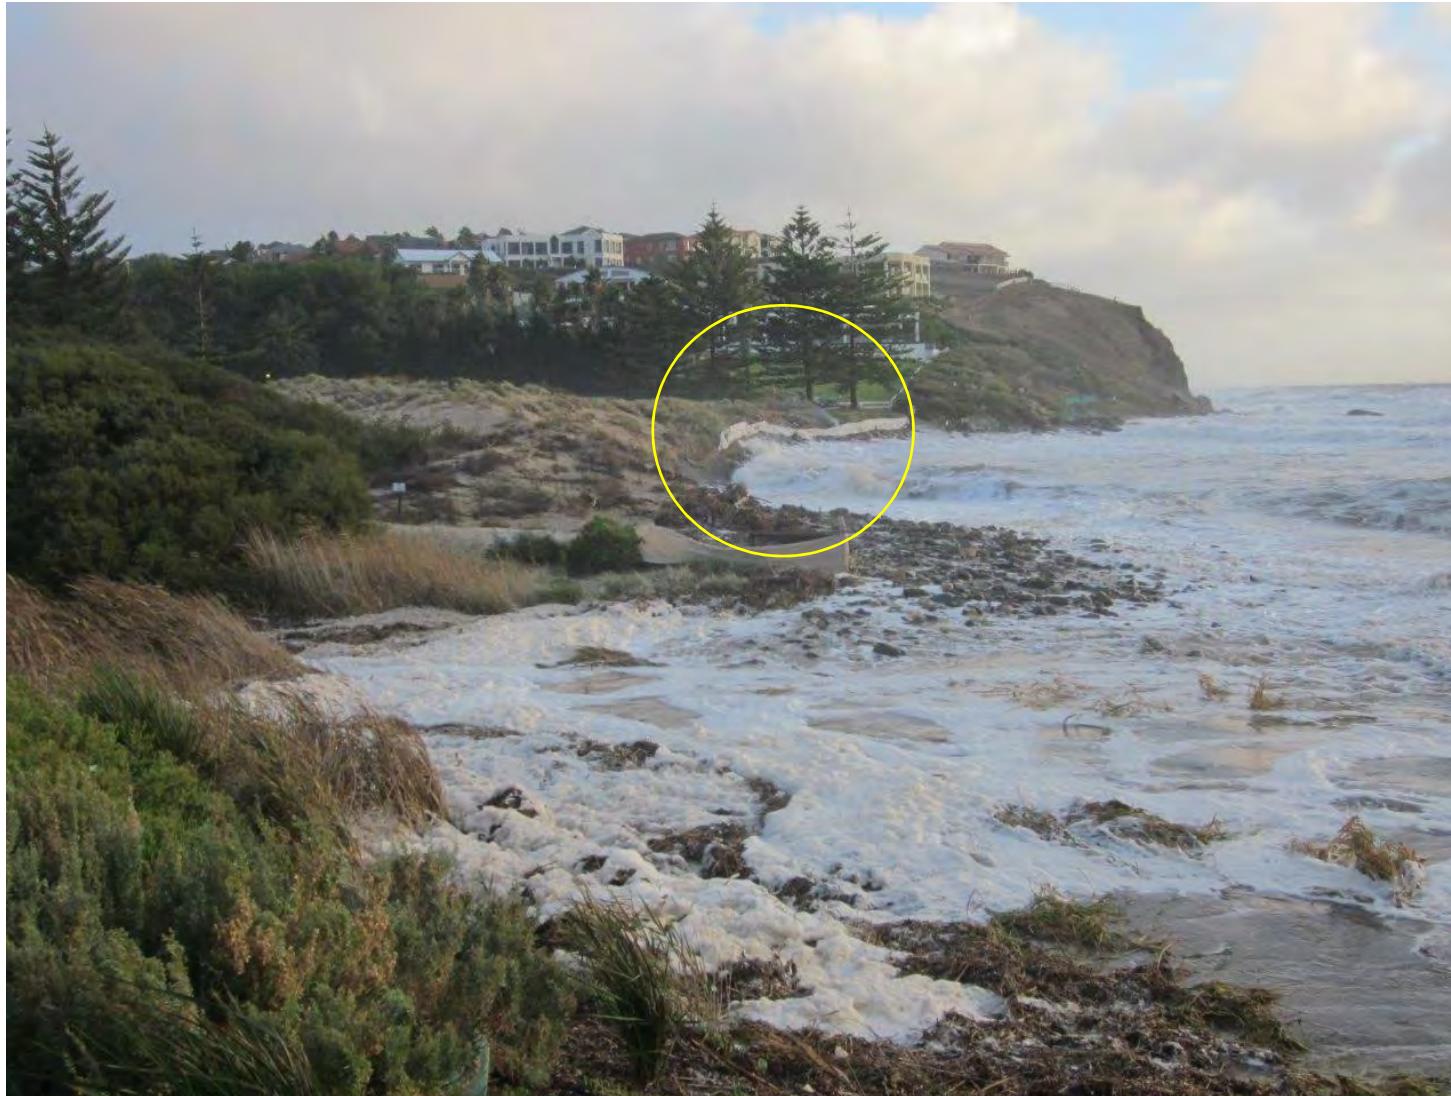
#### Field River 4:1 Historical Event

Photographs taken by Damian Landrigan at observed height of the storm, approximately between 17:50 and 18:15 (although colour in sky suggests it may have been slightly earlier). (Photographs used with permission). The pattern in the photograph above is effectively reproduced with a storm surge and wave height of 2.43m AHD, with wave run-up elevating the storm tide further up the beach. Note the impact of the storm surge on the dune. Doug Lord (2012) maintains that the removal of the rocks from the foreshore is exacerbating the impact of the storm surge upon the dune.
