City of Marion

# Coastal Climate Change Adaptation Study

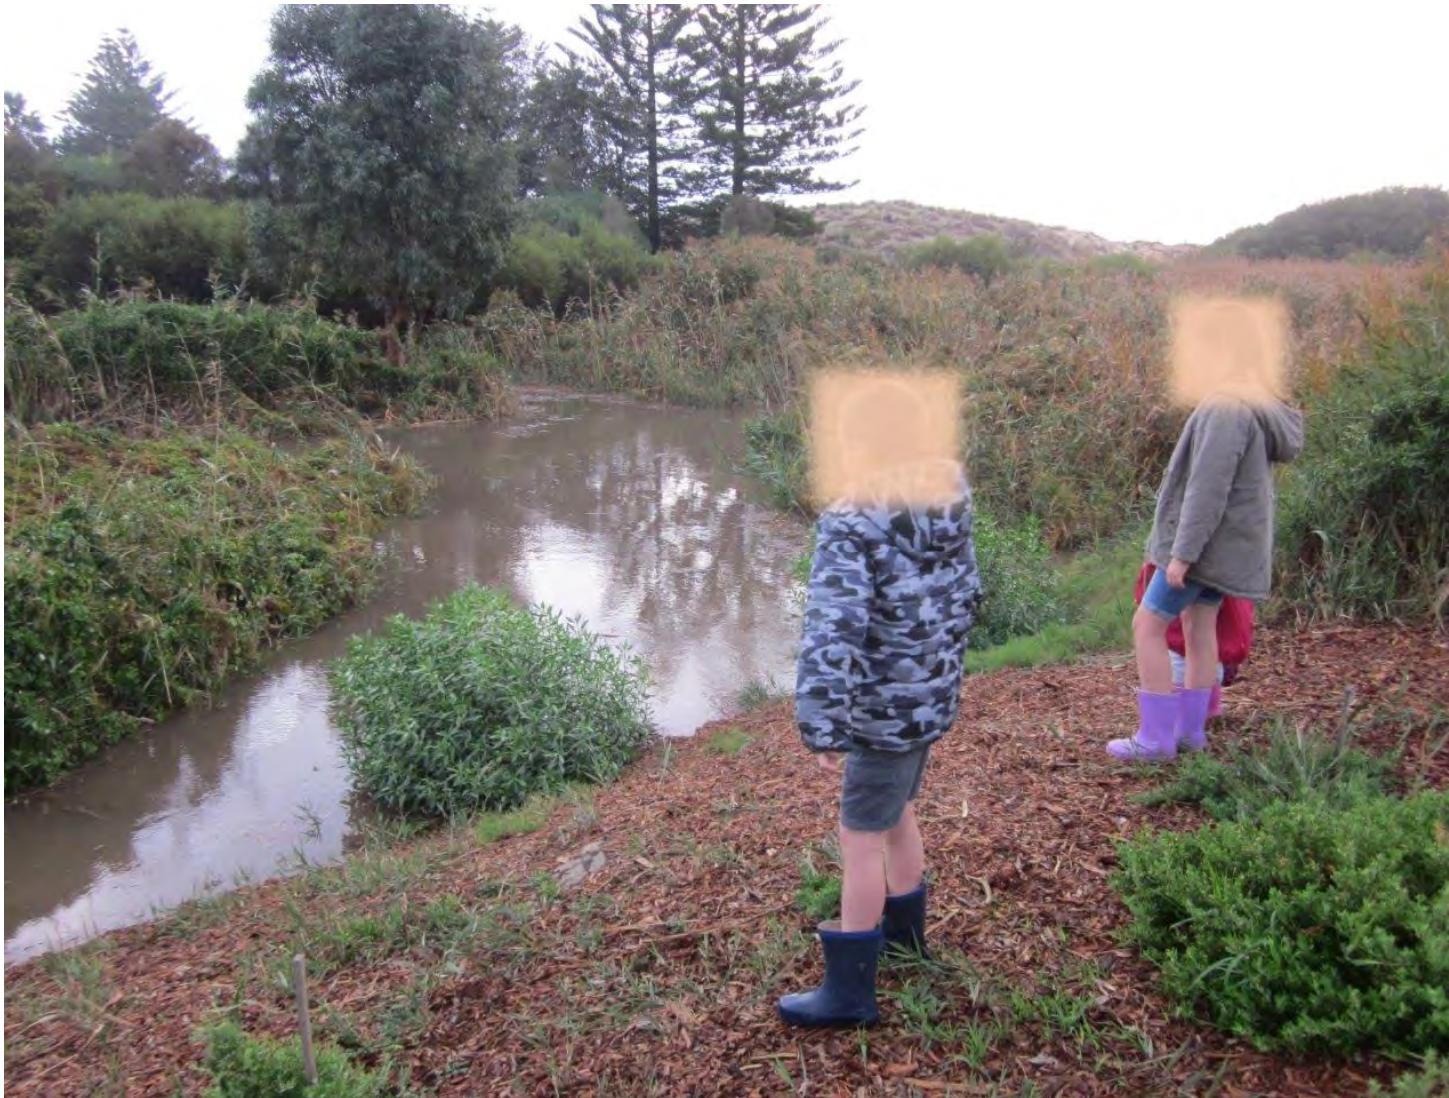
#### Field River 4:2 Historical Event

Photographs taken by Damian Landrigan at observed height of the storm, approximately between 17:50 and 18:15 (although colour in sky suggests it may have been slightly earlier). (Photographs used with permission). Sea-water flowed into Field River (this height could be estimated from the survey data but not from the digital model. Photogrammetry does not handle vegetation well)

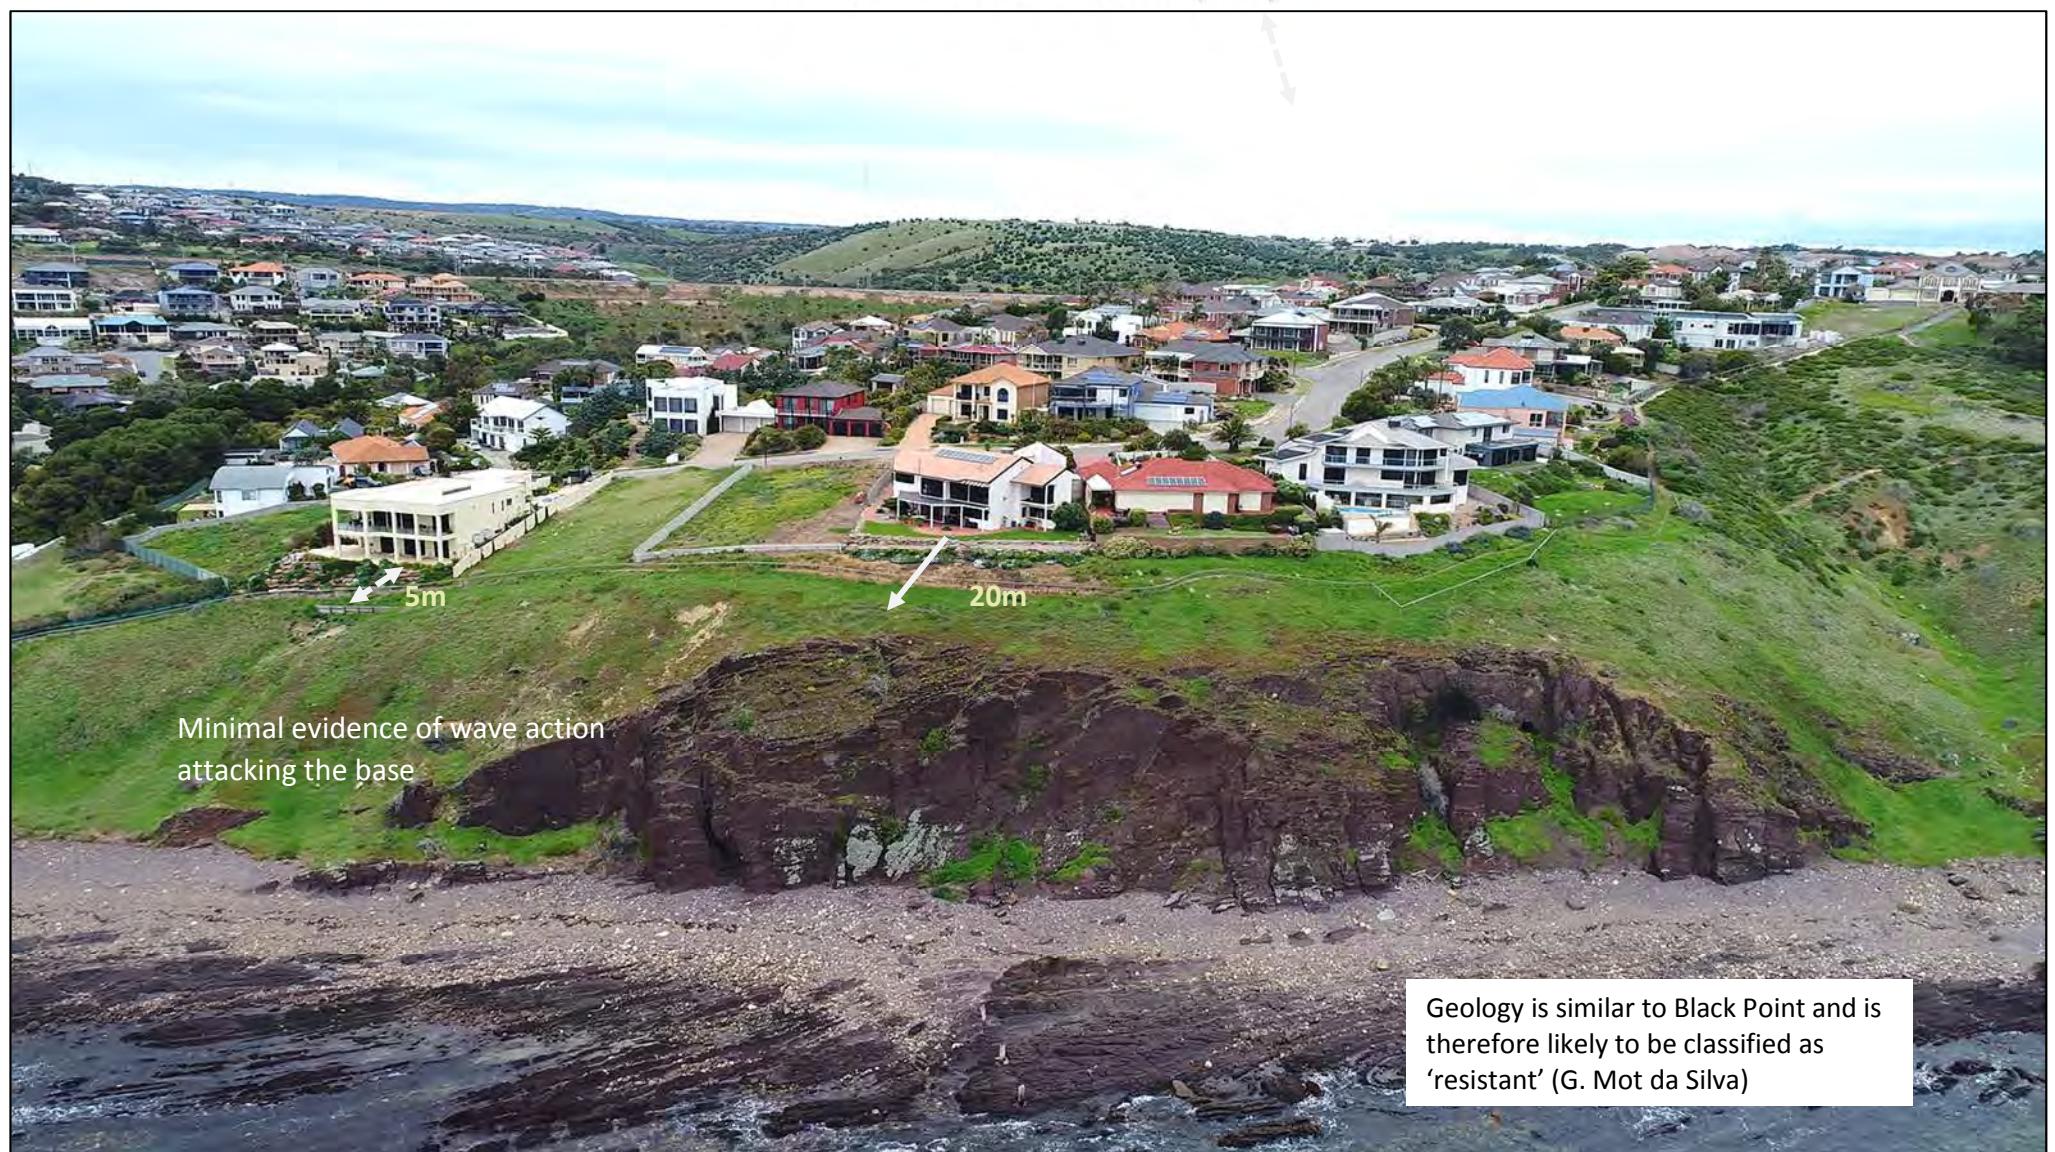
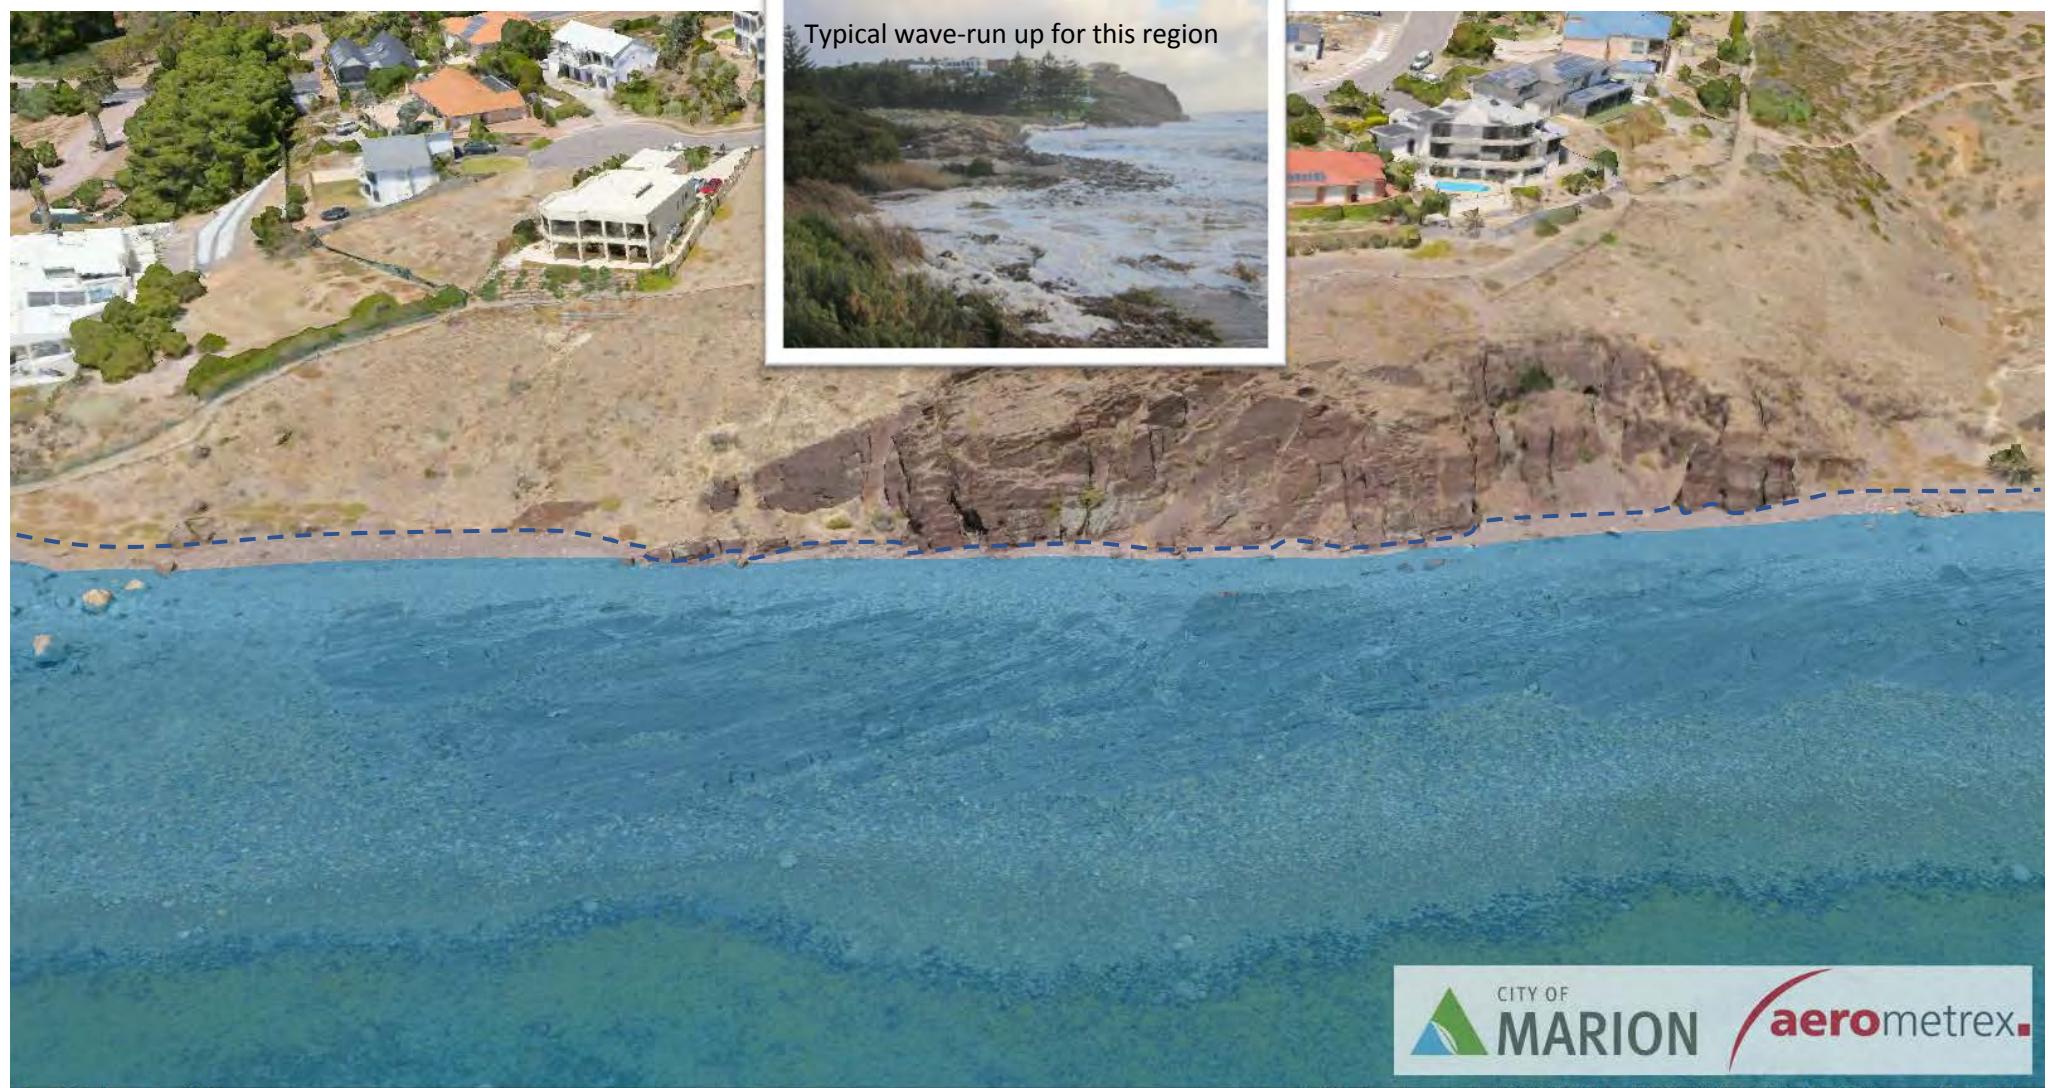
## Cell 5: Southern Cliffs (5:1)

One house is close to the top of the escarpment, but the slope of the embankment is quite low. By 2100, it is likely the base of the cliff will be inundated more frequently, allowing direct wave action against the base of the cliffs. Routine monitoring of the cliff condition and stability should be undertaken (particularly the discharge of stormwater) HCCMS, P. 45

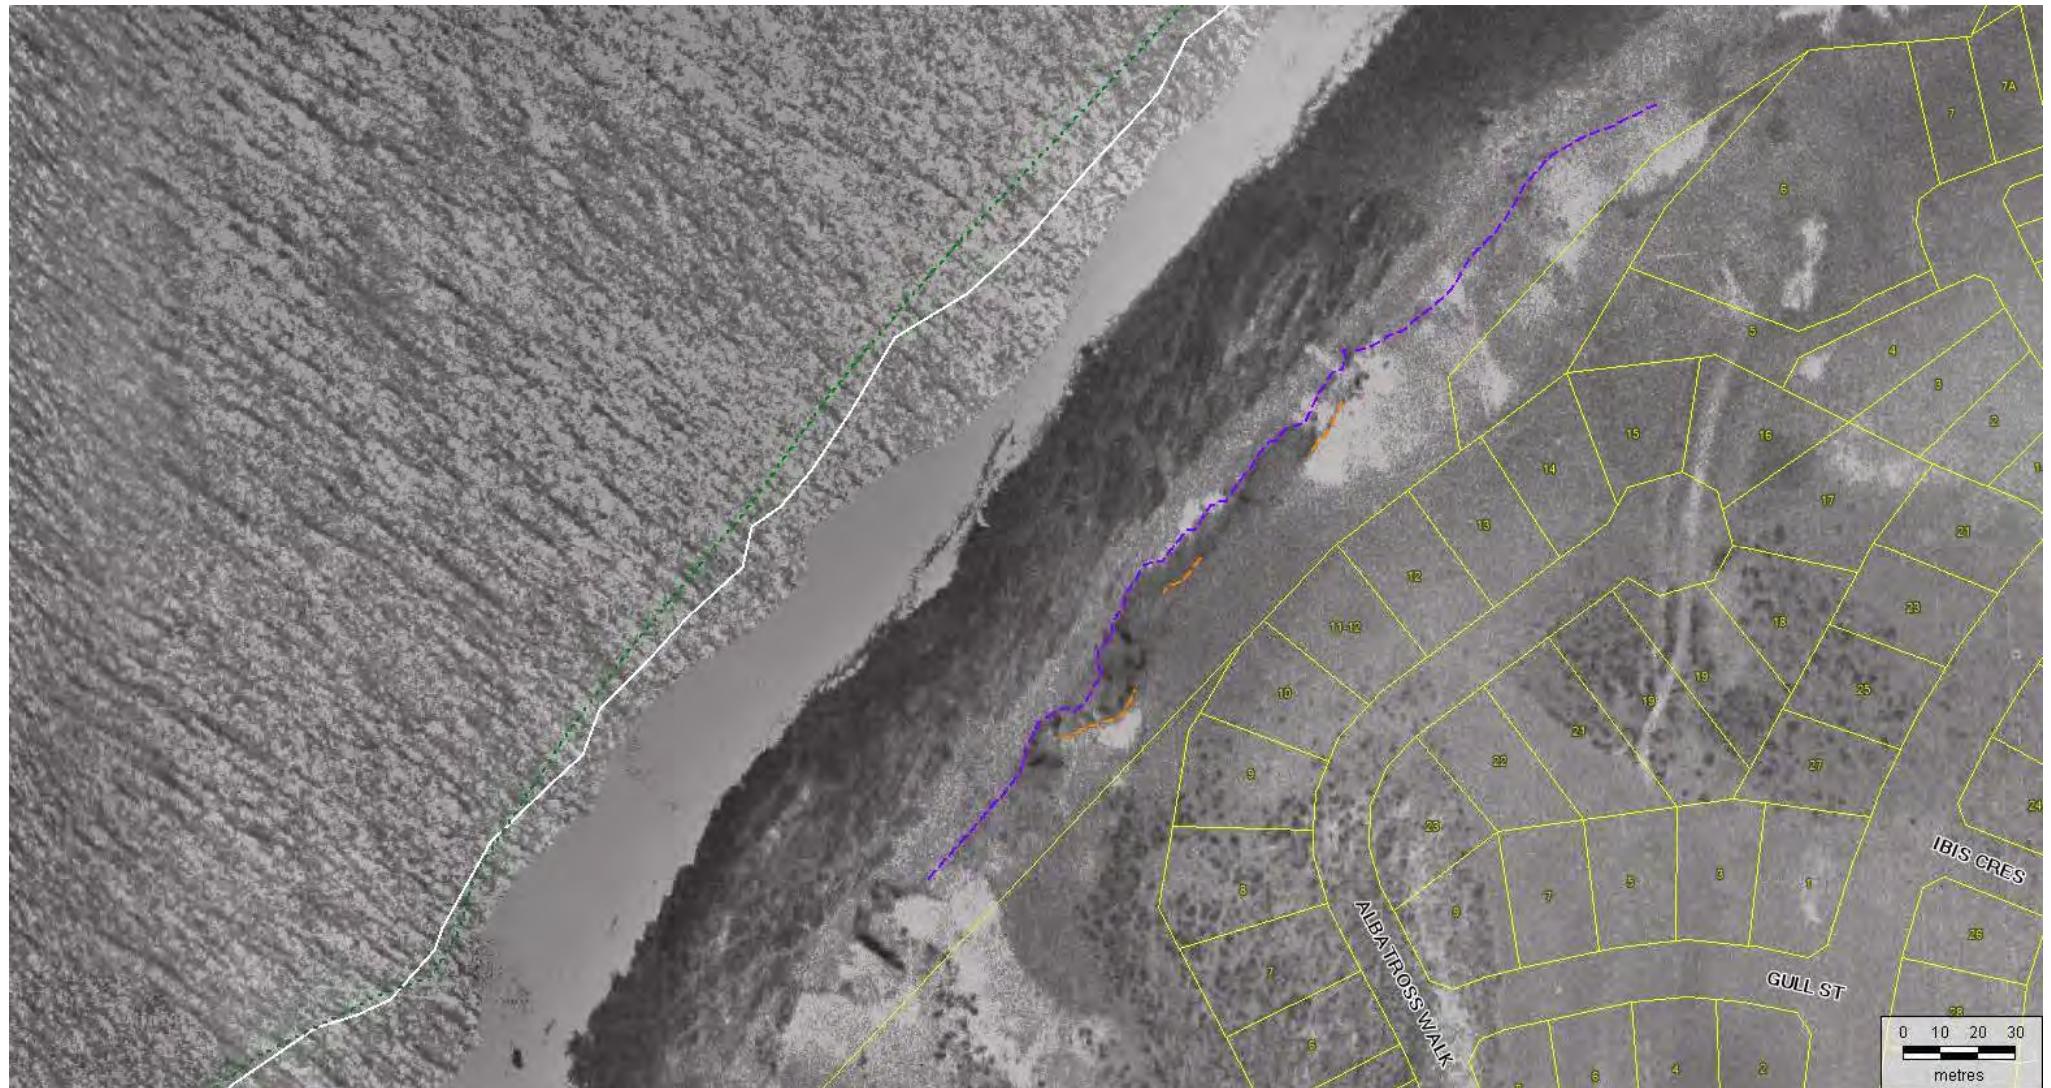
**Southern Cliffs 5:1 Erosion assessment**  
Event: 2002  
Risk: Shoreline recession  
Date: 12 May 2018

Difficult to assess, but top of escarpment appears to be in the same position. More scouring and cracking is observed in later photographs.

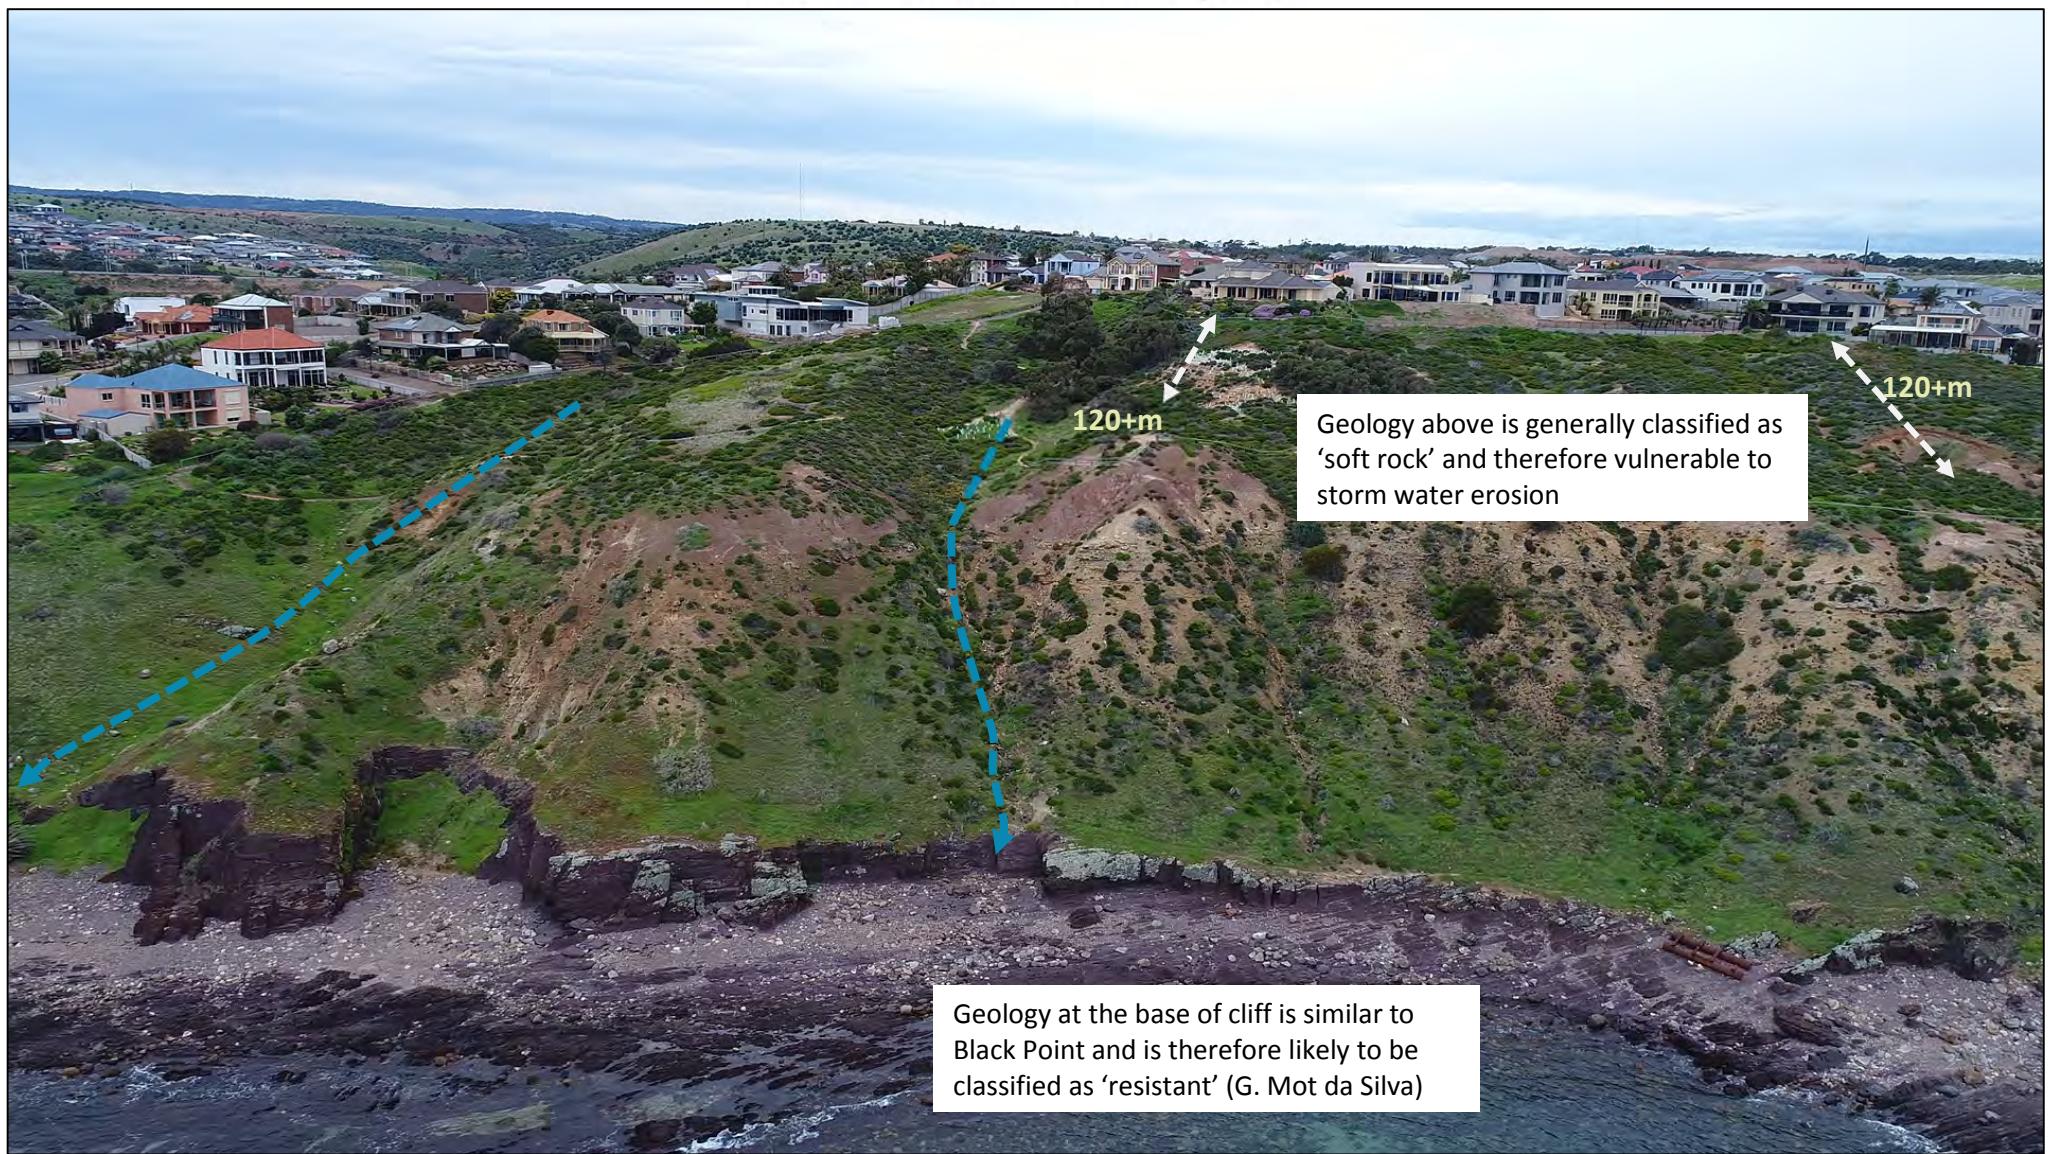
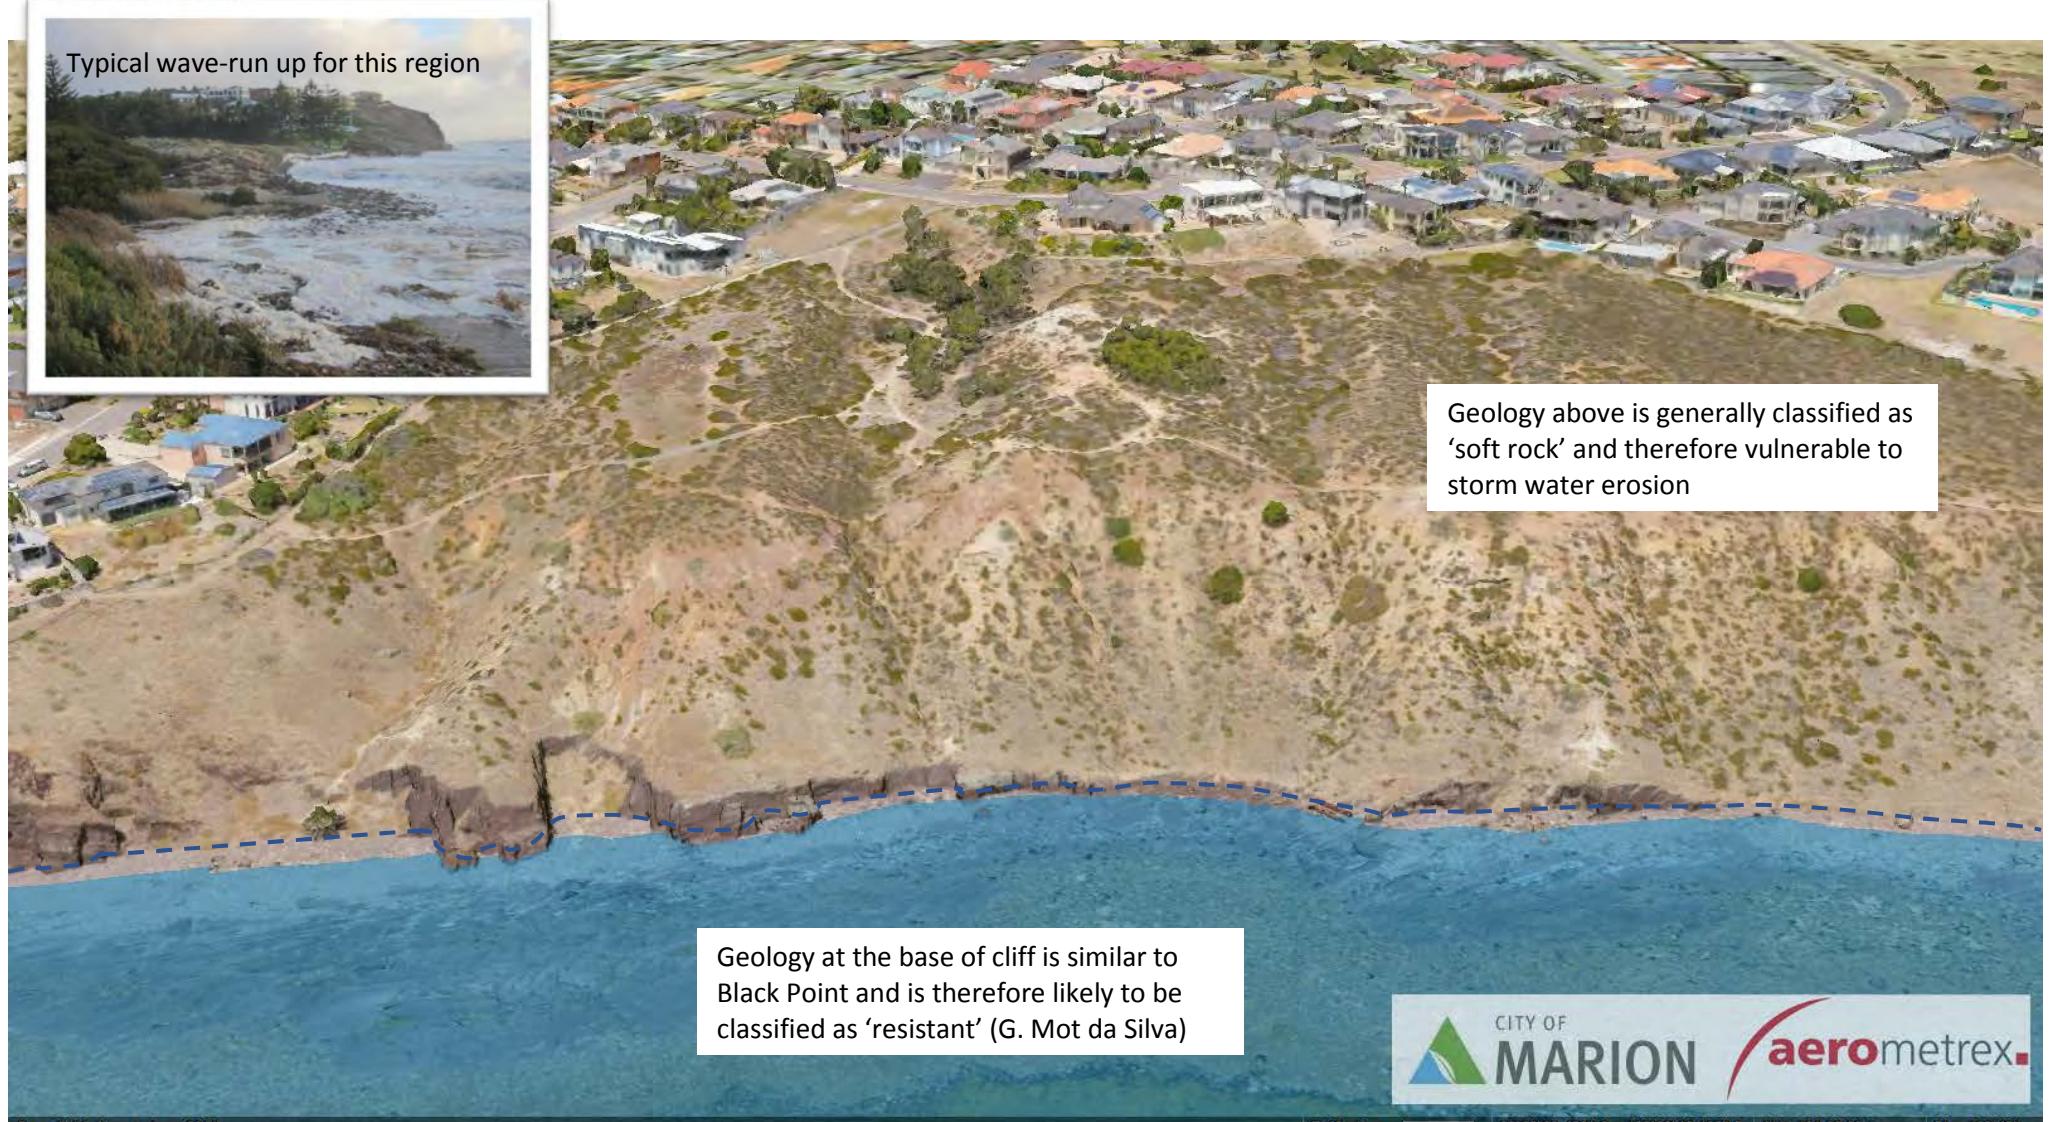
## Cell 5: Southern Cliffs (5:2)

All private and public infrastructure is set well-back from cliffs. By 2100, it is likely the base of the cliff will be inundated more frequently, allowing direct wave action against the base of the cliffs. Routine monitoring of the cliff condition and stability should be undertaken (particularly the discharge of stormwater) HCCMS, P. 45

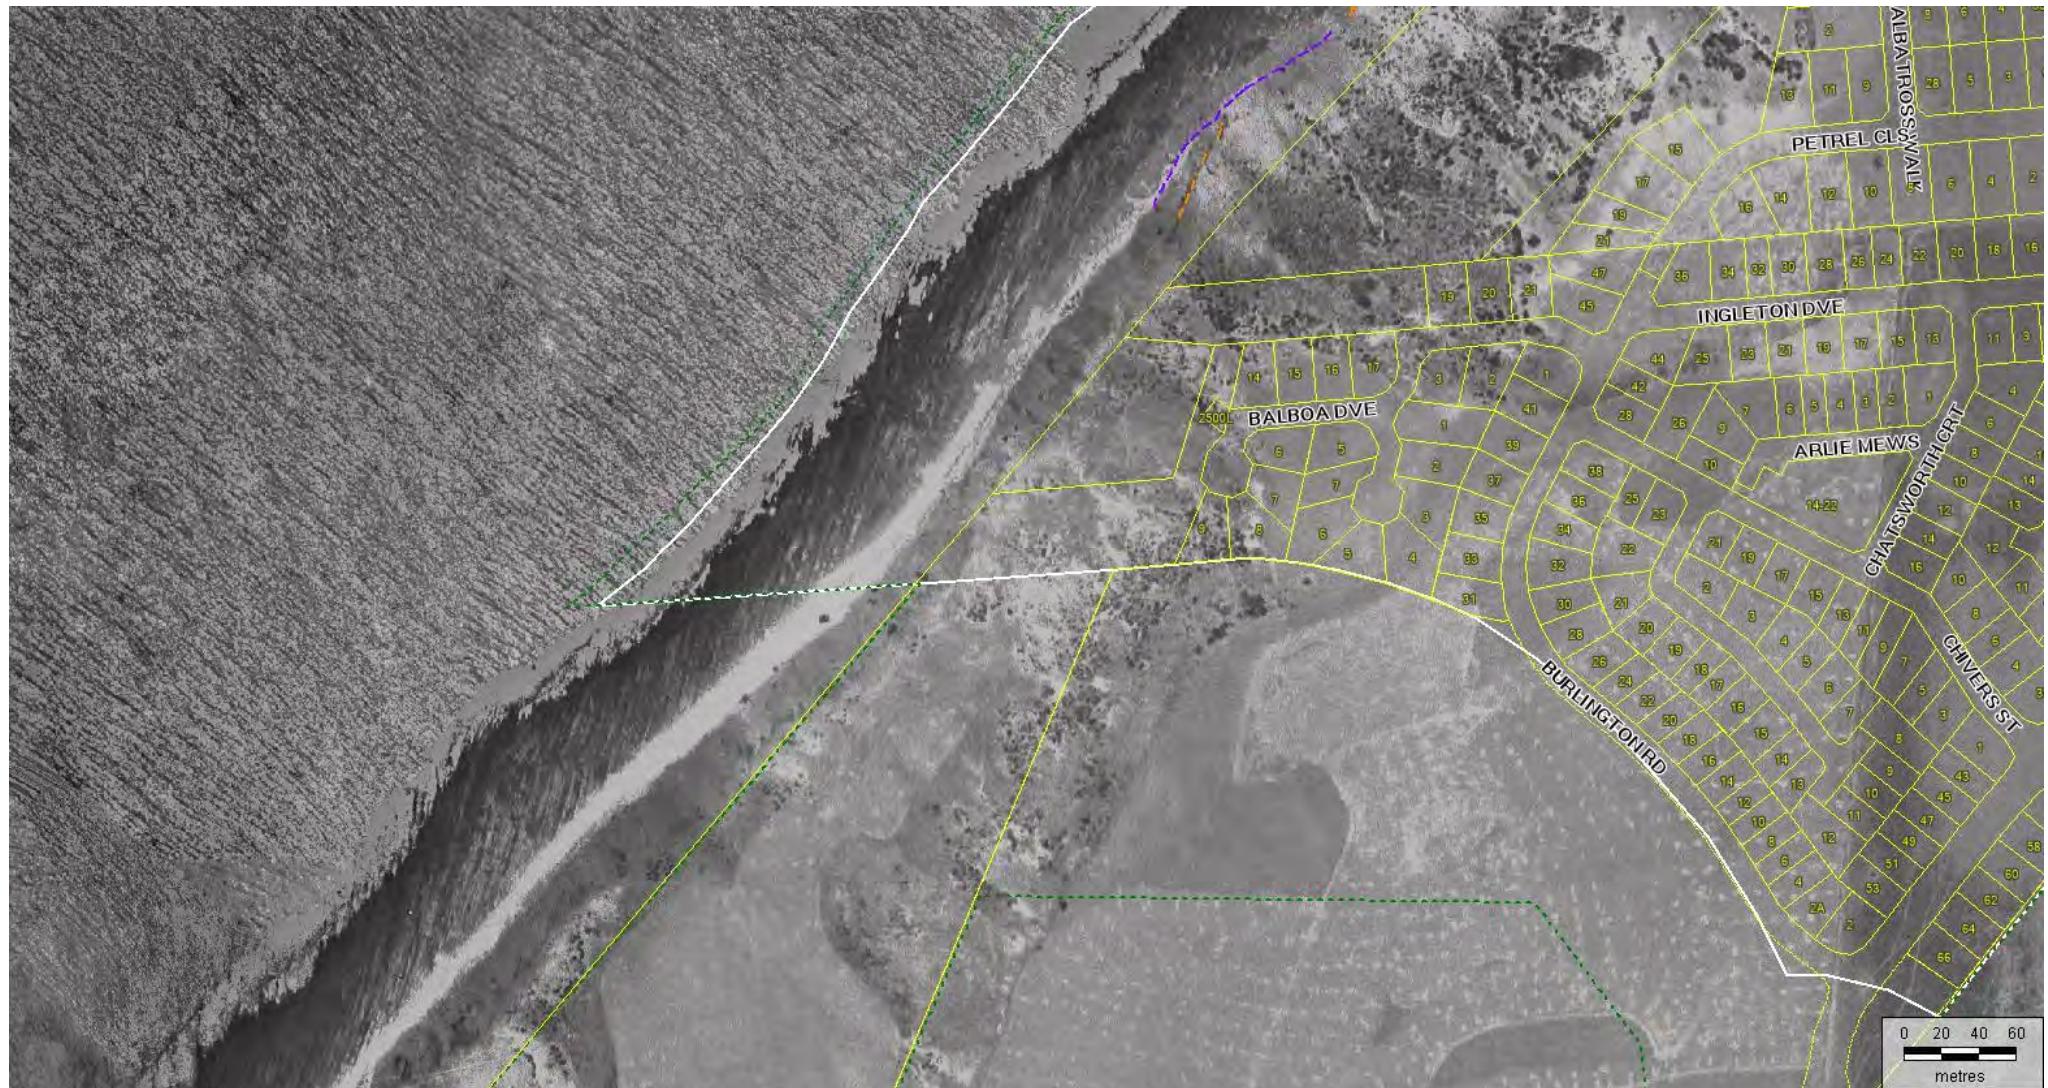
**Southern Cliffs 5:3**  
**Erosion assessment**  
Event: 2002  
Risk: Shoreline recession  
Date: 12 May 2018

The top and bottom of this cliff escarpment appear in the same location and condition as photograph in 2017.
