# GEO-ANOM Task 1 — Field Labeling Guide

Decision rules, the specific farms worth checking in person (with the **real structure coordinates**), and the satellite screenshots behind every call. Updated 2026-09-23. Companion file: GEO-ANOM\_Task1\_Field\_Map.kmz (same layers, offline in Google Earth).

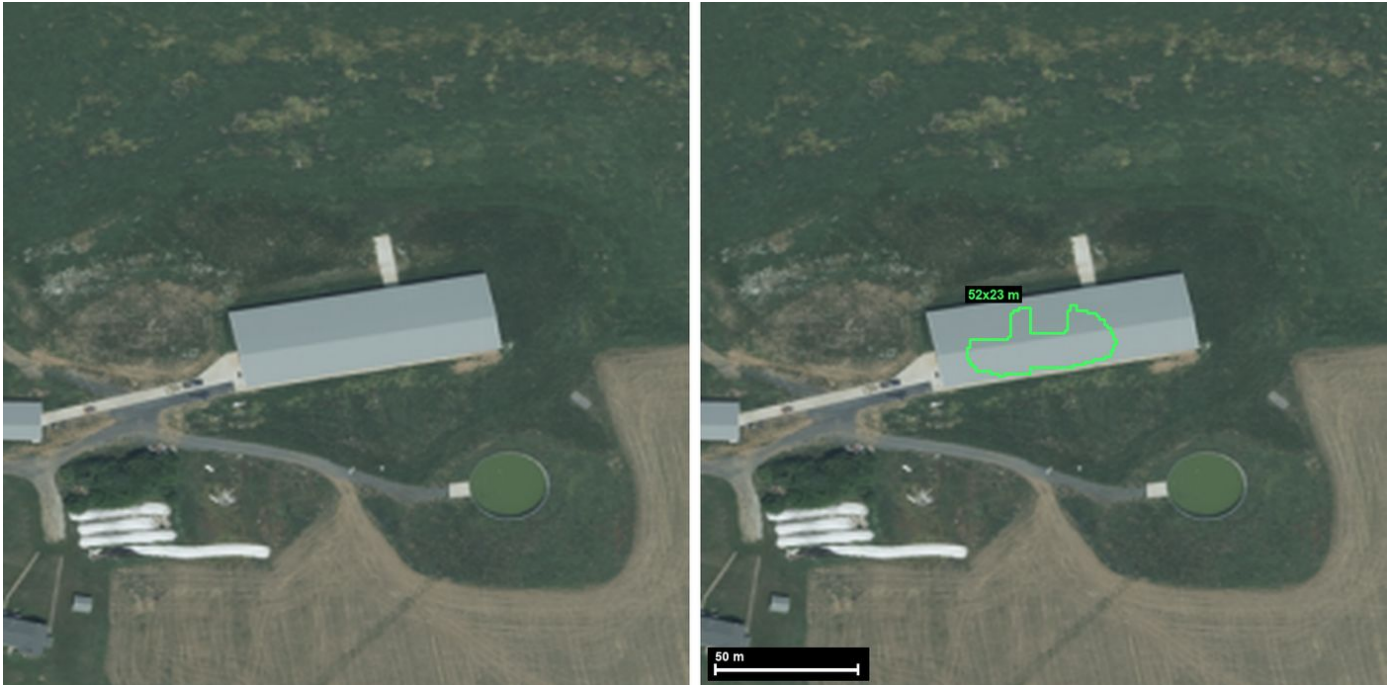
#### [A1] Beef: Dwight Brandenburg / Brandenburg Family LP (Frederick)

| Farm | County | Go to (structure) | Structure is, from permit pt | What to check |
|---|---|---|---|---|
| Dwight Brandenburg / Brandenburg Family LP | Frederick | 39.40455, -77.62259 | 861 m SE | Imagery shows a real ~65x27 m barn, silage bags, a round manure store (A1). Species? Head count? What is the round tank? |

Detection added 2026-09-21 by the beef-specific shape exception. A real barn (~65 x 27 m) with silage bags and a round manure store -- but the green outline covers only about half of the roof. The barn is 861 m SE of the registry point; the permit point falls in a hay field, so the registry geocode is off for this farm. Left: clean imagery. Right: green = pipeline detection.

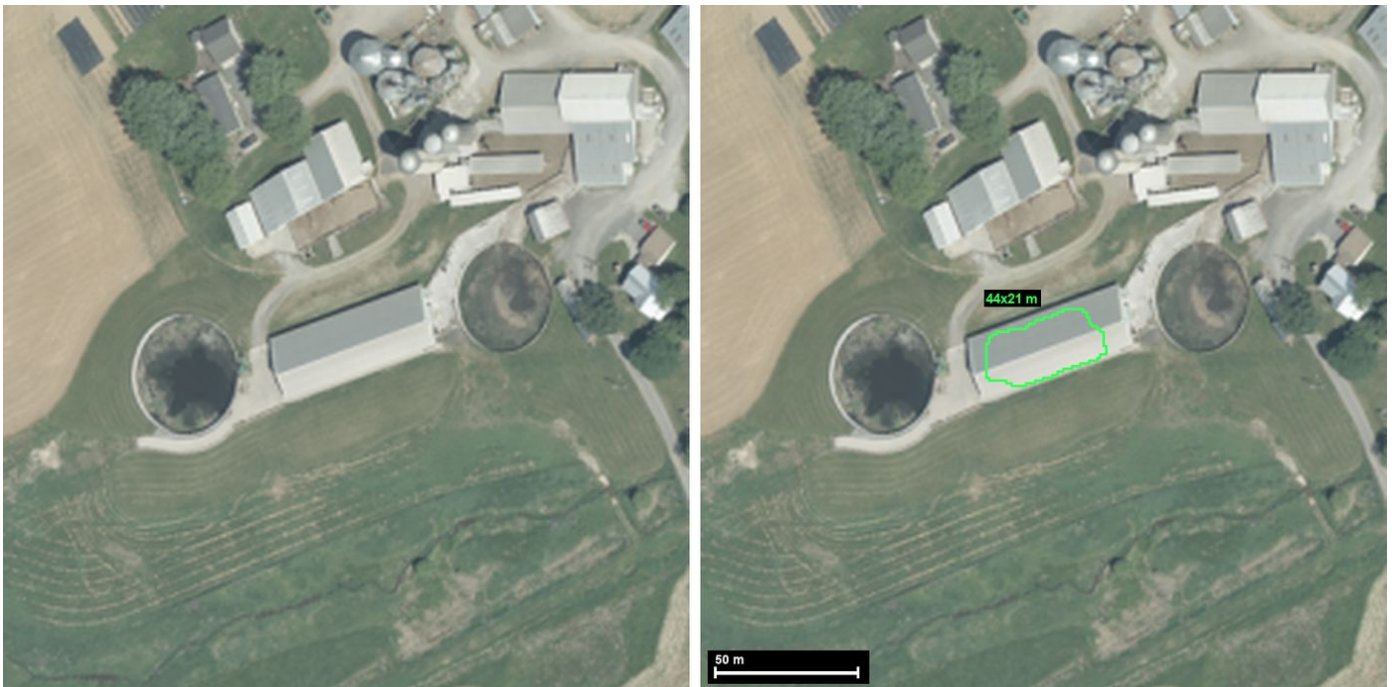
#### [A2] Beef: Panora Acres / Stacy Sellers (Carroll)

| Farm | County | Go to (structure) | Structure is, from permit pt | What to check |
|---|---|---|---|---|
| Panora Acres / Stacy Sellers | Carroll | 39.69321, -76.89273 | 423 m W | Large complex: several barns, silos, two round manure tanks (A2). Beef or dairy? How many barns? Tank contents? |

Second beef detection added 2026-09-21. This is a full livestock complex -- several large barns, feed silos, and TWO ROUND MANURE STORAGE TANKS (dark liquid). The pipeline outlined part of just one barn; the round tanks are a lagoon-type structure the lagoon detector is not built to find. The barn is 423 m W of the registry point.

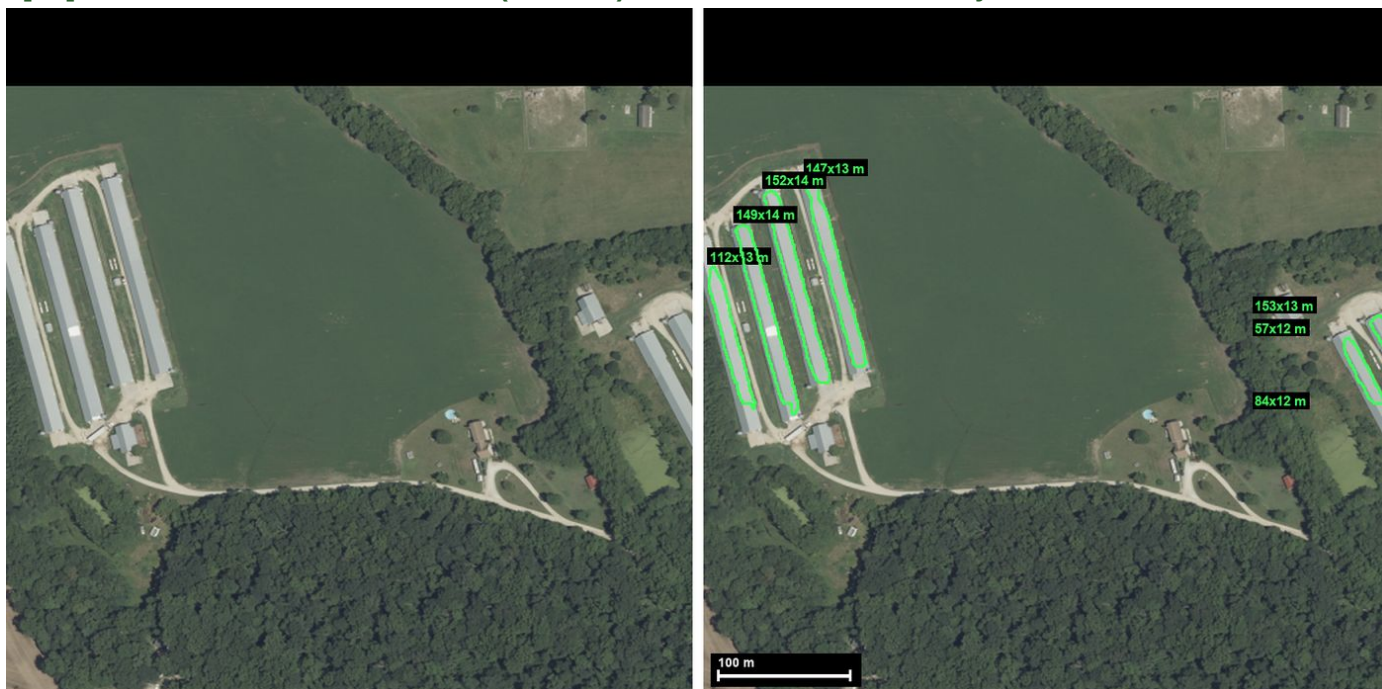
**[A3] Beef reference: Bistate Feeders (Caroline) -- the beef farm that already worked**

7 detections, all long narrow barns (111-153 m x 12-14 m). The Brandenburg/Panora barns are shorter and wider than these.

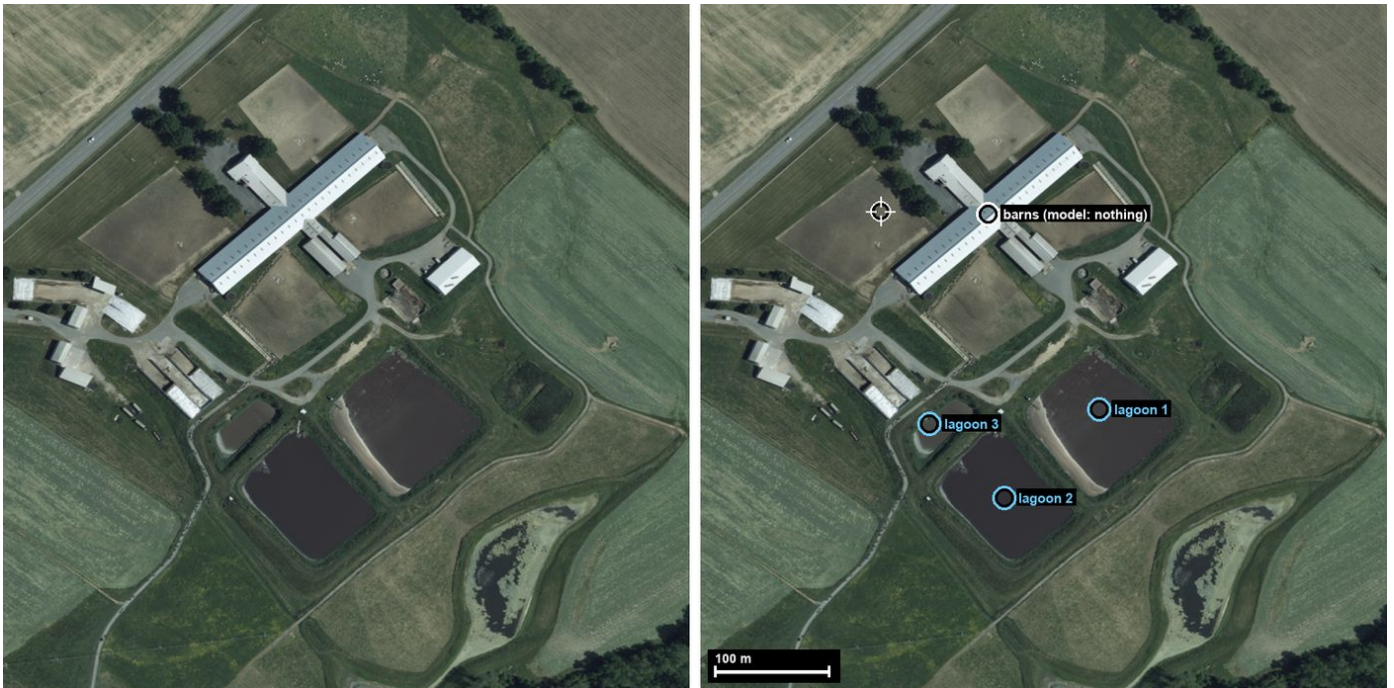
#### [A5] Dairy (model miss): Horizon Organic Dairy (Kent)

| Farm | County | Go to | Structure is, from permit pt | What to check |
|---|---|---|---|---|
| Horizon Organic Dairy (544 head) | Kent | 39.29126, -76.00813 (eyeballed) | 94 m E | MODEL MISS. Cross-shaped light-roof barn + 3 ponds at the permit location (A5). Same questions. |

A cross-shaped long barn with a light roof, three manure ponds, and other outbuildings right at the permit location; the model returned ZERO candidates. Analyst annotations, +/- ~30 m.

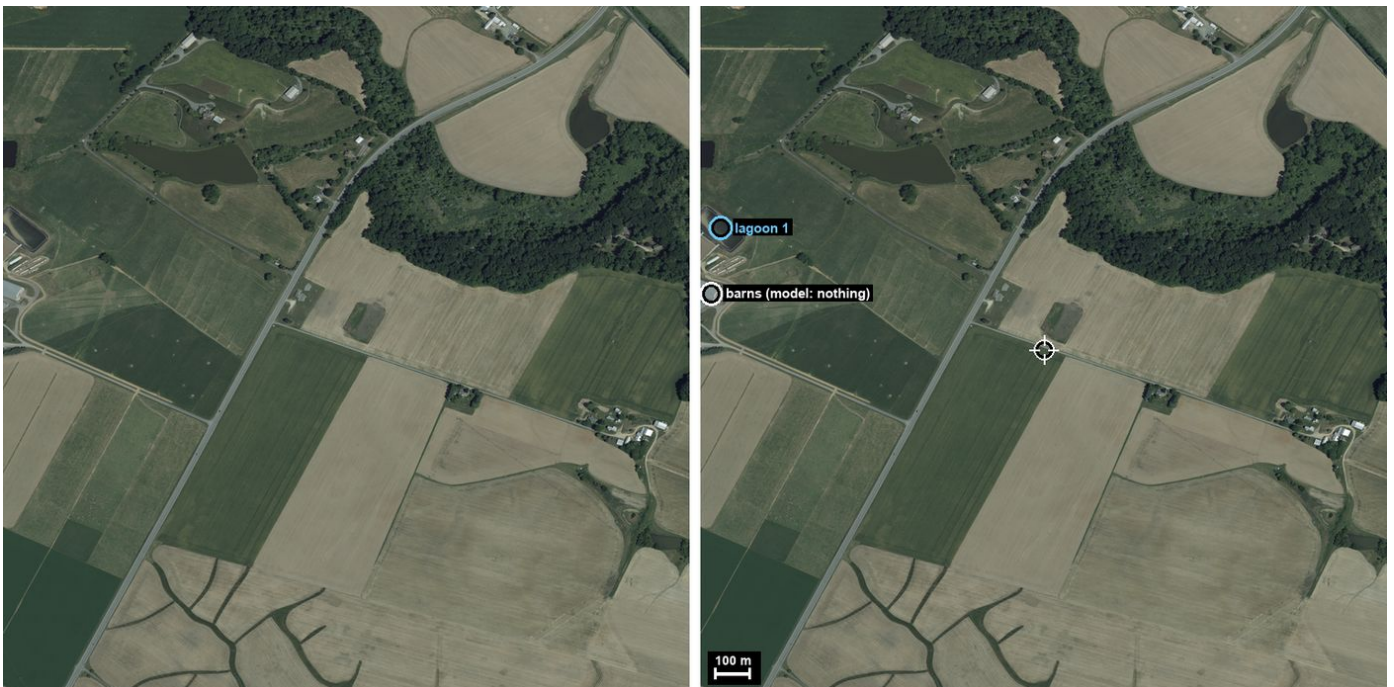
#### [A6] Dairy (geocode error): Matthew Fry / Fair Hill Farms (Kent)

| Farm | County | Go to | Structure is, from permit pt | What to check |
|---|---|---|---|---|
| Matthew Fry / Fair Hill (1,050 head) | Kent | 39.25686, -76.06876 (eyeballed, tile edge) | 982 m W | REGISTRY ERROR? Permit point is at an empty road junction (A6). Where is the real farm address? |

Whole 2 km tile. The permit point (crosshair) is at an empty road junction; the only dairy-looking complex (large blue-roof barn + dark lagoon) is ~1 km WEST at the tile edge. Likely a registry geocoding error, not a model failure -- the real farm may extend outside this tile.

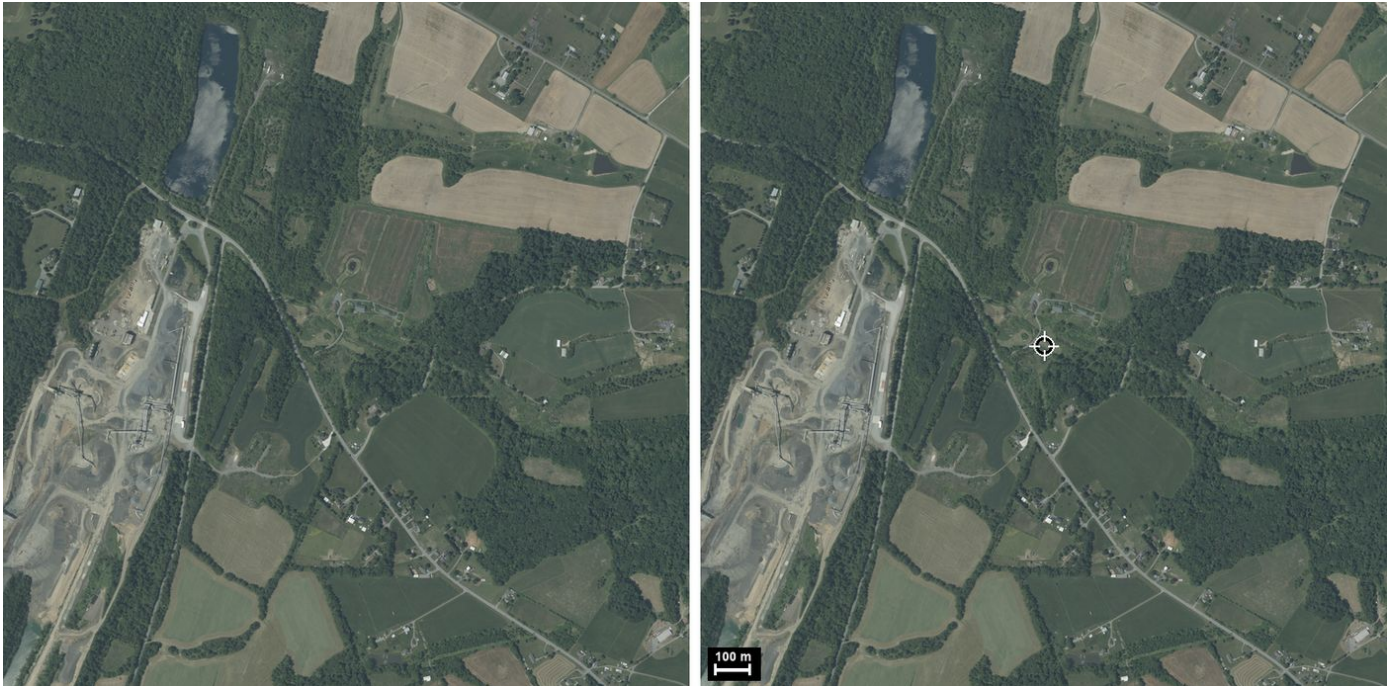
**[A7] Dairy (geocode error): Oak Bluff Dairy Farms (Frederick)**

| Farm | County | Go to | Structure is, from permit pt | What to check |
|---|---|---|---|---|
| Oak Bluff Dairy Farms (1,280 head) | Frederick | 39.52347, -77.29351 (permit pt) | -- | REGISTRY ERROR? No dairy visible near the point; large quarry to the west (A7). Where is the farm? |

Whole 2 km tile. No dairy operation is visible near the permit point (crosshair): wooded land, a large quarry to the west, scattered houses. Likely a registry geocoding error; the farm is probably elsewhere.

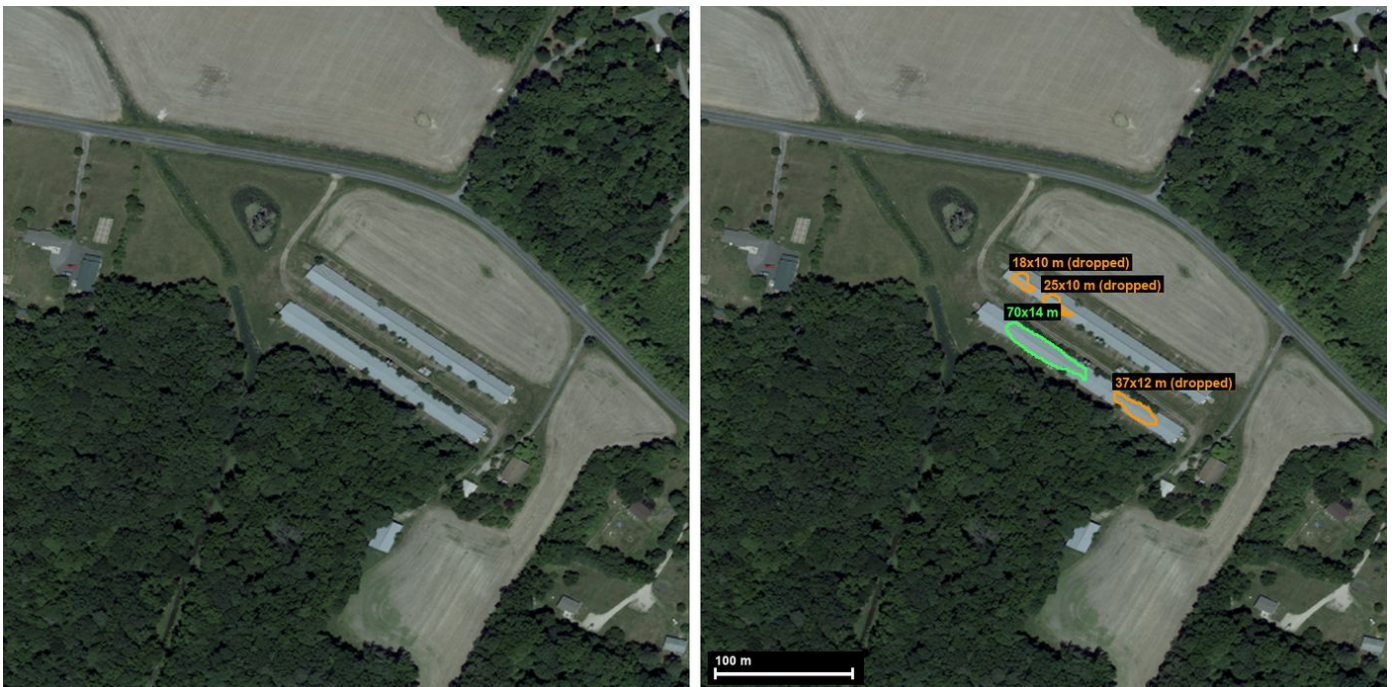
**[A8] Dairy reference: Oakland View Farms (Caroline) -- the one dairy that works**

| Farm | County | Go to | Structure is, from permit pt | What to check |
|---|---|---|---|---|
| Oakland View Farms (reference) | Caroline | 39.01206, -75.86124 | 615 m NE | The one dairy with a kept detection -- two long barns, partial outline (A8). Compare its roof with Lester Jones's. |

1 detection (615 m NE of the registry point). Two long barns are visible; the green outline covers only about half of one and orange fragments (dropped by the filter) mark parts of the other. This is the one dairy where the pipeline produced a kept detection -- and even here the outline is partial.

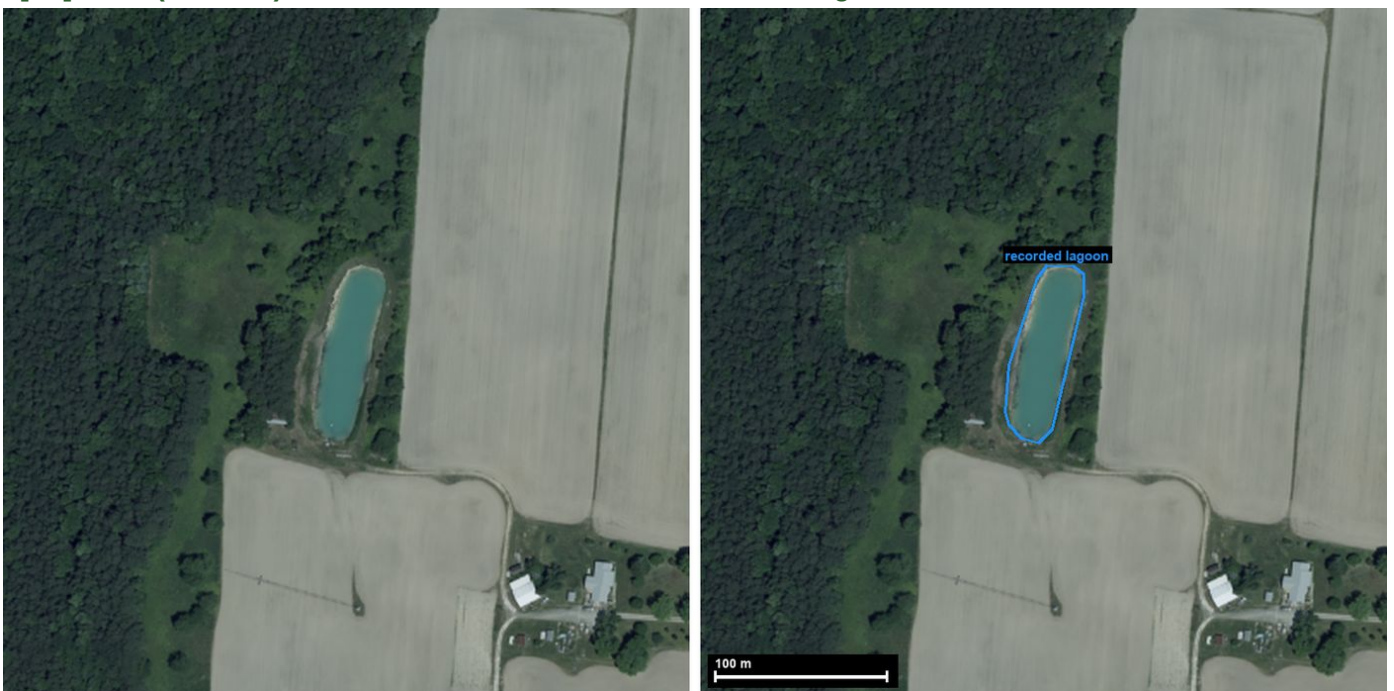
#### [B1] Dulin (Caroline): recorded 'confirmed' -- looks like a real lagoon

A clear teal, regular, banked pond ~380 m from the barns. Polygon aligns on both imagery sources. This is the one recorded lagoon that looks right.

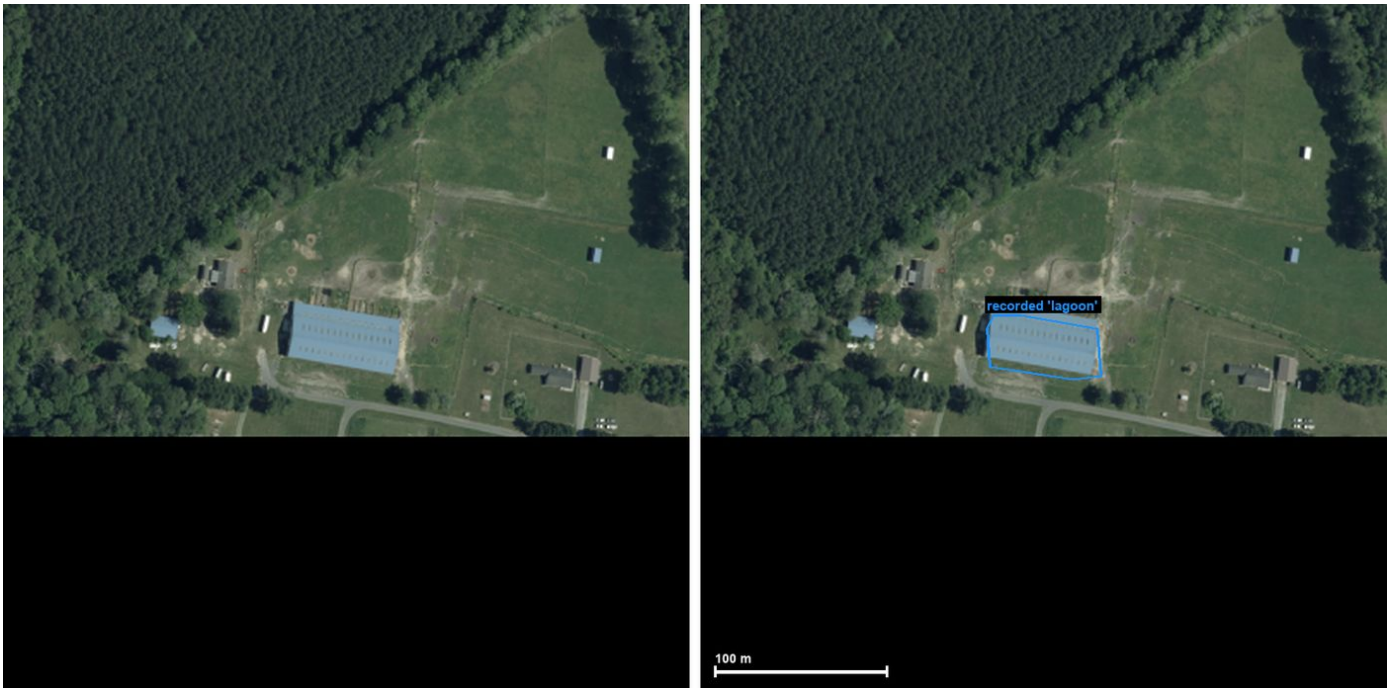
**[B2] Tran (Wicomico): recorded 'confirmed' -- polygon is on a poultry house roof**

| Record | County | Go to | What to check |
|---|---|---|---|
| Hoa Tran -- 'confirmed' | Wicomico | 38.29693, -75.53077 | Polygon sits on a poultry-house roof (B2). Any lagoon anywhere on this farm? |

The recorded lagoon polygon outlines a gray-blue metal roof with ridge lines -- a poultry house, not water. The same on both imagery sources (black band = tile edge).

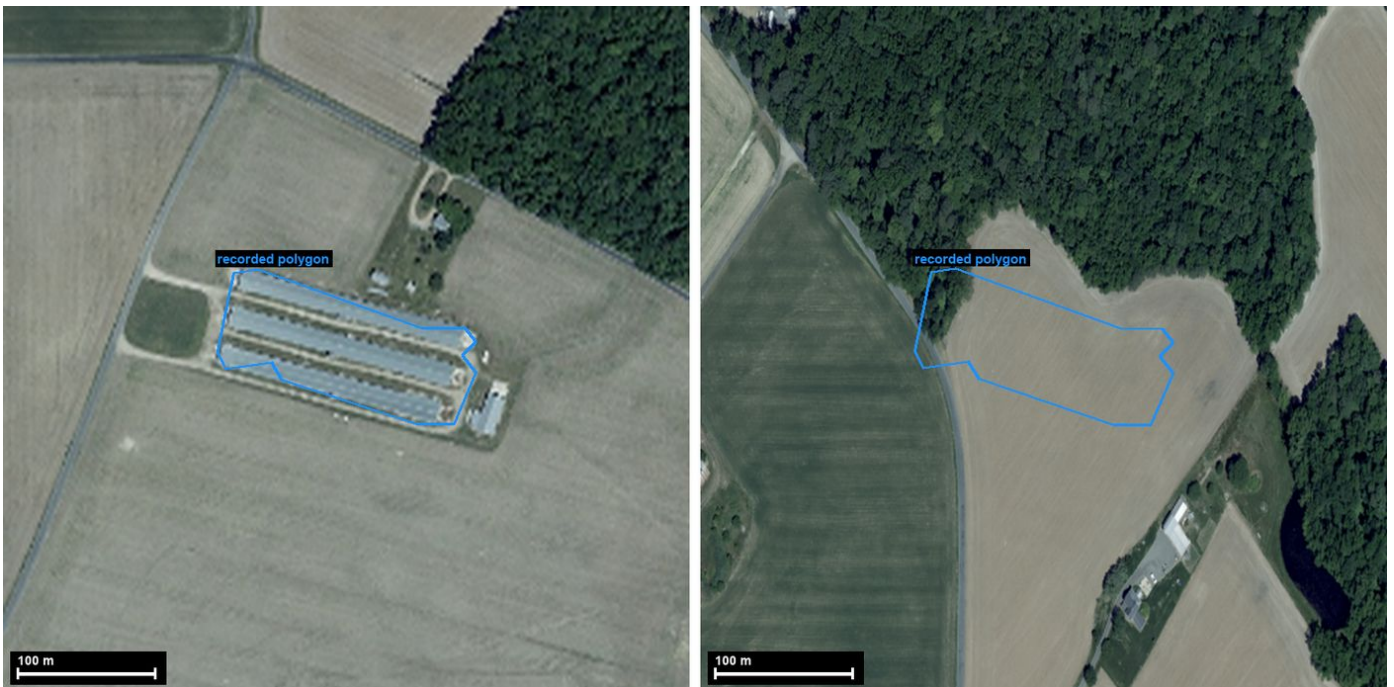
**[B3] Roland Todd (Dorchester): recorded 'confirmed' -- imagery sources disagree**

| Record | County | Go to | What to check |
|---|---|---|---|
| Roland Todd -- 'confirmed' | Dorchester | 38.68623, -75.84334 | Imagery sources disagree by several hundred meters and neither shows a lagoon (B3). Is there a lagoon on this farm? Where? |

Left: MD iMAP imagery -- the polygon outlines three poultry houses, not water. Right: Planetary Computer -- the same coordinates are wood edge/field with no barns. The two sources disagree about what is at this spot by several hundred meters, and neither shows a lagoon inside the polygon. Status unverified -- the recorded 'confirmed' label is not supported by the imagery.

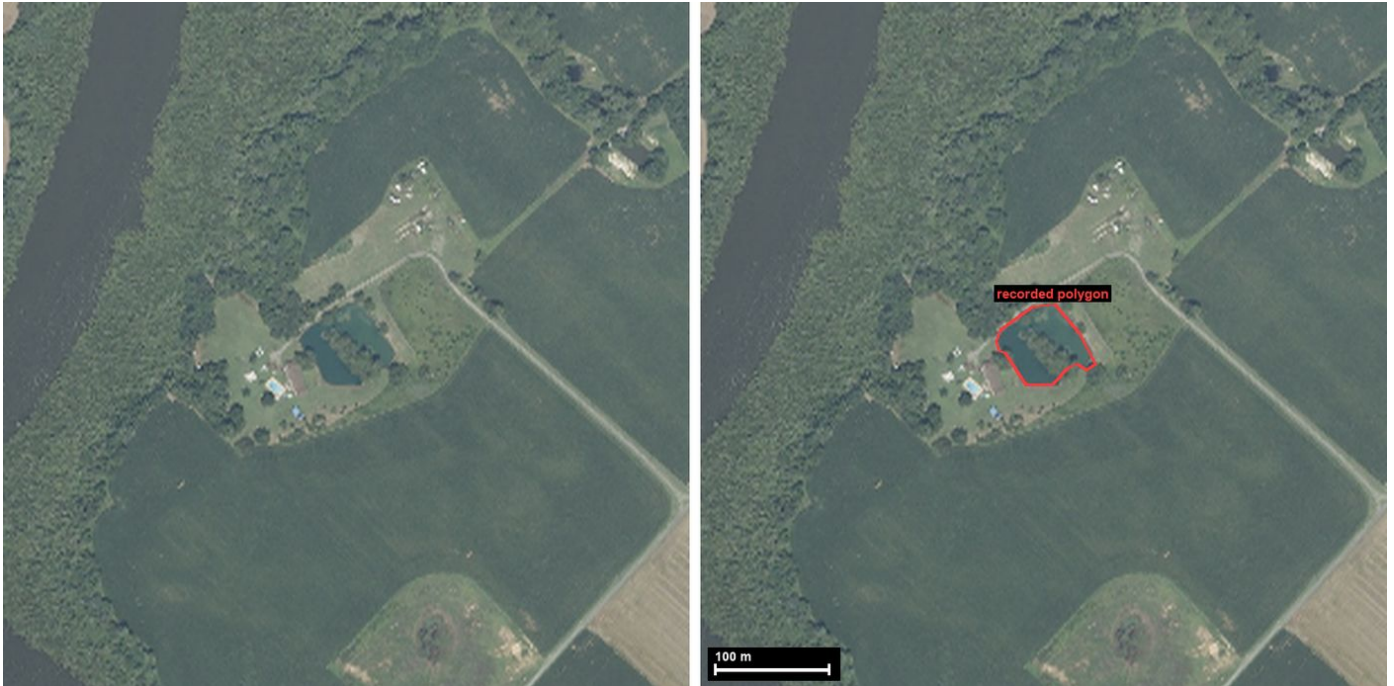
**[B4] Rahim (Dorchester): recorded 'false positive' -- a pond beside a farmhouse**

Small pond next to a house and pool, ~500 m from the barns, near a large river. Not a river fragment as the labeling guide says, but also not lagoon-like by siting. Treat as false positive unless the ground says otherwise.

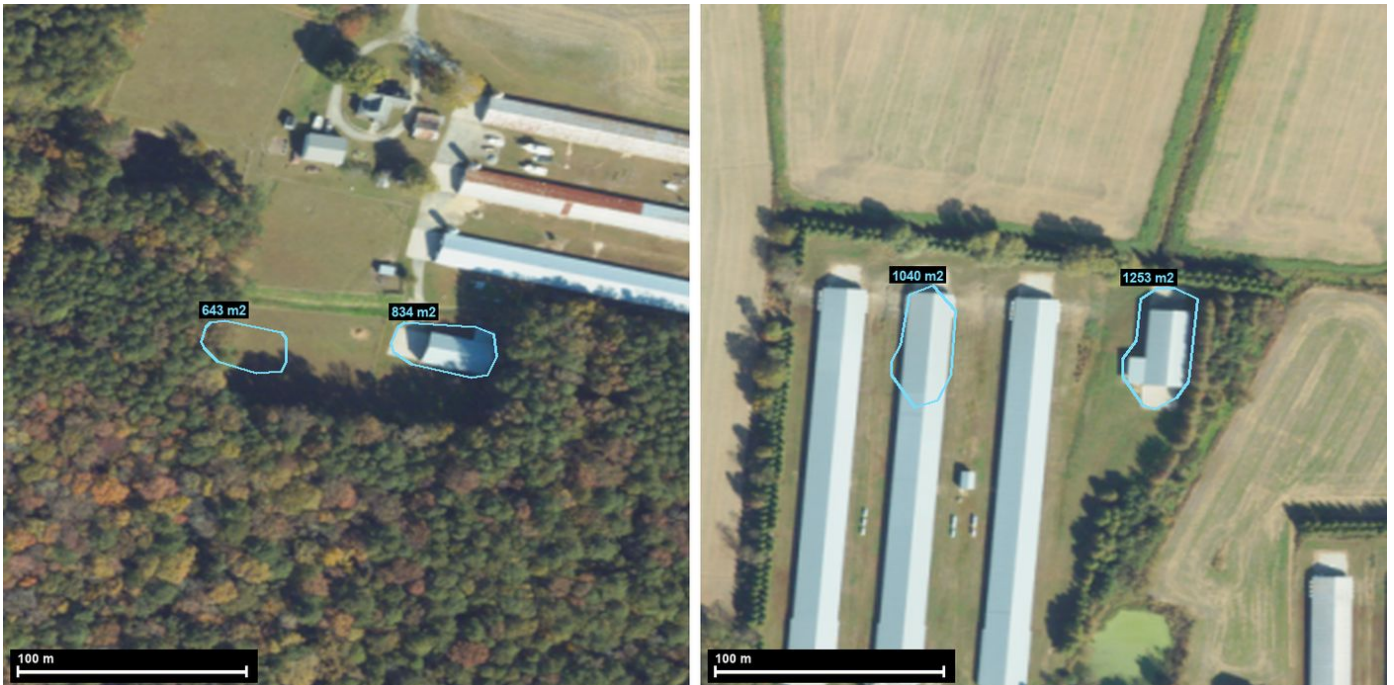
**[B5] Hite / Nguyen (Worcester): 'CAFOSat-corroborated' candidates**

Left (south cluster): one polygon on a small white-roofed building at a forest edge, one on a lawn patch. Right (north cluster, ~850 m away): one on the end of a poultry-house roof, one on a small building. None of the four is water. The CAFOSat match was a loose 300 m patch-level check and does not confirm these specific polygons.

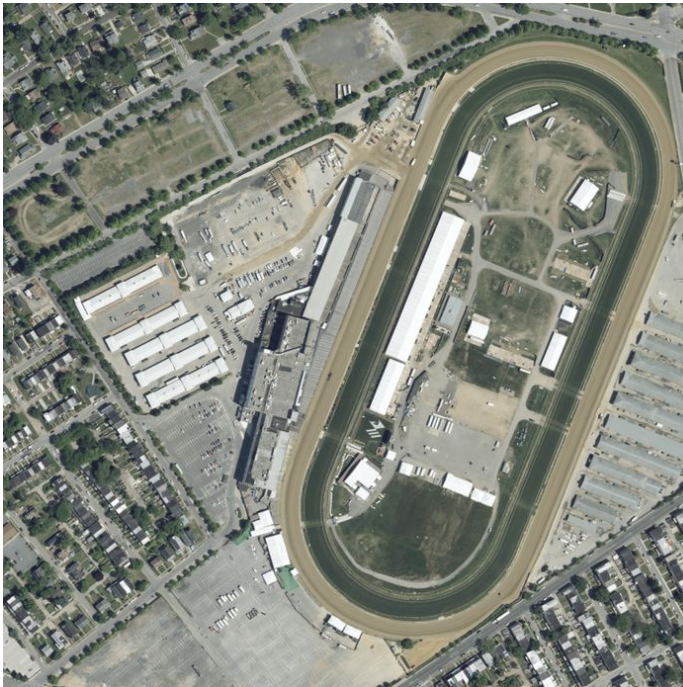
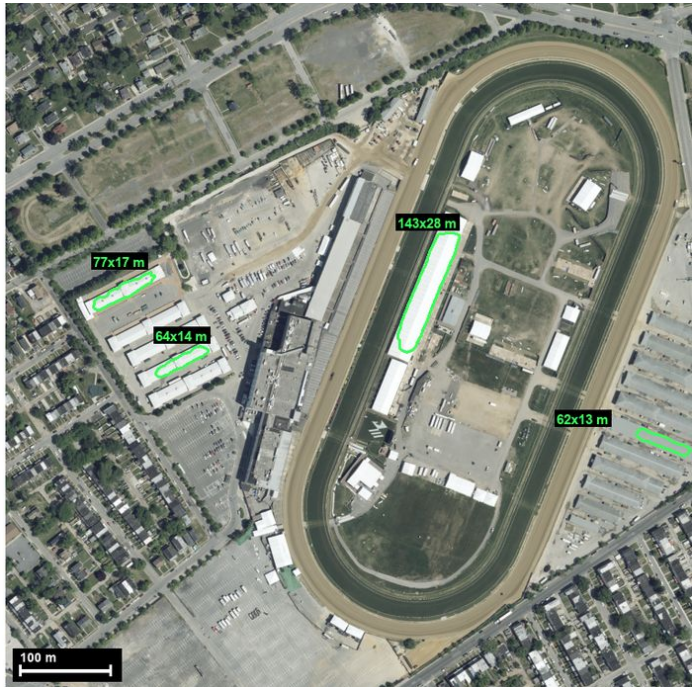
[D1] False positive: Pimlico Race Course grandstand/stable roofs

4 'poultry house' detections on a horse-racing venue (roofs share the long-roof shape). Excluded from the Task 1 output. Green = what the pipeline drew.

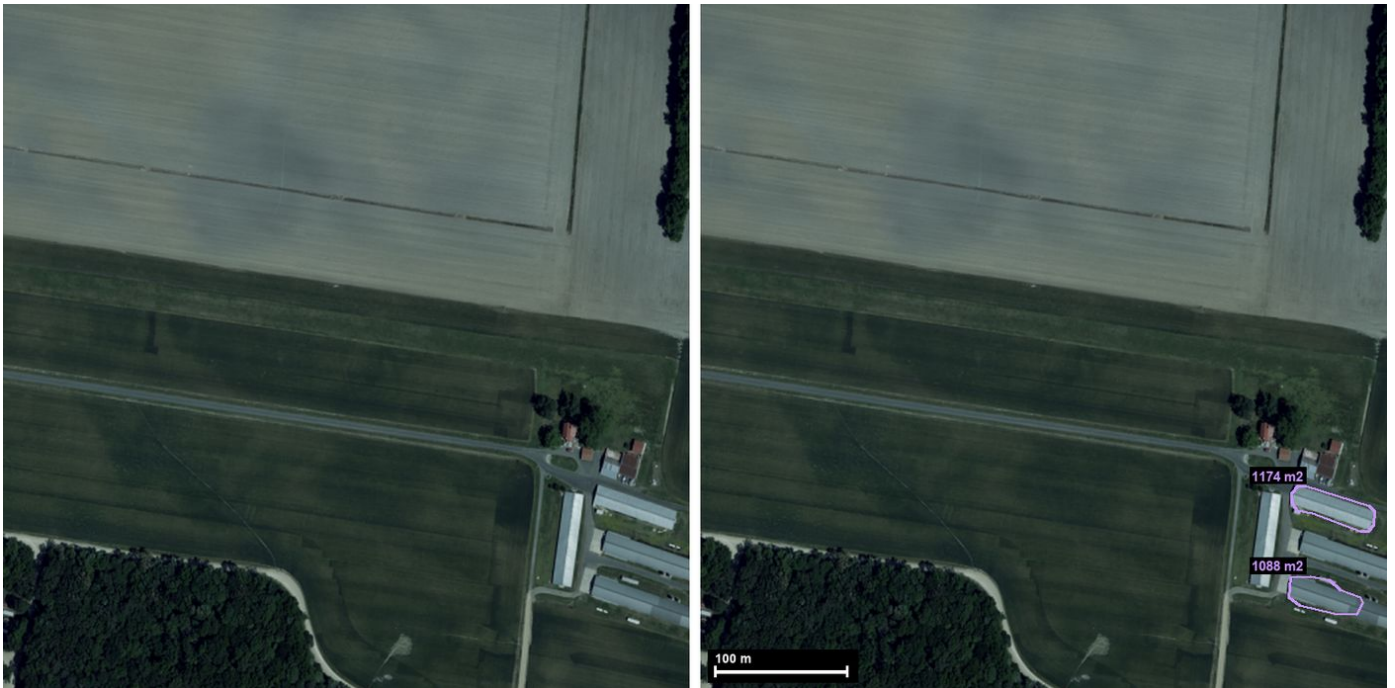
**[D2] False positive: blue-gray metal barn roofs read as 'water' (Wolf Farm)**

Purple = automated lagoon candidates. They outline the blue-gray metal roofs of poultry houses -- the roof color reads as water to the color-based candidate step. This is the most common lagoon false positive seen (also Tran, Roland Todd, Moore).

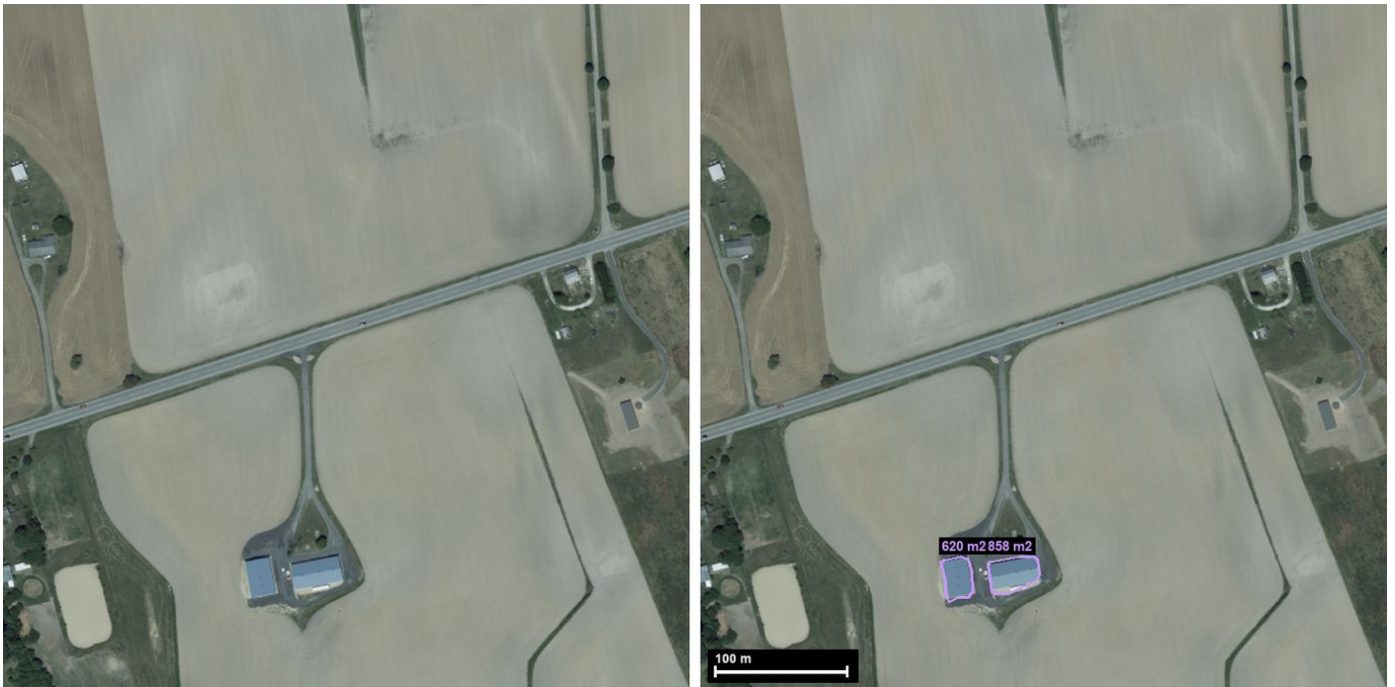
**[D3] False positive: blue metal roofs again (William Moore, III)**

Purple = automated lagoon candidates sitting on two blue metal-roofed buildings. (Forest-shadow-strip false positives are documented in the labeling guide but none is shown here.)
