# Final Inspection

Inspection #: 1278753, 1278754, 1278755,  
1278756, 1278757, 1278758, 1278759, 1278760,  
1278761, 1278762, 1278763, 1278764, 1278765,  
1278766 | Group #: 118994

| Scheduled Inspection Date | | Inspection Started Date | | Submitted Inspection Date | |
|---|---|---|---|---|--|
| Report Type | Final Inspection | Project | ARITZIA | | |
| SKU # | FFS 99-03-32366-SU25-AR001-63219-106-CAN, FFS 99-03-32366-SU25-AR001-63219-72-CAN, FFS 99-03-32366-SU25-AR002-63219-106-CAN, FFS 99-03-32366-SU25-AR002-63219-72-CAN, FFS 99-03-32366-SU25-AR4250-63219-106-CAN, FFS 99-03-32366-SU25-AR4250-63219-72-CAN, FFS 99-03-32366-SU25-AR4290-63219-106-CAN, FFS 99-03-32366-SU25-AR4290-63219-72-CAN, FFS 99-03-32366-SU25-ARH106-63219-106-CAN, FFS 99-03-32366-SU25-ARH106-63219-140-USA, FFS 99-03-32366-SU25-ARH106-63219-72-CAN, FFS 99-03-32366-SU25-ARH300-63219-106-CAN, FFS 99-03-32366-SU25-ARH300-63219-140-USA, FFS 99-03-32366-SU25-ARH300-63219-72-CAN | Description | LADIES' 78% COTTON 22% POLYESTER KNITTED SWEATSHIR | | |

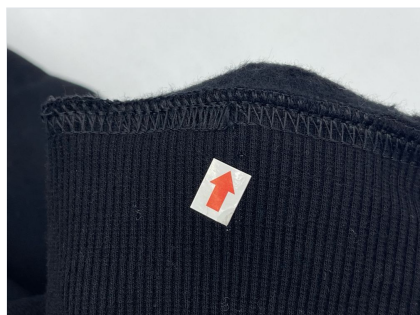
#### 2-Stitching-Needle holes ( E-13 )

| Defect Severity | Quantity | Comment |
|---|---|---|
| Major | 1 | Hole at sleeve |

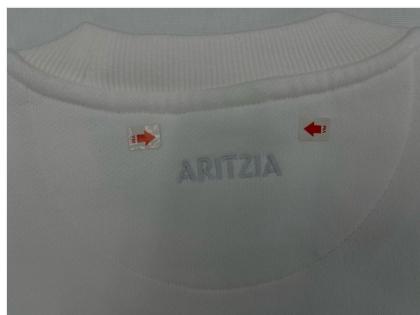
#### 2-Stitching-Stitches: Uneven ( E-21 )

| Defect Severity | Quantity | Comment |
|---|---|---|
| Major | 1 | |

Uneven placement at EMB

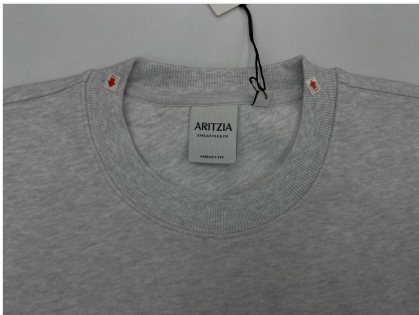
#### 3-workmanship-Collar: Poor setting ( E-29 )

| Defect Severity | Quantity | Comment |
|---|---|---|
| Major | 1 | |

Poor neck shape

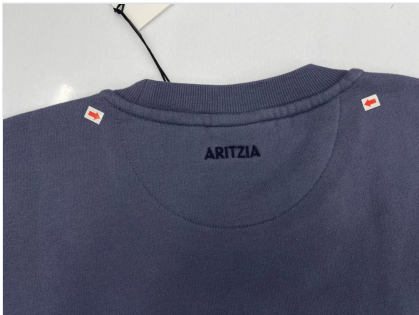
3-workmanship-Slanted/Uncentered ( E-35 )

| Defect Severity | Quantity | Comment |
|---|---|---|
| Major | 1 | |

Half moon off centre
