Car Inspection Report

Hyundai Verna

SX1.5VTVT IVT | 2025 | AT | Petrol

Report generated on: 24 Apr, 2025

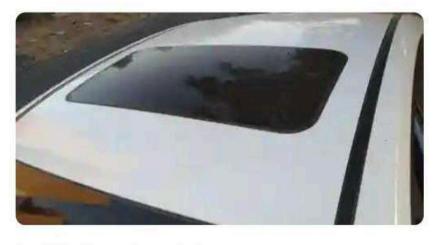
Roof: No Dents, Scratched

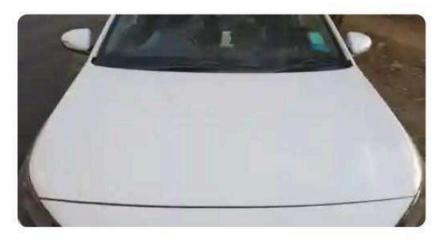
Bonnet/Hood: No Dents, Scratched

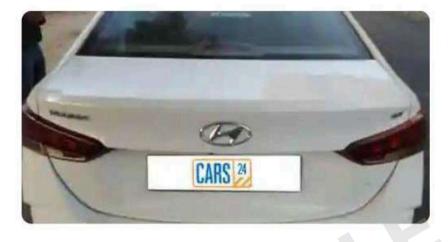
Dicky Door / Boot Door: No Dents, Scratched

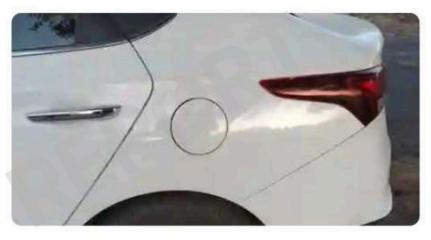
Quarter Panel LHS: No Dents, Repainted

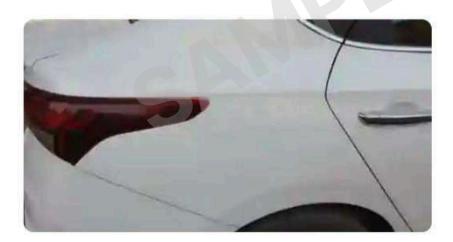
Quarter Panel RHS: No Dents, Repainted

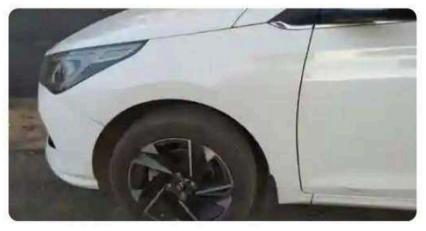
Fender LHS: No Dents, Scratched, Repainted

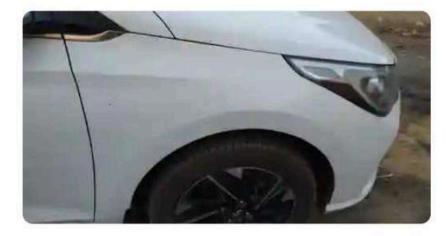
Fender RHS: No Dents, Repainted

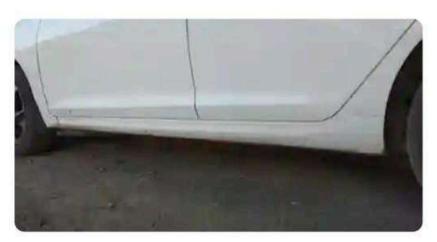
Running Border LHS: No Dents, Scratched, Repainted

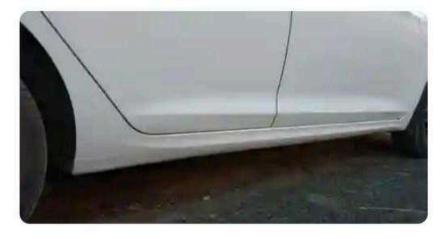
Running Border RHS: No Dents, Repainted

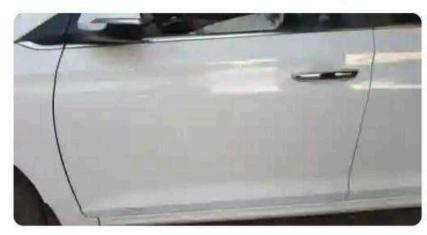
Door LHS Front: No Dents, Scratched, Repainted

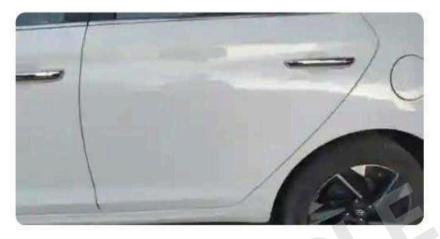
Door LHS Rear: No Dents, Repainted, Scratched

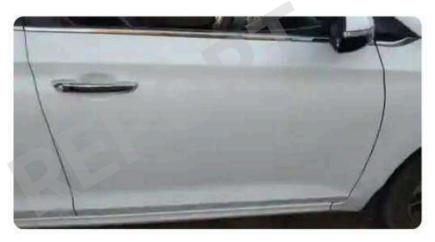
Door RHS Front: No Dents, Repainted

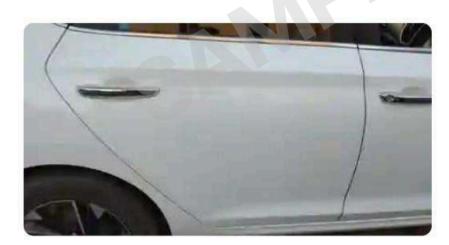
Door RHS Rear: No Dents, Repainted

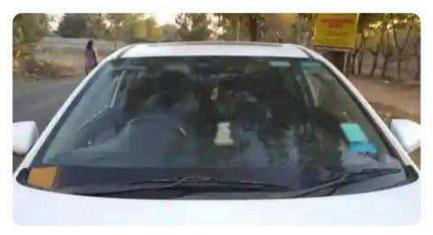
Windshield Front: Scratched

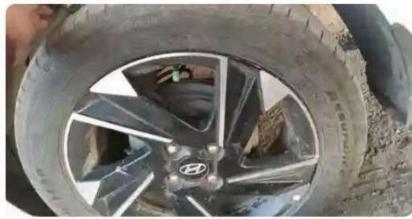
LHS Rear Tyre: 0 30% life remaining

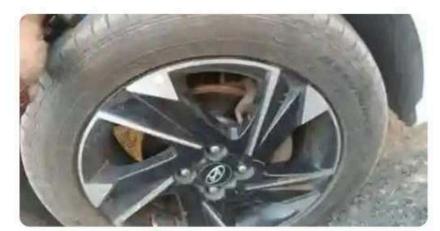
RHS Front Tyre:

70% life remaining

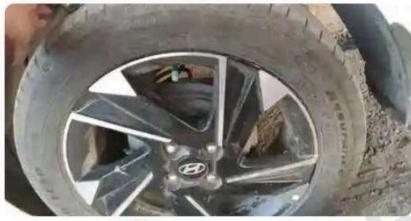
LHS Rear Tyre: 0 30% life remaining
