Transformer Remaining Life Assessment Report				
Project	: RLA of Transformer	Client	: Reliance Industries Ltd	
Rating	: 53 MVA, 220/34.5 kV	Sr. No.	: T-6990 / C-10307	
Location	: DTA CPP PLANT	Date	: 31-12-2018

Report Title : Residual Life Assessment for Transformer

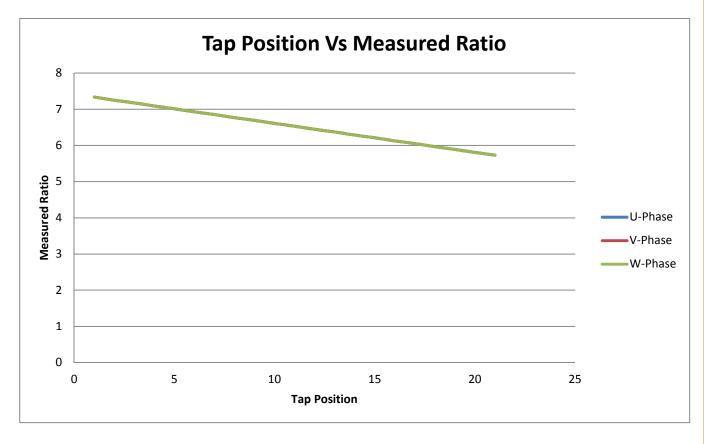
PLOT: Tap Position Vs Measured Ratio (Forward Order)

The variation in measured voltage ratio is found to be within 0.5%, when compared to designed rated value indicated on nameplate and hence the results are found OK as per IEEE Standard 62: 1995 and is thus acceptable.

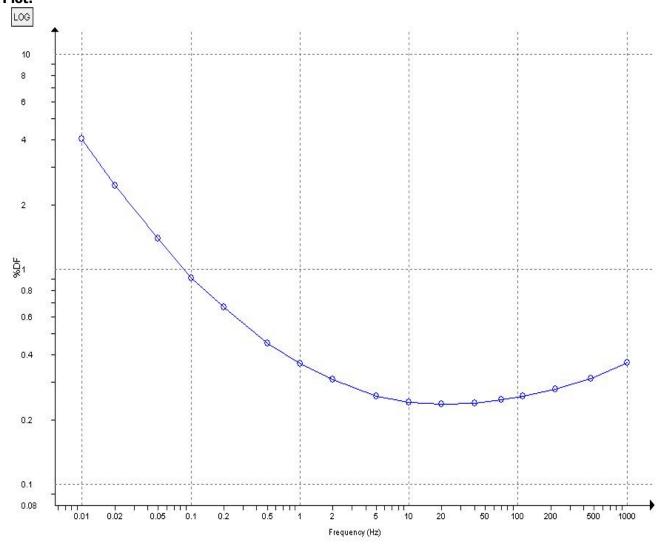
Moisture Assessment curve for CHL insulation measured by FDS+PDC combined method Plot:

Insulation	Moisture Content of inter winding insulation	Remark
HV-LV	0.6%	Dry

Moisture measurement by FDS+PDC method (DIRANA Test) indicates a Dry insulation (as per International Standards for in-service Auto Transformers). Note that moisture reduces the breakdown strength of paper and has direct impact on life of transformer.

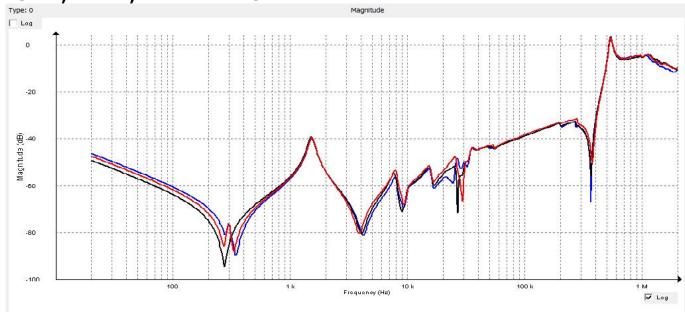
1U-1N, 1V-1N, 1W-1N ALL OPEN TAP 1

- Capacitance and SFRA test indicate no abnormality in mechanical condition of Core & winding assembly inside the transformer.
- Magnetizing current data is also indicating that electrical condition of Transformer is okay.
