Transformer Remaining Life Assessment Report					
Project : RLA of Transformer Client : Reliance Industries Ltd					
Rating	: 16 MVA, 33/6.9 kV	Sr. No.	: TWBO-3060-D7146		
Location	: SEZ-CPP	Date	: 24-02-2022

Report Title : Residual Life Assessment for Transformer

Client : Reliance Industries Ltd., Jamnagar

Location : SE2-CPP Plant

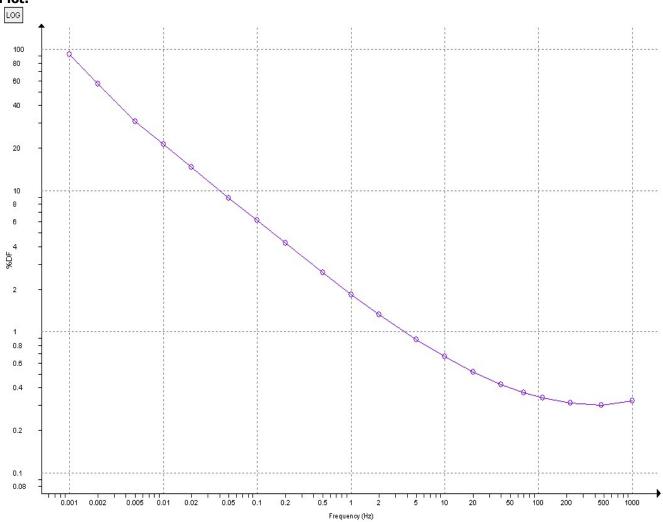
# Moisture Assessment curve for CHL insulation measured by FDS+PDC combined method Plot:

Moisture measurement by FDS+PDC method (DIRANA Test) indicates a Moderately Wet insulation (as per International Standards for in-service Auto Transformers). Note that moisture reduces the breakdown strength of paper and has direct impact on life of transformer.
