# STARDUST

## Test Mission Technical Report

2020/07/20

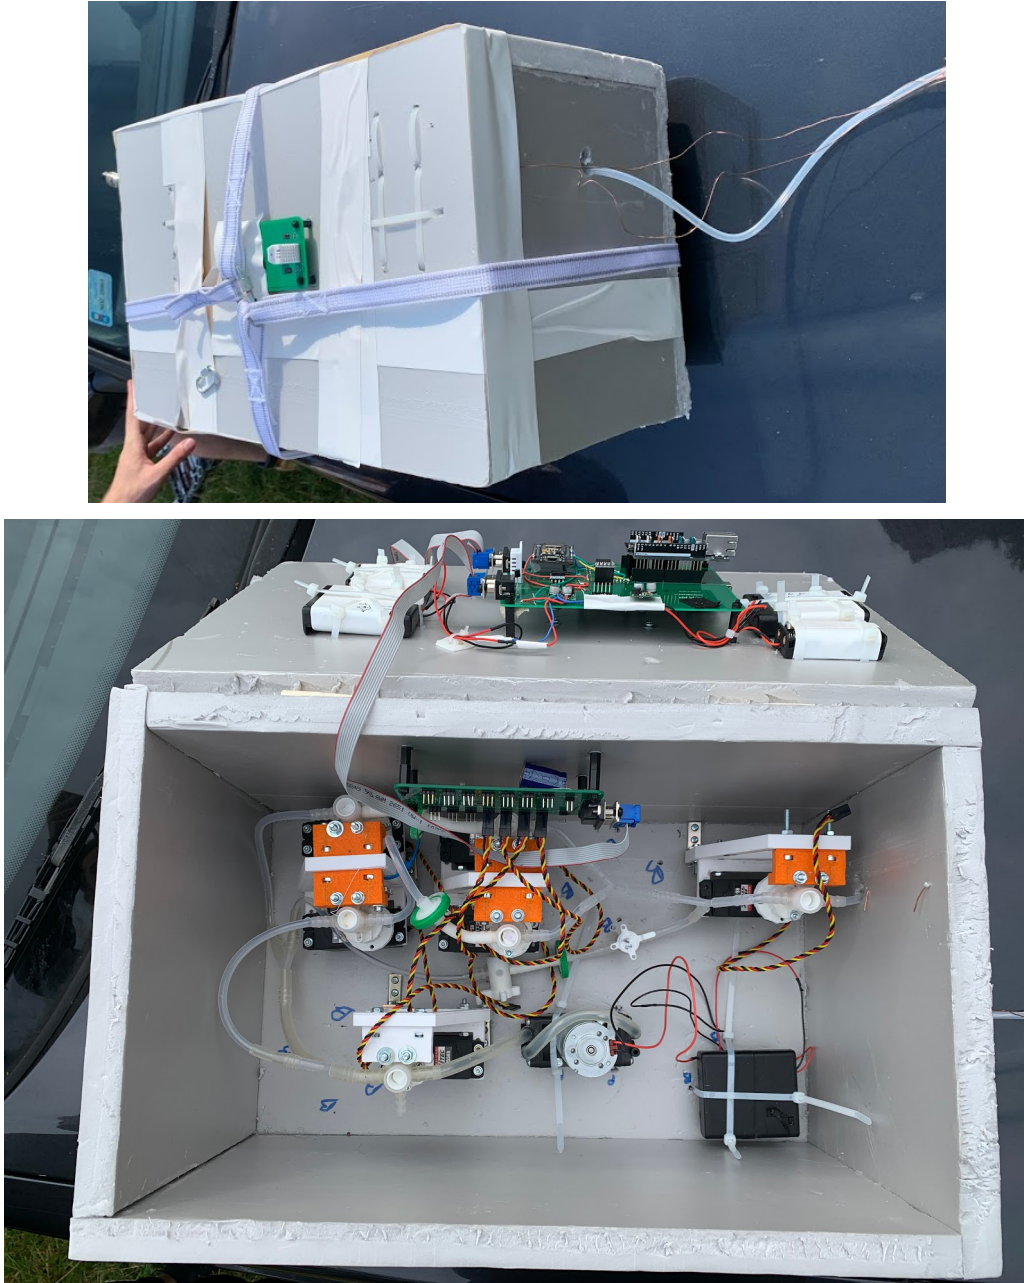
*Fig. 2: Experiment assembly pre launch.*

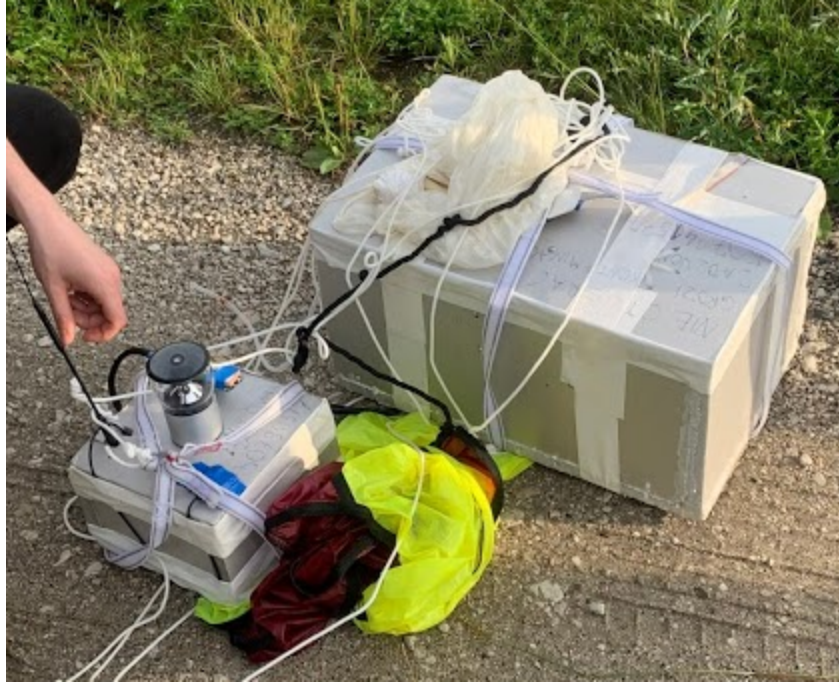
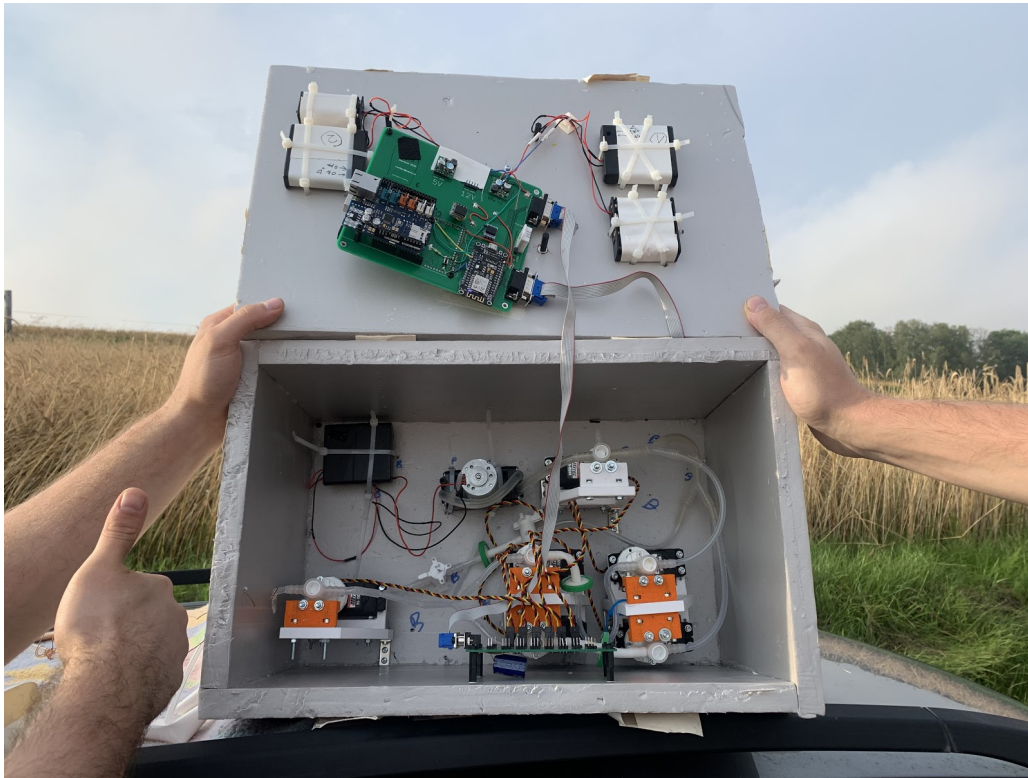
*Fig. 3: Experiment assembly post launch.*

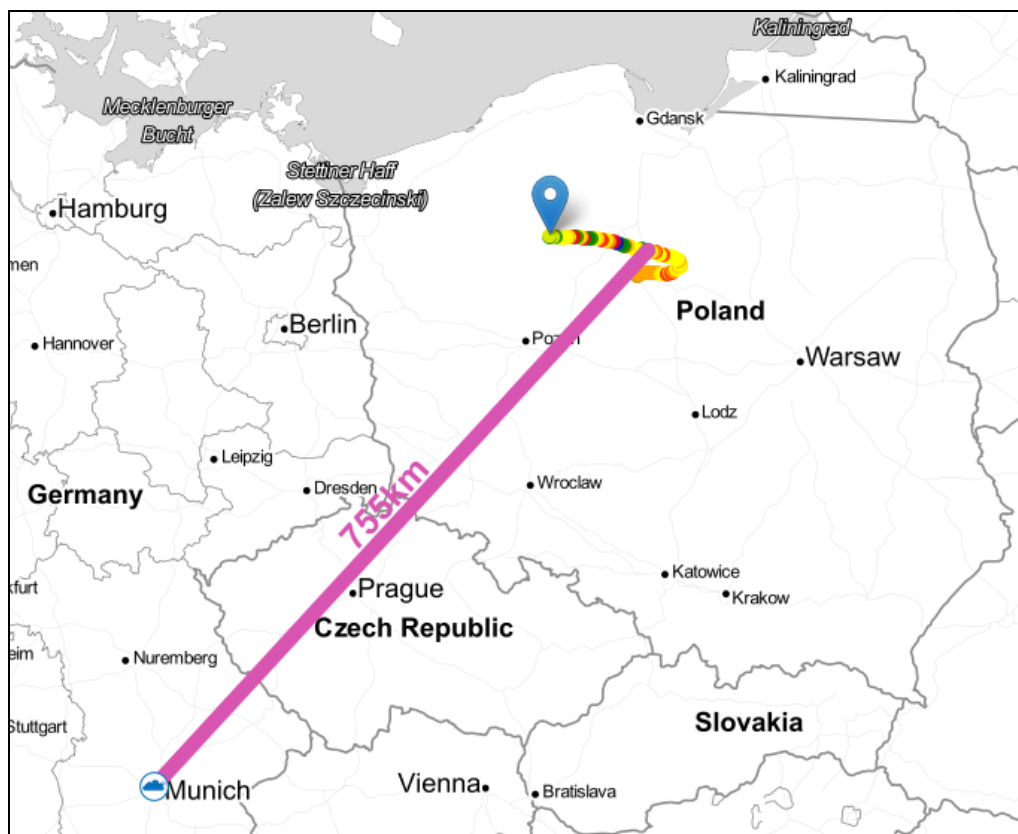
Fig. 5: Ground path and the longest packet acquisition line of sight.

The LoRa link of 755km was a really surprising outcome of the mission. Best to our knowledge, it is one of the longest links ever achieved within the LoRa The Things Network. The previous standing records are 766 and 832km. This experience certainly sheds light on possible future missions utilizing this and other radio technology.

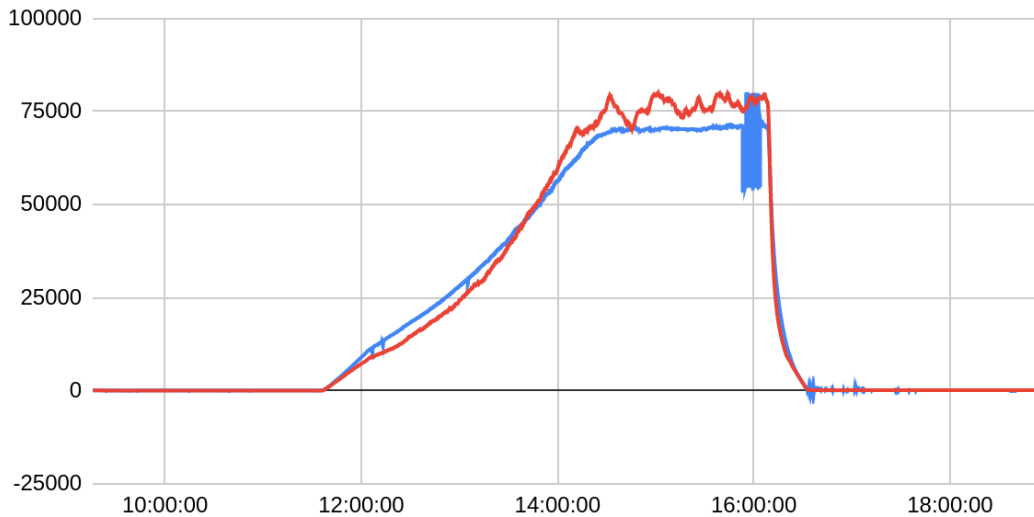
*Fig. 8: Pressure and temperature based altitude calculation [m].*

The altitude calculation was based on average pressure reading and a direct temperature reading. Due to the direct sampling of temperature, the calculation was prone to temperature swings outside of the gondola. The measurement based on sensors placed inside of the gondola is smoother, but was prone to error of the temperature sensor itself - value of which was not sanitized, and error value of  $-50^{\circ}\text{C}$  was used in the calculation.

Due to the characteristic of the used formula and inaccurate altitude calculation, the sampling began at a proportionally lower altitude than expected. The plan was to start sampling at 15km and finish at 11km when falling to avoid sampling “dirty” air from commercial jets flying in tropopause. The actual values were 11km and 8km.

- The formula used to determine altitude should have been tested better before liftoff to ensure a good estimate.
- The parameters used in the altitude formula should be sanitized better.

- In case there is no good formula to estimate altitude > 9km, either use a different formula for that range, or use predetermined pressure values to begin and end the experiment.

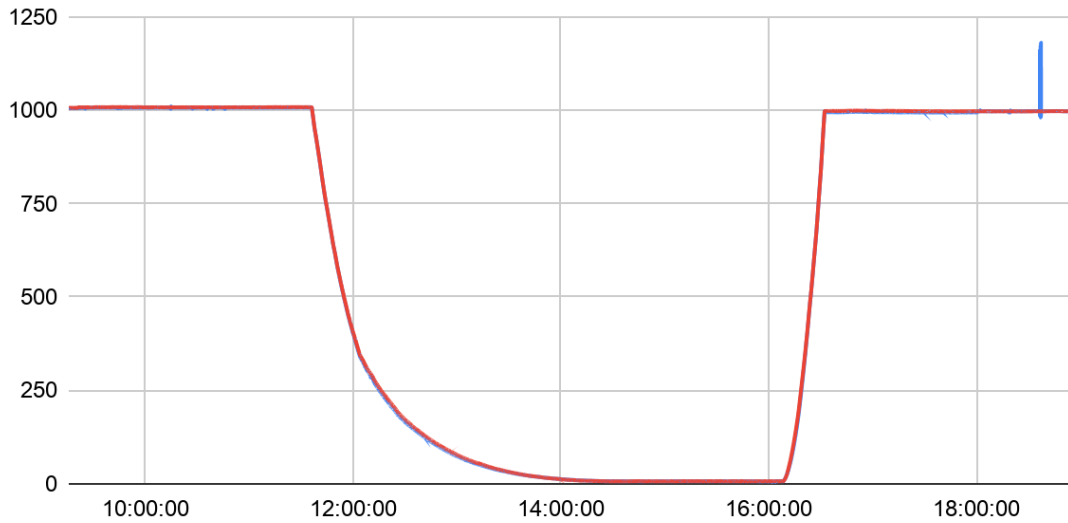
*Fig. 9: Pressure readings [hPa].*

Lowest pressure: 649 Pa inside, 673 Pa outside (30 measurement rolling avg.).  
The pressure gradient in particular will be useful when calibrating the pressure sensors in future missions.

In addition the data shows that the BME280 sensor, recommended at CDR as a replacement for our sensor suite, is insufficient due to the pressure falling below the datasheet value of 300hPa<sup>3</sup>.

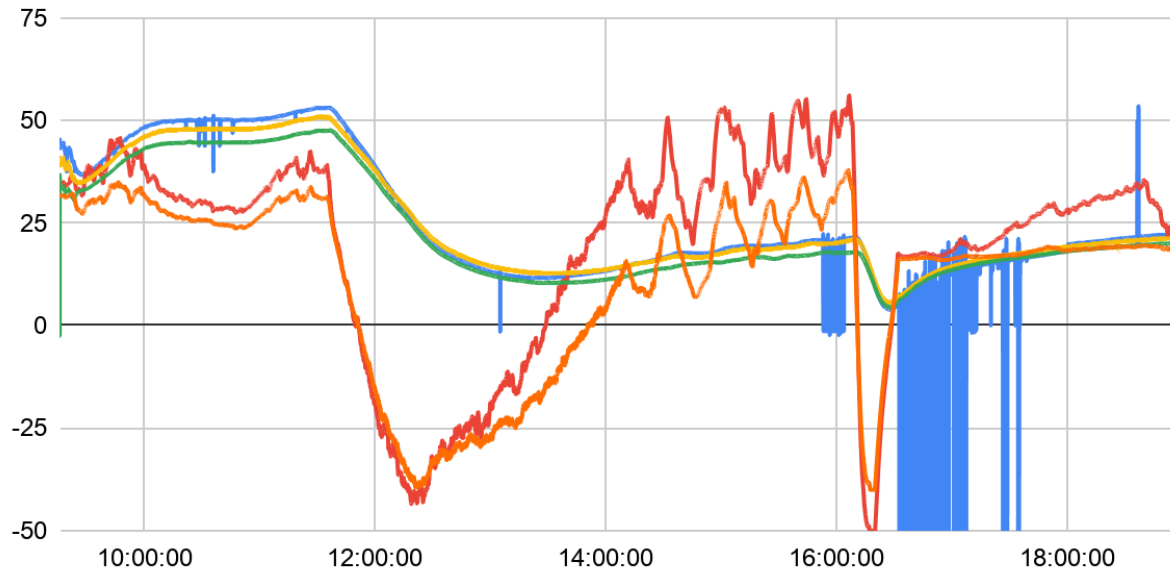
*Fig. 11: Temperature readings [ $^{\circ}\text{C}$ ].*

Lowest temperature:  $-40^{\circ}\text{C}$  in flight,  $-50^{\circ}\text{C}$  when falling (values limited by sensor range).

One of the temperature sensors (the one used for primary altitude calculation) encountered an issue and started returning erroneous values of 0 and  $-50$  degrees.

The raw data from 2 different types of temperature sensors placed outside of the gondola is not scaled the same way, but shows the same characteristics of temperature.

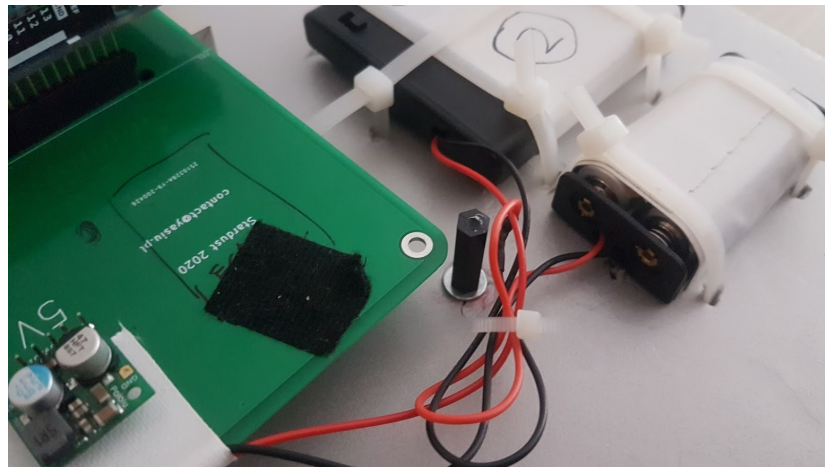
- Even without insulation and with high internal volume, the temperature inside of the experiment gondola never fell below 0°C.
- Stand-offs used to mount main electronics PCBs upside down to the ceiling of the experiment gondola compartment gave way at landing.

*Fig. 12: Broken standoff.*
