### 7.3.16 Compliant Control for Robotic Arm

### Missing Cut Problem

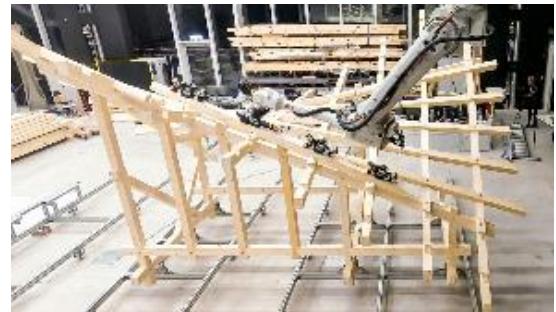
The following images show the imbalance grasp caused by using the screwdriver as a gripper. In this case, the spacing between the four joints does not permit the use of any parallel grippers. The even number of joints on the beam also means that it is not possible to hold it near the centre using the screwdriver as a gripper method. This type of scenarios occurred 5 times

during construction and they often suffer from misalignment problems (*see 7.5.6 Screwdriver Tip Misalignment* )

- In general, always use a parallel gripper if its size does not cause a collision problem. Choose the biggest gripper size possible for the beam length.
- If parallel gripper cannot be used, use the longer SL1\_G200 if possible. Pick a joint near the middle of the beam length to avoid imbalance deflection.
- If collision is still a problem, SL1 can be used. However, it is not recommended for long elements.

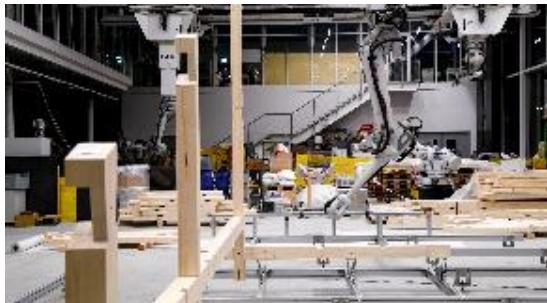
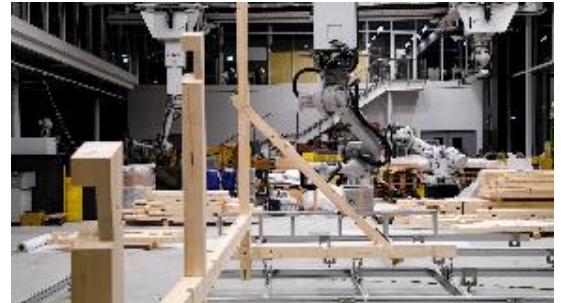
The photo below (left) shows another view of the three columns after the horizontal beam is assembled. The tall column can still be unstable in this plane (left-right rotation in this viewing direction). The next element being added is a diagonal bracing that can help support and correct the column's deviation in this plane.

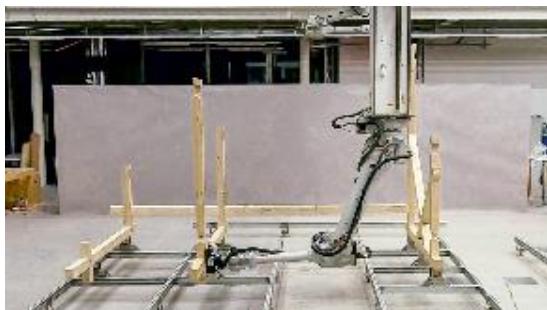
The photo below (left) shows the assembly of the column in the front. This is also a high-risk element, the subsequent horizontal beam (in the right photo) helped support and correct it.

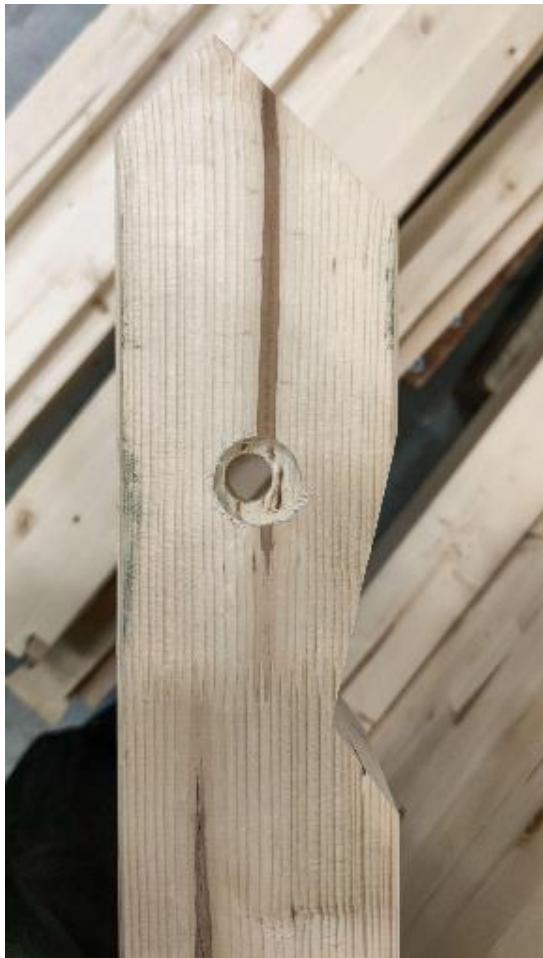
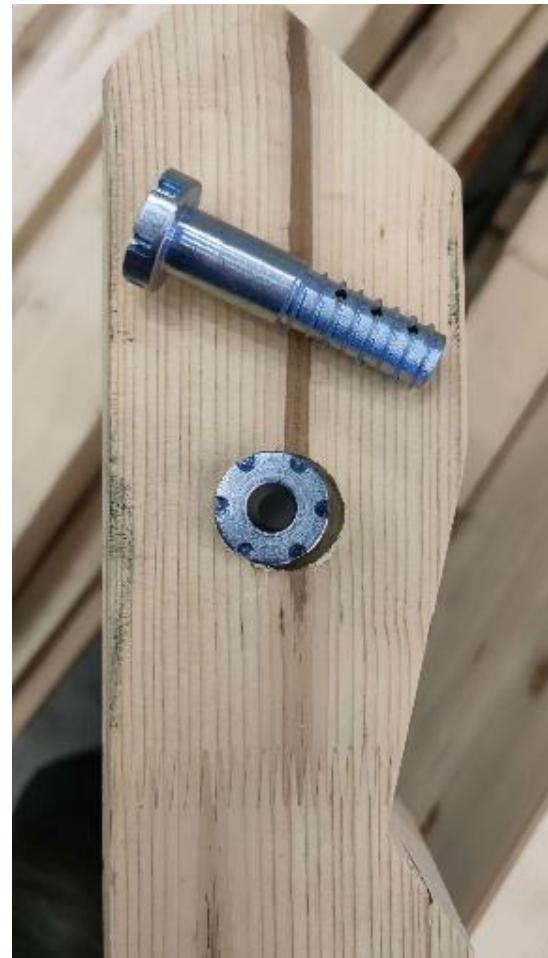
The pre-drilled holes for the hollow screws were found to be inaccurate during test fit. The problem affected almost all the screw holes and are more severe for short elements.

Ideally all four portions of the holes need to be concentric. However, the machining tolerance was found to be poor. In about half of the joints, the screw cannot fit into the hole.

The photo below shows poor alignment between step 1 and step 2. When the screw is passed through the hole, the screw head does not fit inside the counterbore.

**Correction of the Screw Holes** A correction method was devised to fix the misaligned hole by drilling them bigger. It is a compromise because the holes have to be made bigger than they should be.

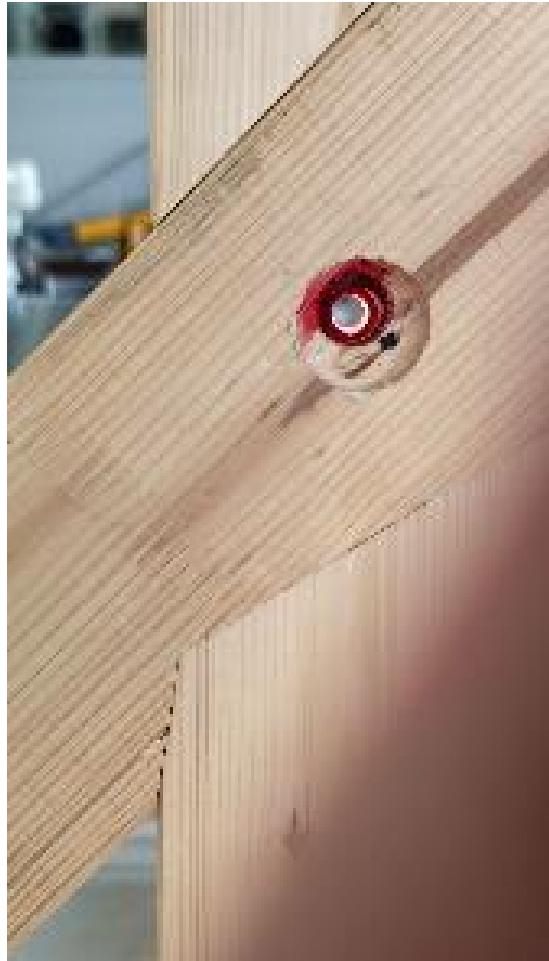
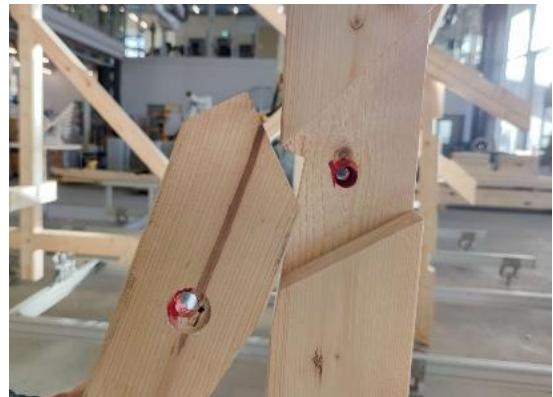
The photo below shows the same beam, having poor alignment between step 2 and step 3. Red

spray paint was sprayed into the hole when the two halves were assembled (photo below, left). After the two sides are separated, the mark left inside the joint (on the thread-side) indicated that the holes were not concentric (photo below, right).

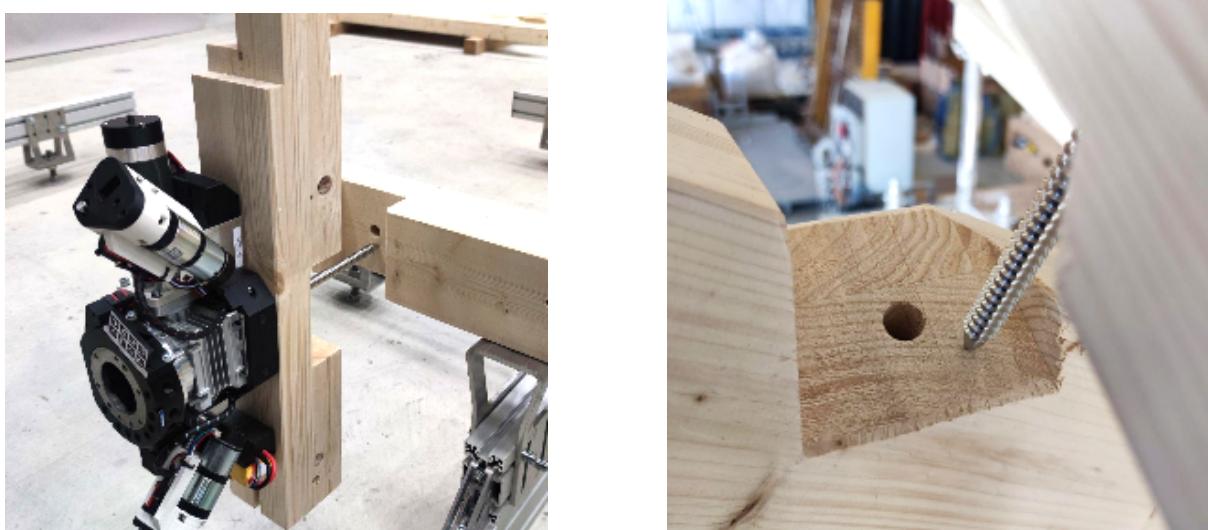
It was found that if I kept the gripper in a top grasp (gripper opening facing downwards), I was able to manually jog the robot to a rough location without an overloading error. And to continue the assembly process by installing the screwdriver at that position. It is likely that a tilted grasp in the automatically planned Free Motion trajectory caused an over-torque on the robot's wrist. The photo below shows the jogging in progress.

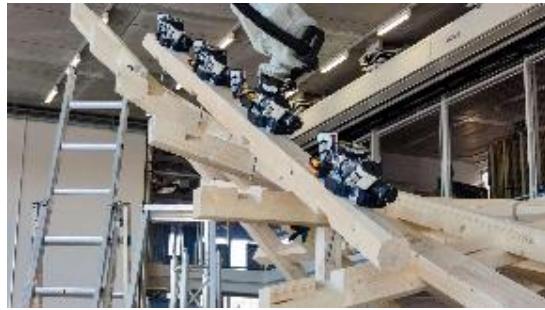
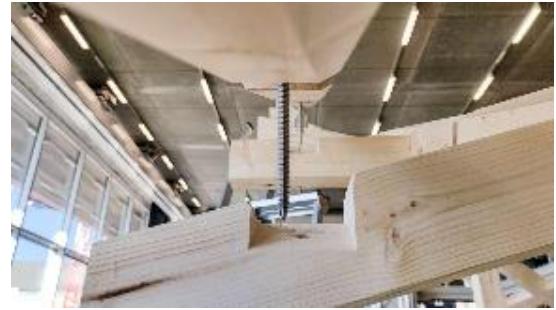
During the assembly of the roof elements, especially during the 4-screwdriver pieces, the alignment was often poor. I suspect that this is caused by the low stiffness of Joint 6, and the payload (including the 4 screwdrivers) being close to overload.

Similar to the problem observed in the previous section. A stronger robot will likely solve these problems.

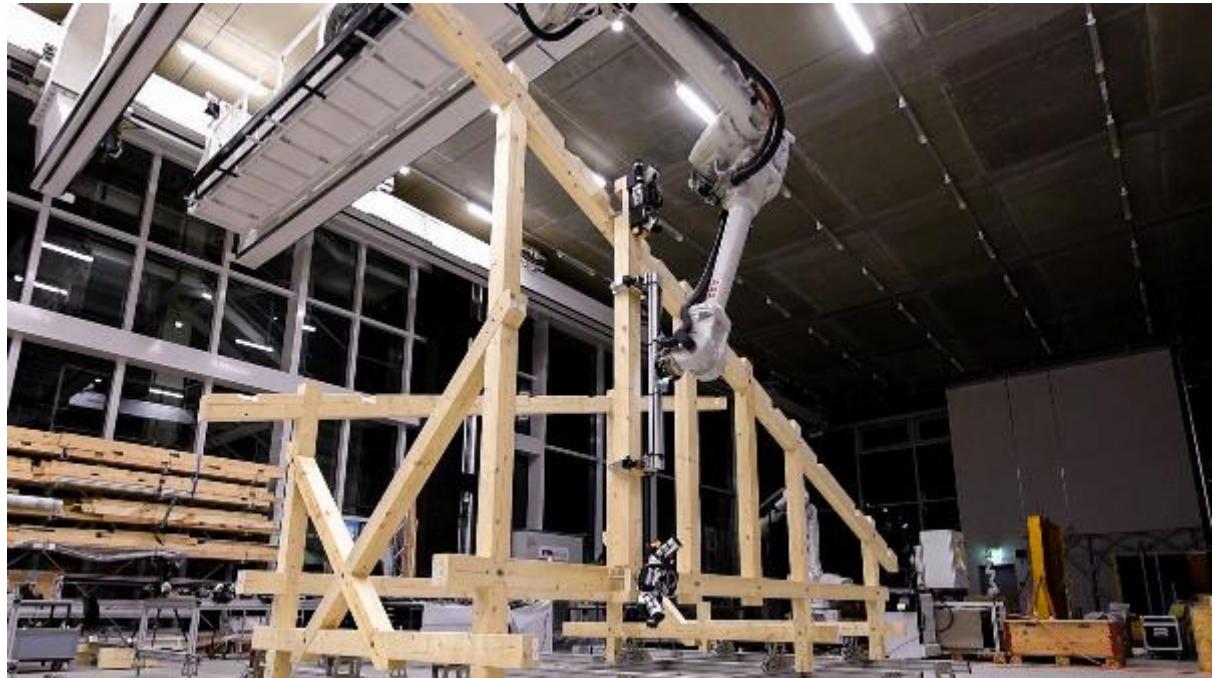
During the assembly of a beam with two screwdrivers, misalignment prevented the tip of one of the screwdrivers to land inside the hole (refer to the image below). This problem was not detected by the operator and the linear movement was allowed to continue. This caused one of the screwdrivers to break free from the pin gripper and come loose from the beam. Fortunately, the screwdriver was still hanging in the screw hole and did not fall out.

This incidence is caused by the failure to detect the misaligned condition. In the current implementation, there is no automatic detection and has to rely on the operator's visual check at the physical location.

The operator visual check was never meant to be a permanent solution but was intended to be necessary during the development phase. In an automatic scenario, it will be necessary to include failure detection for all critical operations that can result in dangerous conditions. For this specific failure mode where the screw tip did not enter the hole, the following hypothetical sensing methods can potentially detect it:

None of these solutions was pursued within this thesis. Future work should consider risk assessment and mitigation more seriously. A more detailed discussion can be found in the discussion chapter (*see 10.2 Risk Assessment of Robotic Processes* )

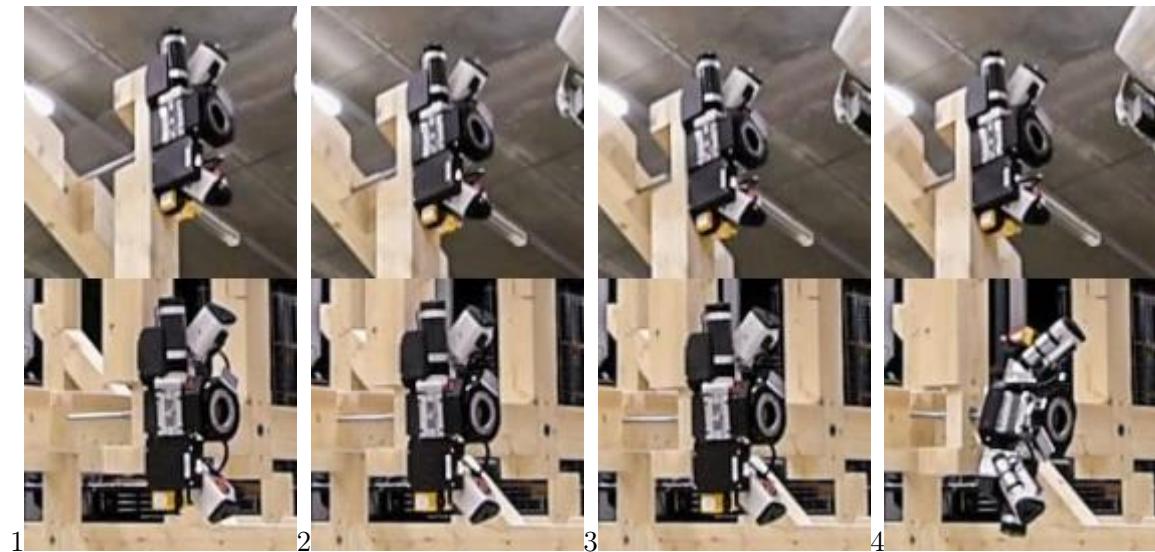
The event was captured by the documentation camera, the following images show the zoom-in region near the two screwdrivers. In step 1, the two screwdrivers and the robotic arm began the synchronised screwing motion. In step 2, the top screwdriver successfully engaged into the hole, but the bottom screwdriver failed.

In step 3, the top screwdriver can be seen pulling the joints closer; however, the bottom screwdriver did make any progress because the tip did not enter the hole. This caused the entire beam to tilt. Note that the robotic arm is continuing to push the beam towards the structure; this indirectly presses the lower screwdriver towards the stationary side. In step 4, the bottom screwdriver was pushed out of the beam from the back side and rotated about 180 degrees around the screw hole.

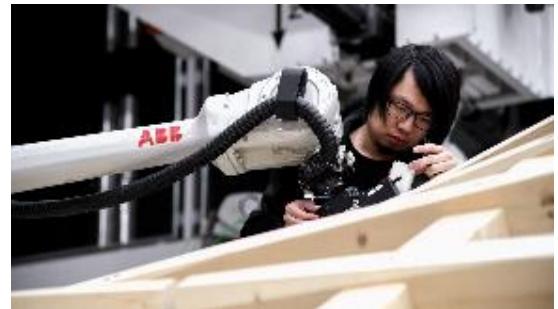
The pin grippers were occasionally found to be stuck in the locked state after assembly. This prevented the automatic retrieval of the screwdriver using the robot. This problem occurred about ten times. In about half of those cases, the pin gripper can be remotely actuated to wiggle it back and forth, and it has a chance to free itself.

- The motor of the pin gripper was too weak.
- After the joint is closed and the hollow screw is tightened, the system becomes more constrained, and the pin gripper can become more stressed.
- When the pin is under bending stress, the actuating threads that were located behind the tip could be jammed due to the bending.
- The docking of the robot to the screwdriver may have increased the stress that bends the pins.

The photos below show the scenario where the problem has to be fixed physically by turning the pin shaft. When this happened on the roof elements, access to the screwdriver was sometimes difficult.

The pin extension mechanism and gearbox would have to be redesigned to overcome this problem. This solution was not pursued further within this thesis. Future work should consider the effect of the bending of the pin.
