# **City Exploration #2 – Why Is Bike Riding Still Dangerous? An Analysis of Infrastructure and Risk Areas**

Seungyeon Kim

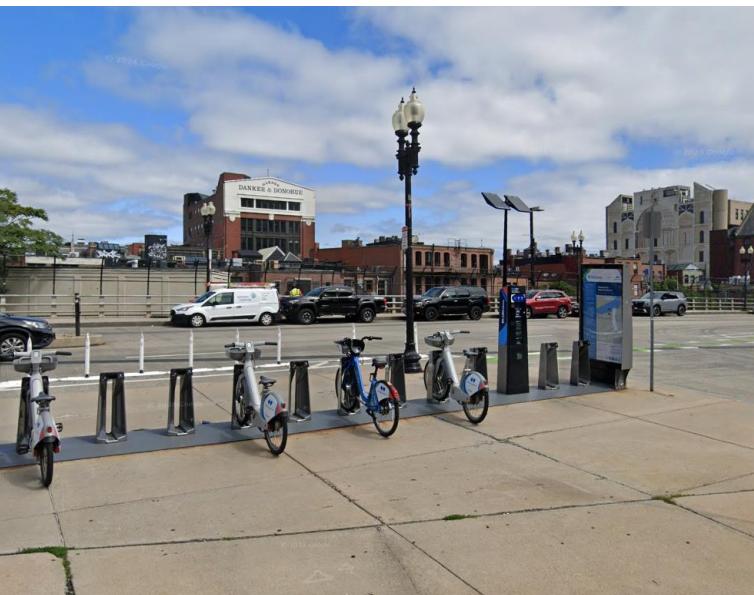
#### 1. Boylston St at Massachusetts Ave (listed both in 2015 and 2024)

Boylston St at Massachusetts Ave is located along Boylston Street, where bike lanes are shared with vehicle lanes. The bike infrastructure is designated for cyclists only; however, it consists solely of **painted markings without any physical buffers or protective barriers.**

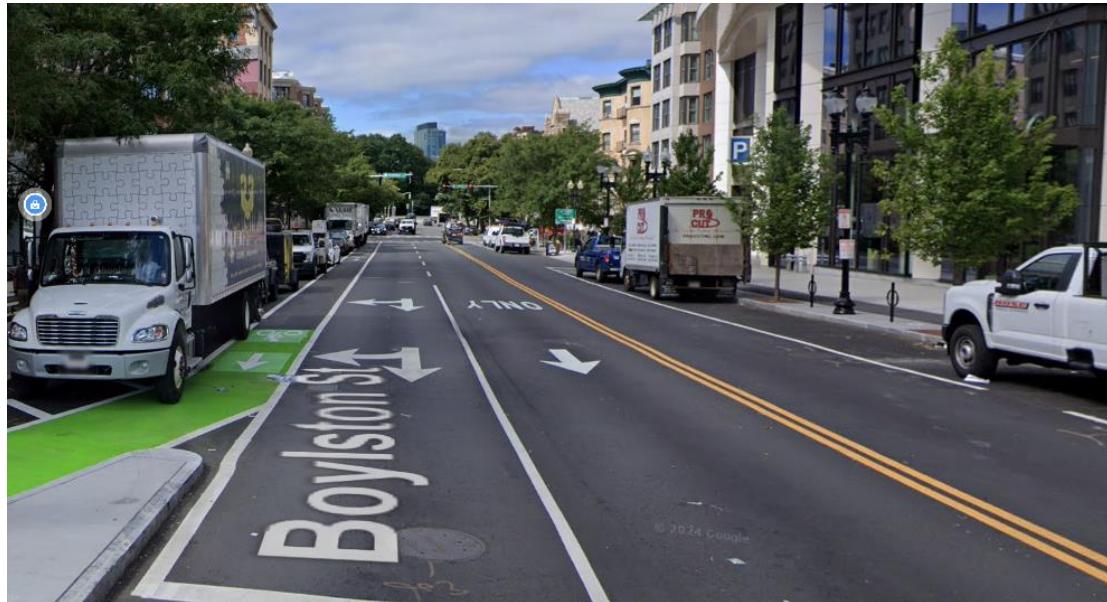
In this photo, **the bike lane can be seen squeezed between traffic lanes and parking zones**, leaving cyclists with minimal space and putting them at greater risk of collisions with vehicles.

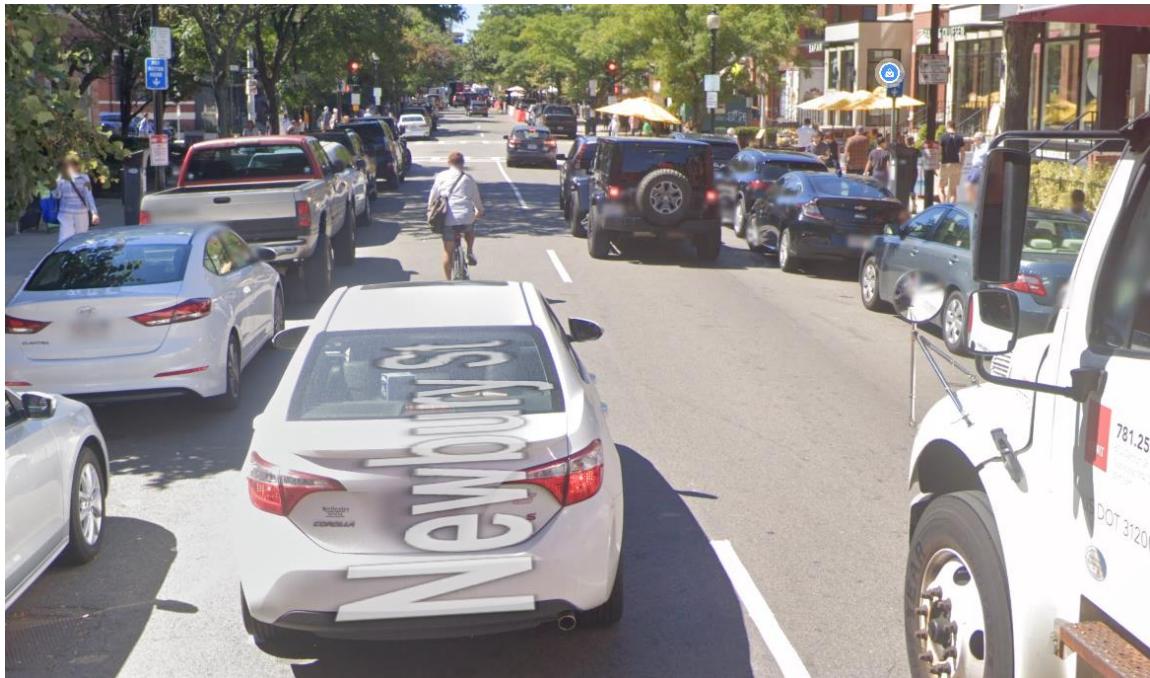
## 2. Newbury St at Hereford St (listed both in 2015 and 2024)

Newbury St at Hereford St is located along narrow roads in a mixed commercial and residential area. Unlike other top accident locations, this site is not situated near major vehicle lanes; however, **it lacks any designated bike infrastructure. Only pedestrian sidewalks and vehicle lanes are present, with no dedicated space for cyclists.** Observations from Google Maps show several riders using the vehicle lanes to navigate the area.

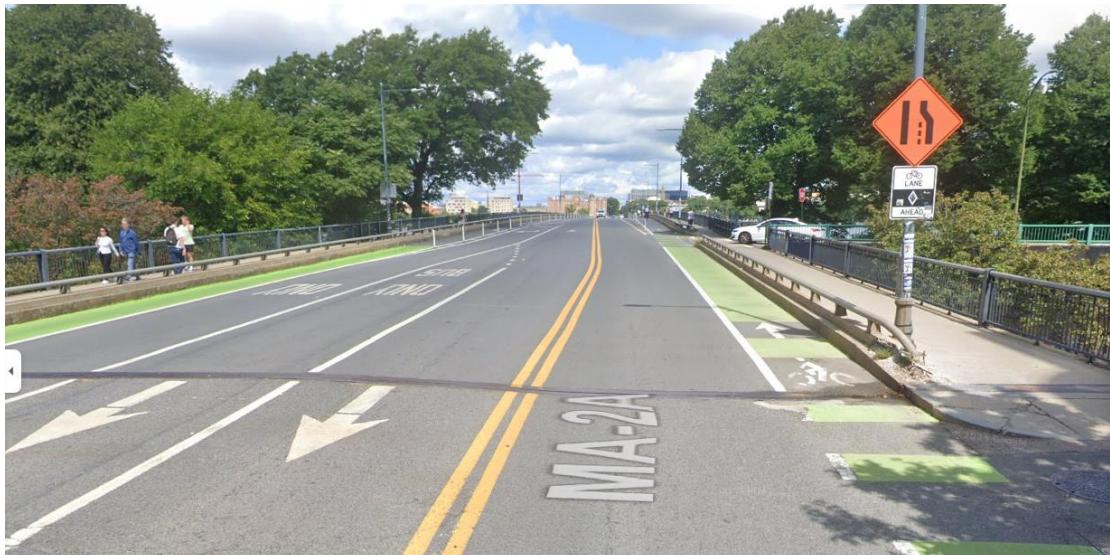
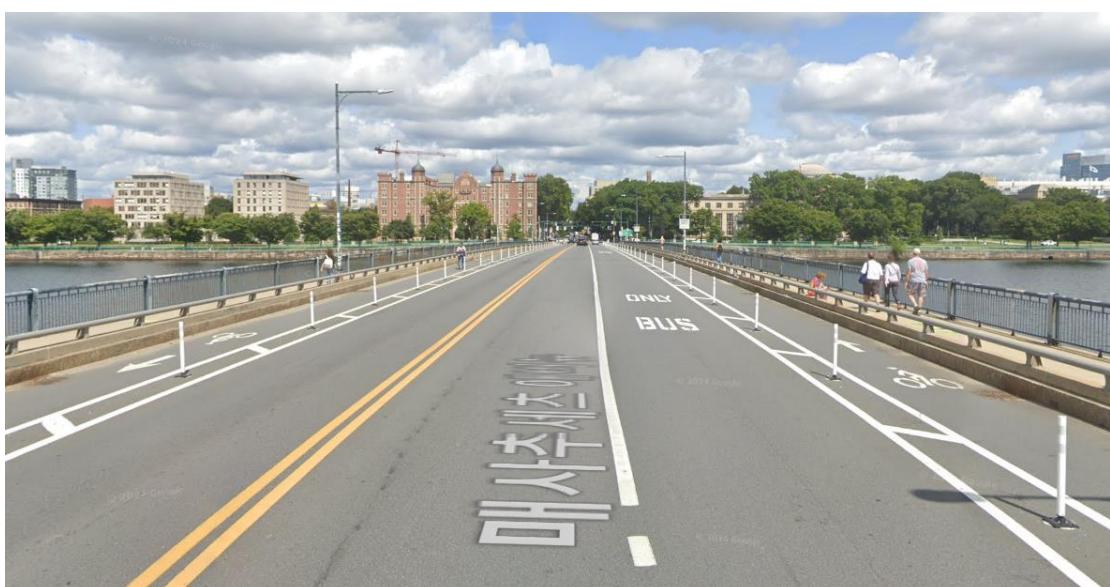
### 3. Beacon St at Massachusetts Ave (listed both in 2015 and 2024)

Upon reviewing the area, it was evident that the bike lane shares the roadway with vehicle traffic. **Most of the nearby bike infrastructure consists of painted markings, with occasional buffers provided when the bike lane overlaps with bus lanes.**

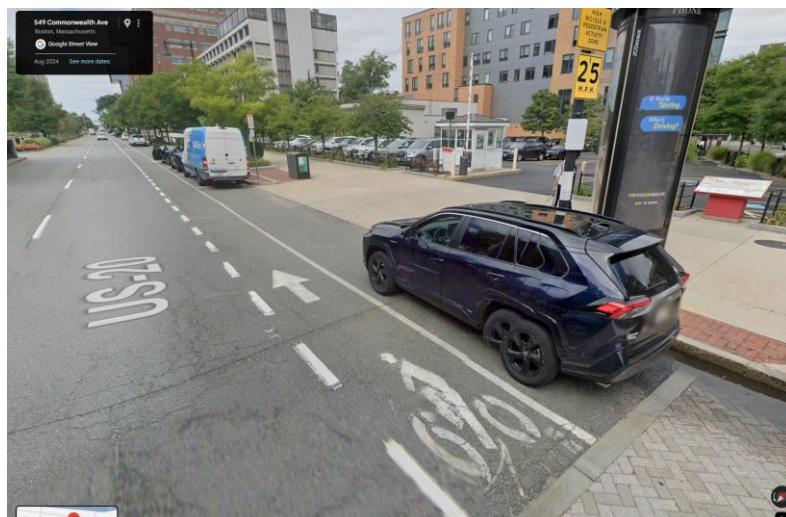
#### 4. Deerfield St at Commonwealth Ave station and Kenmore Square station (Top station from 2024)

I also reviewed the two stations that appeared only in the top five list from 2024 to see if there were any exceptions. However, these stations similarly lacked separated bike lanes and offered no physical protection for cyclists.
