# Production Order: 500000294024

## Material: SA0155-01 Rev F

Material Type:	ZFRT	Description: Edwards Flex Shaft Commander 155885	Order Type: ZSTD
Production Version:	7987		Project Phase:
Plant / Business Unit:	1213 / AC5

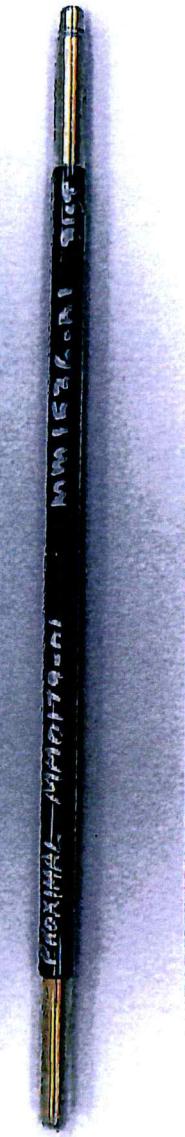
Image- 1

- 100% inspection at Op#1050 per the instructions below.
- Inspect 1 part at a time.
- Inspection is focused on the correct MM0179-01 and MM1536-01 assembly.
- Use the example MM0179-01 and ~~MM1536-02~~ fixture for inspection. (See image 1)  
**① MM01536-01 type connection TS12 10AUG-23**

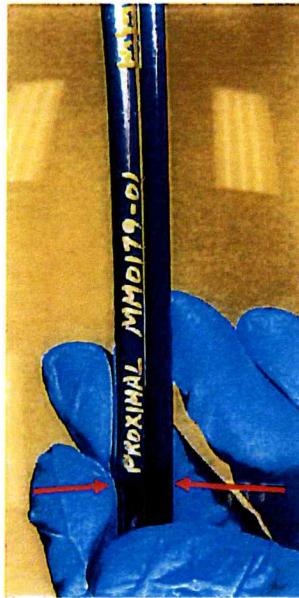
Image- 2

- Visually locate the MM0180-01 (Vestamid) transition to MM0179-01 on the completed part approximately 9.75" from the distal end using magnification light 2.25X minimum.
- Align the fixture MM0179-01 extrusion proximal end to the Vestamid transition on completed part.  
(See image 2)
