Production Order: 500000303482

Material Type: ZFRT Description: Edwards Flex Shaft Commander 155885
 Production Version: 7987
 Plant / Business Unit: 1213 / AC5

Requestor Name:	Udhesha Kapadnis		
Document Number Affected	3107610	Revision	L
Deviation From:			
<p>QIP3107610, Section 8.0 Inspection Requirements (Supplemental Visual Inspection) OP 1050:</p> <p>Current QIP3107610 does not state to inspect for the correct extrusion configuration.</p>			
Deviation To:			
<p>This DA allows addition inspection for correct assembly of extrusion material MM0179-01 and MM1536-01 during performing QIP3107610, Section 8.0 Inspection Requirements (Supplemental Visual Inspection) OP 1050.</p> <p>See instructions attached to this DA.</p>

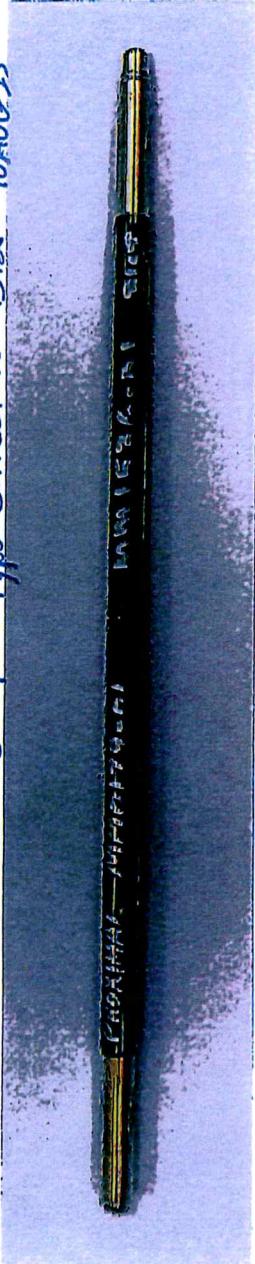
Image- 1

- 100% inspection at Op#1050 per the instructions below.
- Inspect 1 part at a time.
- Inspection is focused on the correct MM0179-01 and MM1536-01 assembly.
- Use the example MM0179-01 and MM1536-02 fixture for inspection. (See image 1)
① **MM0179-01** **MM1536-01** **Type Connection TS12** **10AUG23**

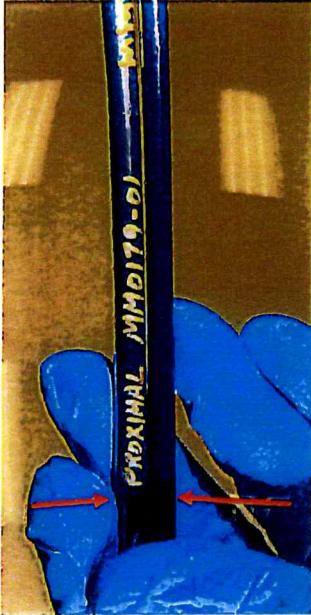
Image- 2

- Visually locate the MM0180-01 (Vestamid) transition to MM0179-01 on the completed part approximately 9.75" from the distal end using magnification light 2.25X minimum.
- Align the fixture MM0179-01 extrusion proximal end to the Vestamid transition on completed part.
(See image 2)

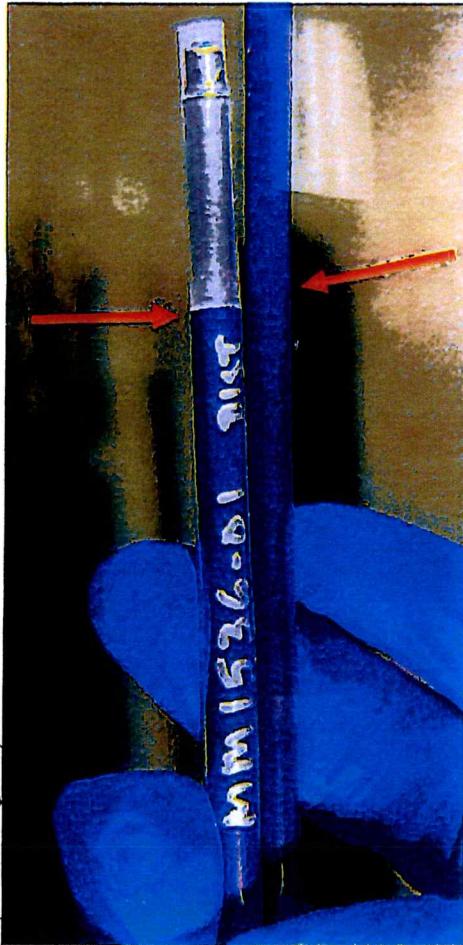
Image- 4

- Visually verify the MM1536-01 distal end of the fixture is approximately at the same location on the completed part. (See image 4)

- Scrap the part if the transition is not approximately aligned. Save the scrapped parts for Engineer review.
- If the part transition is aligned, the part passes inspection.
- Use Image 5 as a guide for GOOD and BAD extrusion transition alignment.
