Production Order: 500000295350

Material: SA0155-01 Rev F

Material Type: ZFRT Description: Edwards Flex Shaft Commander 155885
 Production Version: 7987
 Plant / Business Unit: 1213 / AC5

CONTROLLED COPY DEVIATION AUTHORIZATION NUMBER: 2484
** See added email extension to MSEPs*

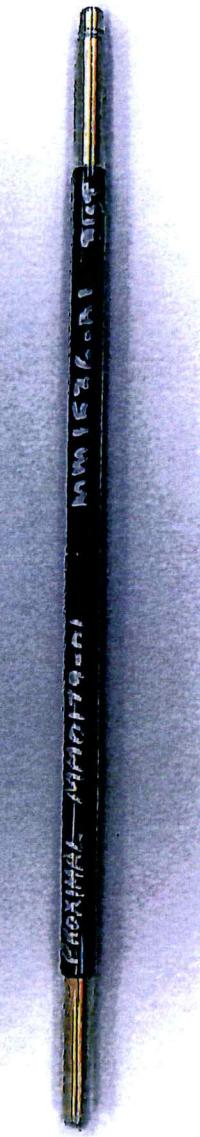
Image- 1

- 100% inspection at Op#1050 per the instructions below.
- Inspect 1 part at a time.
- Inspection is focused on the correct MM0179-01 and MM1536-01 assembly.
- Use the example MM0179-01 and MM1536-01 fixture for inspection. (See image 1)
①MM0179-01 *10AUG-23* *512* *typo correction*

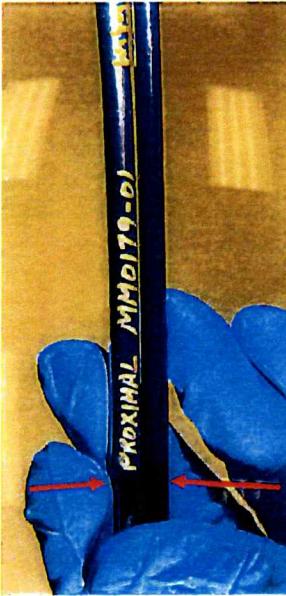
Image- 2

- Visually locate the MM0180-01 (Vestamid) transition to MM0179-01 on the completed part approximately 9.75" from the distal end using magnification light 2.25X minimum.
- Align the fixture MM0179-01 extrusion proximal end to the Vestamid transition on completed part.
(See image 2)
