Production Order: 500000306365

Material: SA0155-01 Rev F

Material Type: ZFRT Description: Edwards Flex Shaft Commander 155885
 Production Version: 7987
 Plant / Business Unit: 1213 / AC5

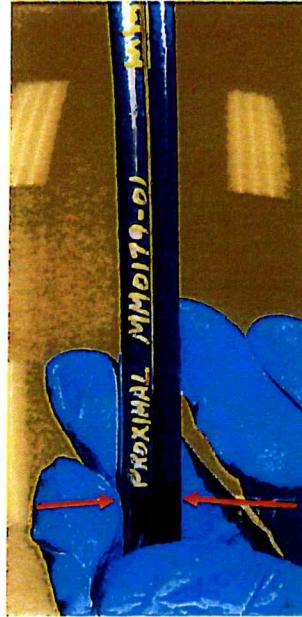
Image- 2

- Visually locate the MM0180-01 (Vestamid) transition to MM0179-01 on the completed part approximately 9.75" from the distal end using magnification light 2.25X minimum.
- Align the fixture MM0179-01 extrusion proximal end to the Vestamid transition on completed part. (See image 2)
