Production Order: 500000294403

Material Type: ZFRT Description: Edwards Flex Shaft Commander 155885

CONTROLLED COPY DEVIATION AUTHORIZATION NUMBER: 2484
*See added email extension to 24SEP23

DEVIATION AUTHORIZATION FORM

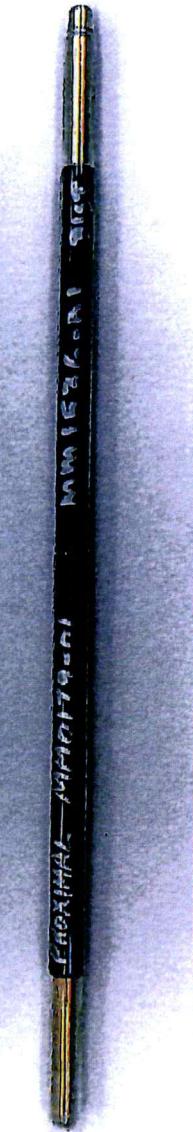
Image- 1

- 100% inspection at Op#1050 per the instructions below.
- Inspect 1 part at a time.
- Inspection is focused on the correct MM0179-01 and MM1536-01 assembly.
- Use the example MM0179-01 and ~~MM1536-02~~ fixture for inspection. (See image 1)
① **MM01536-01** type connection **(S)2** 10AUG-23

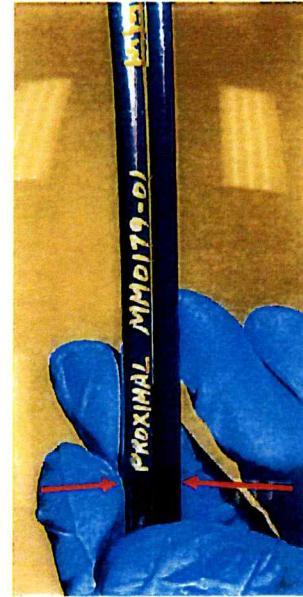
Image- 2

- Visually locate the MM0180-01 (Vestamid) transition to MM0179-01 on the completed part approximately 9.75" from the distal end using magnification light 2.25X minimum.
- Align the fixture MM0179-01 extrusion proximal end to the Vestamid transition on completed part.
(See image 2)
