# Sensor troubleshooting

February 5-6, 2024

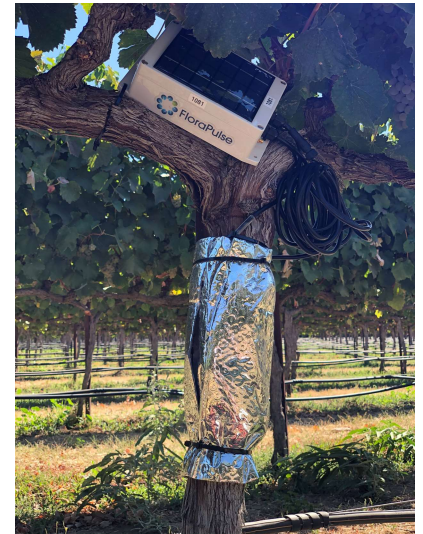
- Similar behavior to sensor flooding. The sensor goes to zero and stays there, but right after a rain/wetting event.
- Cause: water stuck inside the insulation is wetting the trunk for multiple days and getting to the sensor install site.
- Solution: the sensor bubble wrap insulation should be attached somewhat loosely so that excess moisture can evaporate. Especially important in wet climates.
- Might need to ignore SWP data right after a big rain storm, until excess water dries out.
- New small probe may be less affected by outside rain due to use of better sealant (still under testing).

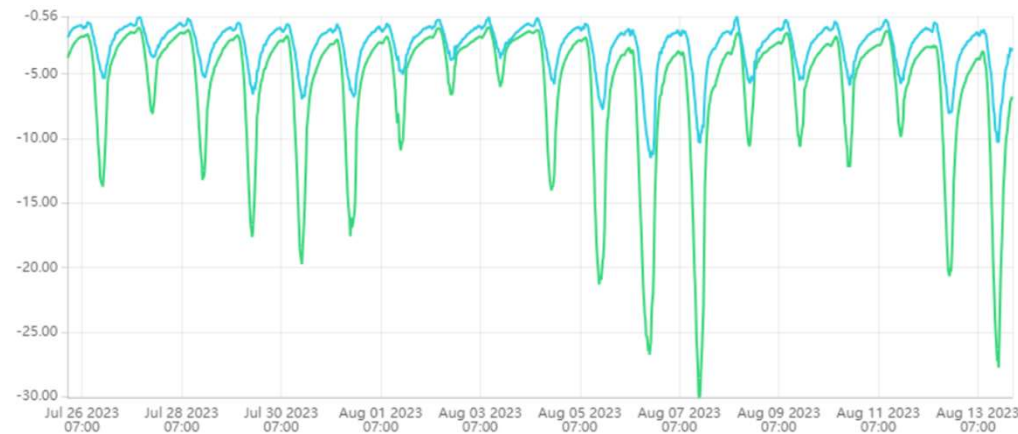
- Reading WP is extremely difficult because tiny temperature differences cause huge errors. Usually not a problem with FloraPulse, except when there's a gap between the sensor and xylem.
- In the field, this shows up as reasonable SWP values when temperature isn't changing much (at night), but very negative SWP measurements during the midday.
- Cause: bubbles in the mating clay, sensor disconnected because moved/hit, extremely hot days with poor insulation. More likely in very hot climates.
- Solution: recommend re-installing sensor.

Grape install. Green sensor reads unrealistically low SWP during HOT times.
