DLA Report 14

Alexey Yermakov
12 April 2022

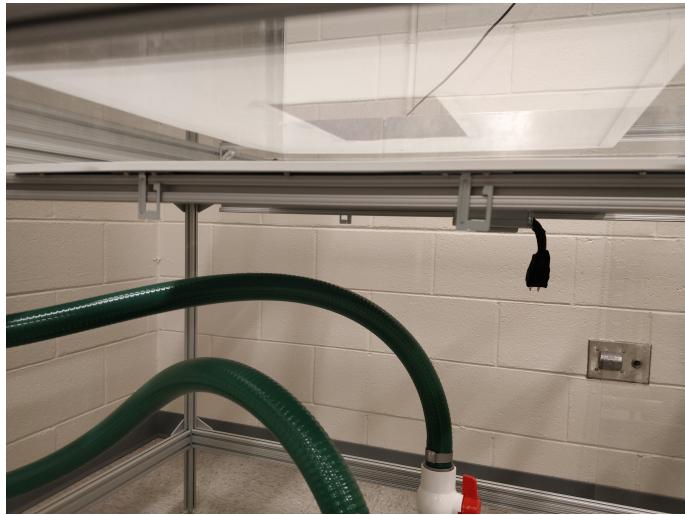
Figure 2: LED under the water table (bottom view). Note that the LED has hinges we can use to keep it from sliding off and falling, which is a nice feature. Note also that the black cable connects to a larger extension cable to turn the LED on. This larger cable can reach almost any outlet in the lab, making turning on and off the LED easy. The larger cable can also be stored easily when the water table is not in use.

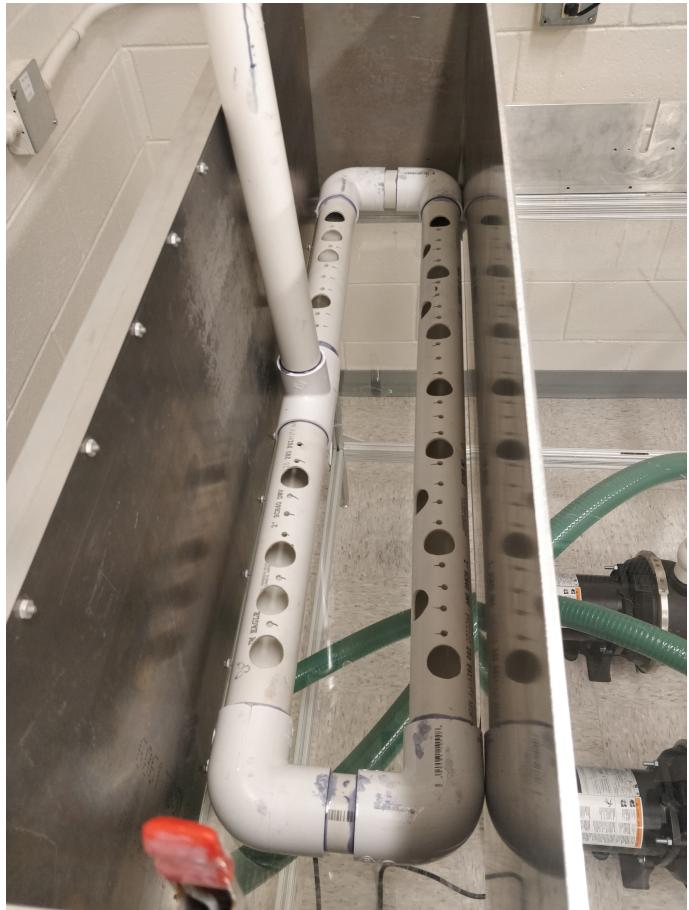
Figure 3: Pipes with larger holes to allow for smaller fountains when pumps are running.

I was able to resolve the water fountain problem by drilling larger holes into the output pipes of the water table. Below are images of the water table with various modifications:

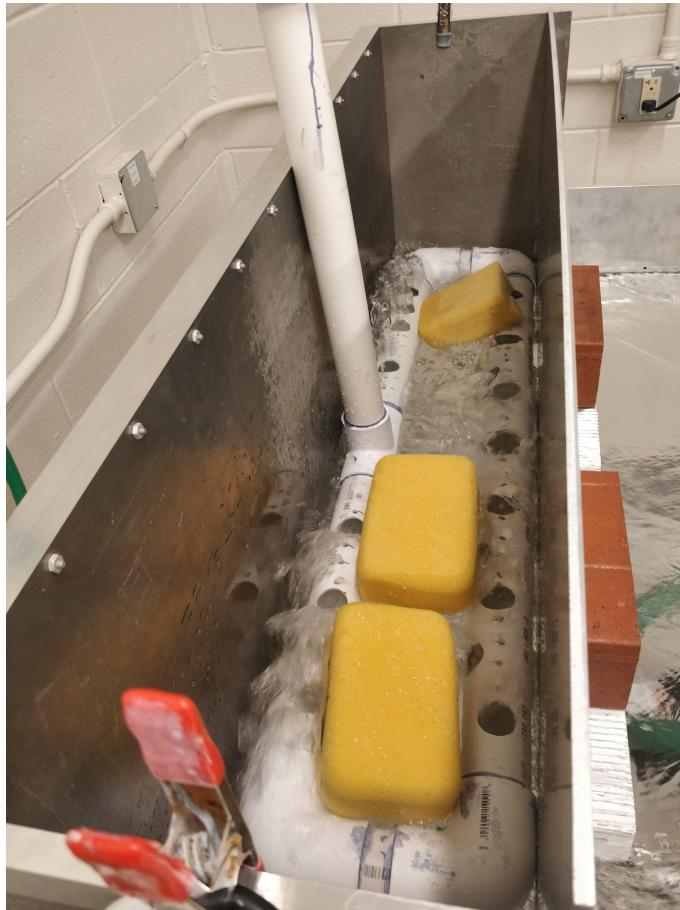
Figure 6: Water table with one pump running and flow straighteners (inside sluice gate).

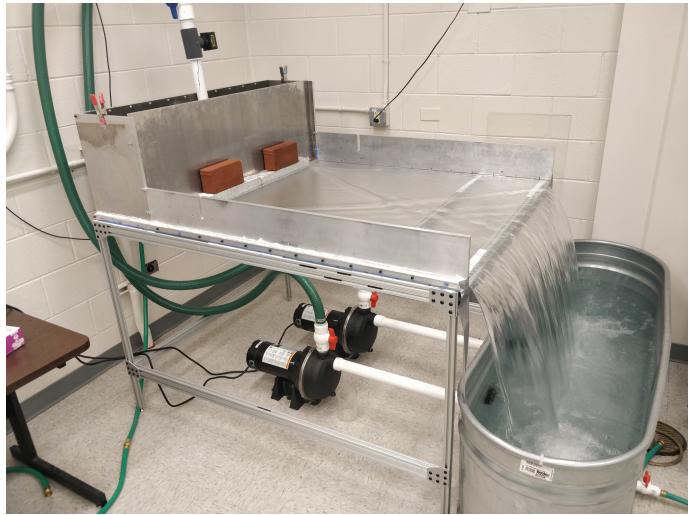
Figure 7: Water table with two pumps running and flow straighteners.

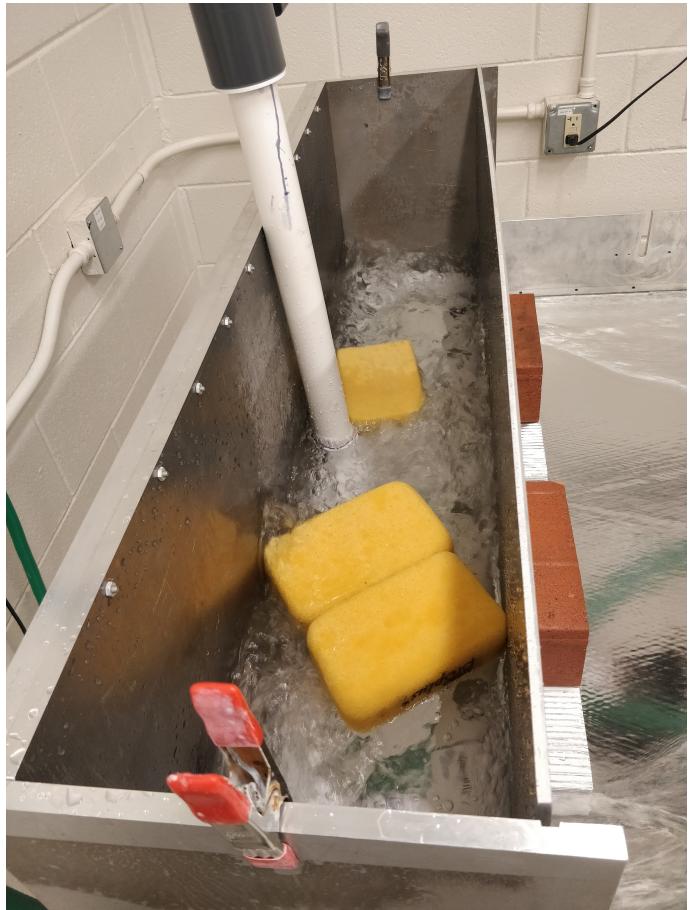
Figure 8: Water table with two pumps running and flow straighteners (inside sluice gate).

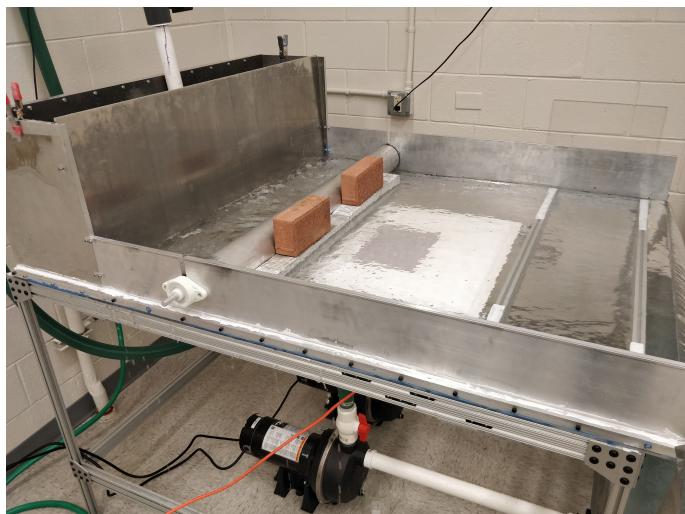
Figure 10: Water table with two pumps running, the cylinder, and flow straighteners. Note that this image was taken after figure 9, potentially resulting in more water being built up behind the sluice gate/ cylinder causing the water to be smoother in this image. It's also possible the acrylic was bending due to the bricks on the flow straighteners, causing a concave shape on the water table where water was collecting.

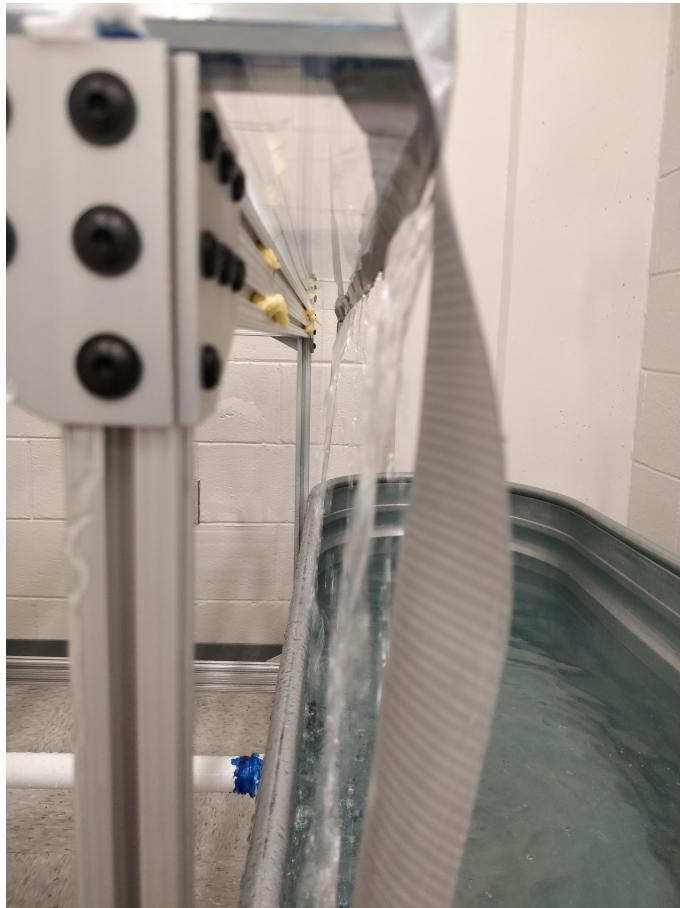
Figure 13: Water table leakage when pumps are disconnected. Disconnecting the pumps results in water velocity decreasing, but this means that surface tension causes water to go everywhere since it misses the tank. I thought moving the table forward a bit would fix this, but even with over an inch of overhang there is still leaking. The best solution to this would be to replace duct tape with a stronger lip for the water table, but some brainstorming is required for the best way to make a stronger lip. 3D printing comes to mind but it seems like an over-engineered solution to this problem. Note that there is water dripping down the leg of the water table, this was from the same leak identified in figures 11 and 12.

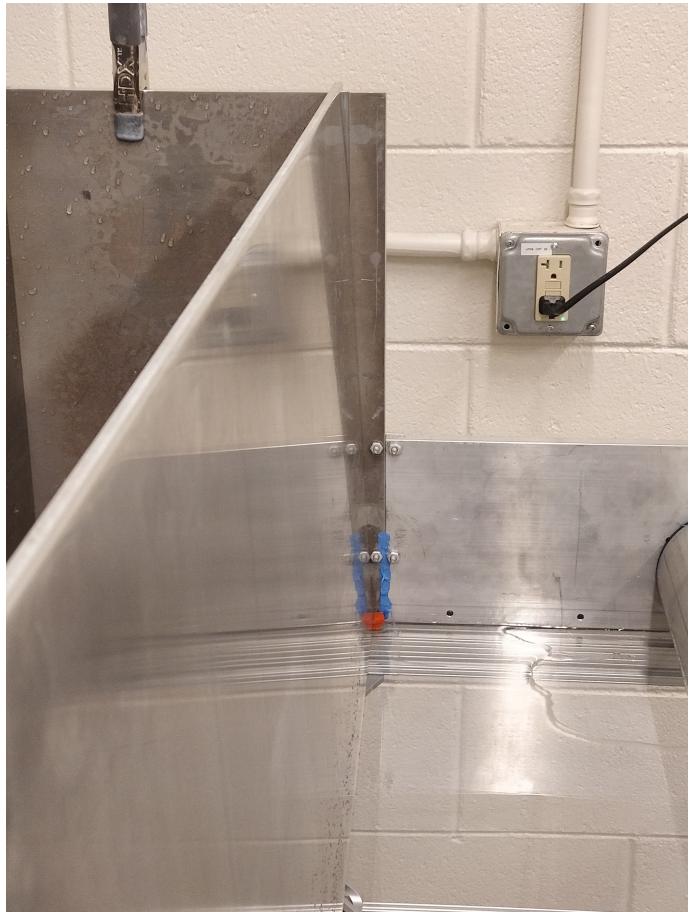
Figure 14: Slanted sluice gate. When the water table is run with two pumps the sluice gate starts to slant. This makes sense since, as we know, the sluice gate isn't as secured to the table as it could be. This may or may not be a problem, but it's important to mention. I have plans to fix this, see the section Water Table Work [2.5](#) below.

- Using screws to hold the sluice gate in place. These screws would support the sluice gate from the flat sides on both sides, instead of what we currently have where the sluice gate is supported by screws pushing into it.

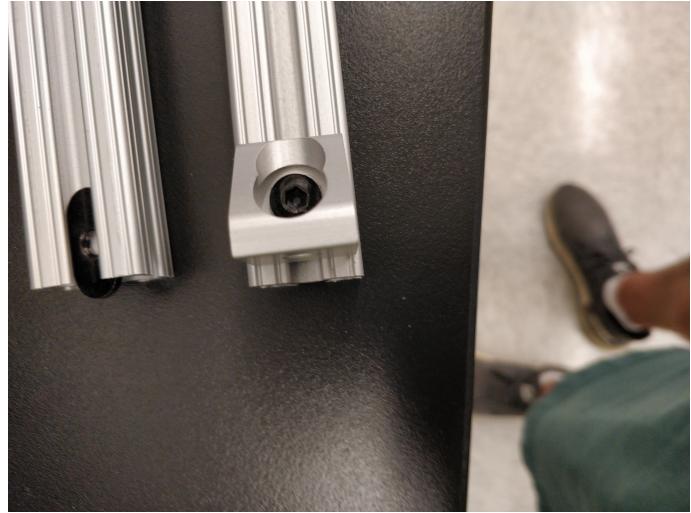
Figure 15: 80/20 sizing. It turns out that the provided 80/20 aluminum bar for the LED is just slightly too big. This isn't a major problem, since it can easily be machine down to size. We would only need to do this if we want to attach the LED about an inch closer to the bottom of the water table.

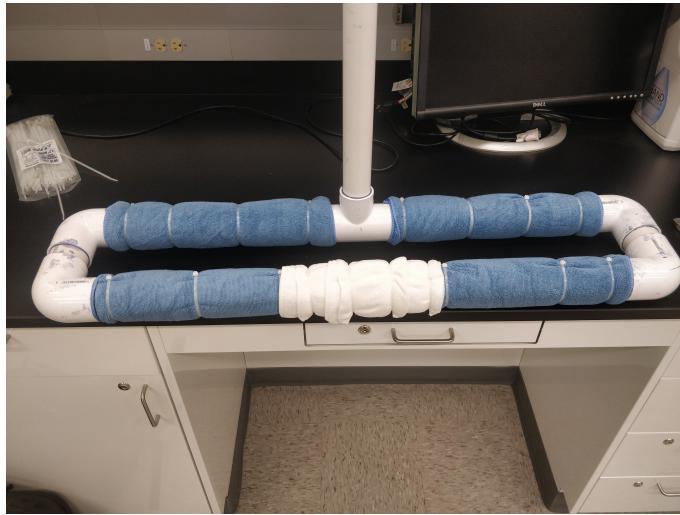
Figure 22: Rags zip-tied to the pump’s pipes outputs. This should help reduce turbulence in the water.

- I think zip-tying rags to the pump outputs will help reduce turbulence. It has the same effect as the sponges should have, but they will stay in place.
- I can bring in an extension cord I have to use two pumps at once without tripping a breaker, since different outlets in the lab correspond to different breakers.
