# DLA Report 13

Alexey Yermakov  
29 March 2022

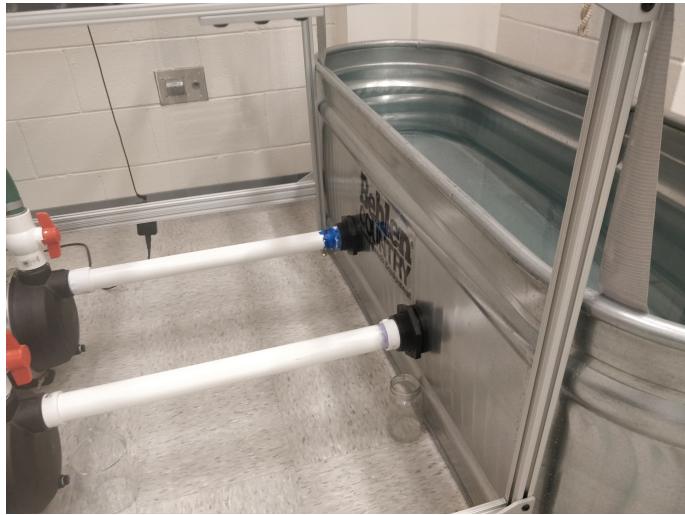
Figure 1: Stock Tank Filled with No Leaks. Note that there was minor leaking (slow water drops) from the pump pipes, but beakers contained the extent of the leaking.
