# **FEDERAL TRANSIT BUS TEST**

**Manufacturer: New Flyer of America  
Model: XE40**

**Partial test  
12 Year / 500,000 Miles**

**Report Number: LTI-BT-R1915-P**

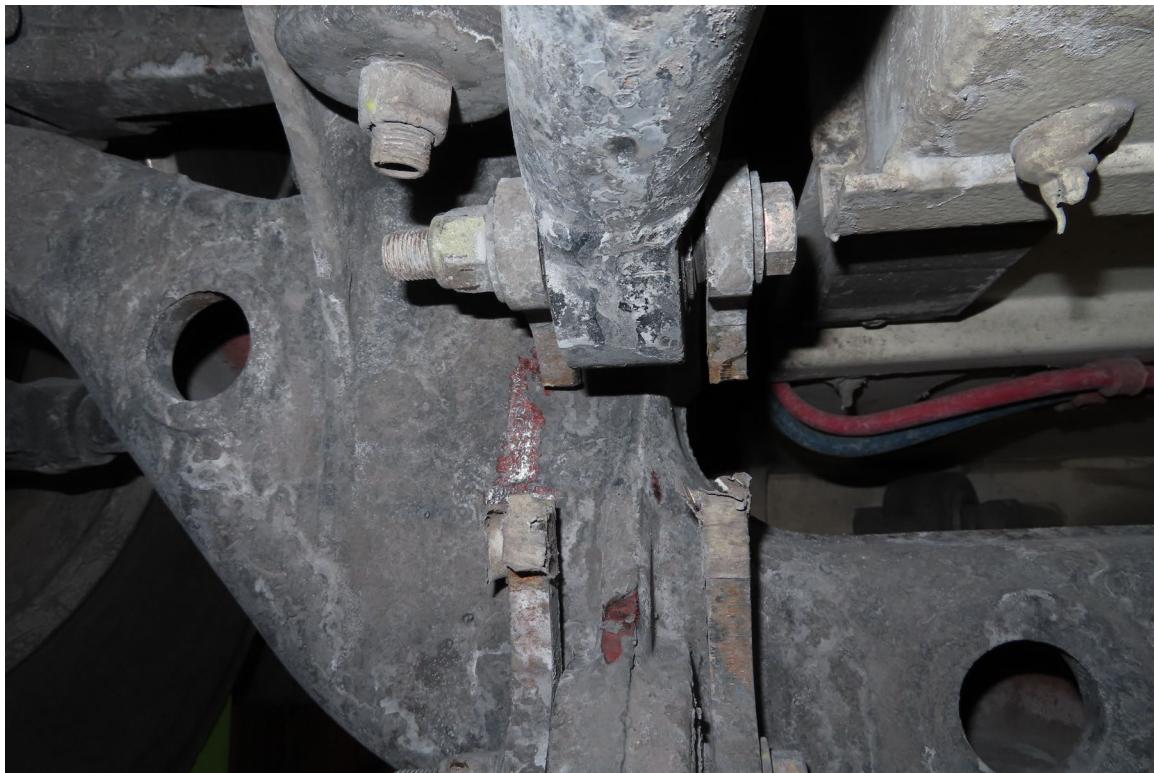
**BROKEN FRONT SWAY BAR LINK  
(2,549 TEST MILES)**

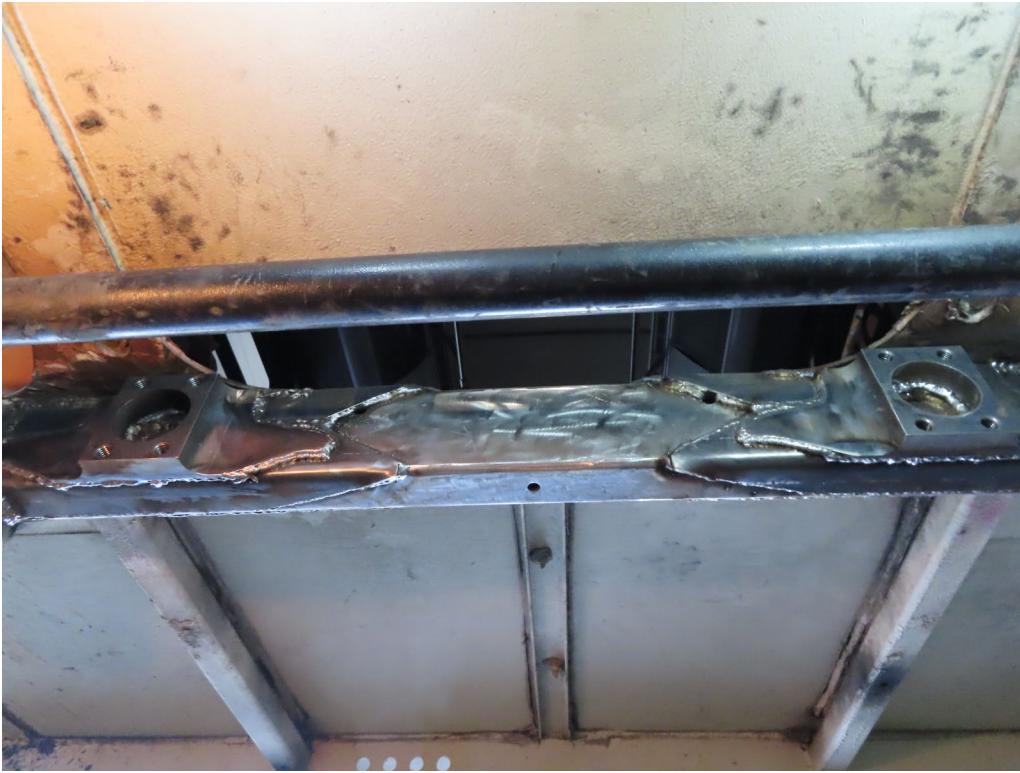
**FRONT SWAY BAR MOUNT LOCATION REPAIRED  
(8,027 TEST MILES)**

Removed sway bar and brackets, cleaned for welding. Welded crack in front support beam by the rear of the front wheels curbside, streetside and middle. Original mounting brackets for the sway bar had to be cut off and the frame was ground smooth.			
			New mounting brackets and steel plating were welded to crossbeam.			
09/08/20 to 10/28/20	7,977 to 8,027	Cracks found in front support beam by the rear of the front wheels, curbside, streetside and middle. Several cracks formed in the structure just behind the sway bar mount.	Cracks were welded in structure behind front sway bar mount, new supports and plates were added. This work was done by the manufacturer's representatives.	36.00	Frame	3

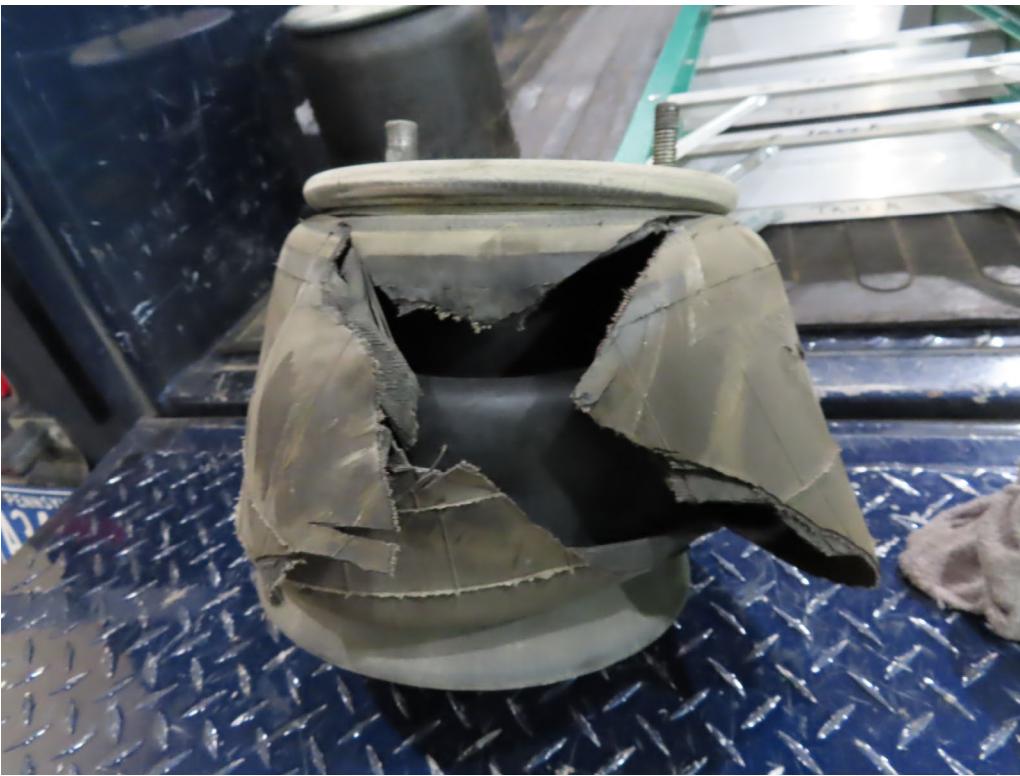
**BLOWN CURBSIDE FRONT AIRBAG  
(8,331 TEST MILES)**

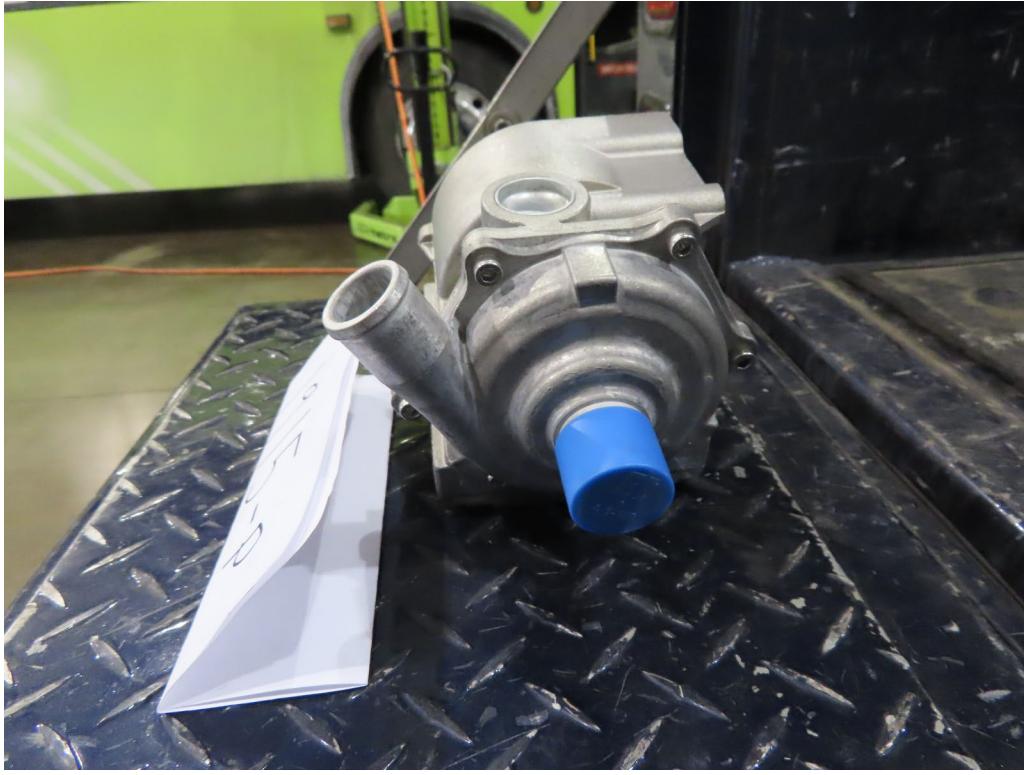
**REPLACED COOLING PUMP FOR MOTOR INVERTER  
(11,023 TEST MILES)**

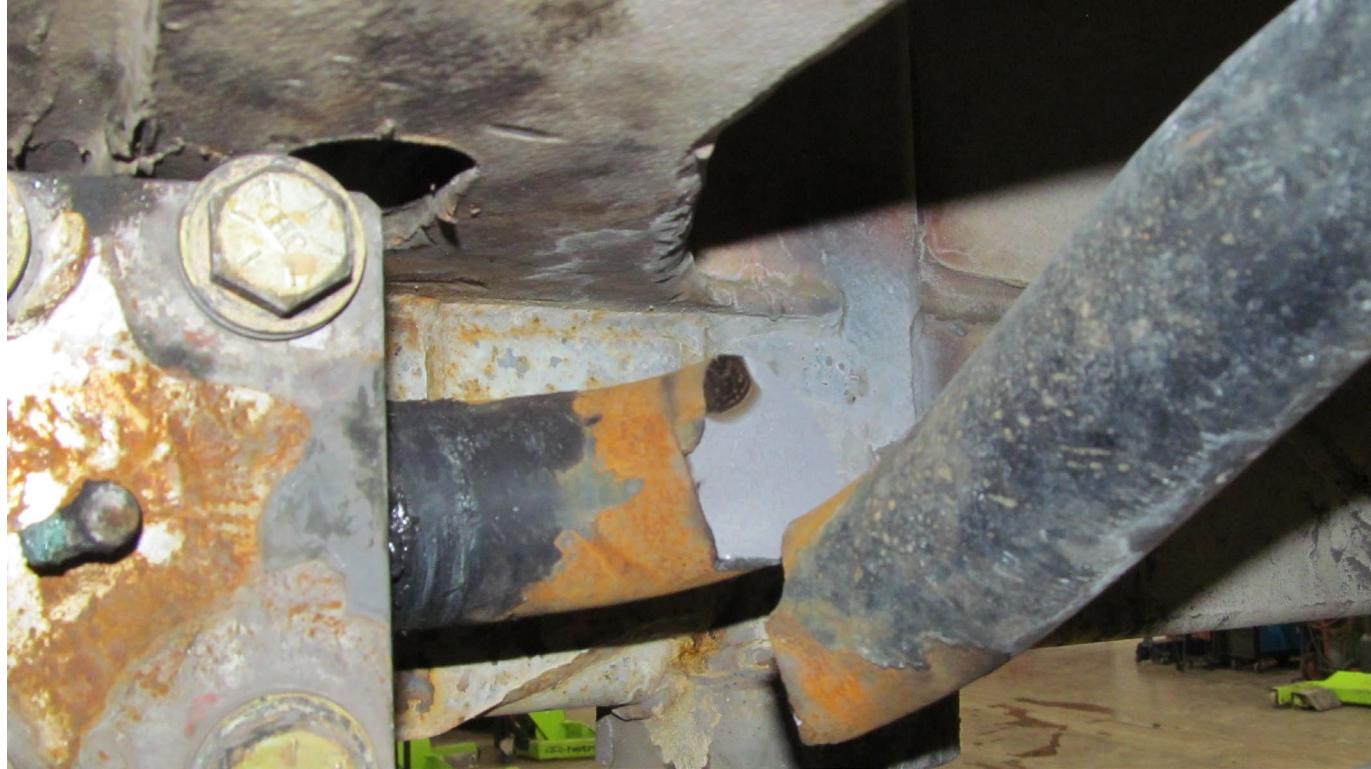
**FRONT SWAY BAR IS BROKEN ON THE STREETSIDE  
(11,937 TEST MILES)**

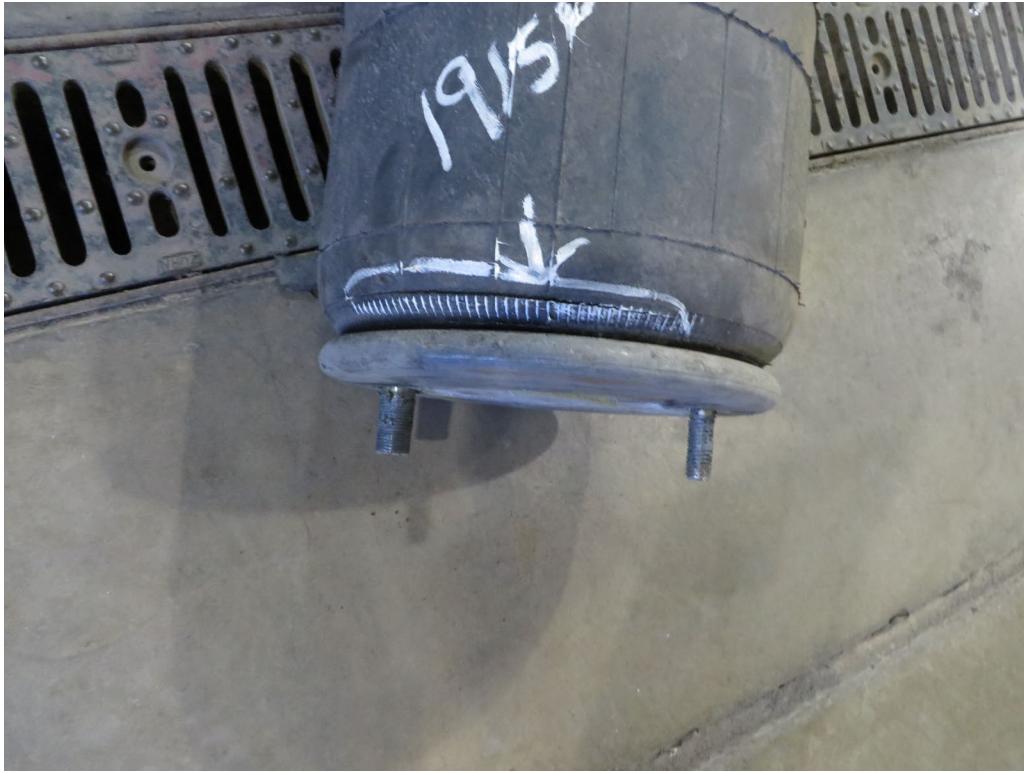
**CURBSIDE FRONT AIRBAG IS STARTING TO SPLIT  
(12,262 TEST MILES)**

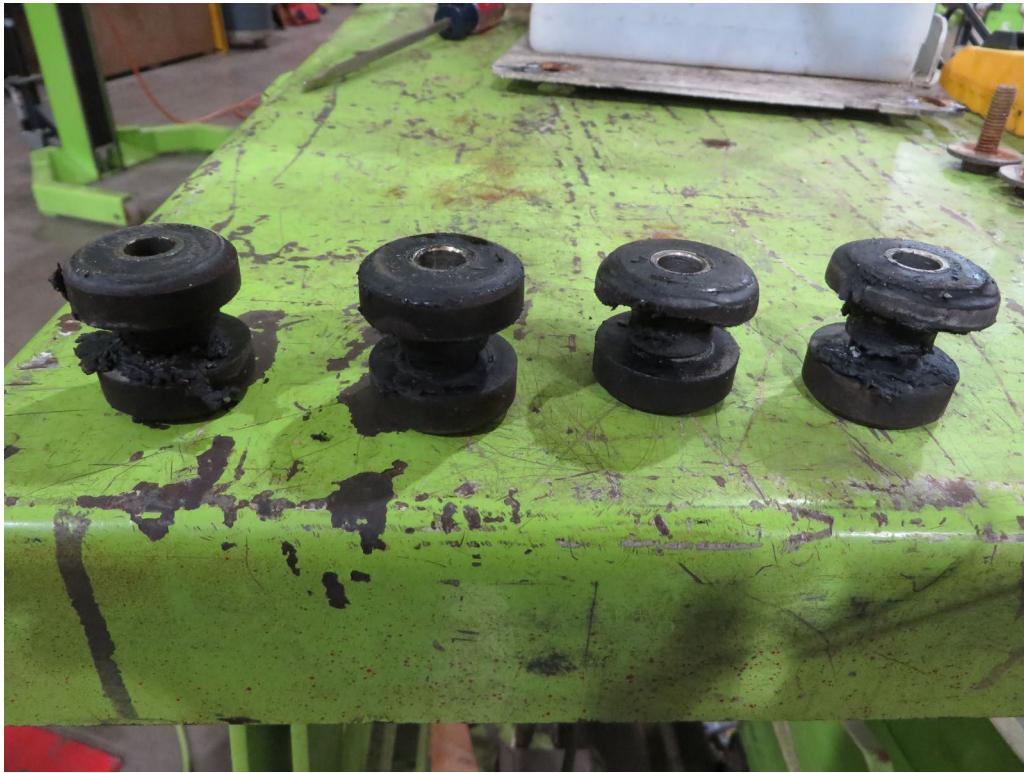
**WORN ISOLATORS FROM ELECTRIC HYDRAULIC STEERING PUMP  
(13,267 TEST MILES)**

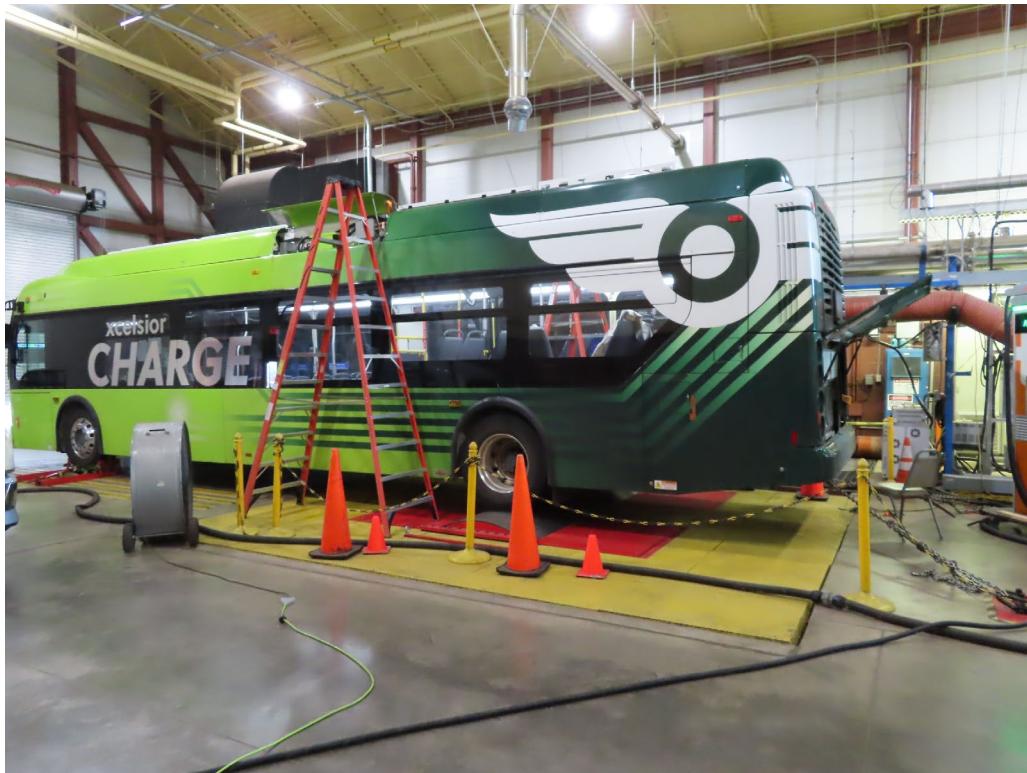
<b>Comments:</b> After the test was completed, it was brought to the test center's attention by the manufacturer's representative that one of the six battery strings was offline during the test. There was no indication on the driver's instrument panel that one of the strings was offline. The manufacturer was offered to retest, but the offer was declined.
--

**BUS TESTED ON CHASSIS DYNAMOMETER FOR PERFORMANCE AND ENERGY ECONOMY**
