Post-installation Analysis of Locally Manufactured Small Wind Turbines: Case Studies in Peru

J. Leary¹, R. Howell¹, A. While¹, J. Chiroque², K. VerKamp³, C. Pinedo³
¹E-futures DTC, University of Sheffield, UK

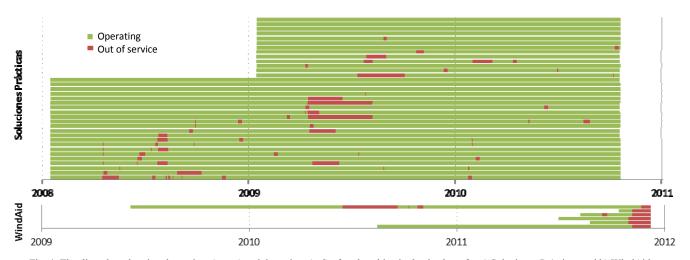
Fig. 4 is a graphical representation of the complete database for both Soluciones Prácticas and WindAid, whilst Fig. 5 shows three key indicators of the post-installation technical performance of the two organisation's wind power systems. Reliability is measured by the Mean Time Between Failures (MTBF), i.e. how often failures occur. Resilience is measured by the Mean Time To Return (MTTR), i.e. how quickly the system can be put back into operation when a failure does occur. The technical availability is a combination of both reliability and resilience, and represents the amount of time that the system is technically able to provide power to the end user.

Fig. 4 Timeline plots showing the uptime (green) and downtime (red) of each turbine in the database for a) Soluciones Prácticas and b) WindAid.
