# *Overview of Performance of Ports, Harbors, Infrastructures and Buildings in Sri Lanka and India*

*By Peter Yin, Port of Los Angeles  
ASCE-COPRI Reconnaissance Team Member*

*January 31- February 11, 2005*

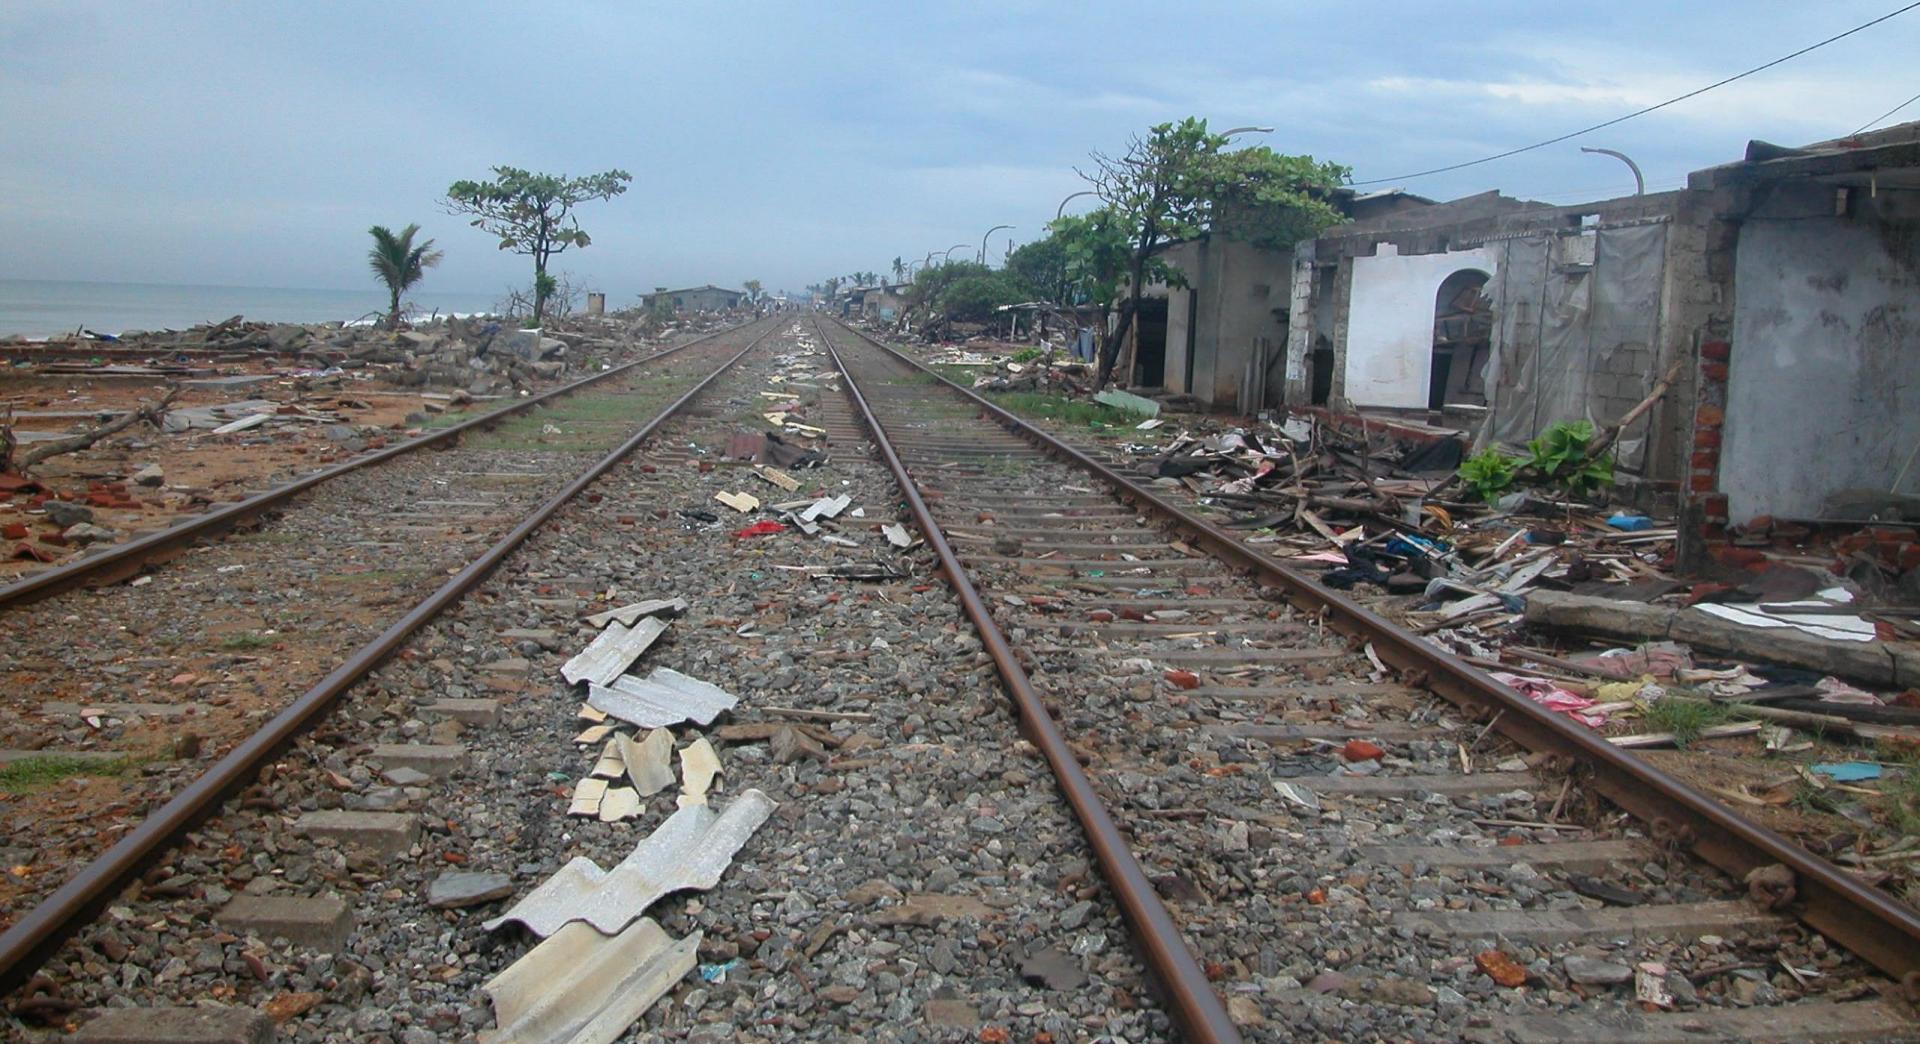
**Panadura, 25 km South of Colombo**  
**Nearly all houses along this west coast line were destroyed.**

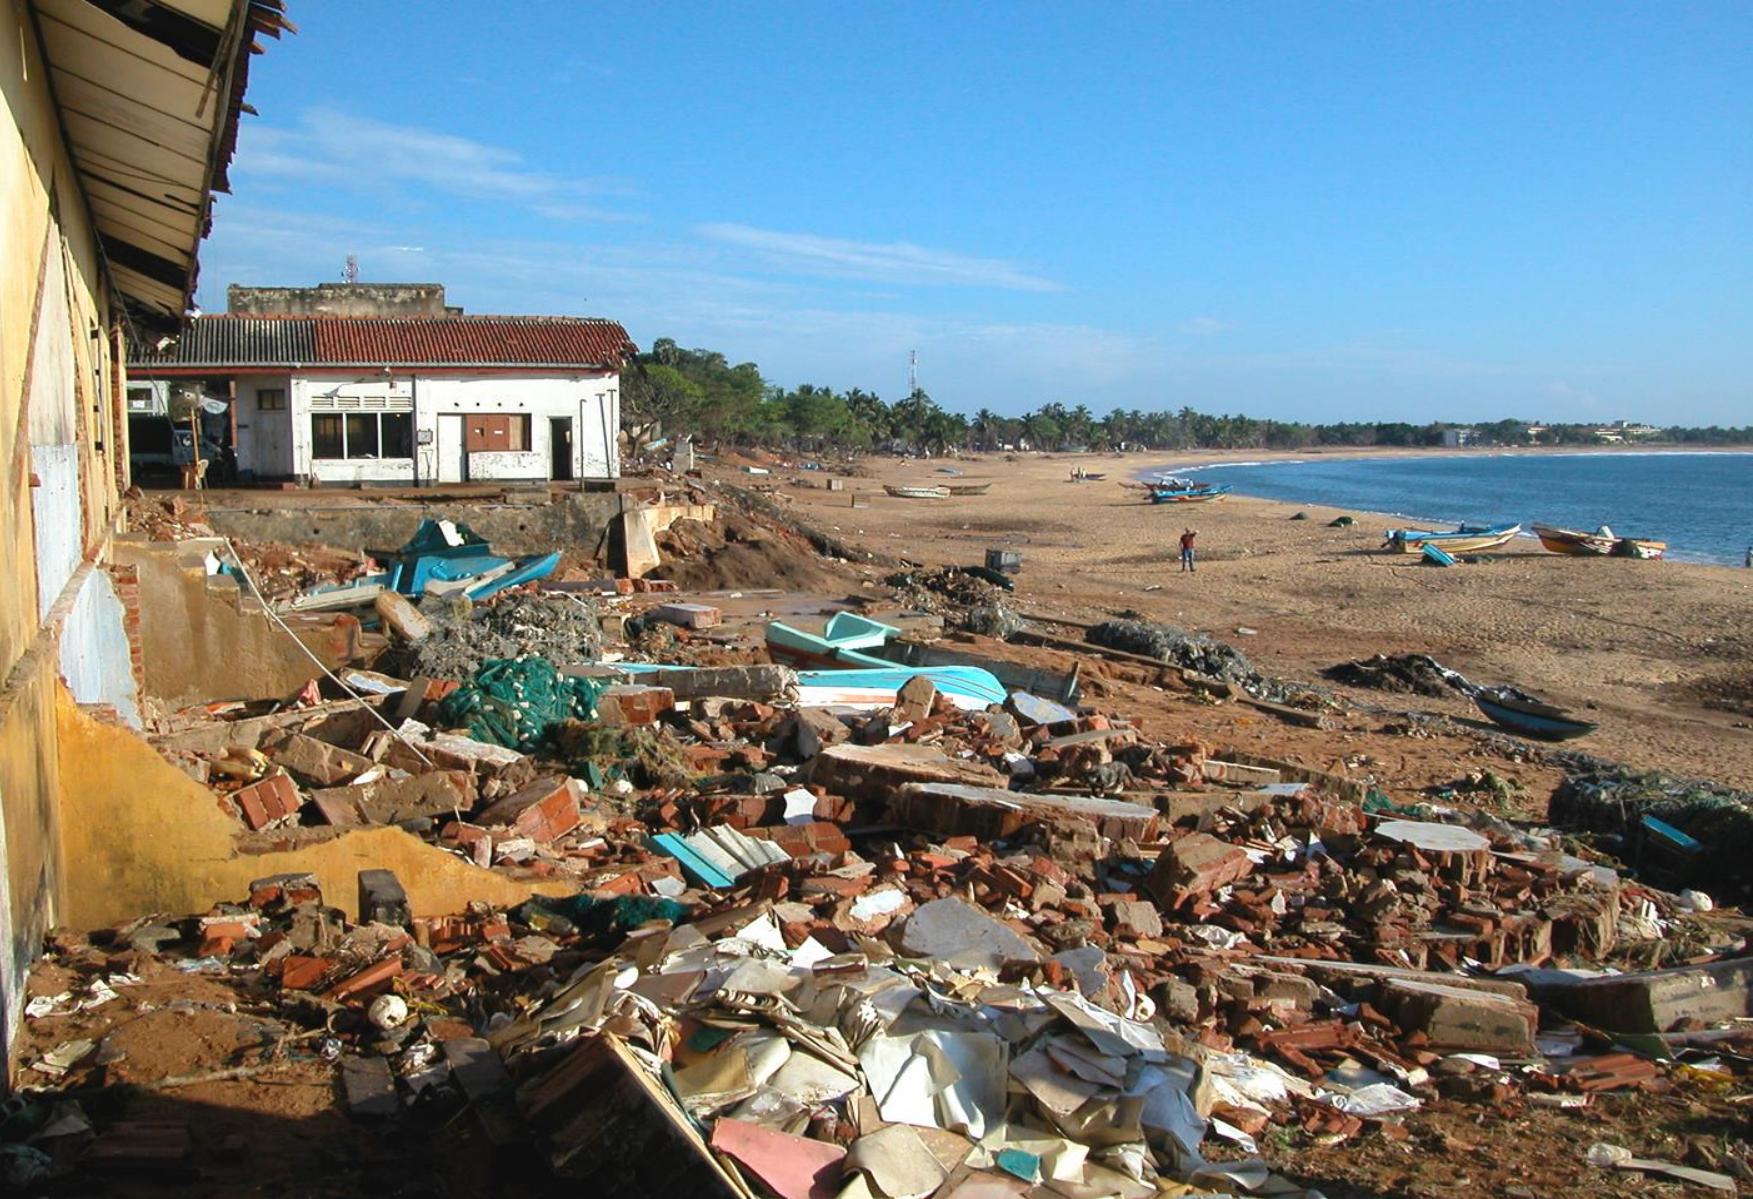
**Hambantota, S.E. Lanka:  
11 m (33 ft) water level was the highest.**

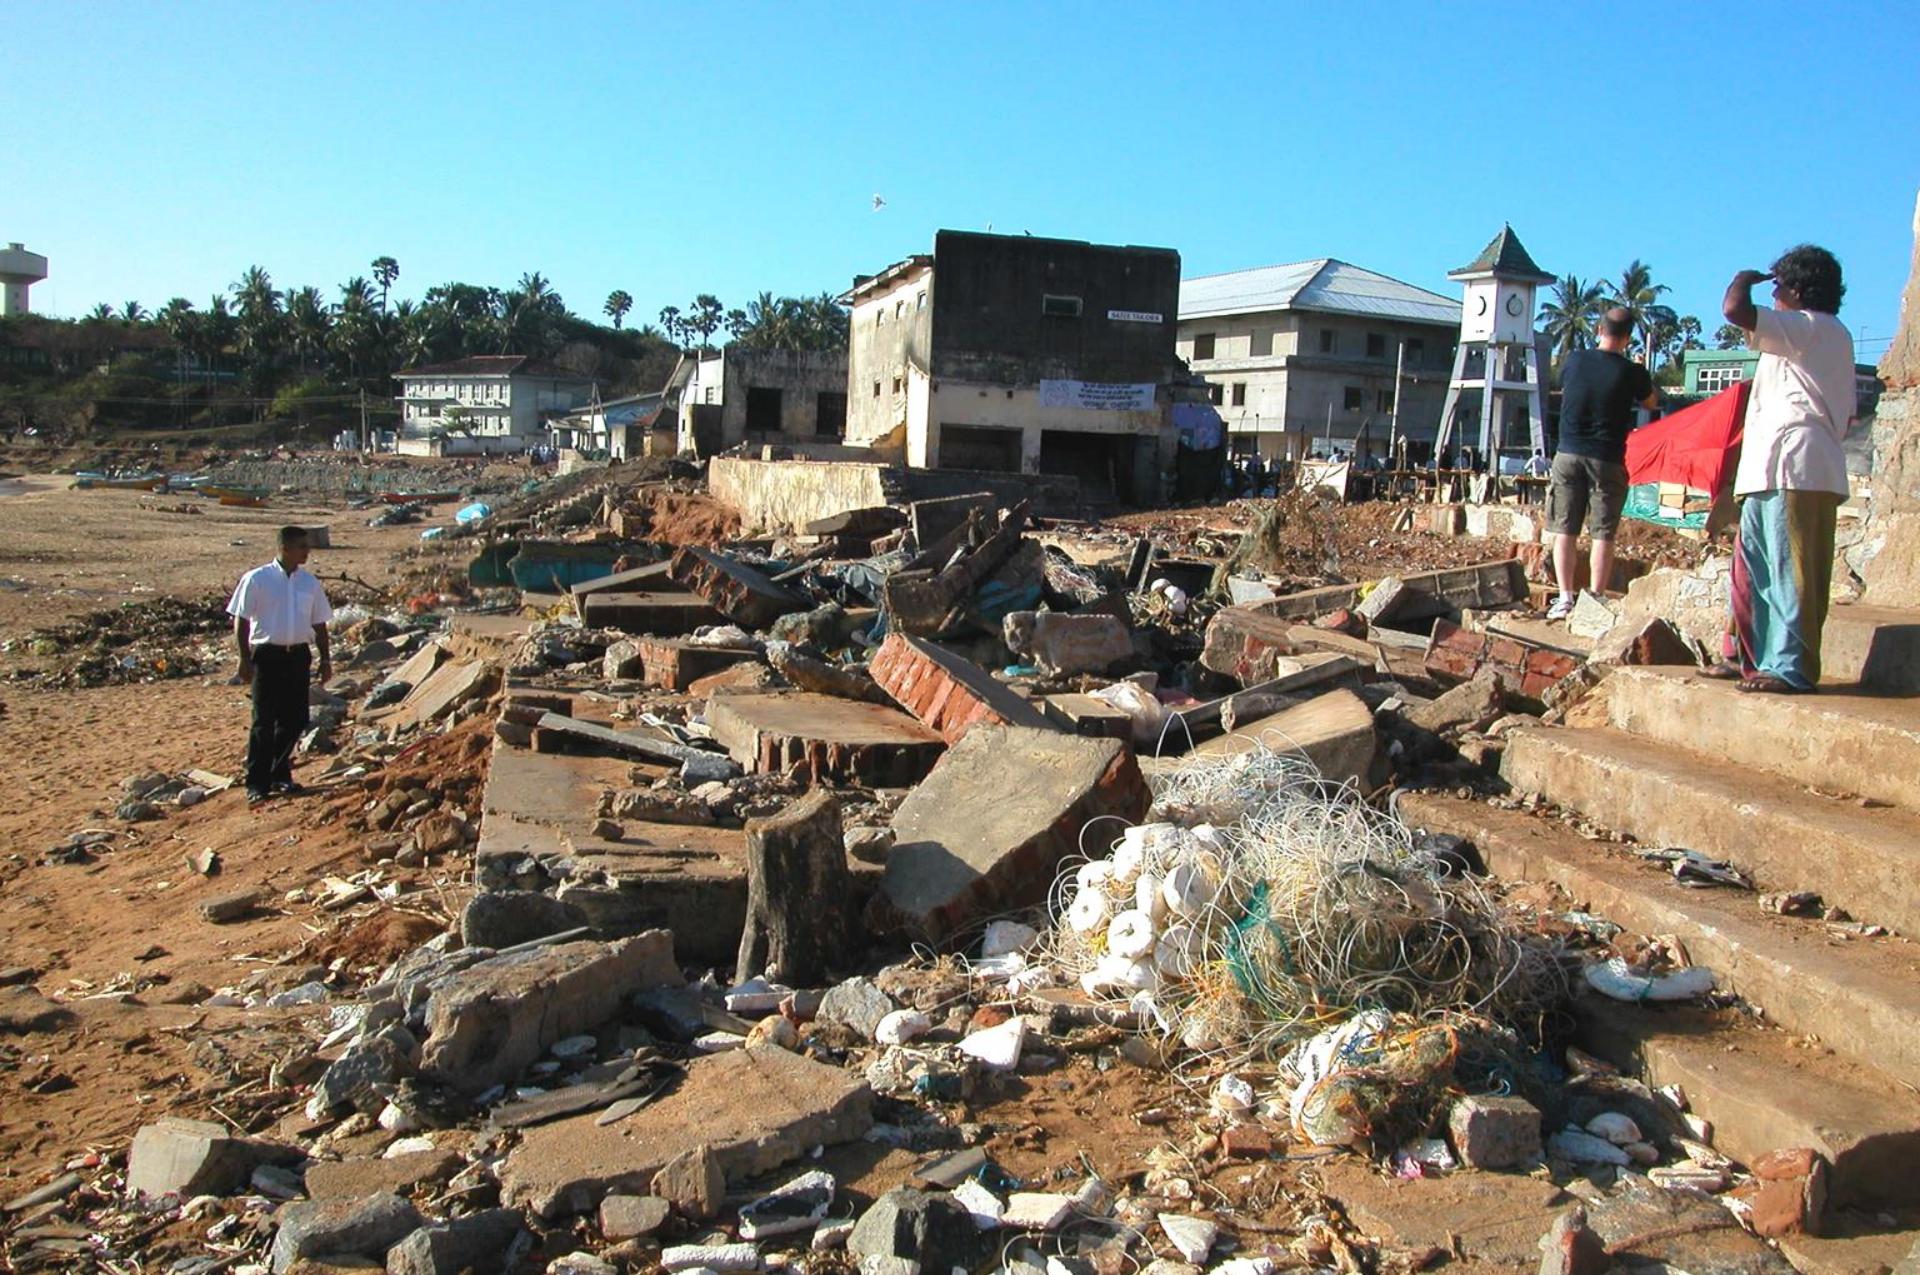
**Hambantota:  
4,500 people perished at this fishing town.**

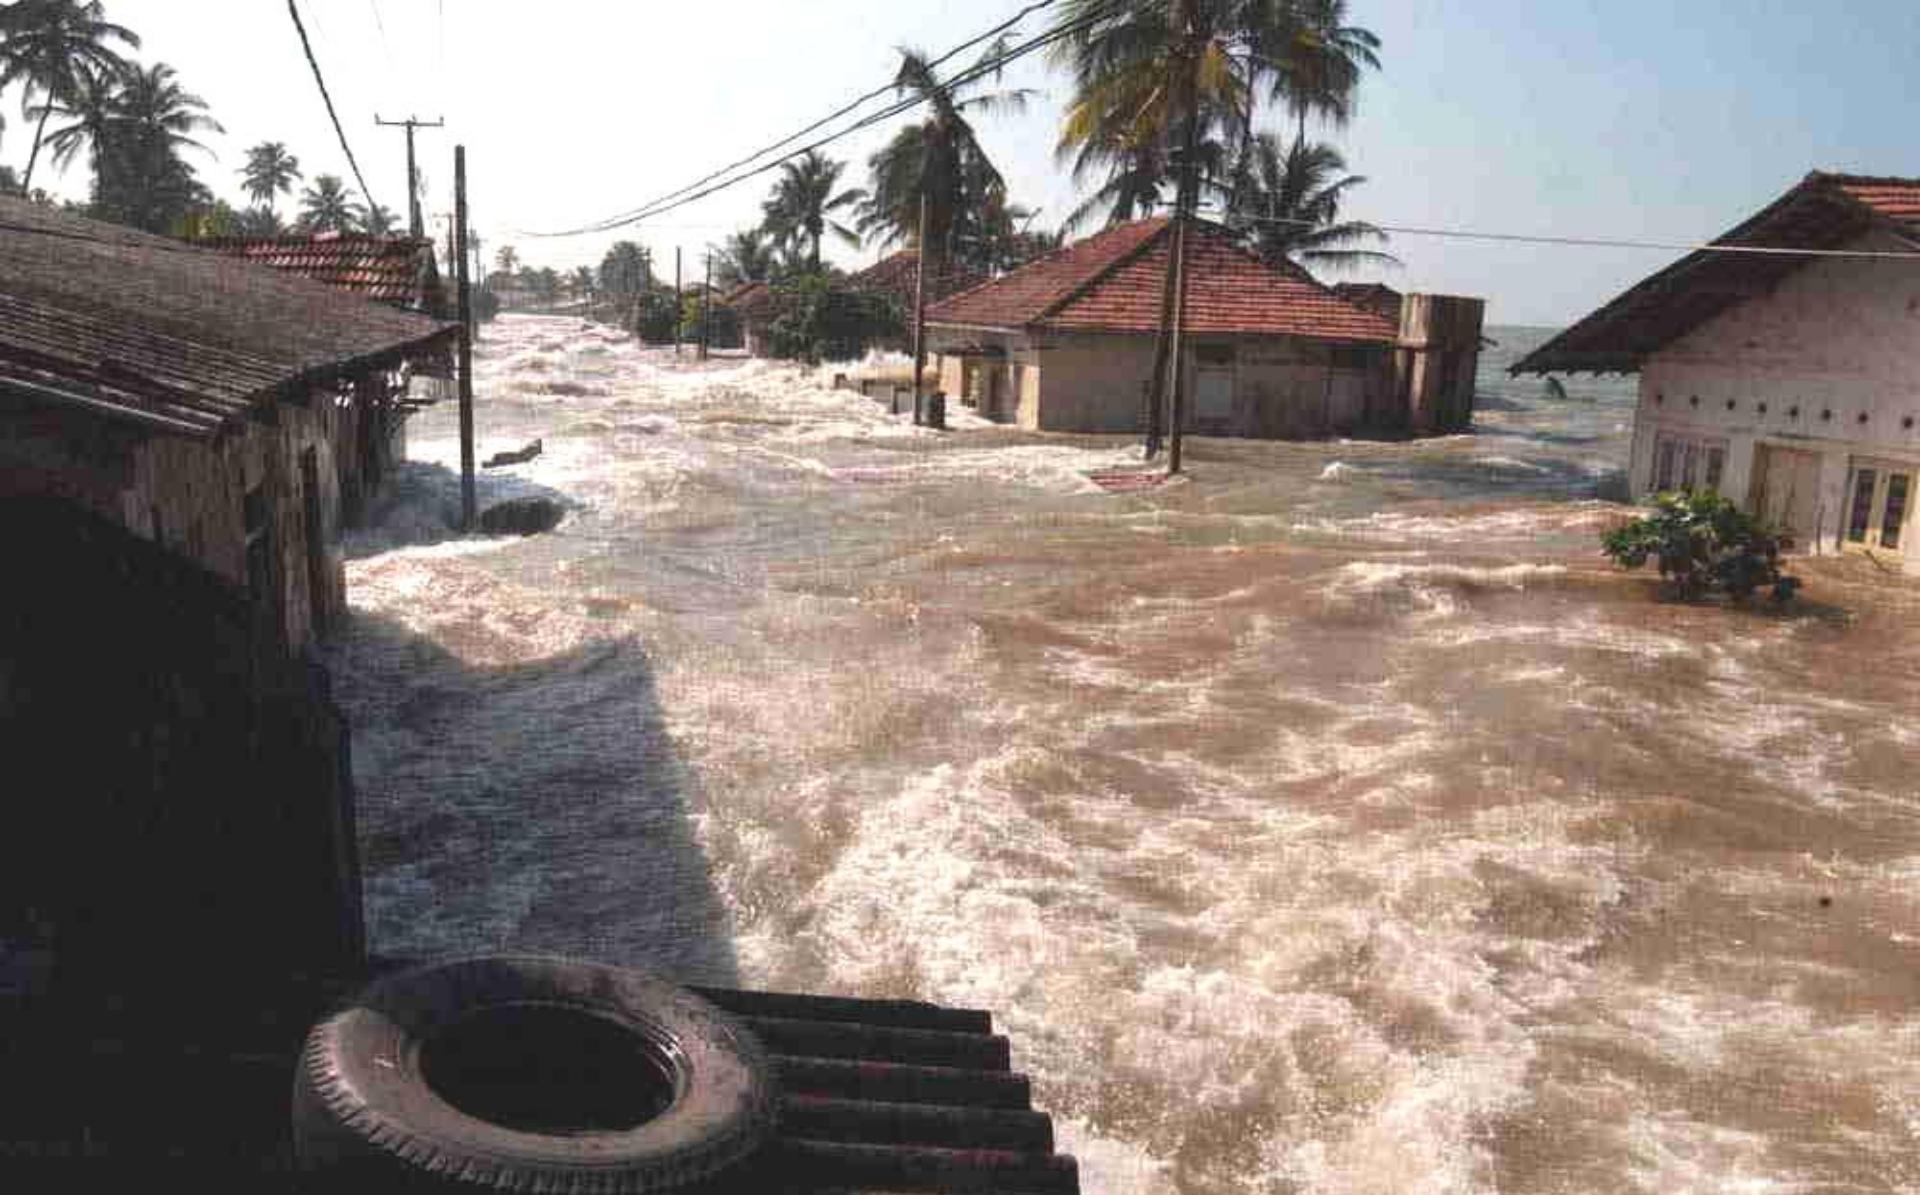
**East Sri Lanka (AP Photo):**  
**Raging water at beach front properties.**

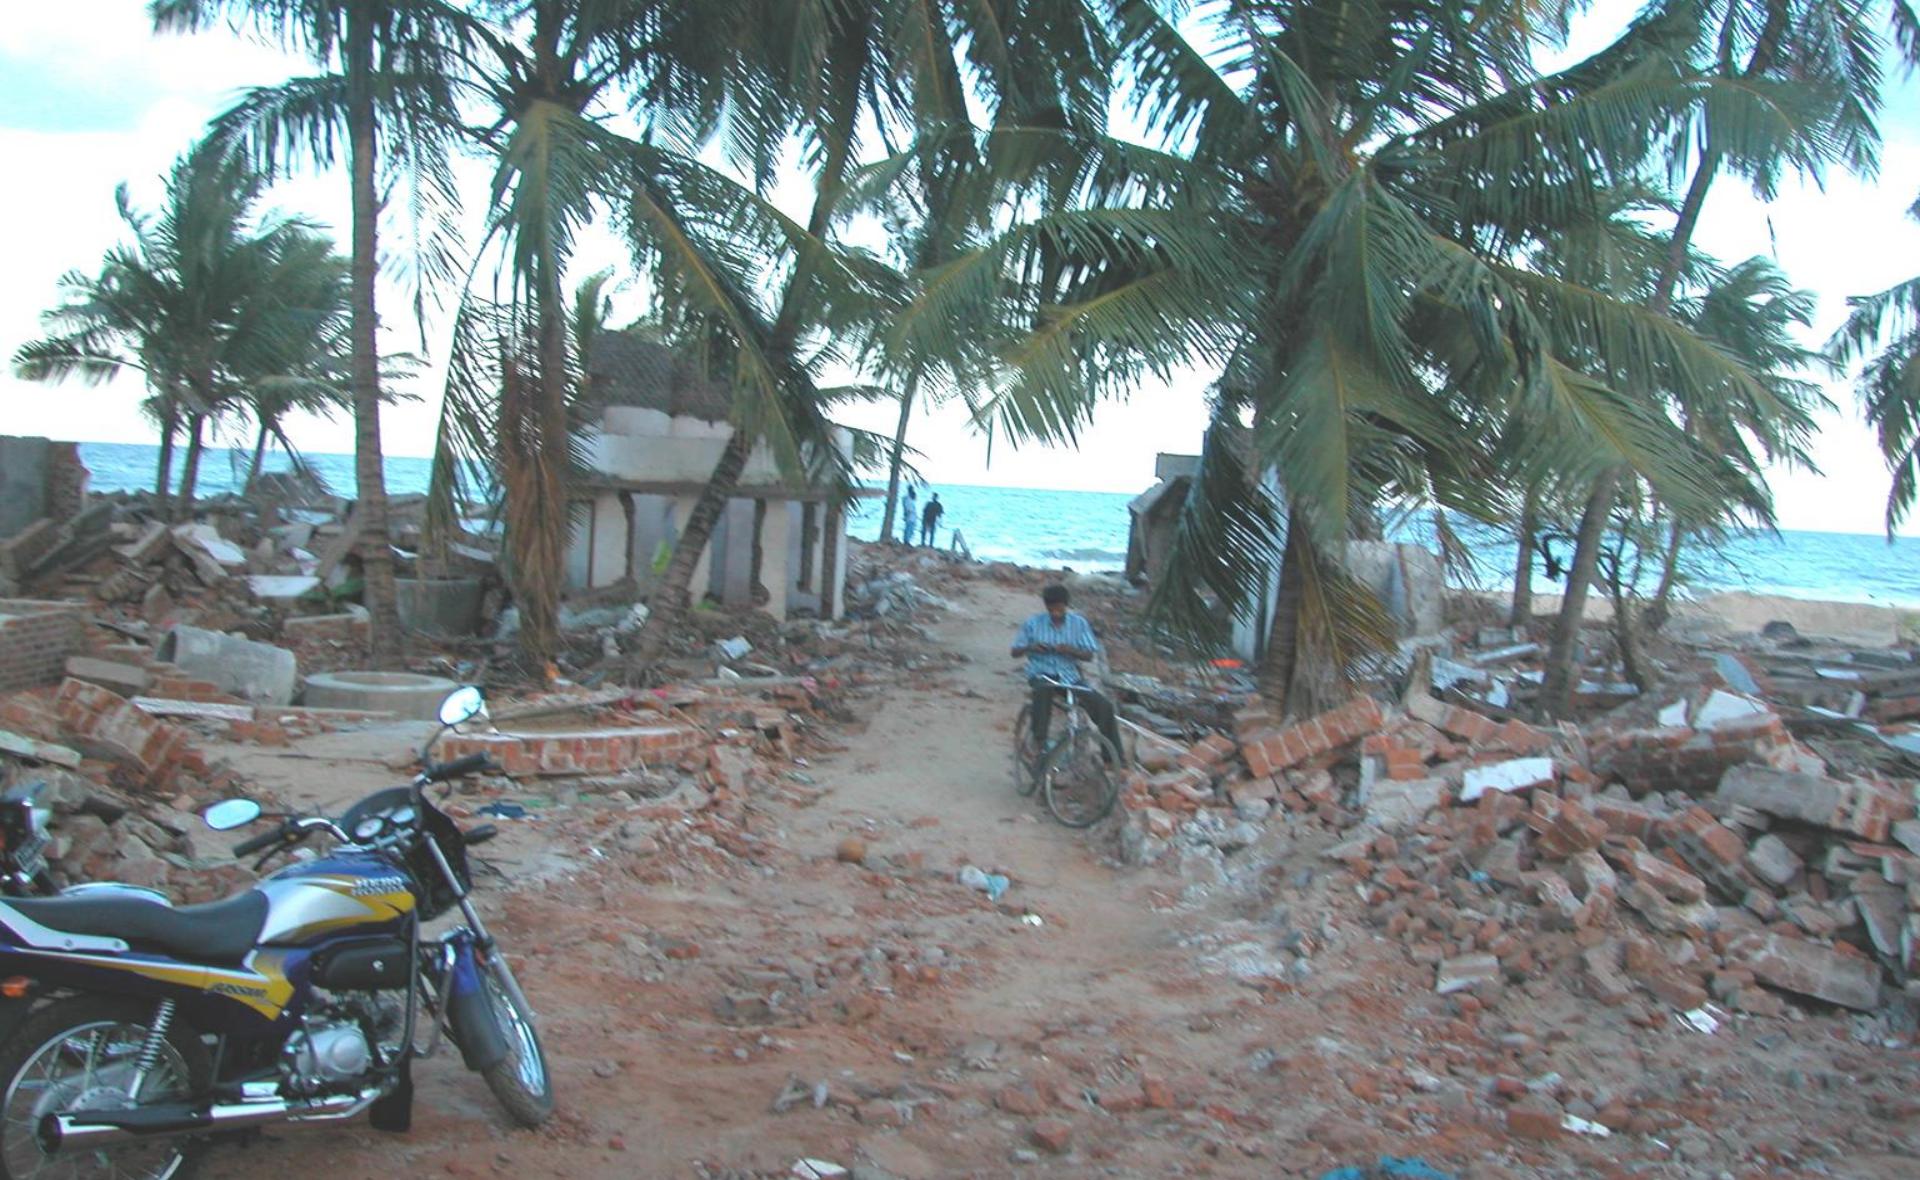
**East Sri Lanka:  
From Kalmunai to Batticaloa, many houses ended up like this  
one at the coast line.**

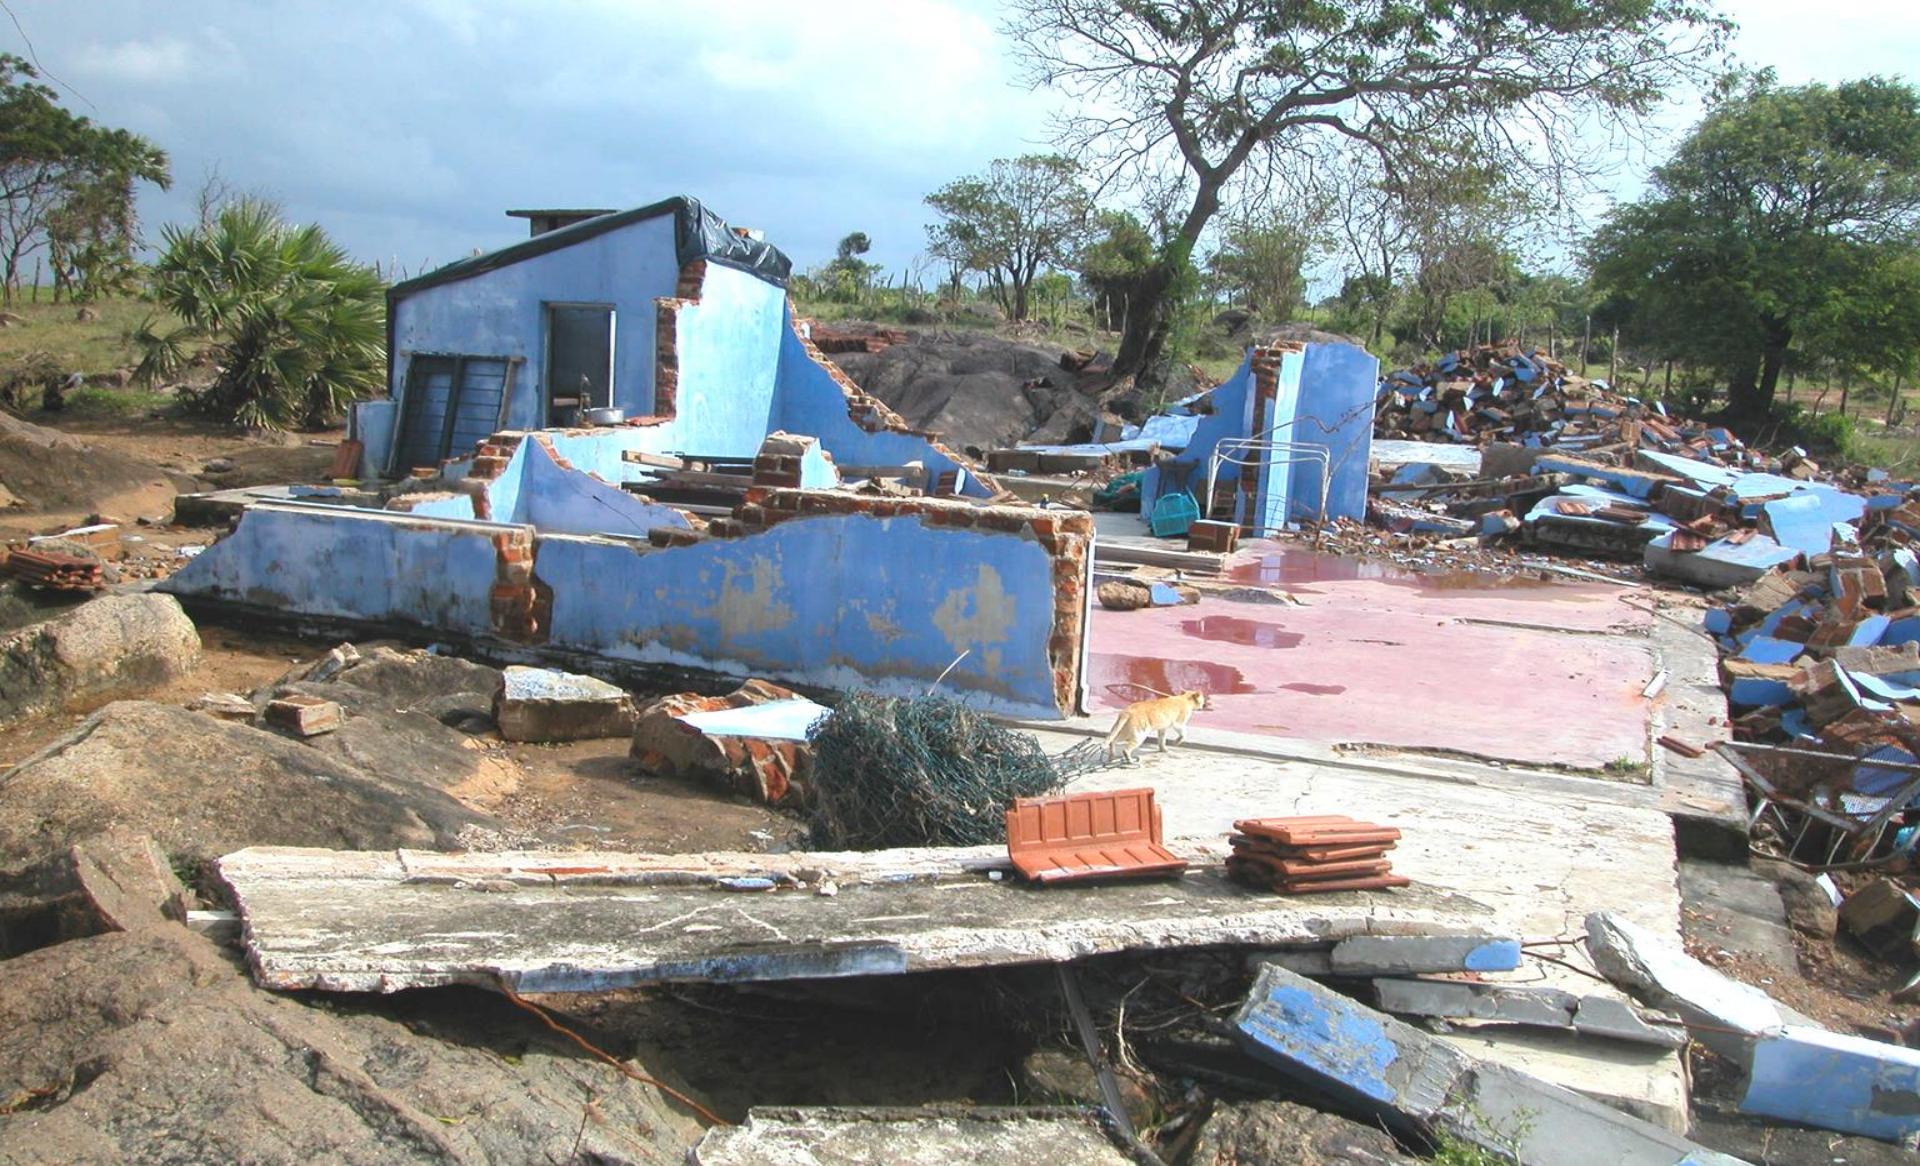
**East Sri Lanka:**  
**Another ocean front community. Un-reinforced brick and/or masonry construction were typical in the region.**

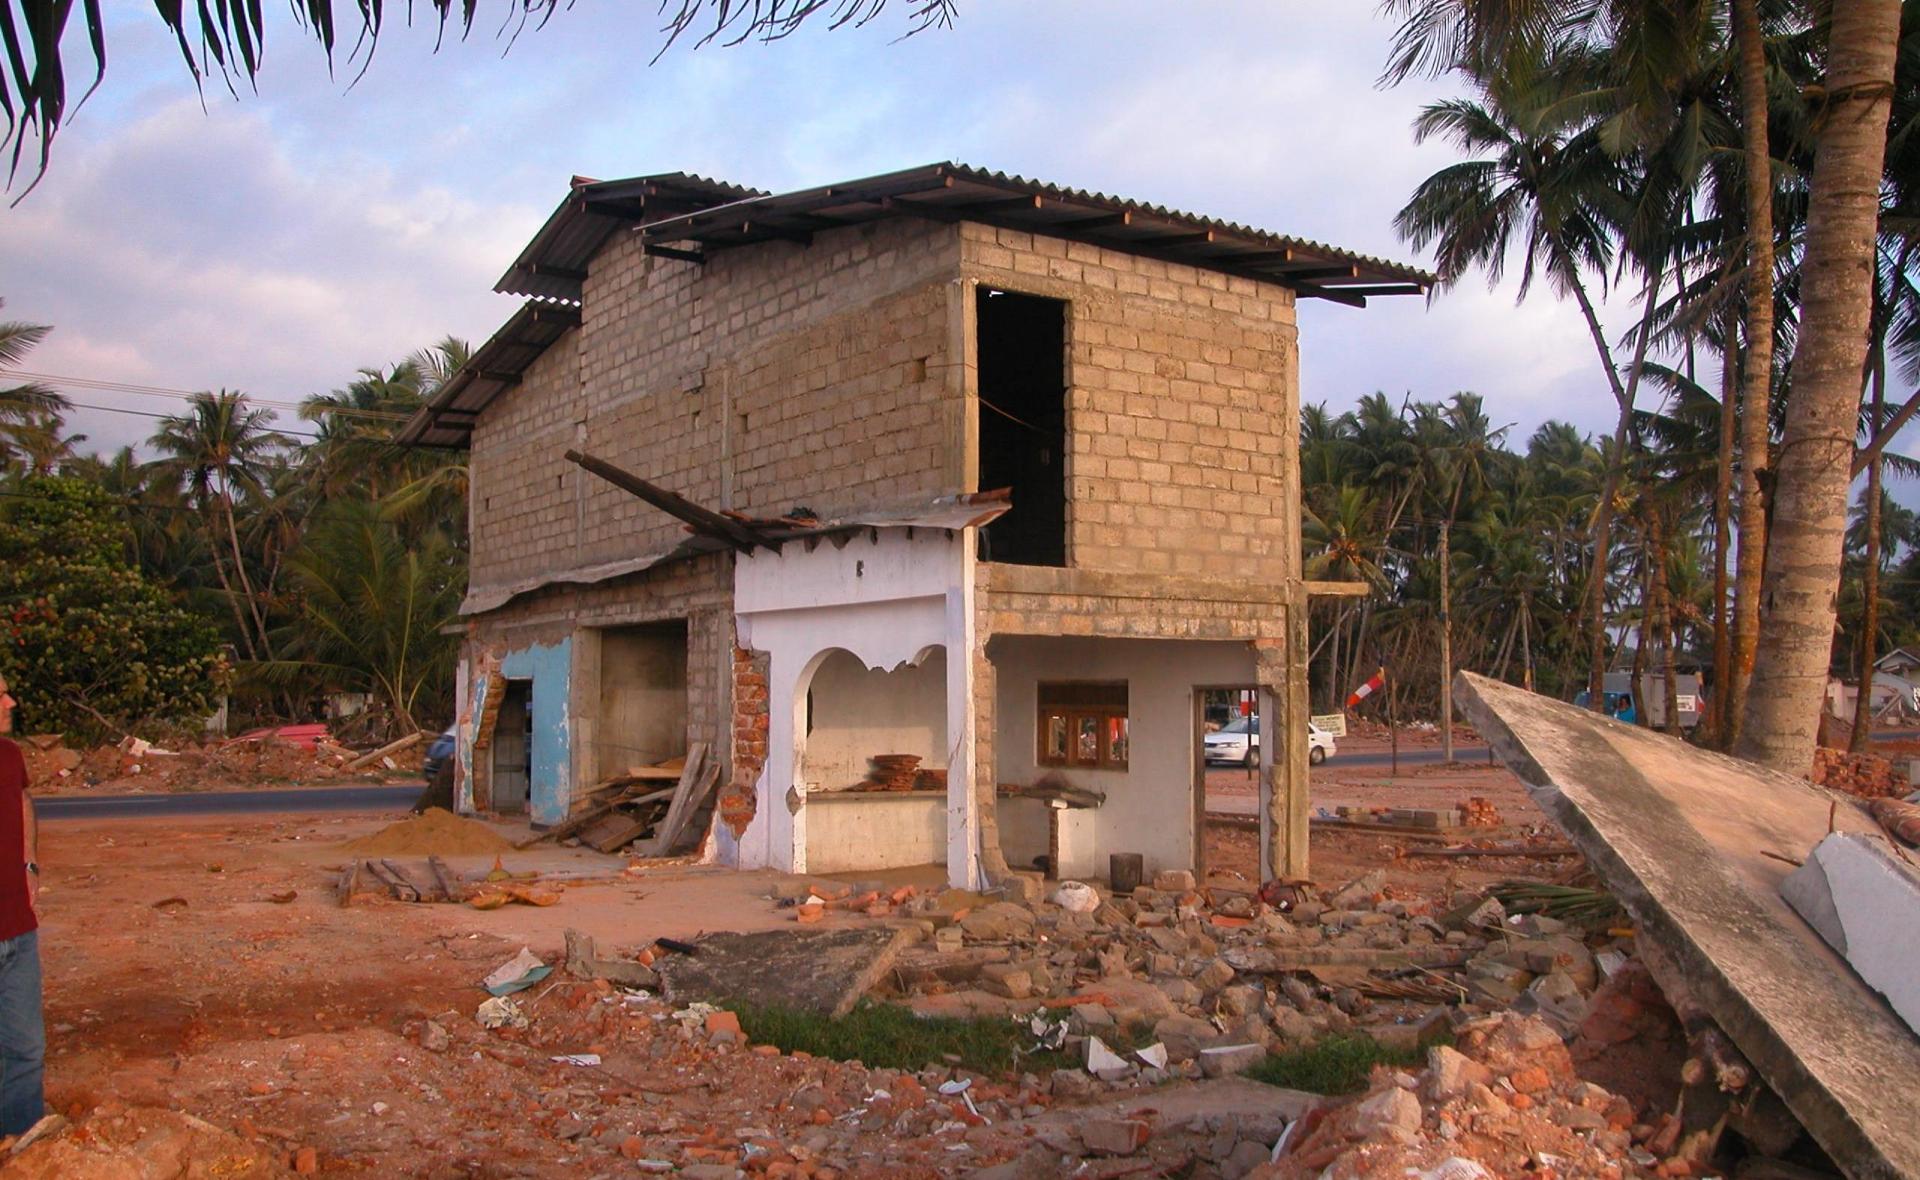
**Common damages: Un-reinforced masonry structures were no match for the wave, but reinforced concrete members survived.**

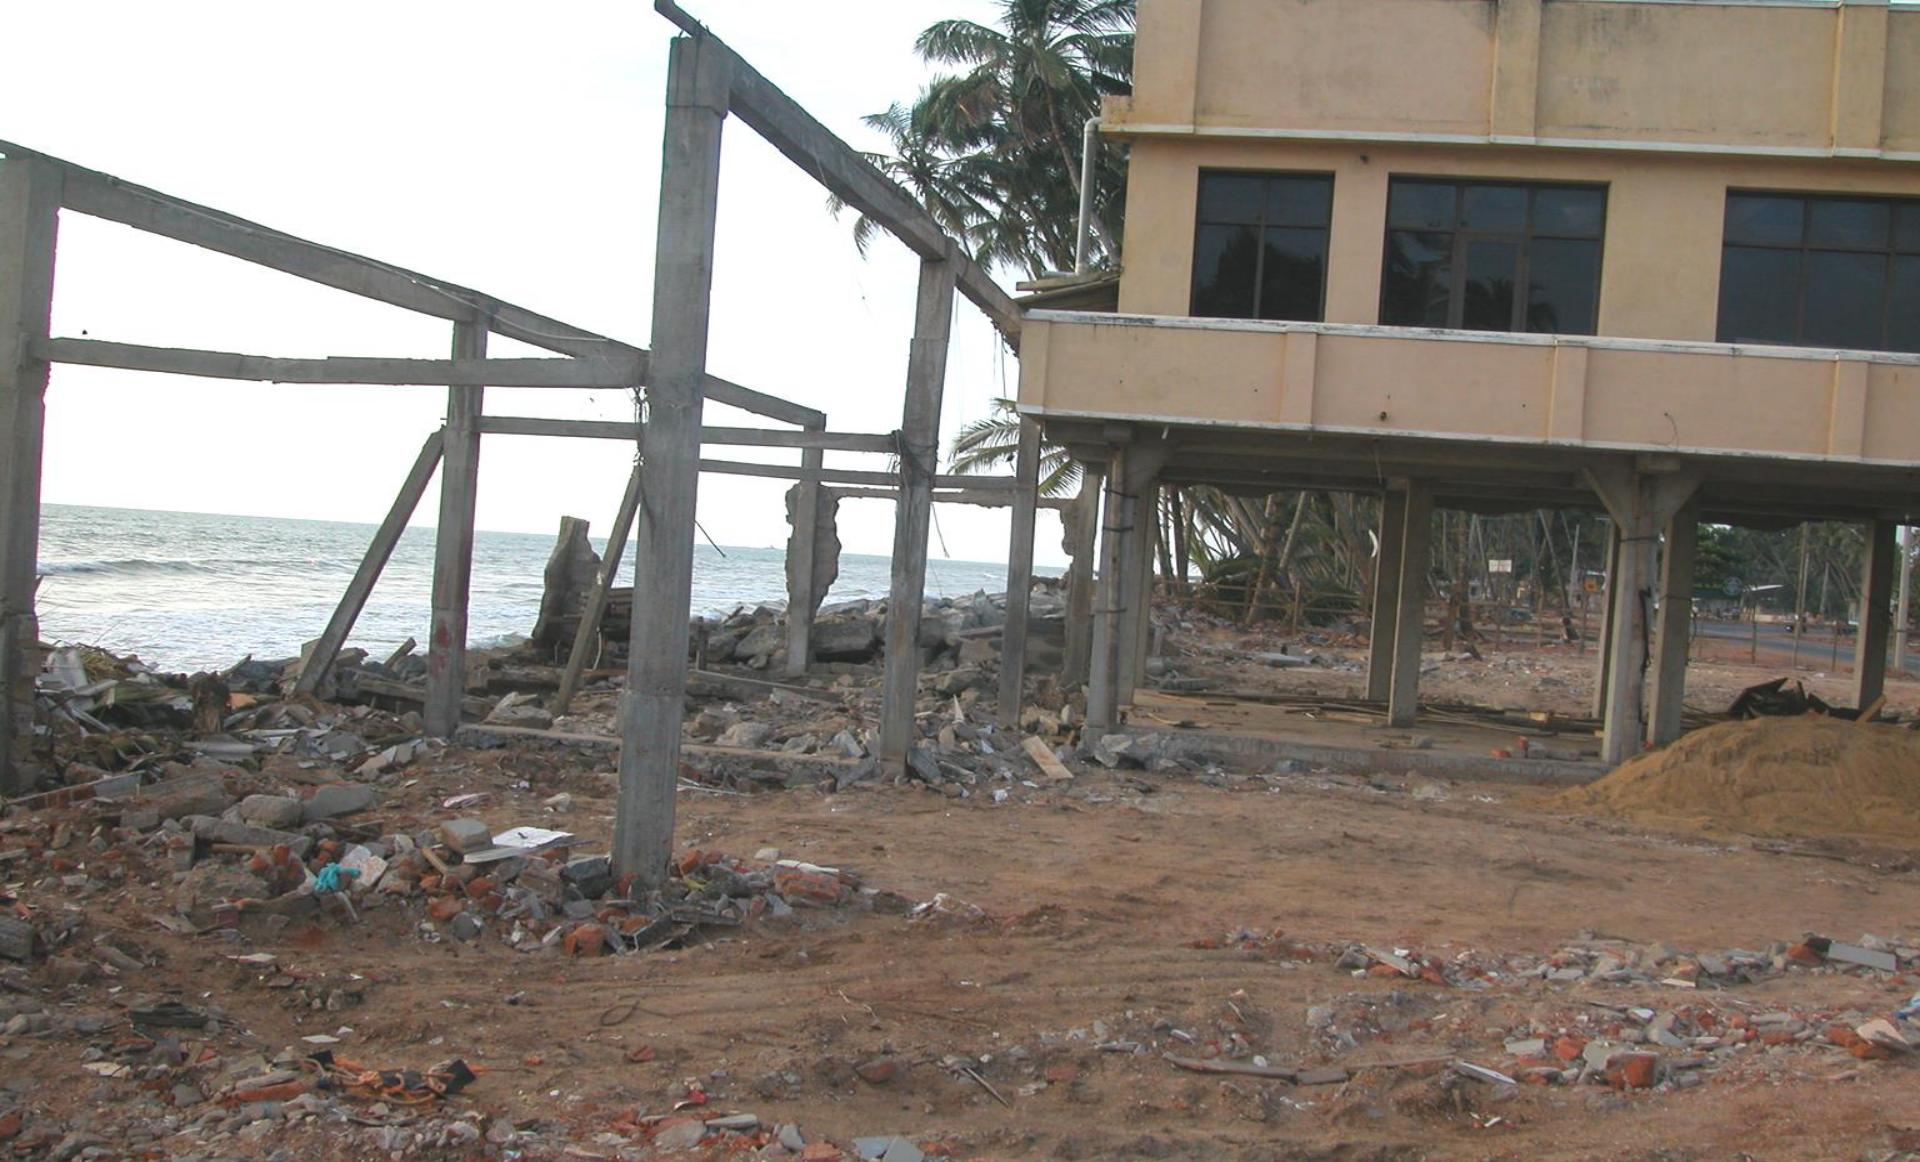
**Another comparison between un-reinforced and reinforced members.**

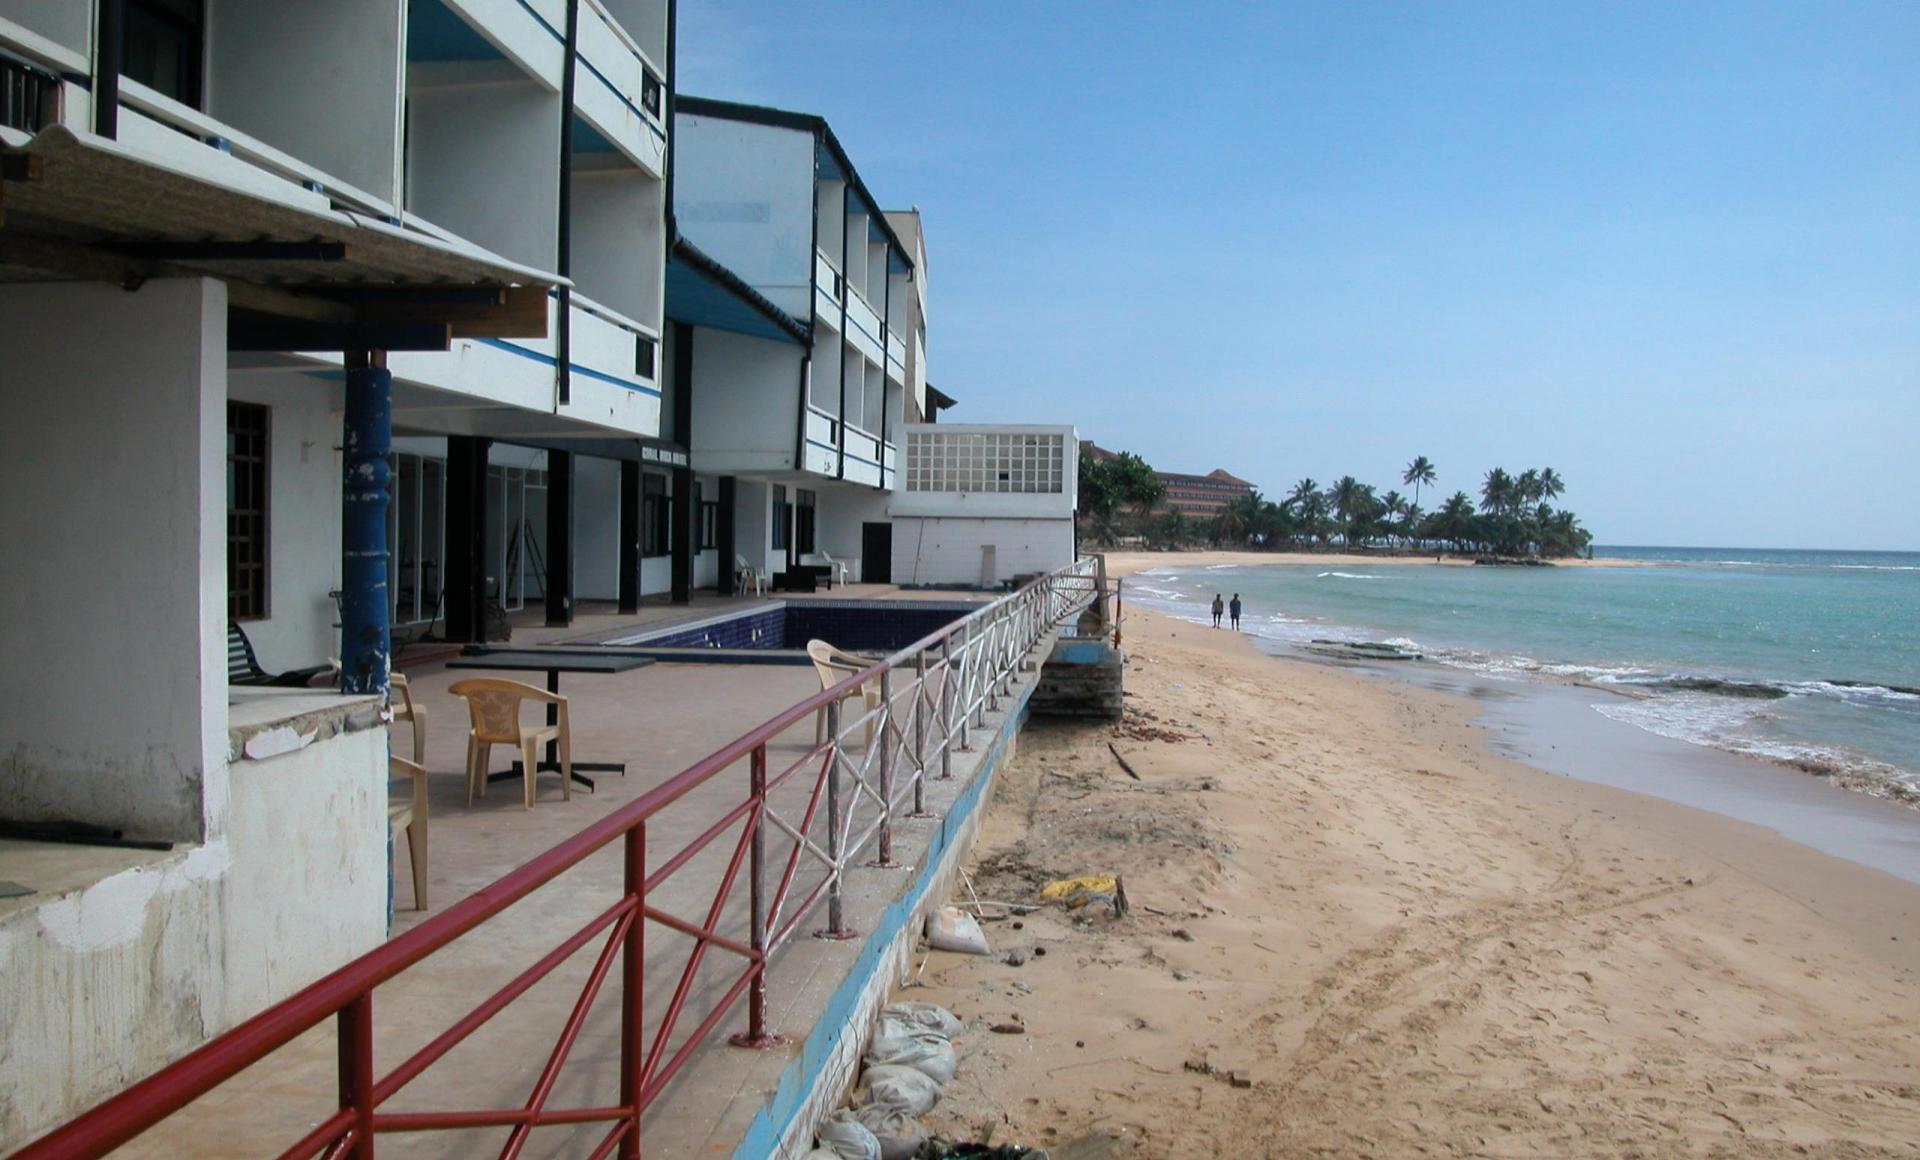
**In the same region, properly designed and constructed buildings suffered minimum damages.**

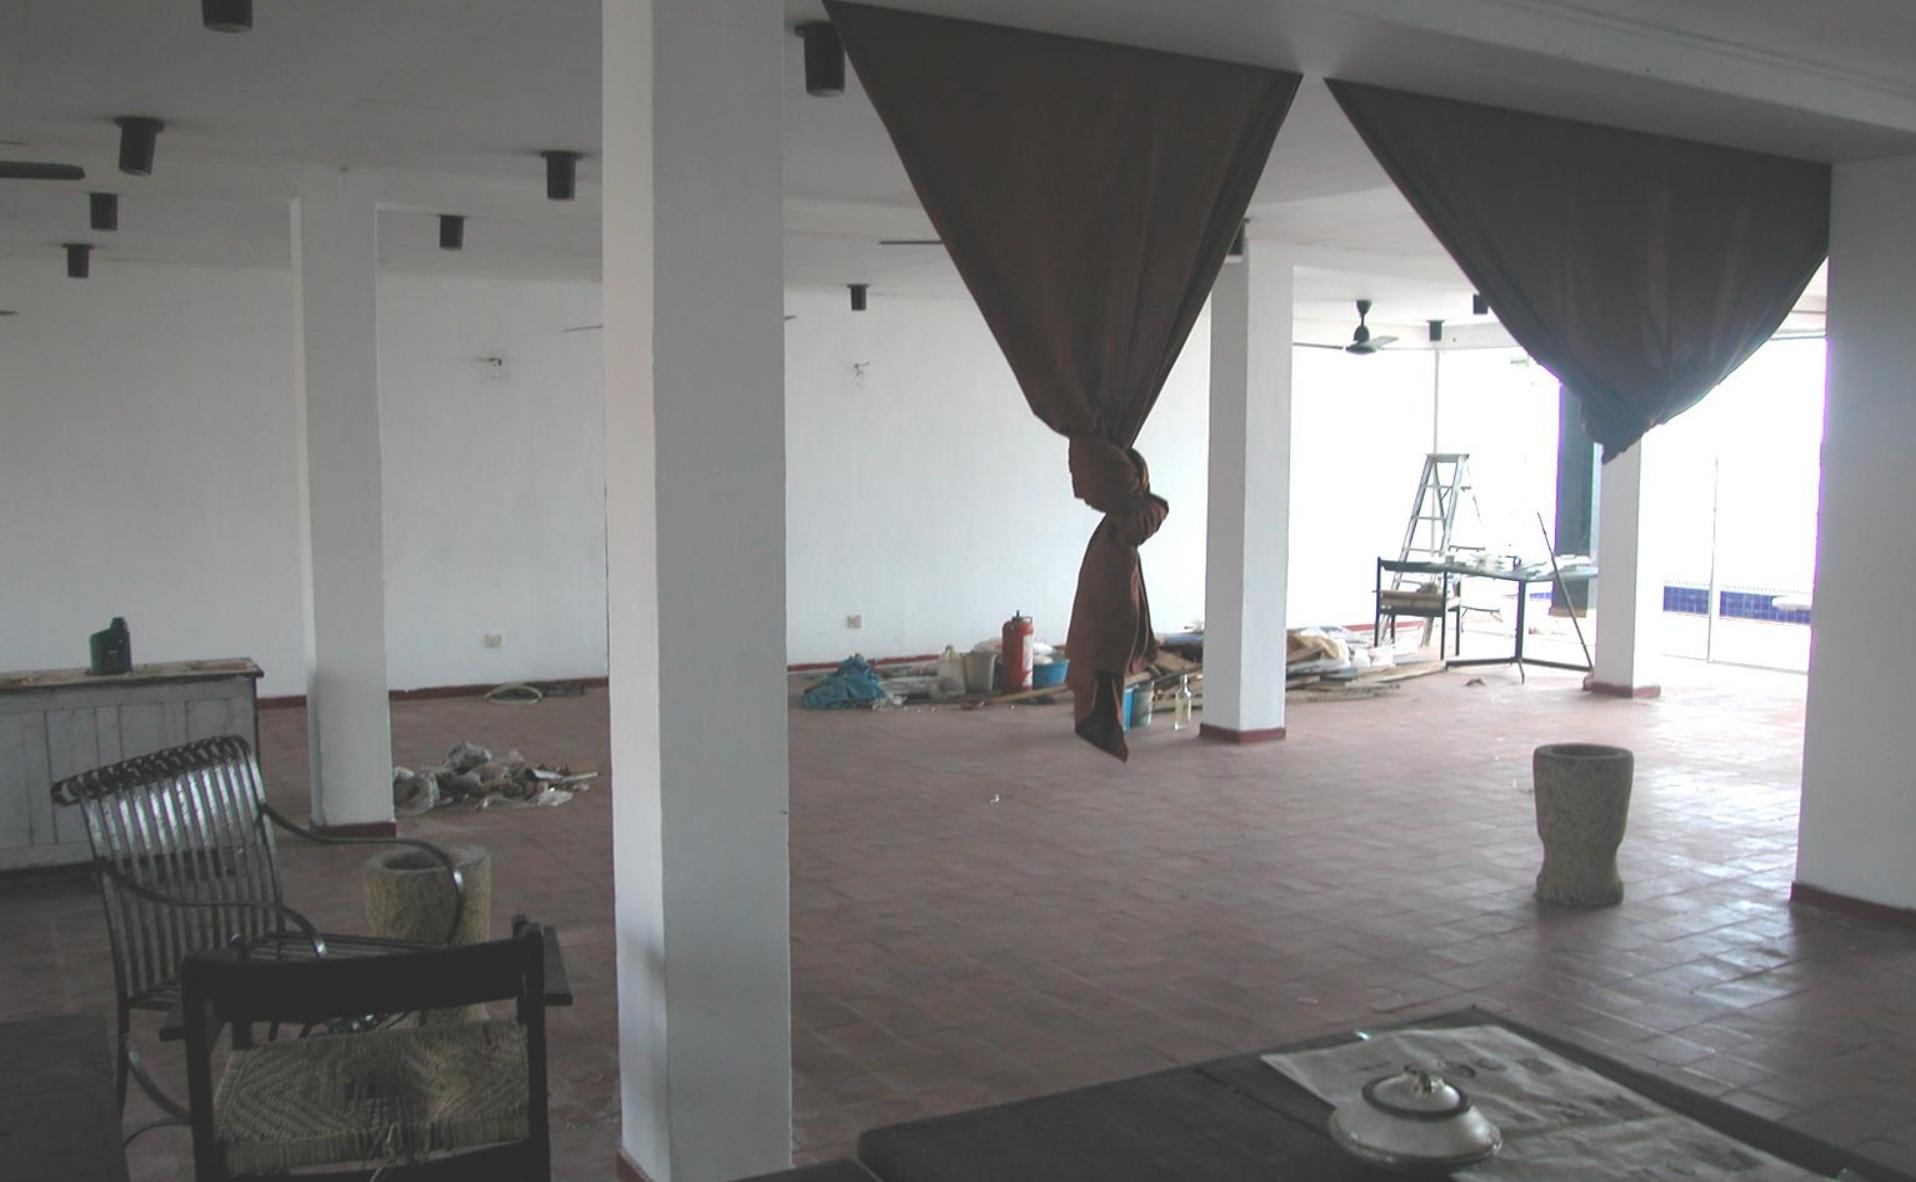
**Inside the same ocean front building. Only glass windows were broken.**
