# *Overview of Performance of Ports, Harbors, Infrastructures and Buildings in Sri Lanka and India*

*By Peter Yin, Port of Los Angeles  
ASCE-COPRI Reconnaissance Team Member*

*January 31- February 11, 2005*

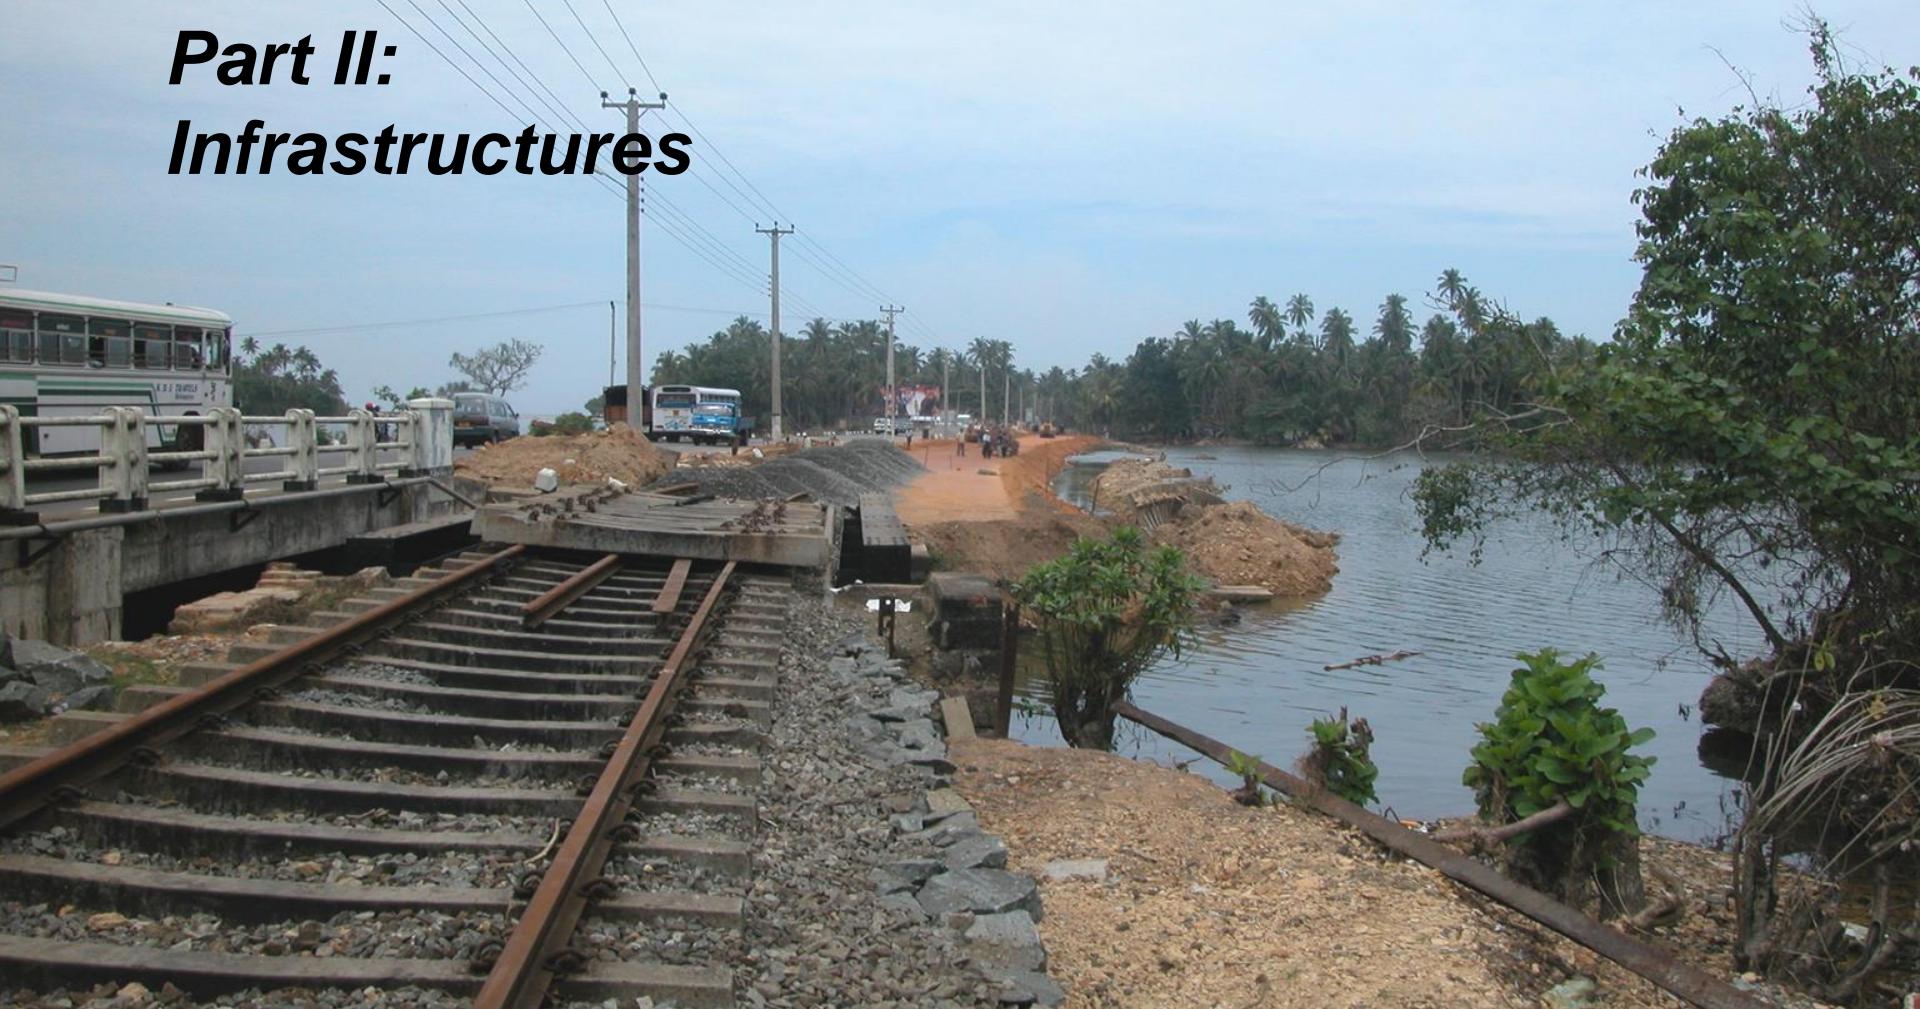
**South of Kalutara:  
Railroad bridge was destroyed, highway bridge next to it was not.**

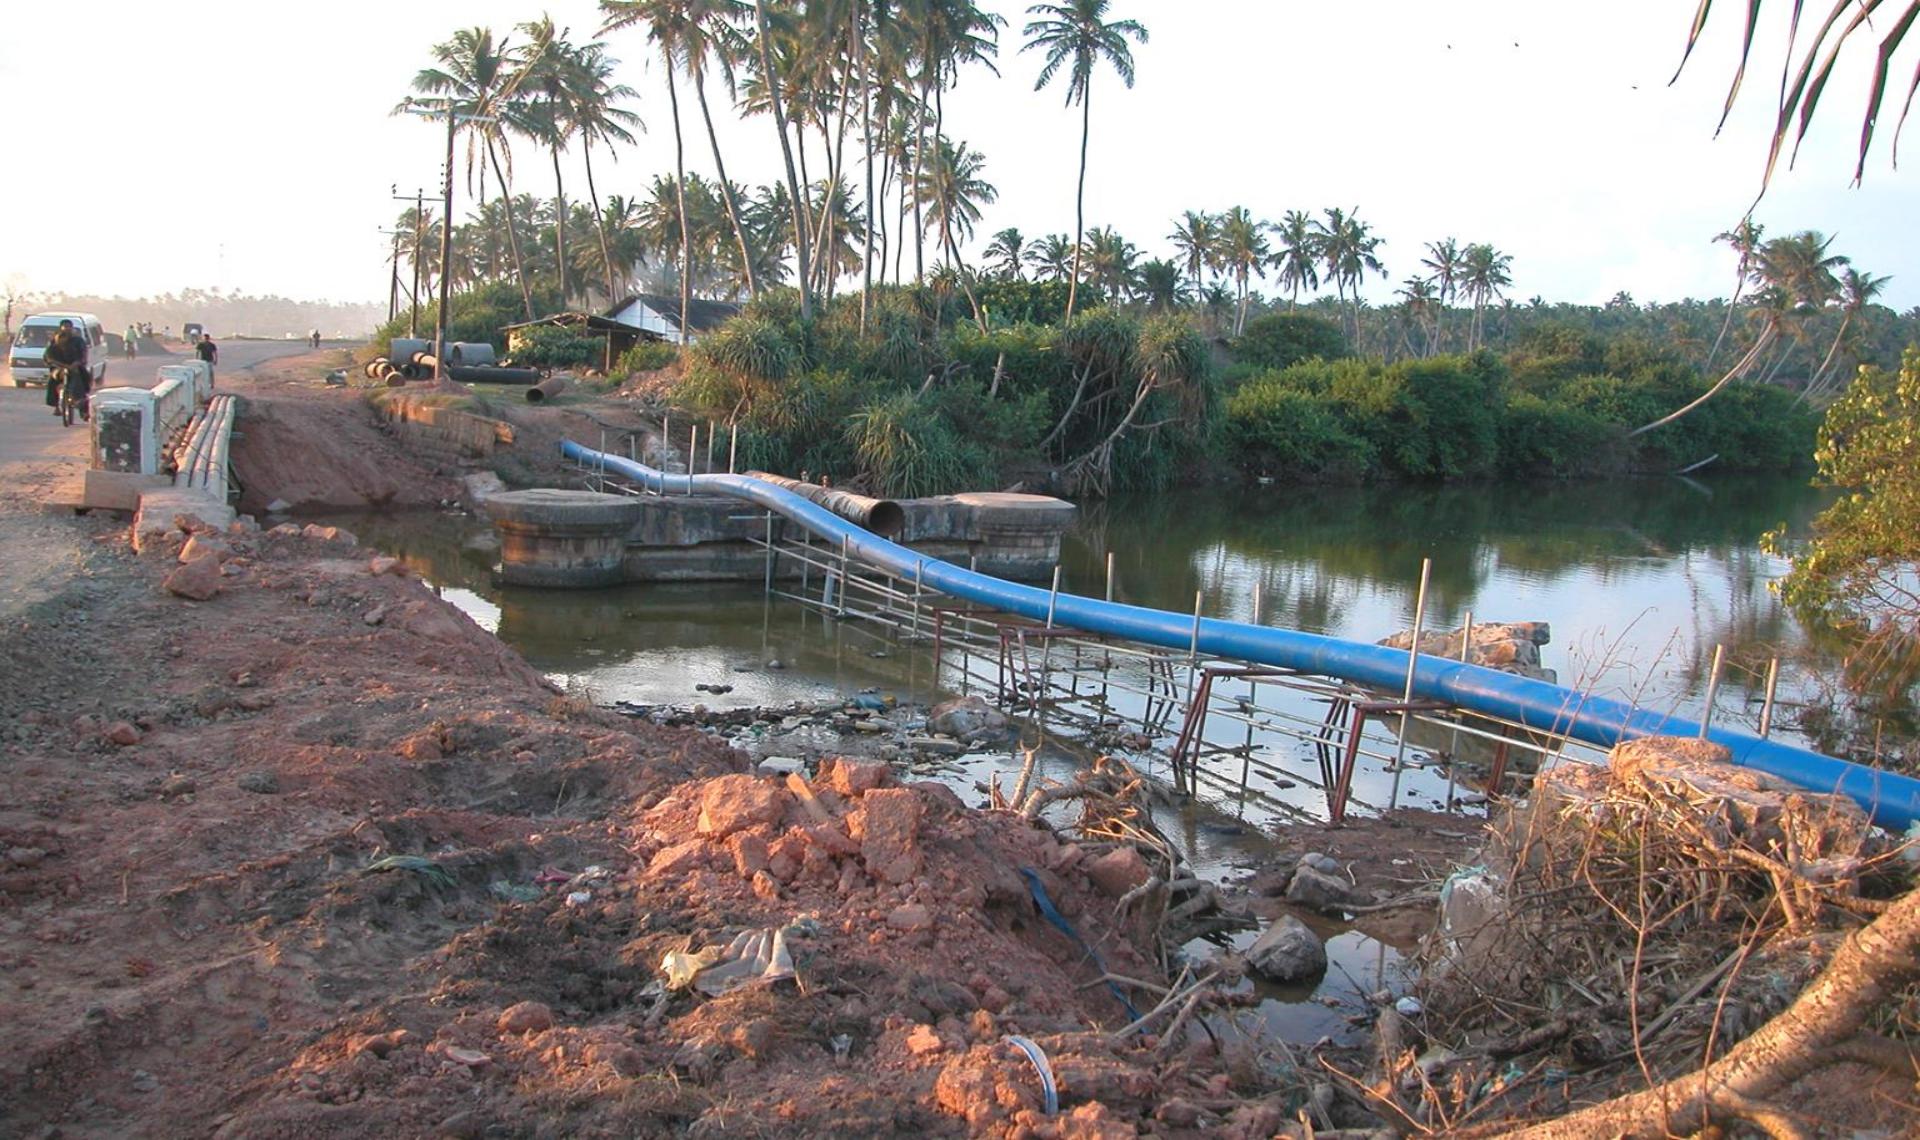
**River connect to the ocean collected most of the flow. Bridge and abutment at upper stream were washed away by receding water. The highway bridge facing in-coming surge survived.**

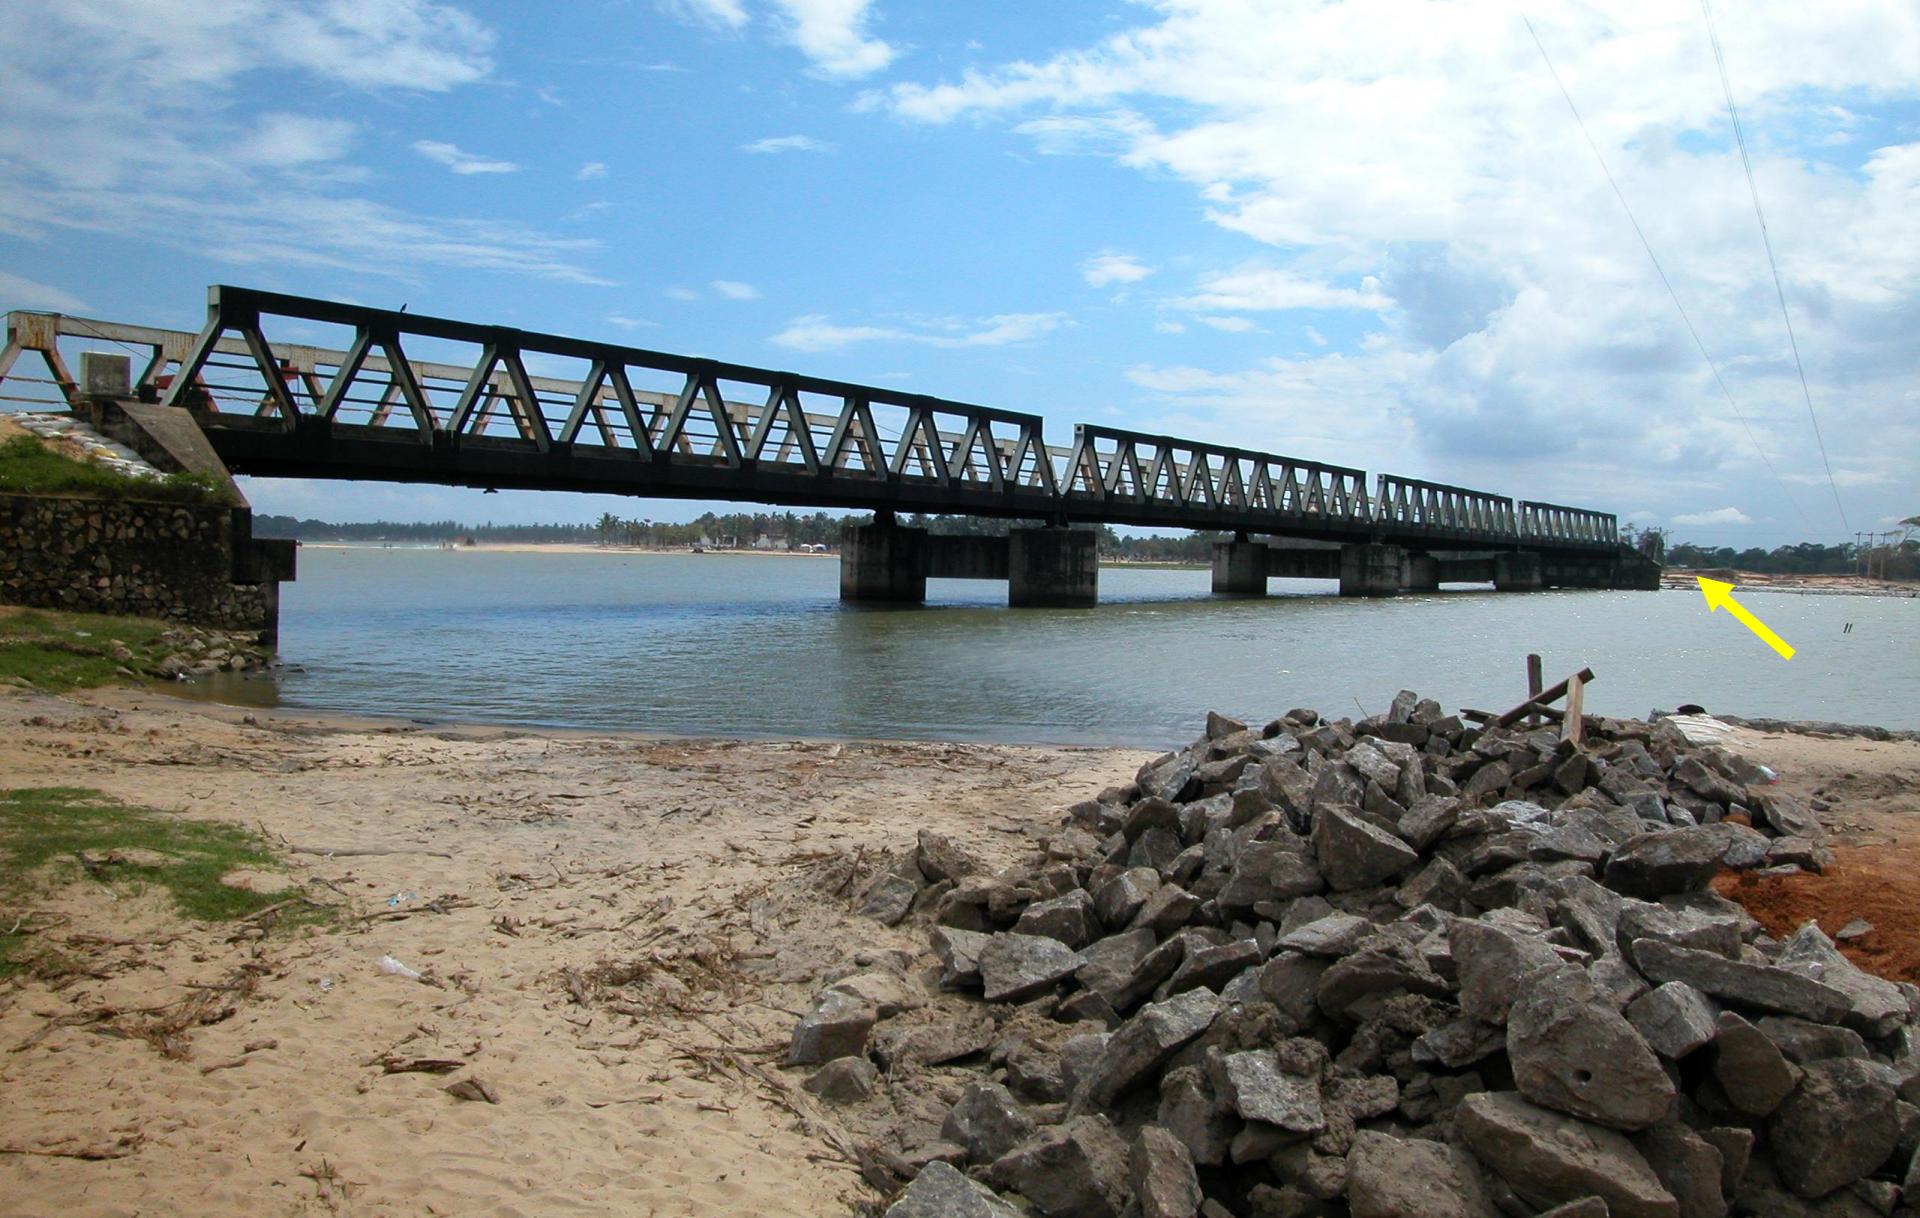
**Arugam Bay:Bridge at southeast coastline  
Water over-flowed the superstructure.**

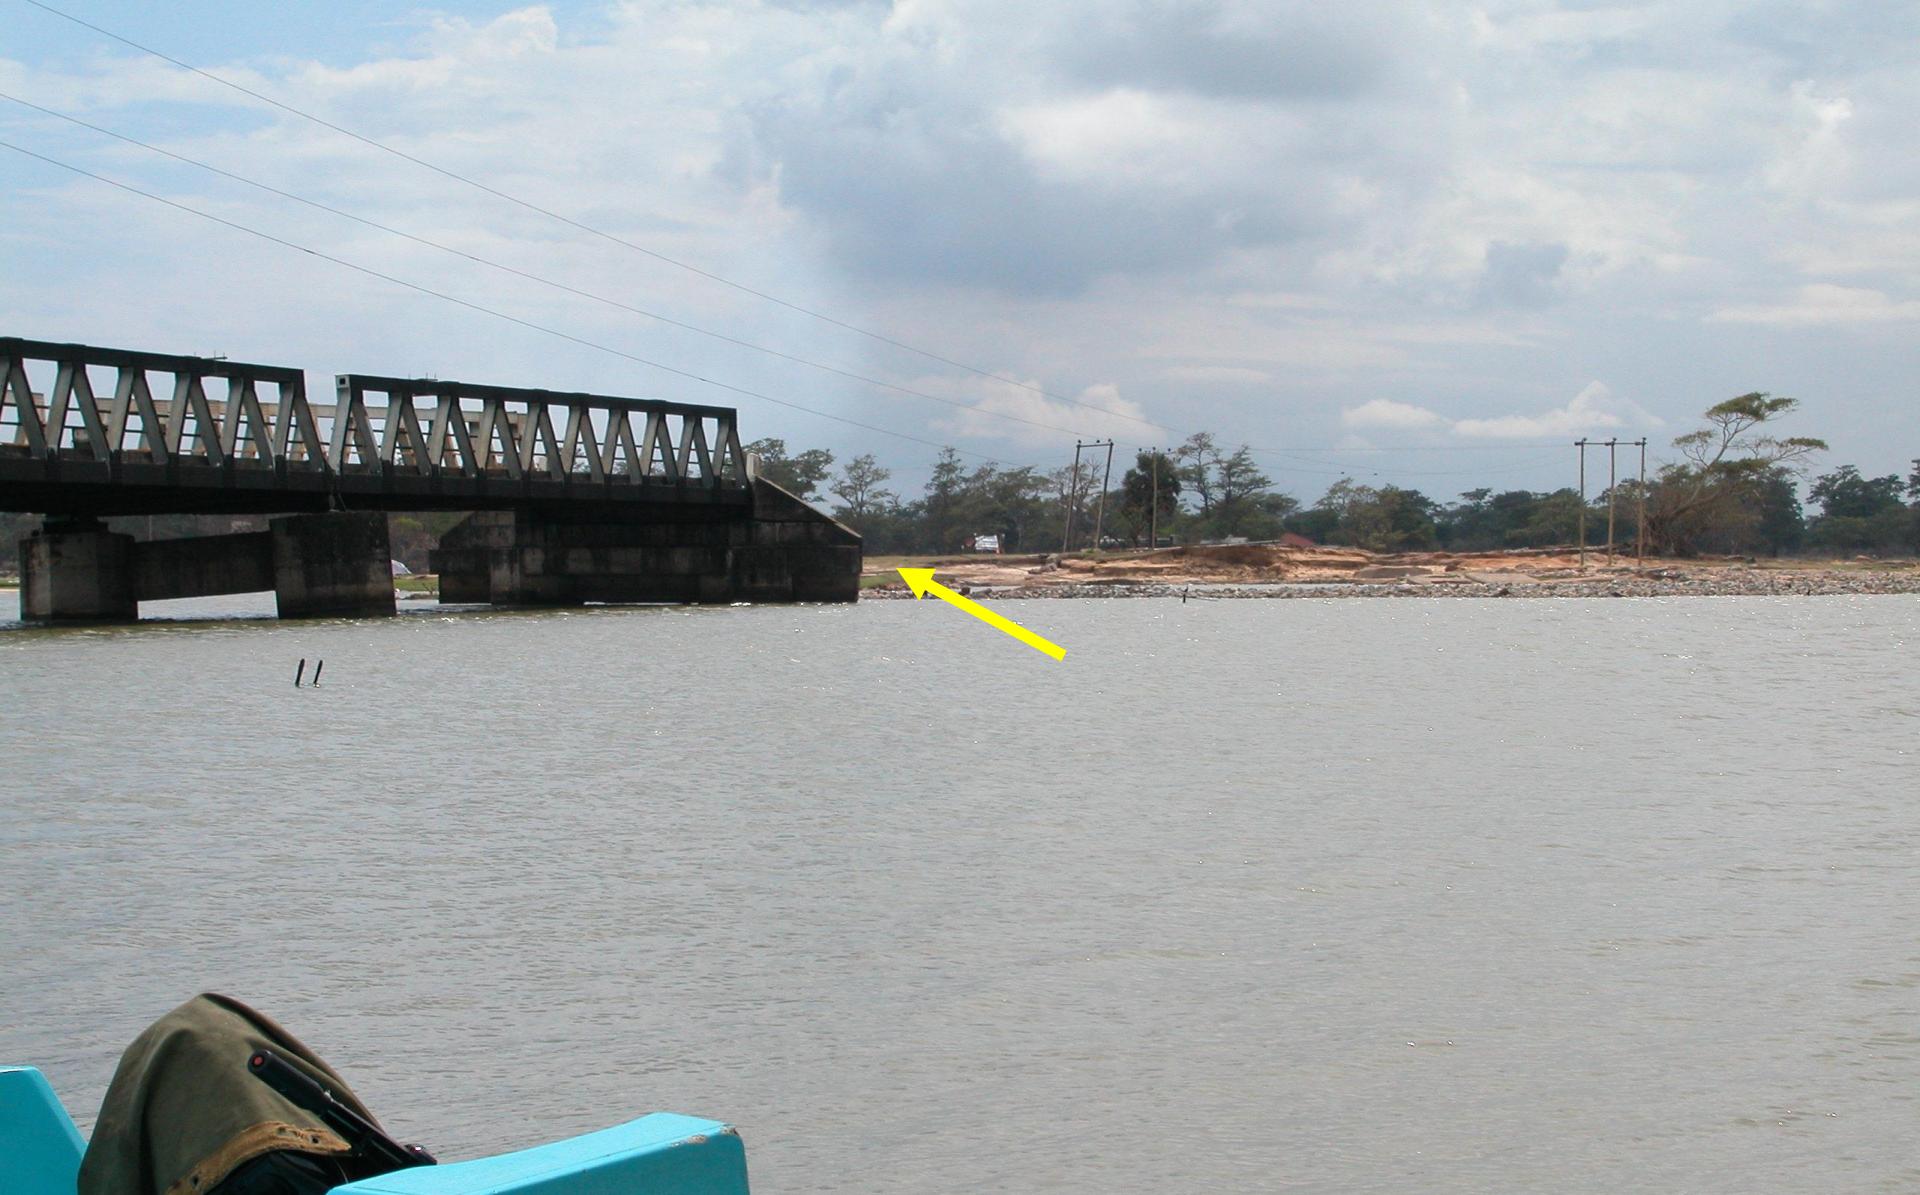
**South abutment and approach road were washed away.**

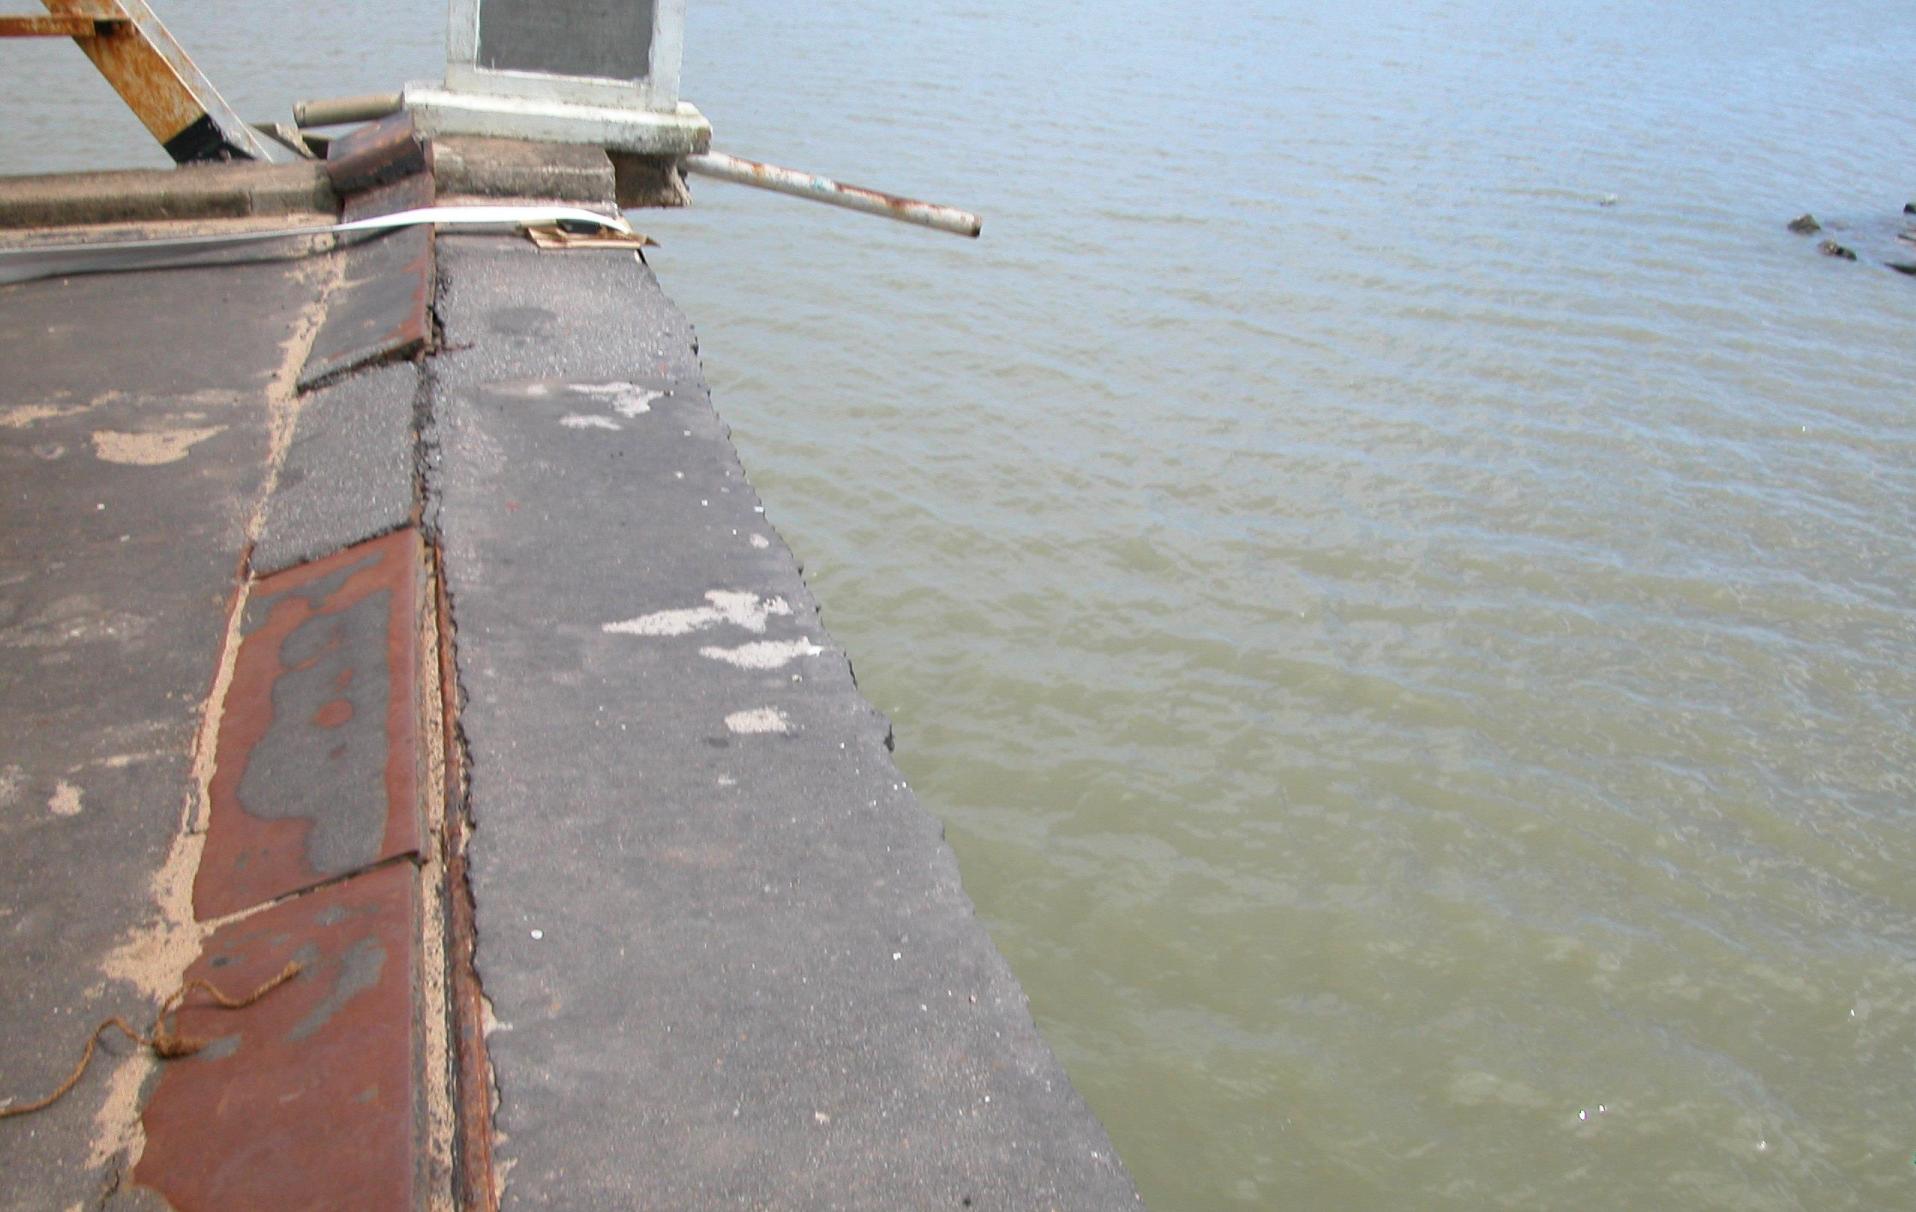
**Expansion joint still there, high above the water.**

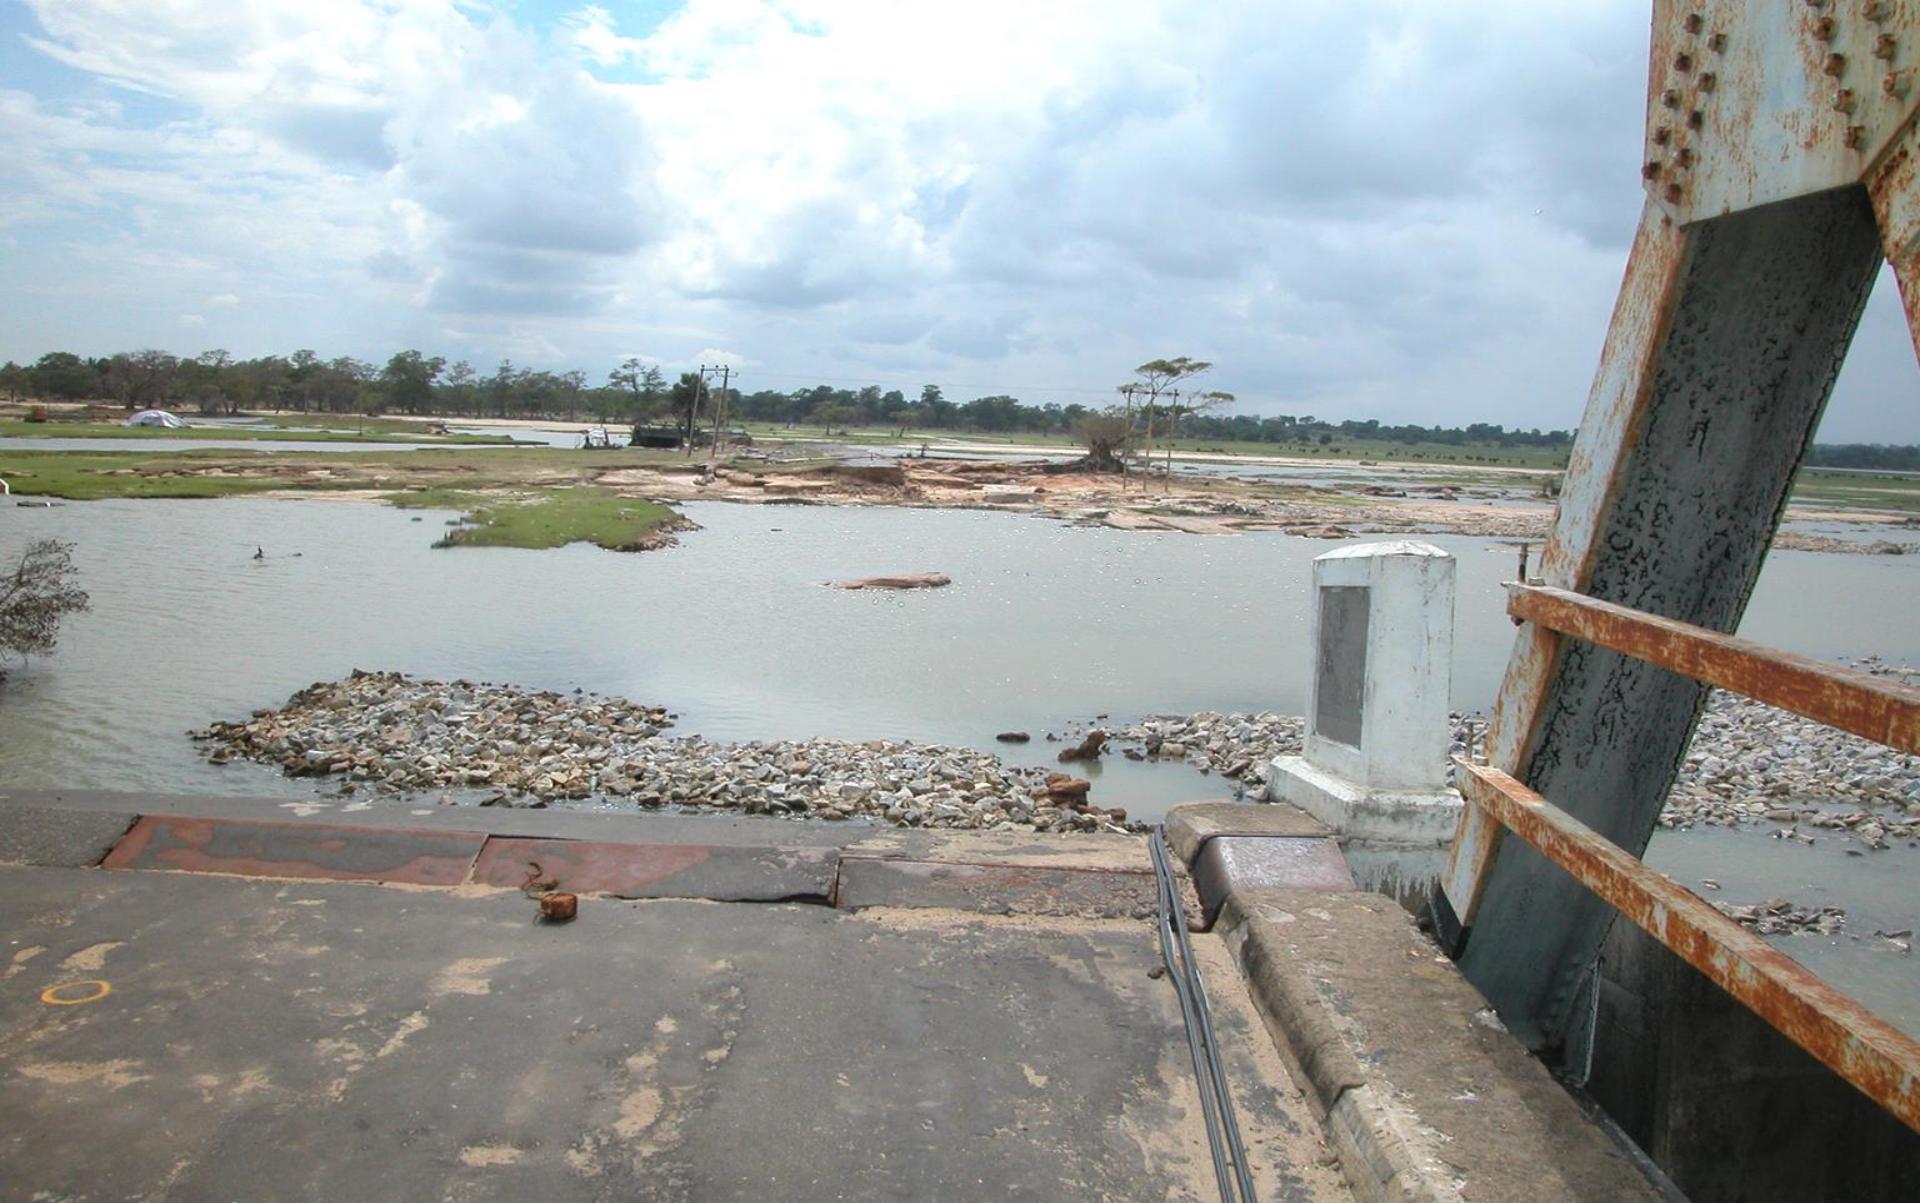
**Approach road and abutments connecting the two bridges were gone.**

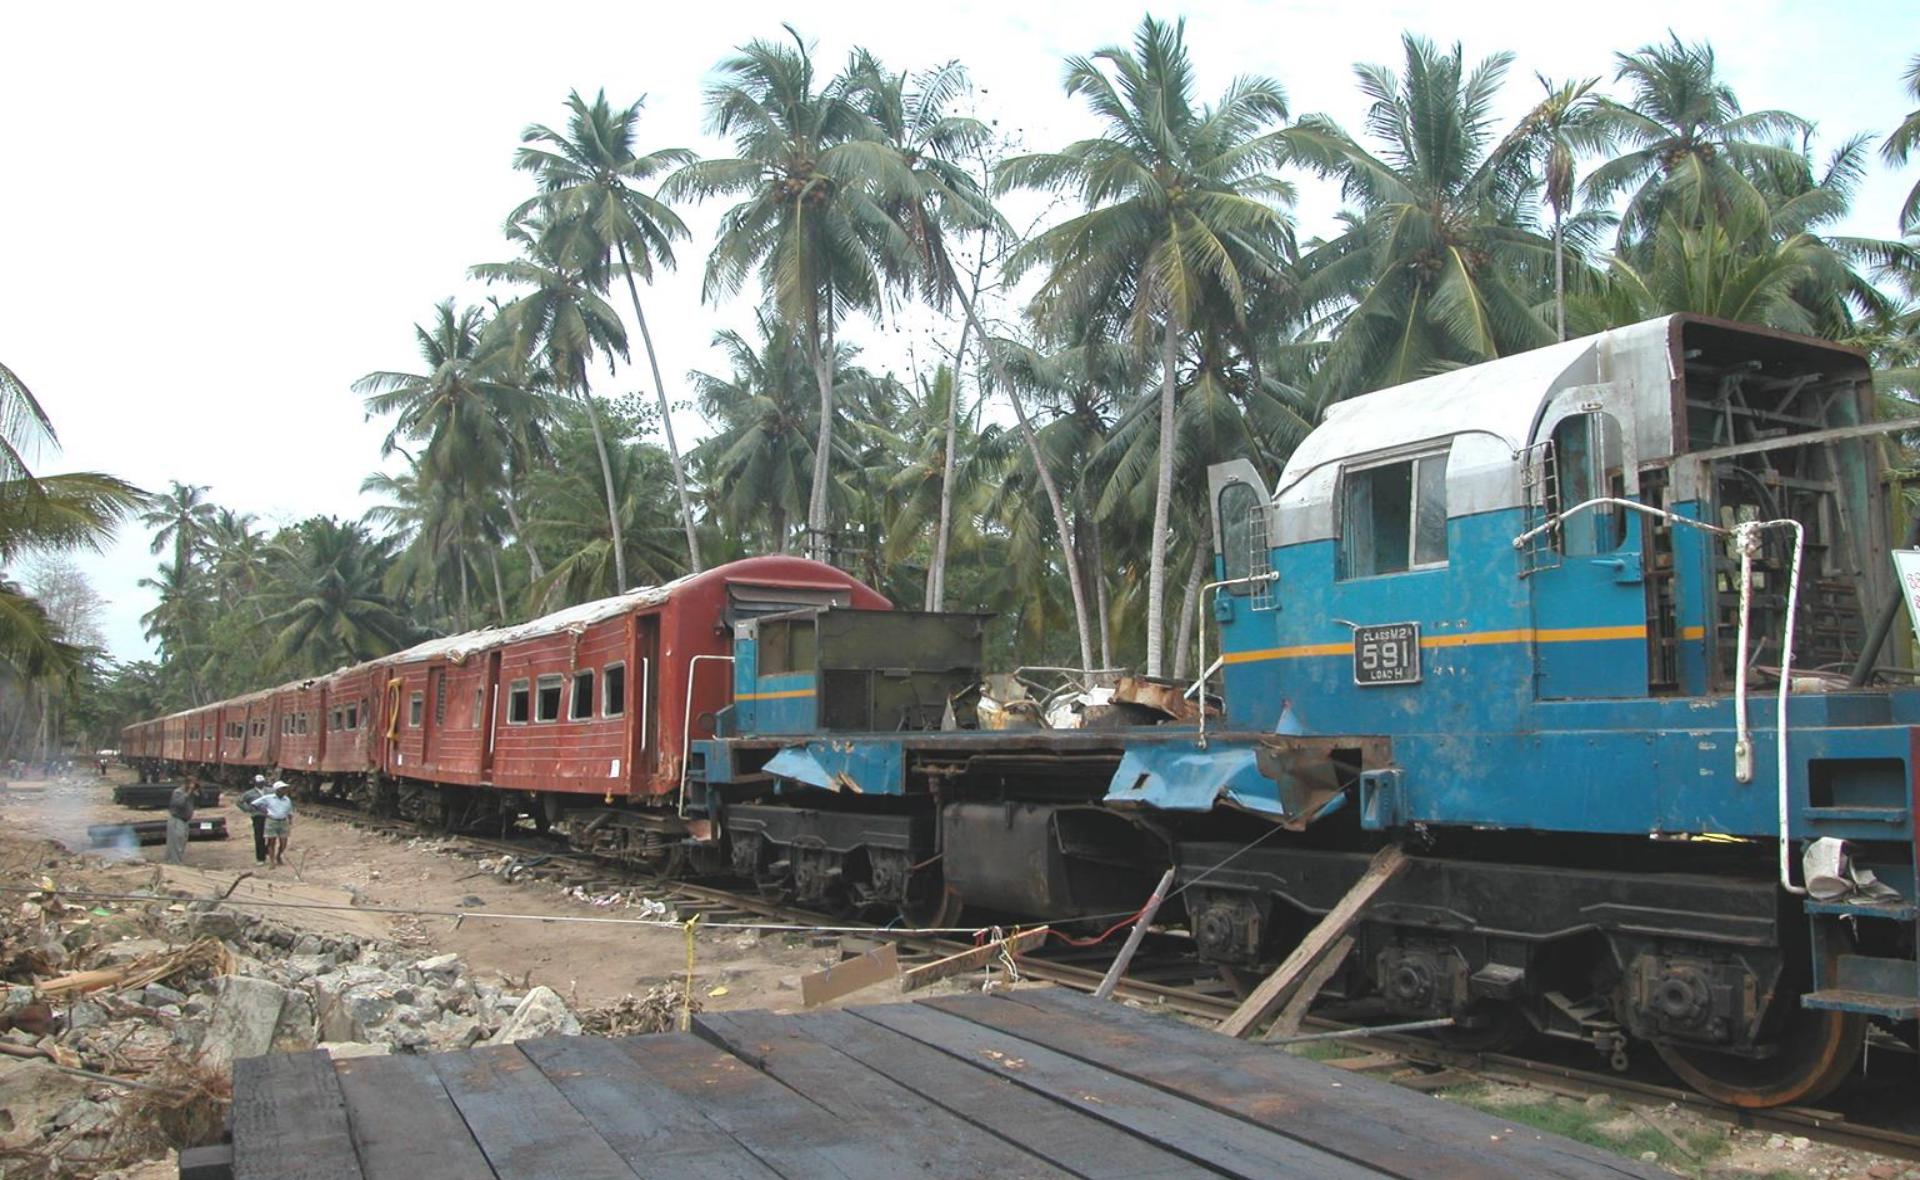
**Doomed morning ride at Bentota, 60 km south of Colombo:**  
Railroad track was several thousand feet from the ocean, but the water level reached 20 ft or more above the ground at this location.

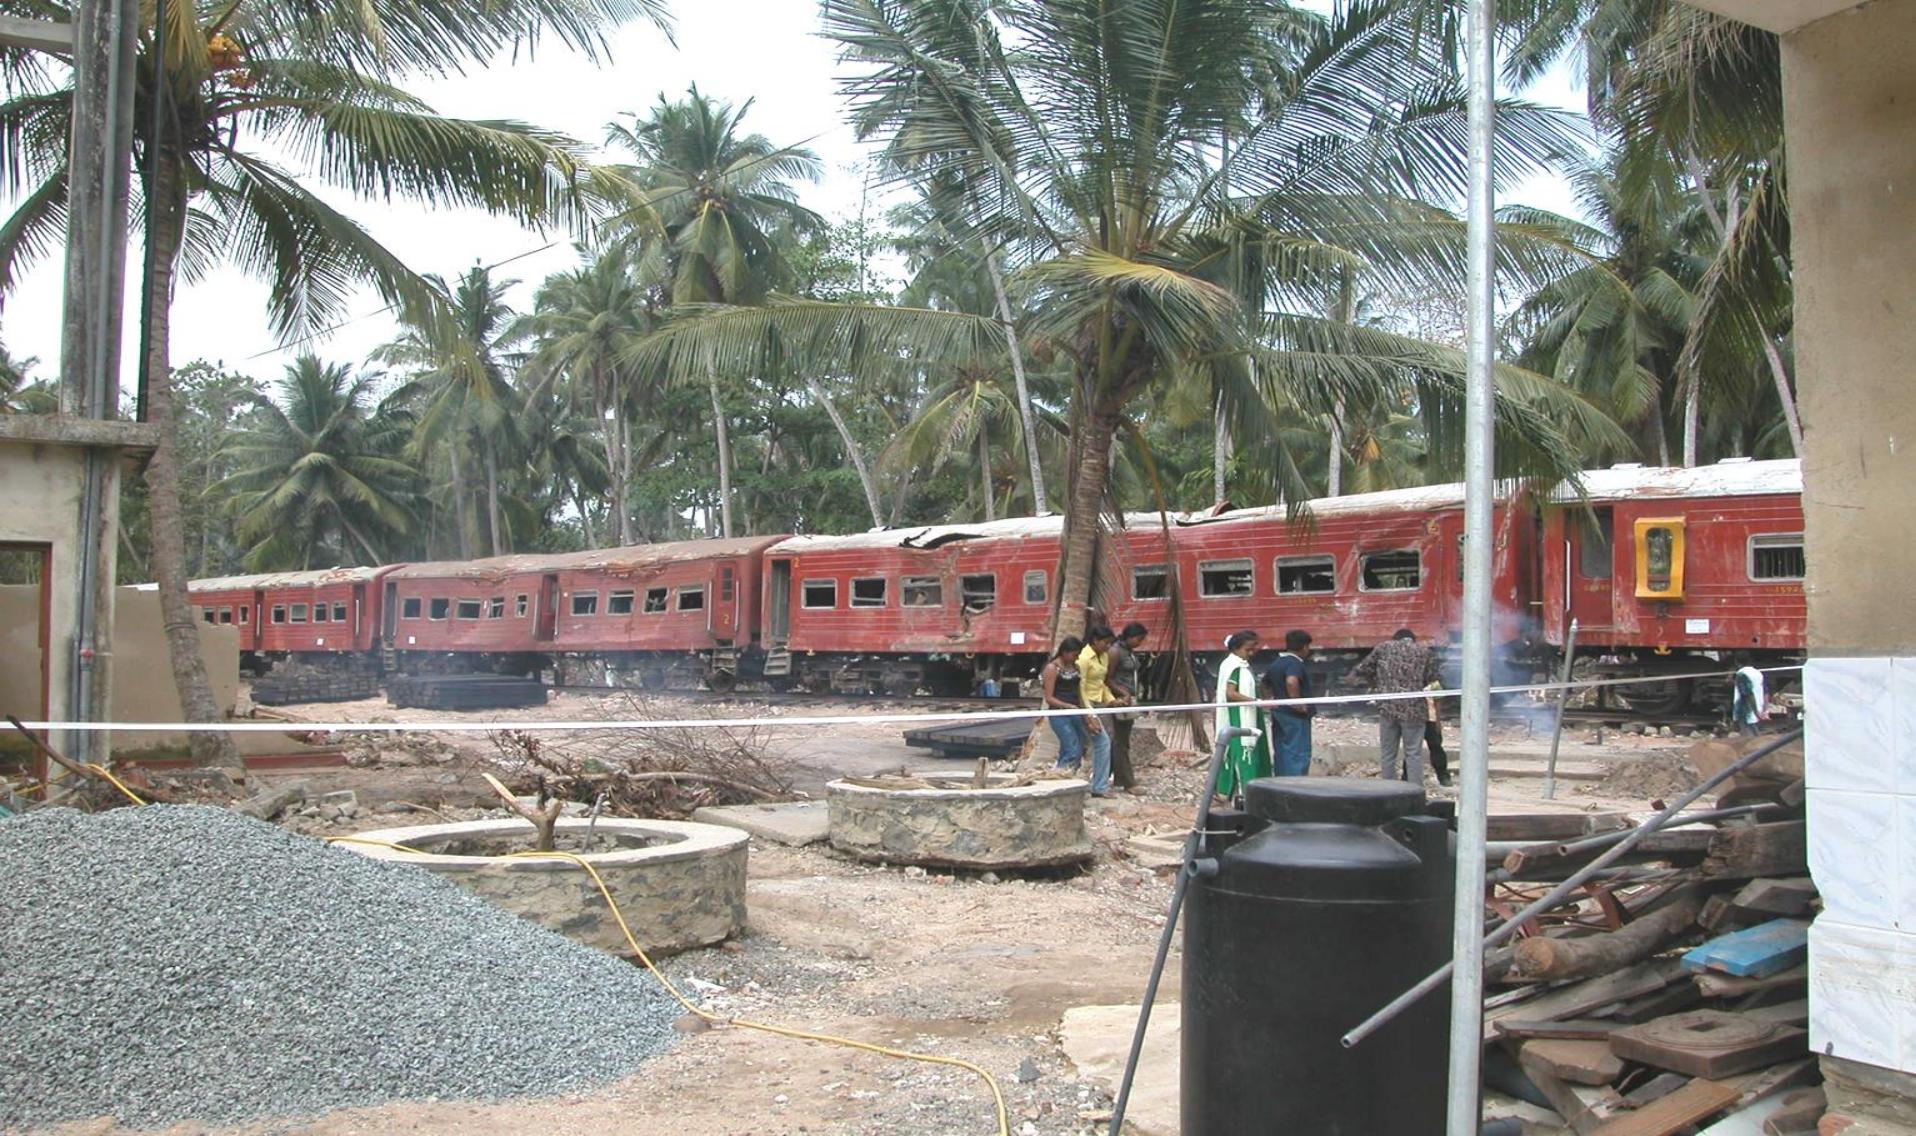
**People jumped on the train in the attempt to escape, but the train was toppled and battered by the flood. 1500 lives perished.**

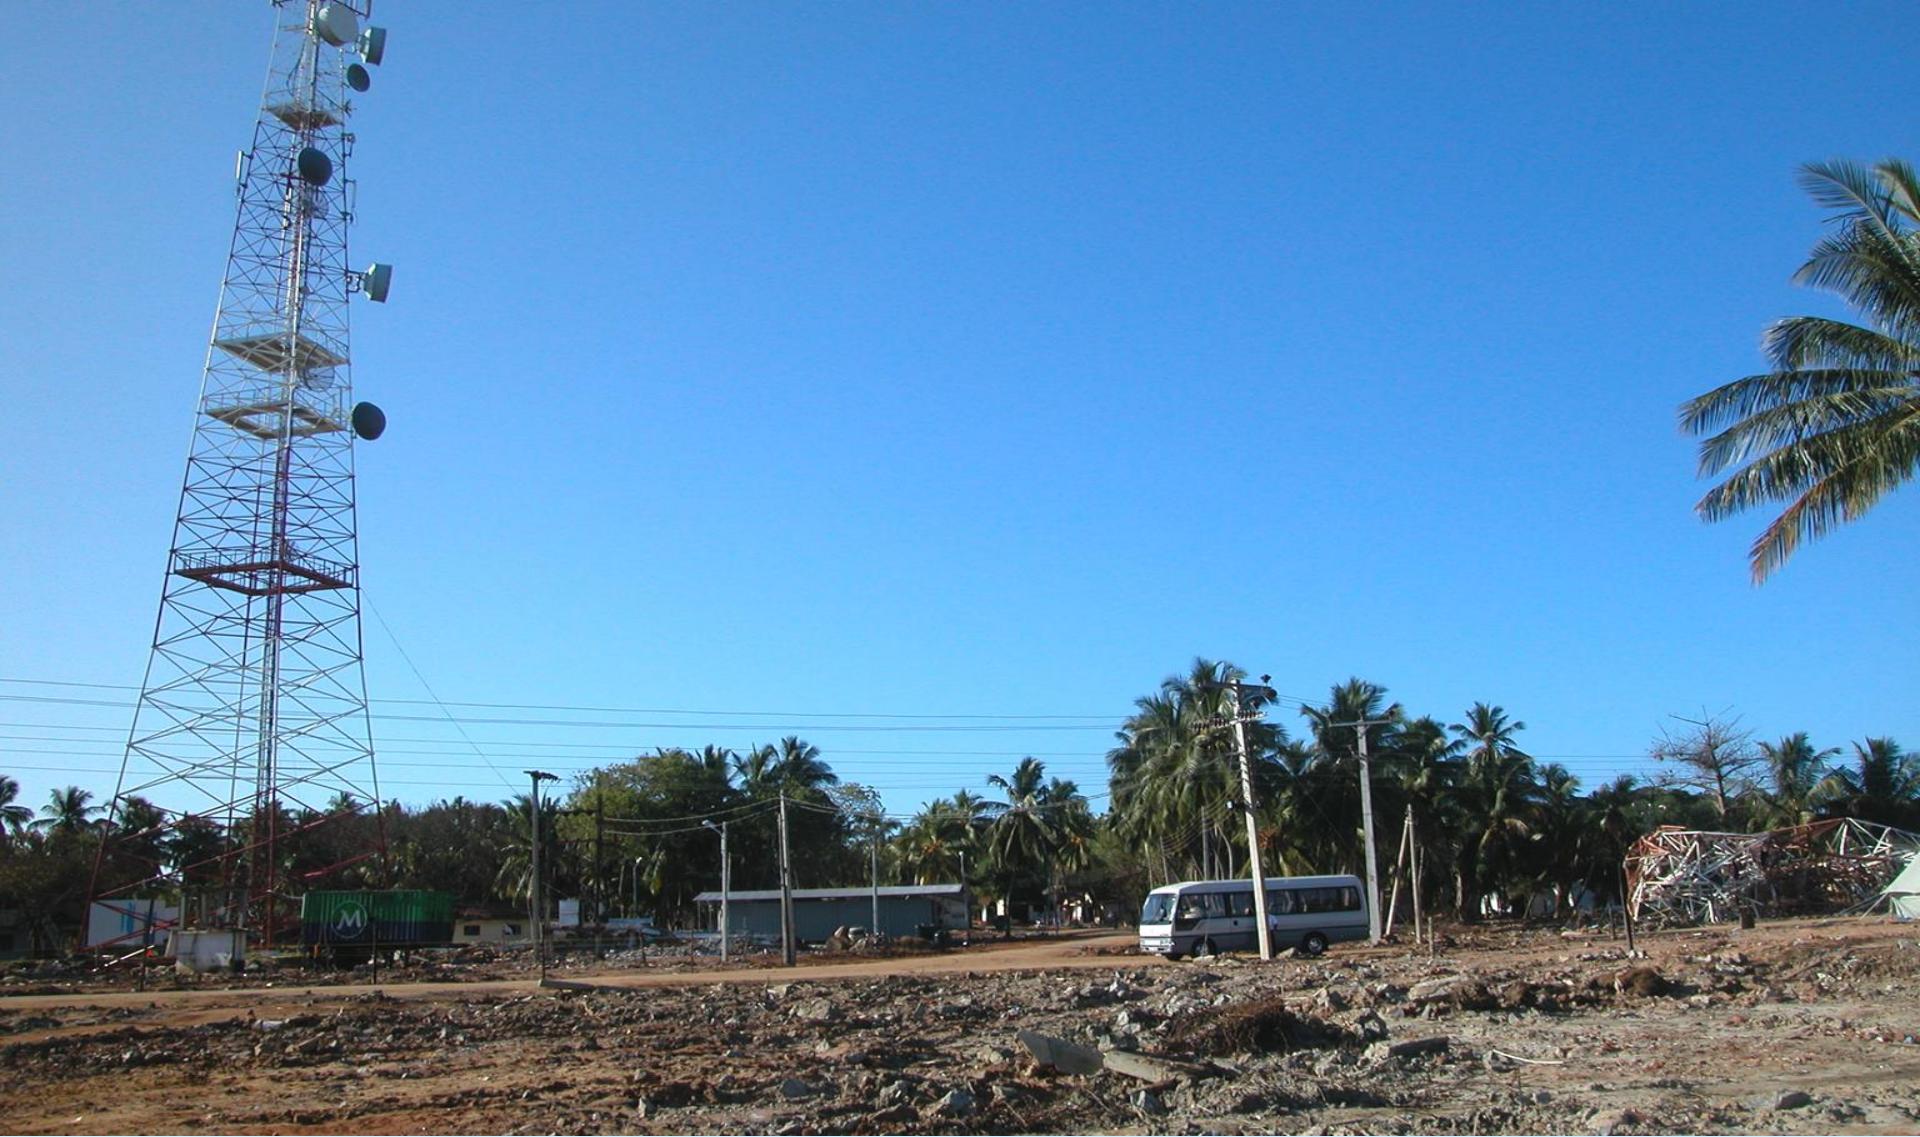
**Hambantota: Thousands feet away from shoreline, this transmission tower was stuck down by the current with a floated bus. Noted all the houses nearby were destroyed.**

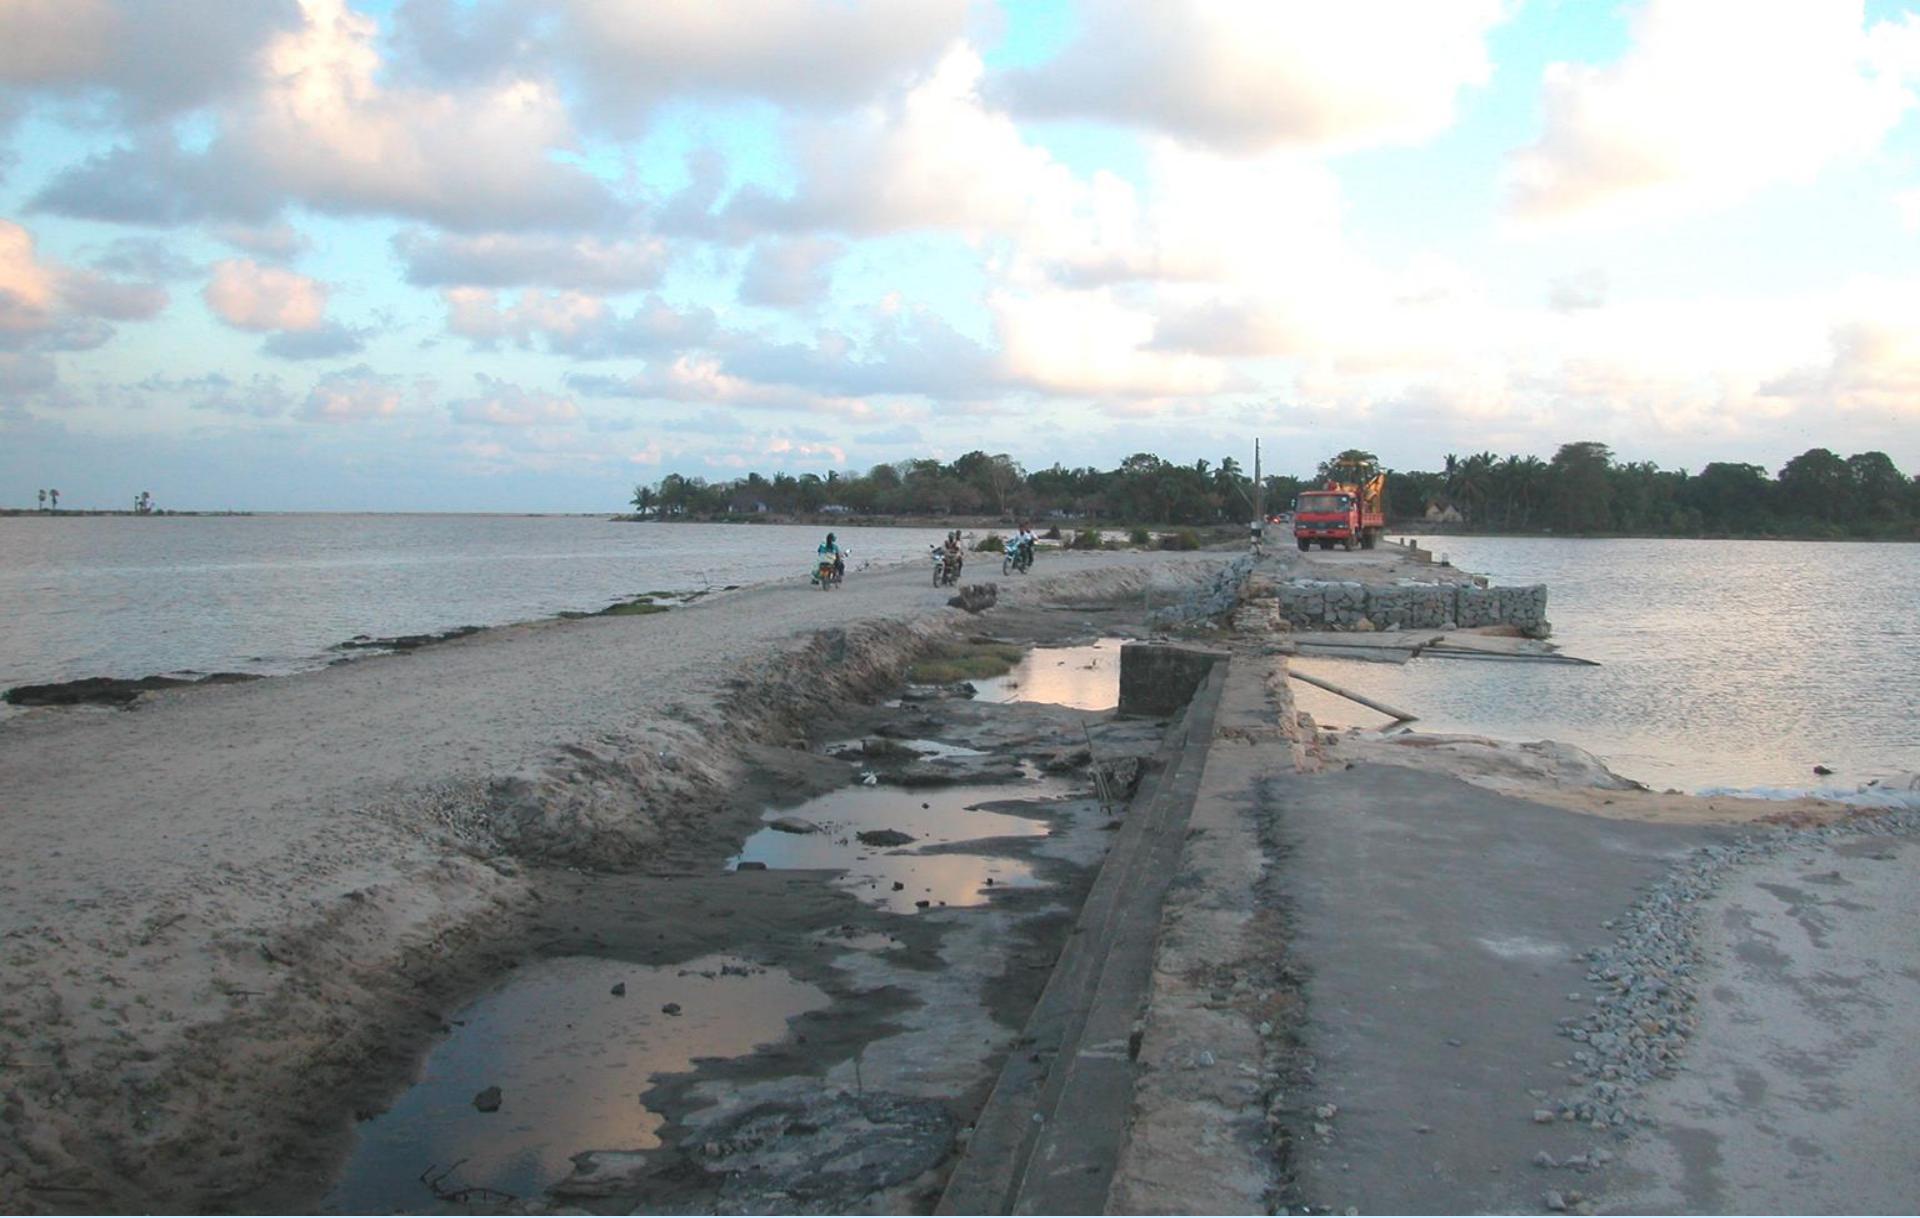
**Along east coastline, from Arugam Bay to Trincomalee Bay,  
many roads adjacent or connect to lake or lagoon need major repair.**
