# *Overview of Performance of Ports, Harbors, Infrastructures and Buildings in Sri Lanka and India*

*By Peter Yin, Port of Los Angeles  
ASCE-COPRI Reconnaissance Team Member*

*January 31- February 11, 2005*

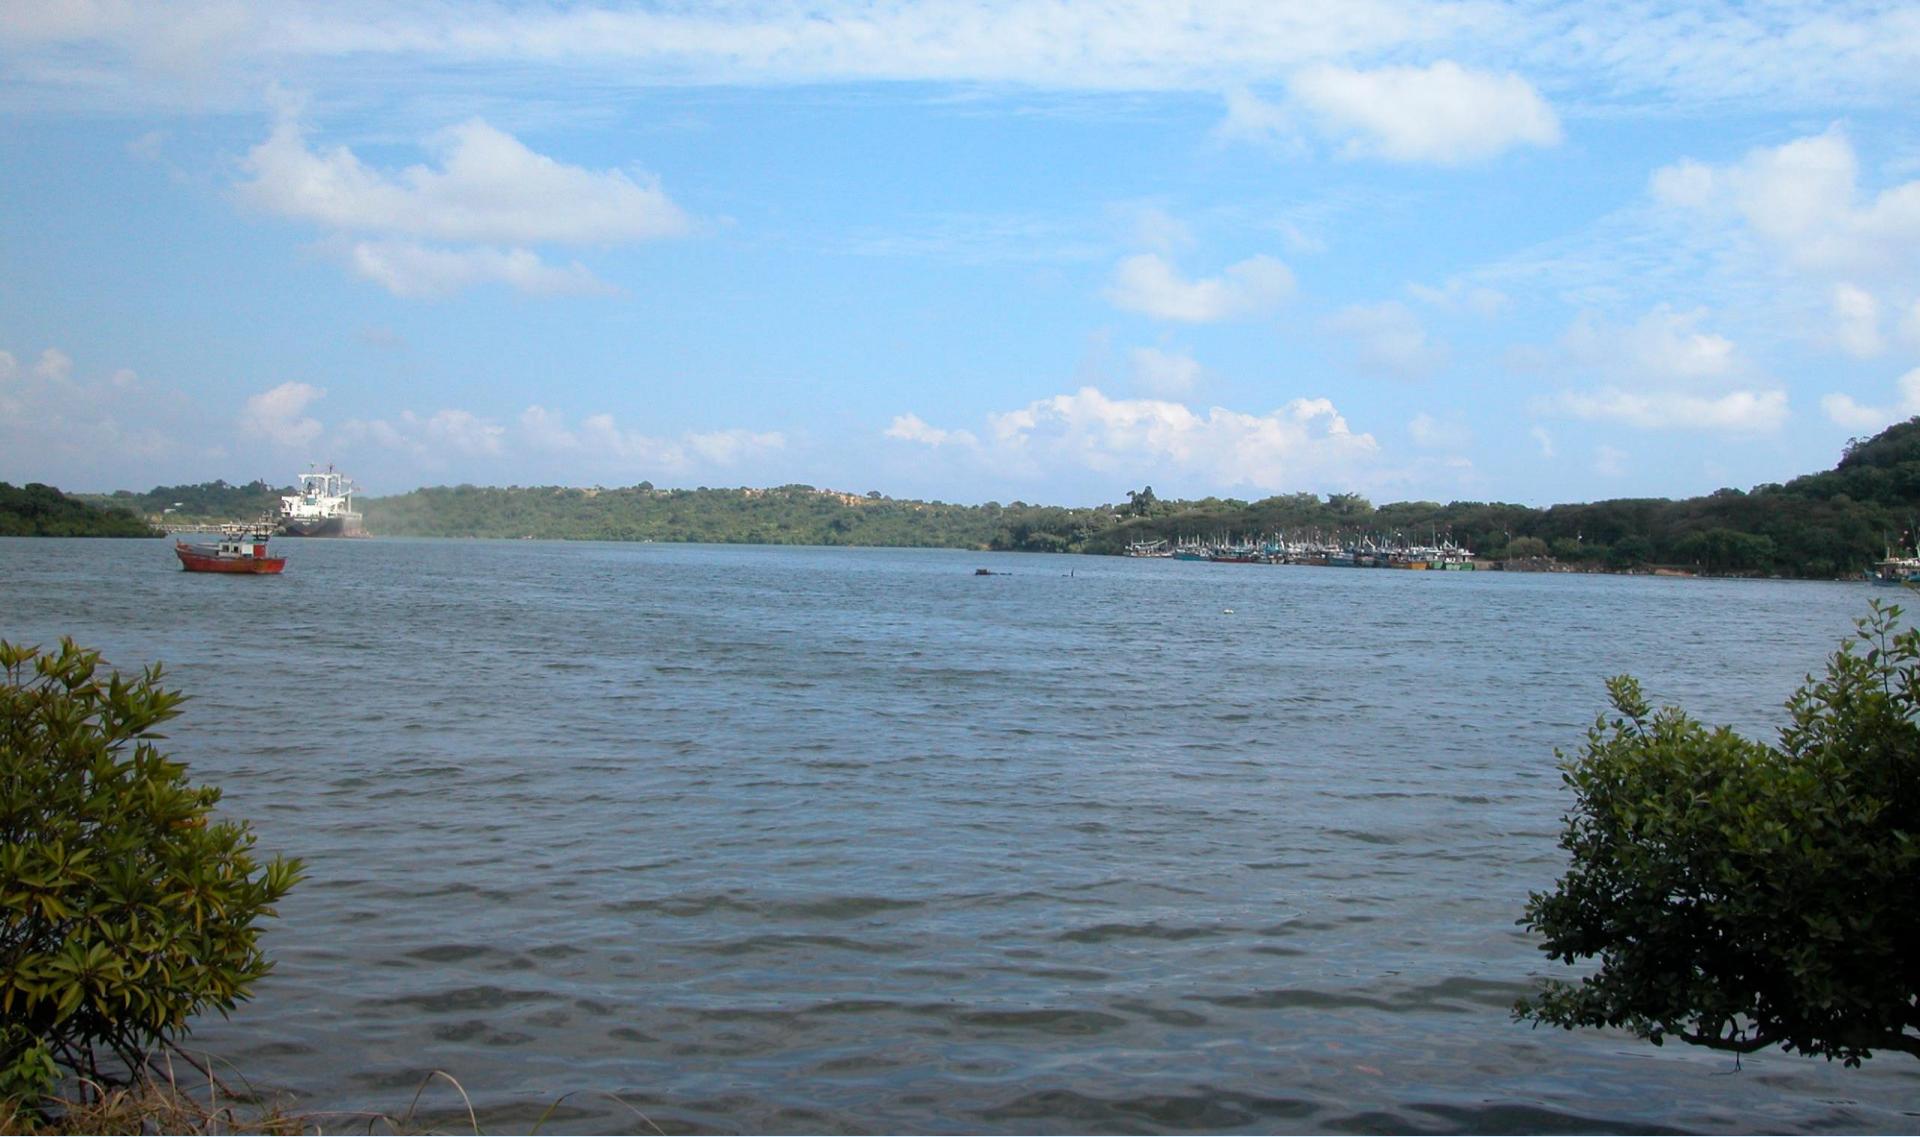
**Tricomalee Inner Harbor:**  
Even though fierce surge attacked outer harbor, narrow entrance minimized the damages to the inner harbor facilities.

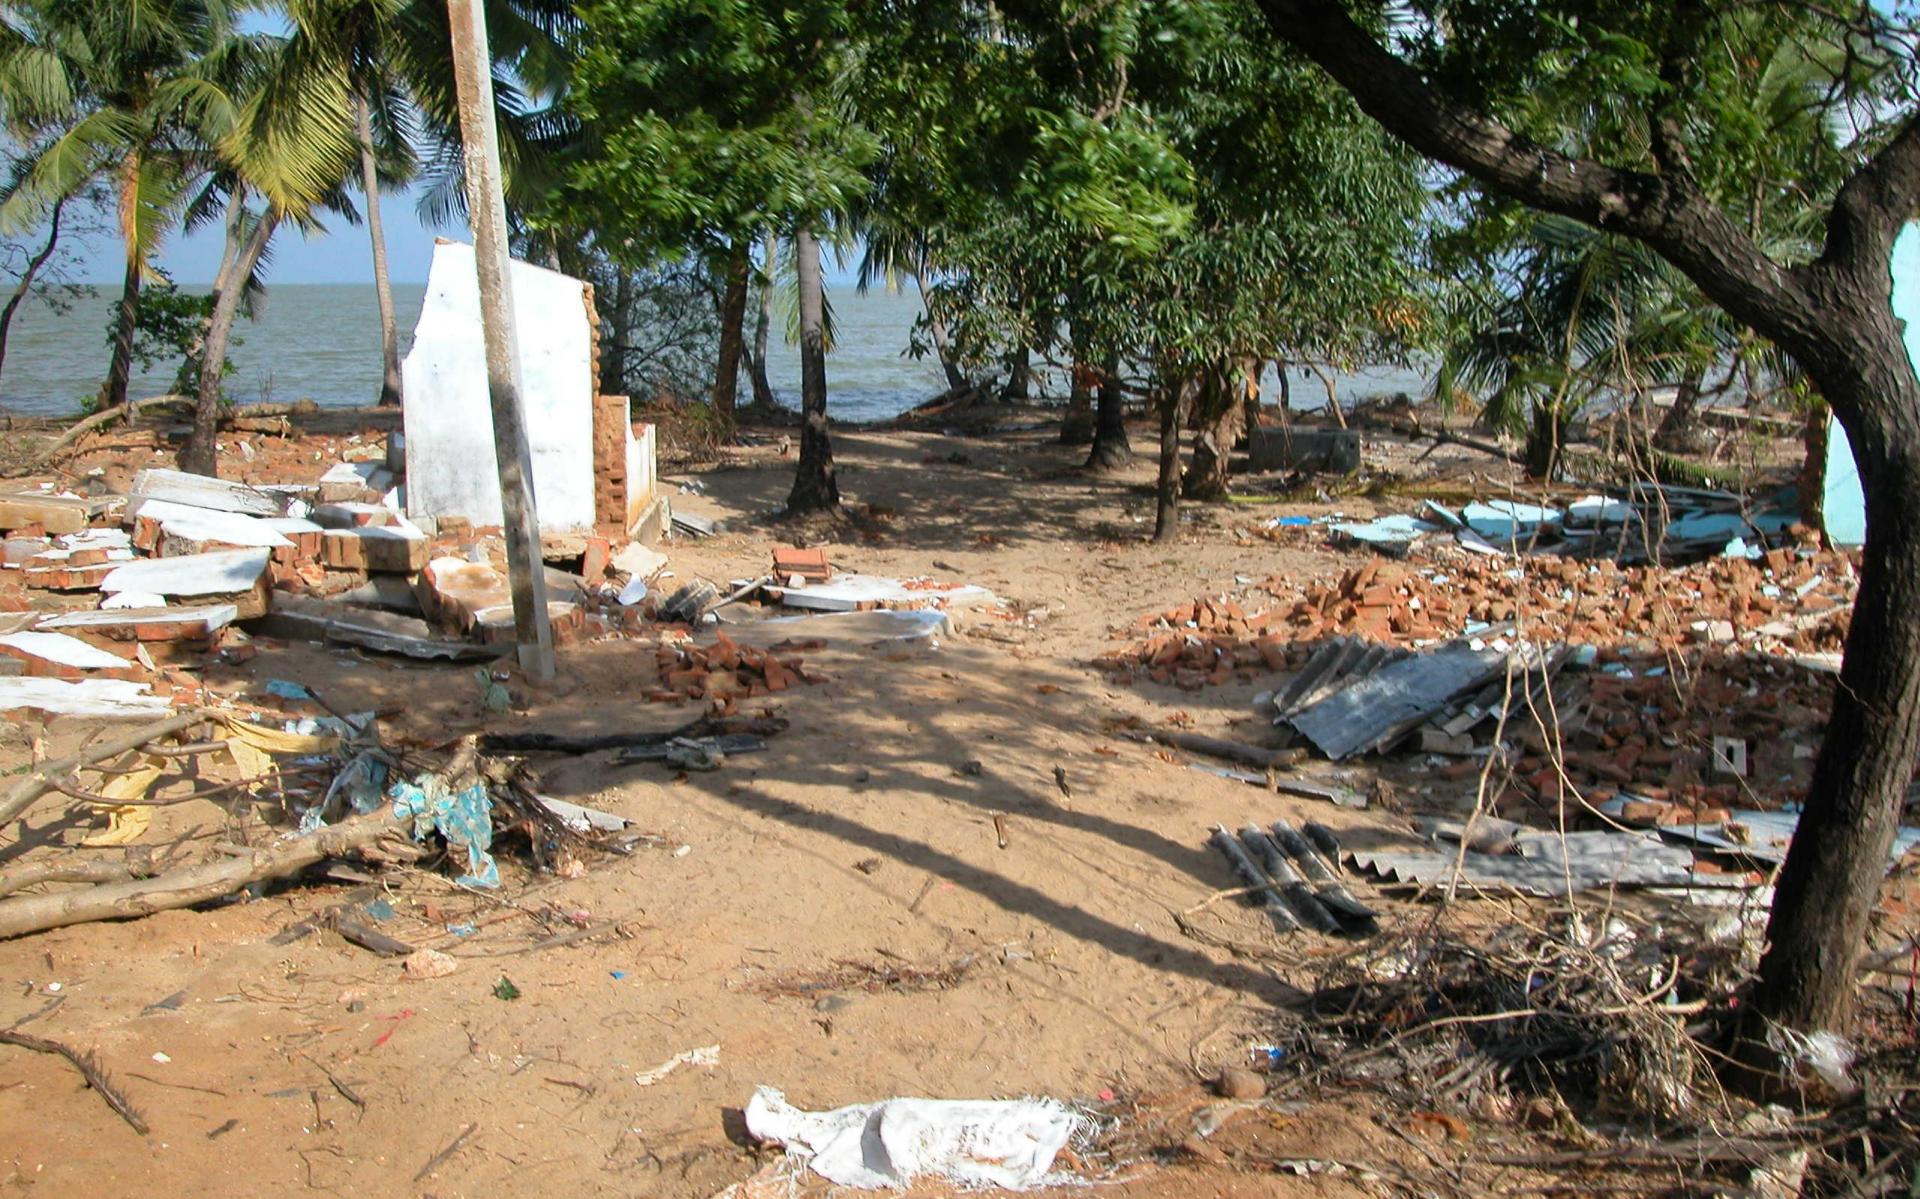
**Tricomalee Outer Harbor:  
Almost all the houses at coast line were destroyed.**

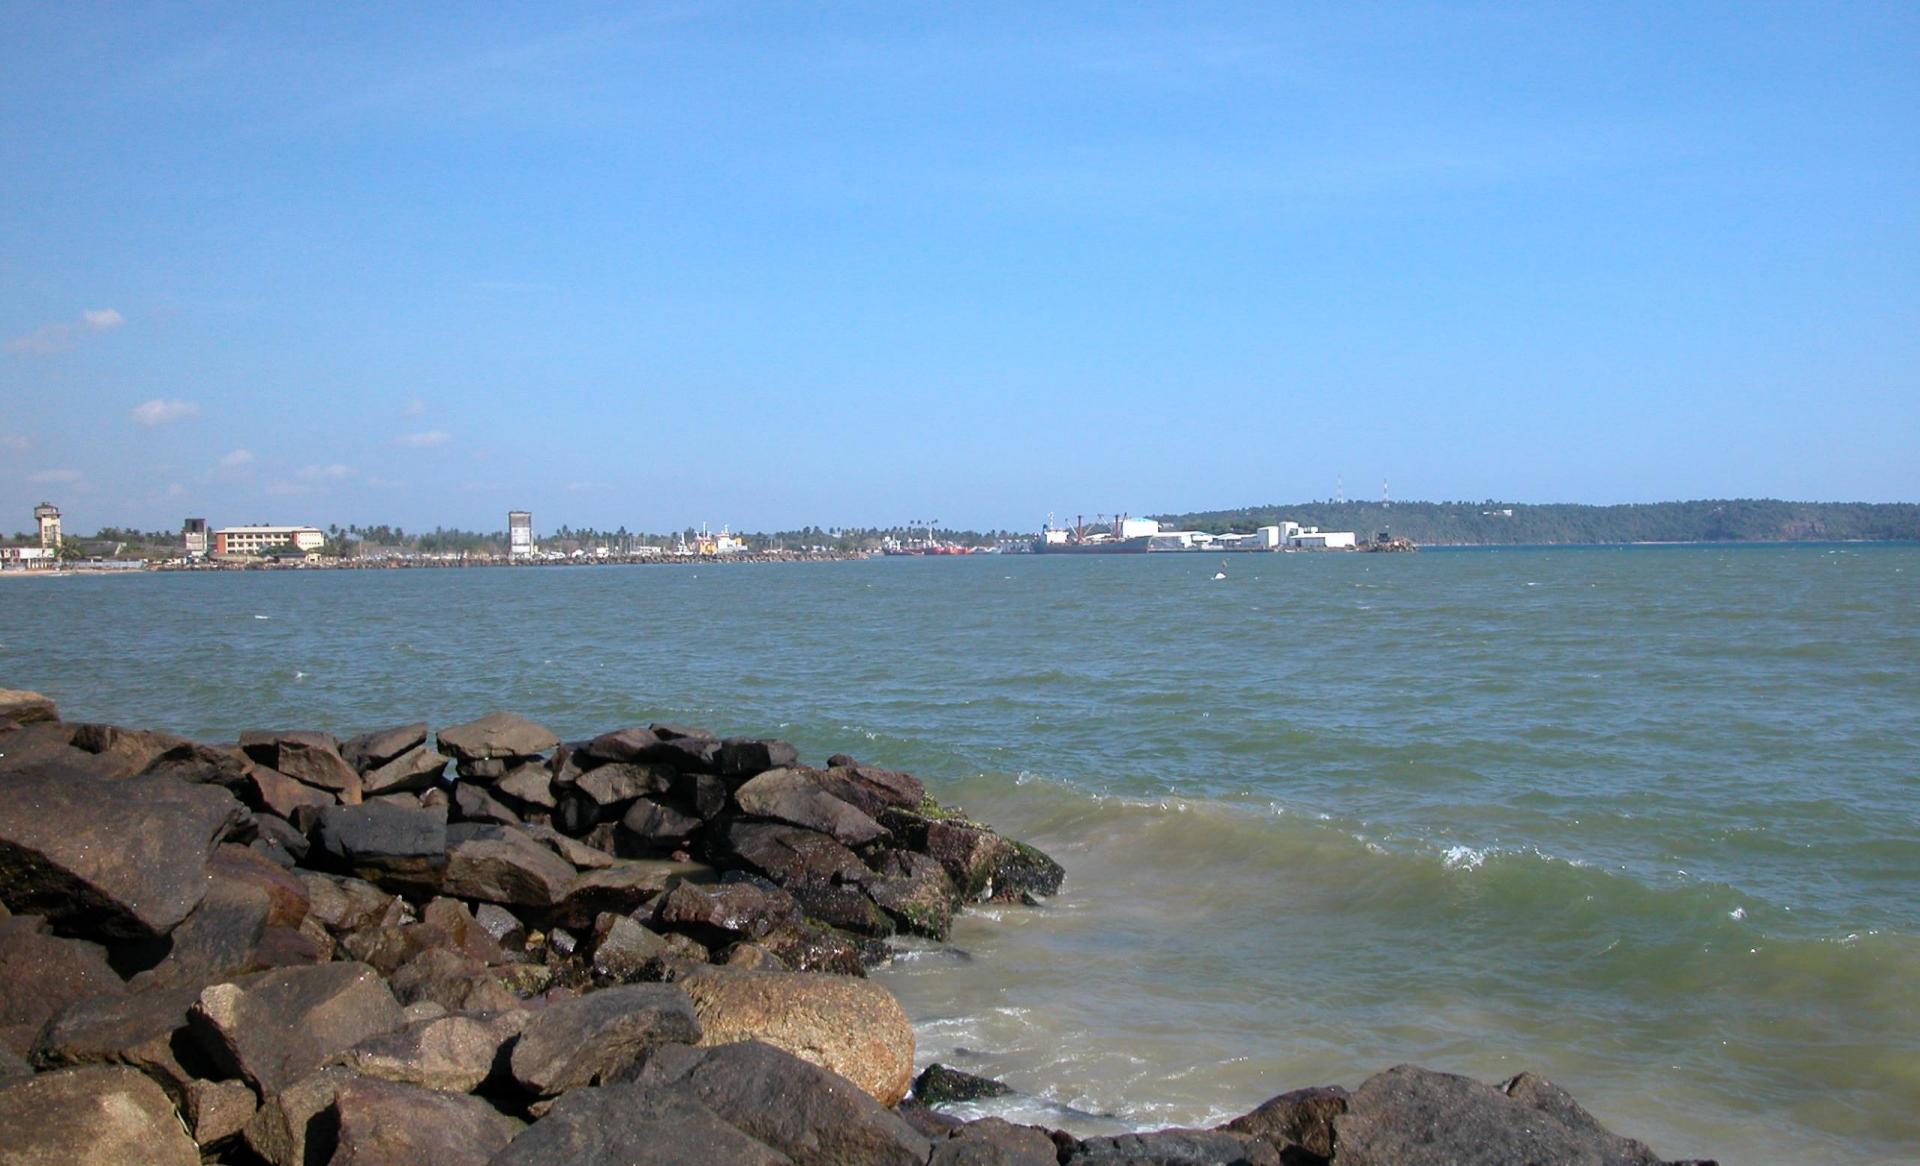
**The Port of Galle, Southwest Sri Lanka:  
Water was 10 ft above the deck and port buildings.**

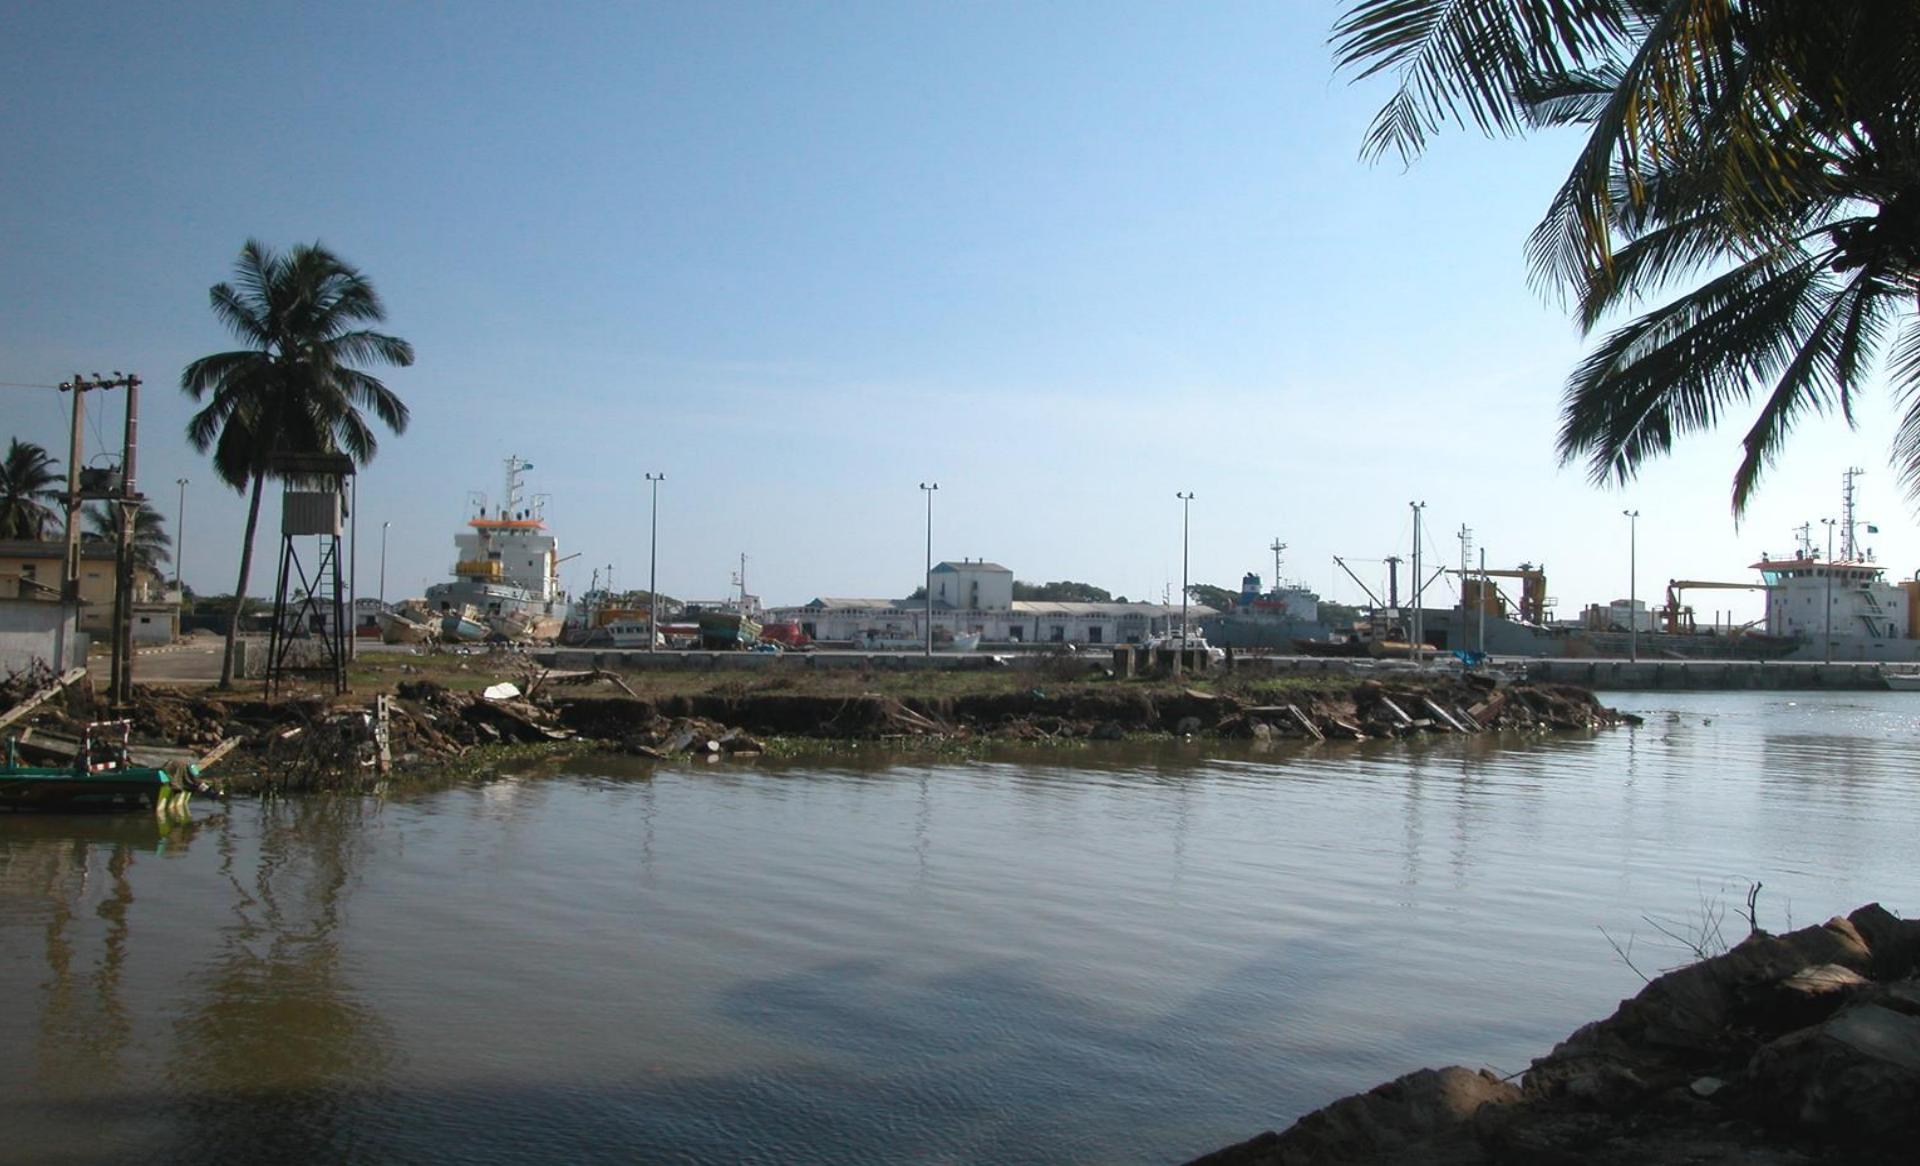
**No major damage was reported, even though 2 m (6') of silt filled the inner harbor and a 650 ton ship was tossed to on top of the deck.**

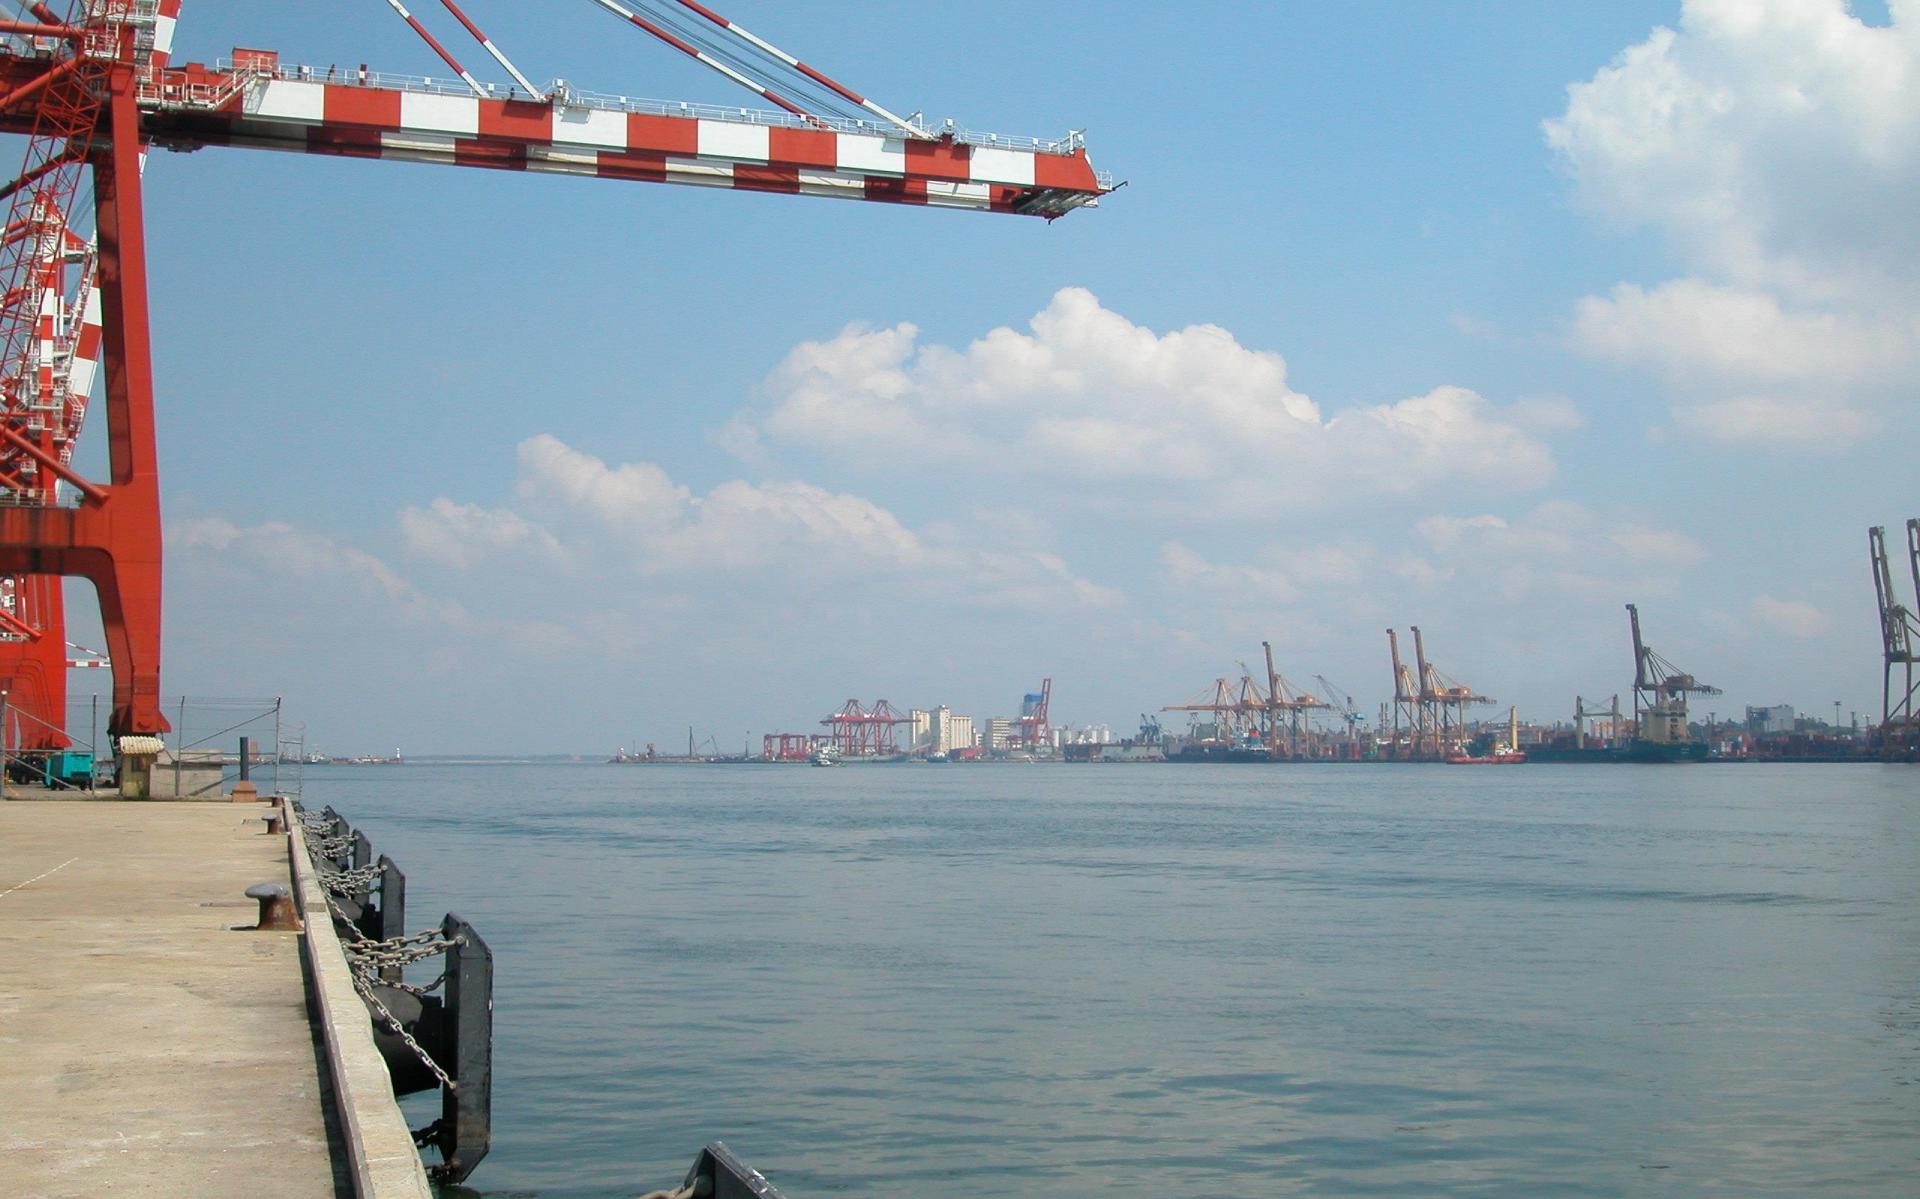
**Tsunami brought no surging waves, but fast rising water.**

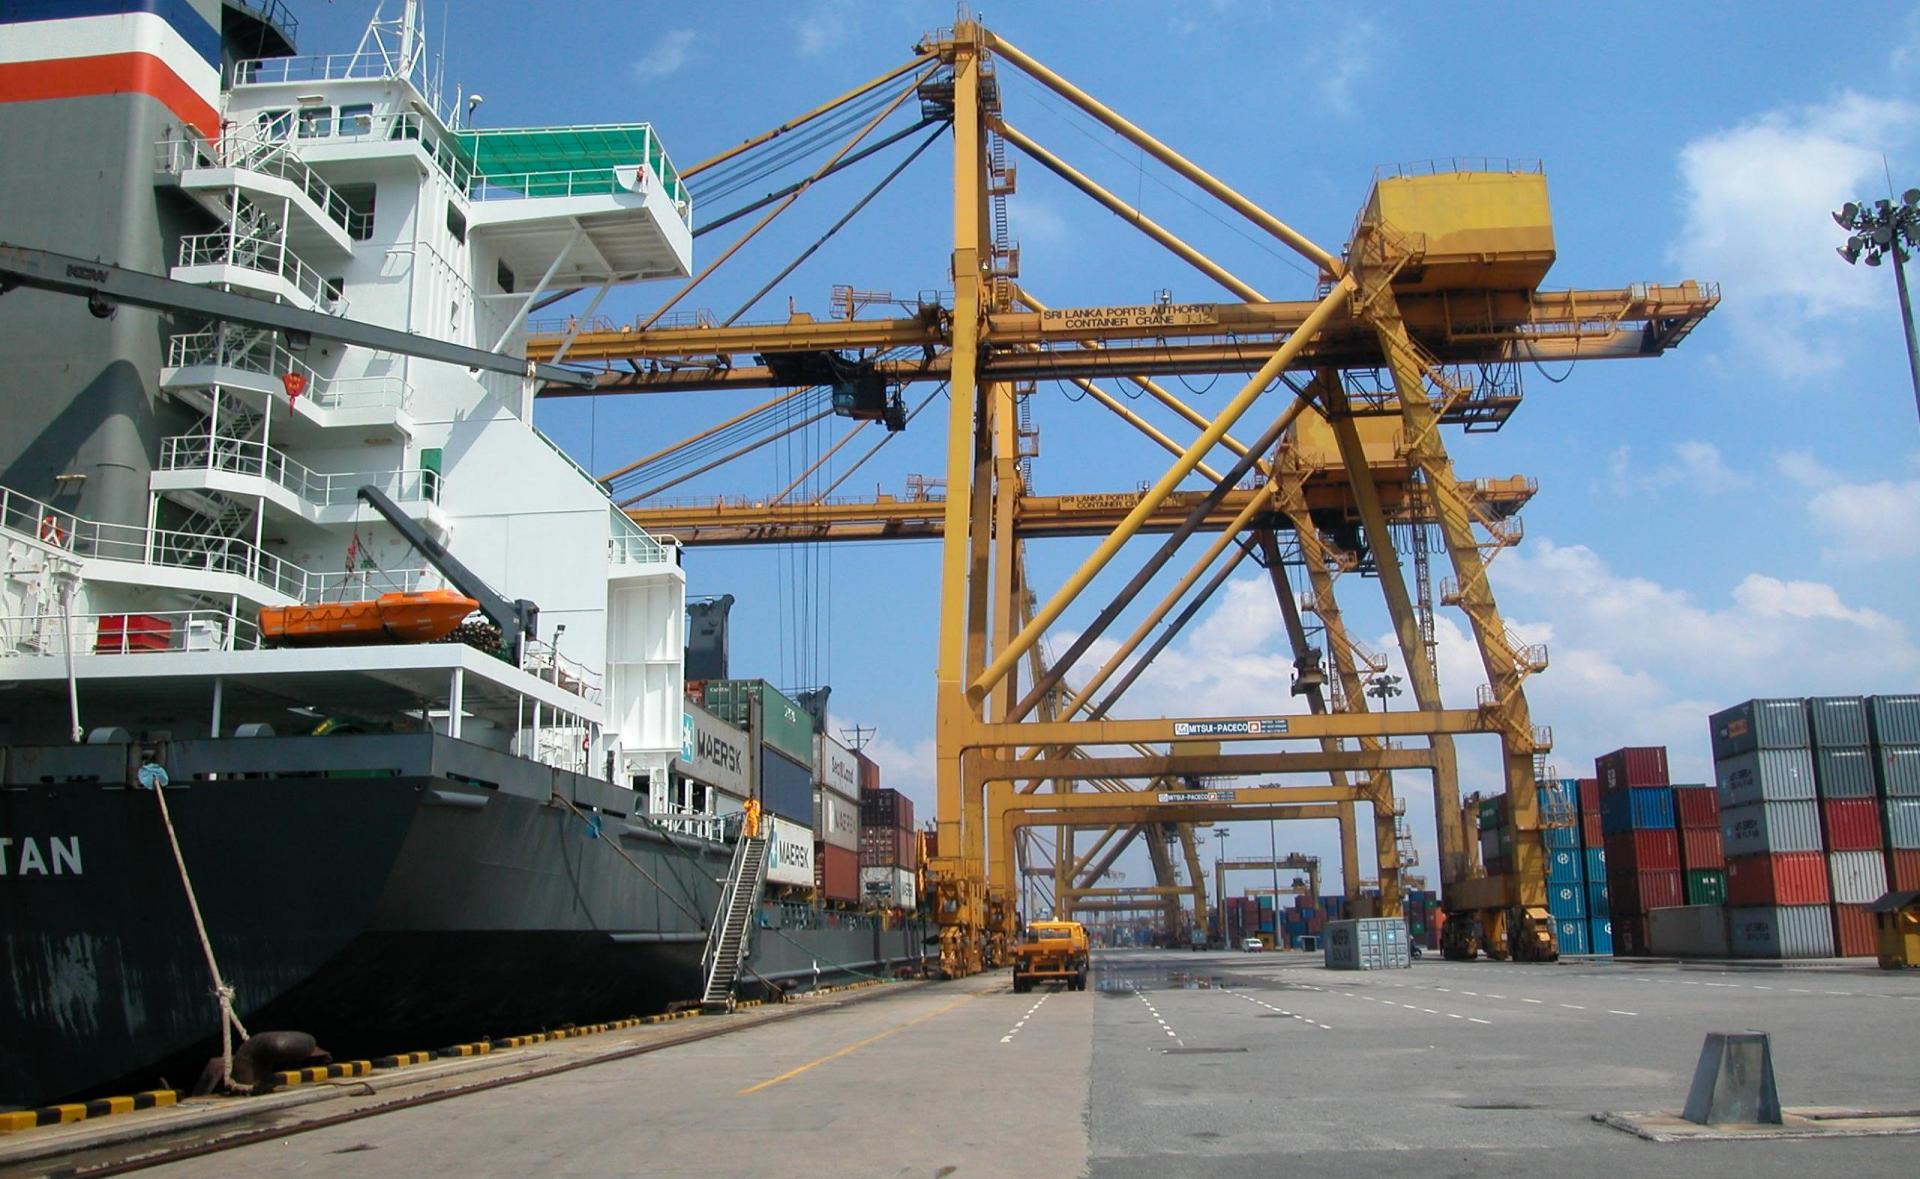
**Three feet of water covered the wharfs before receding.**

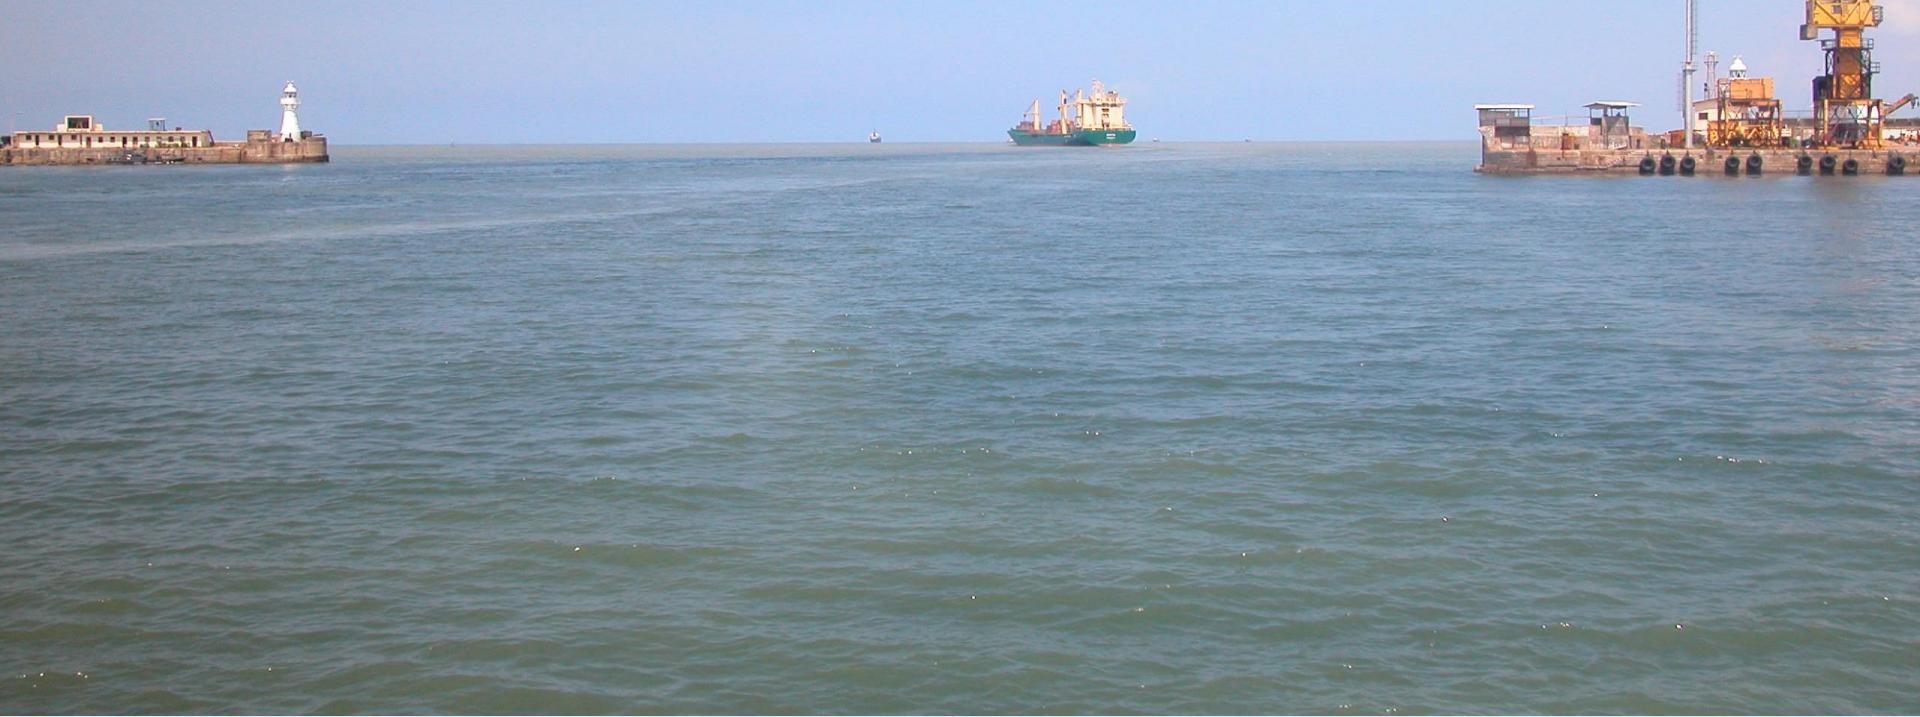
**Minor damages occurred near light house when a ship hit the breakwater (slipped away from the wharf by receding water).**

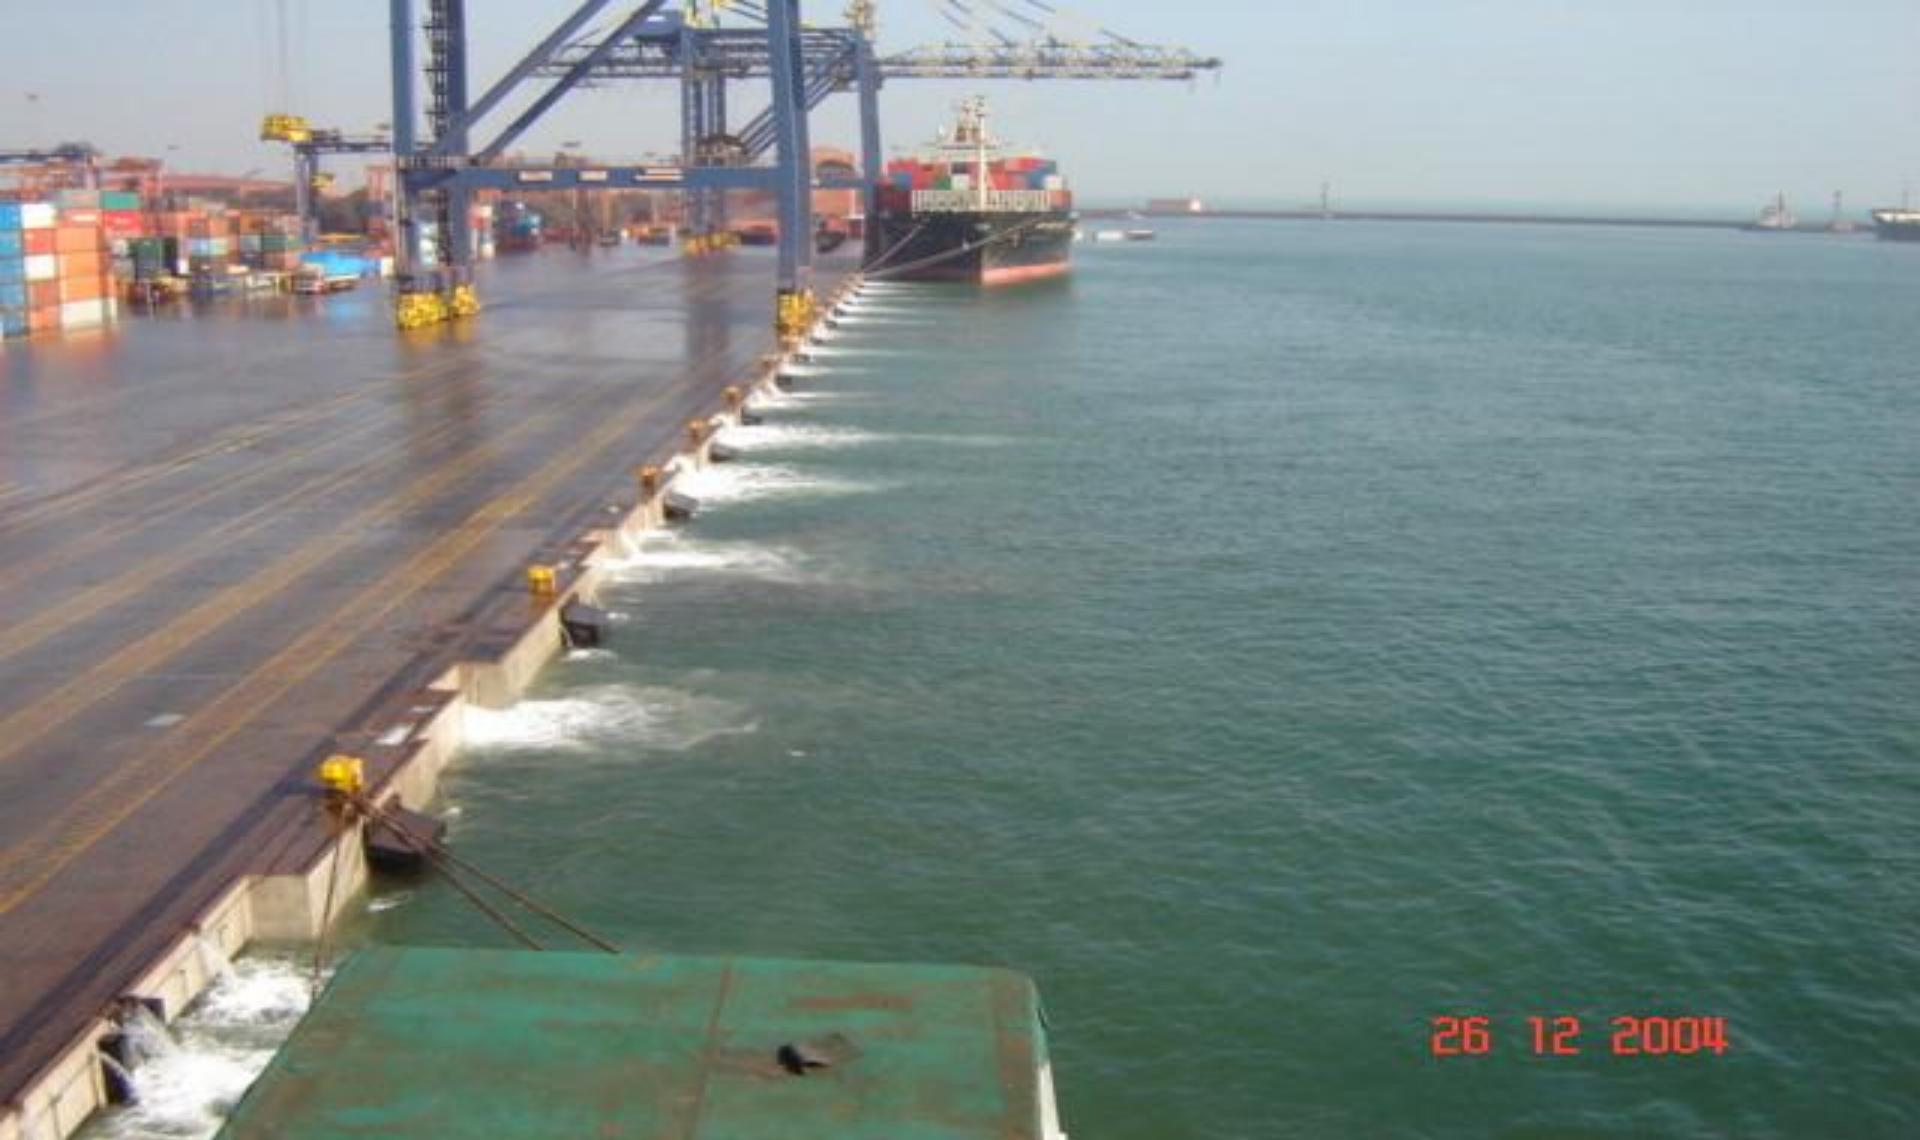
**Chennai Port: 5 m (16 ft) or higher waves hit the port and fish harbor. (Deck is 4 m above MLLW level)**

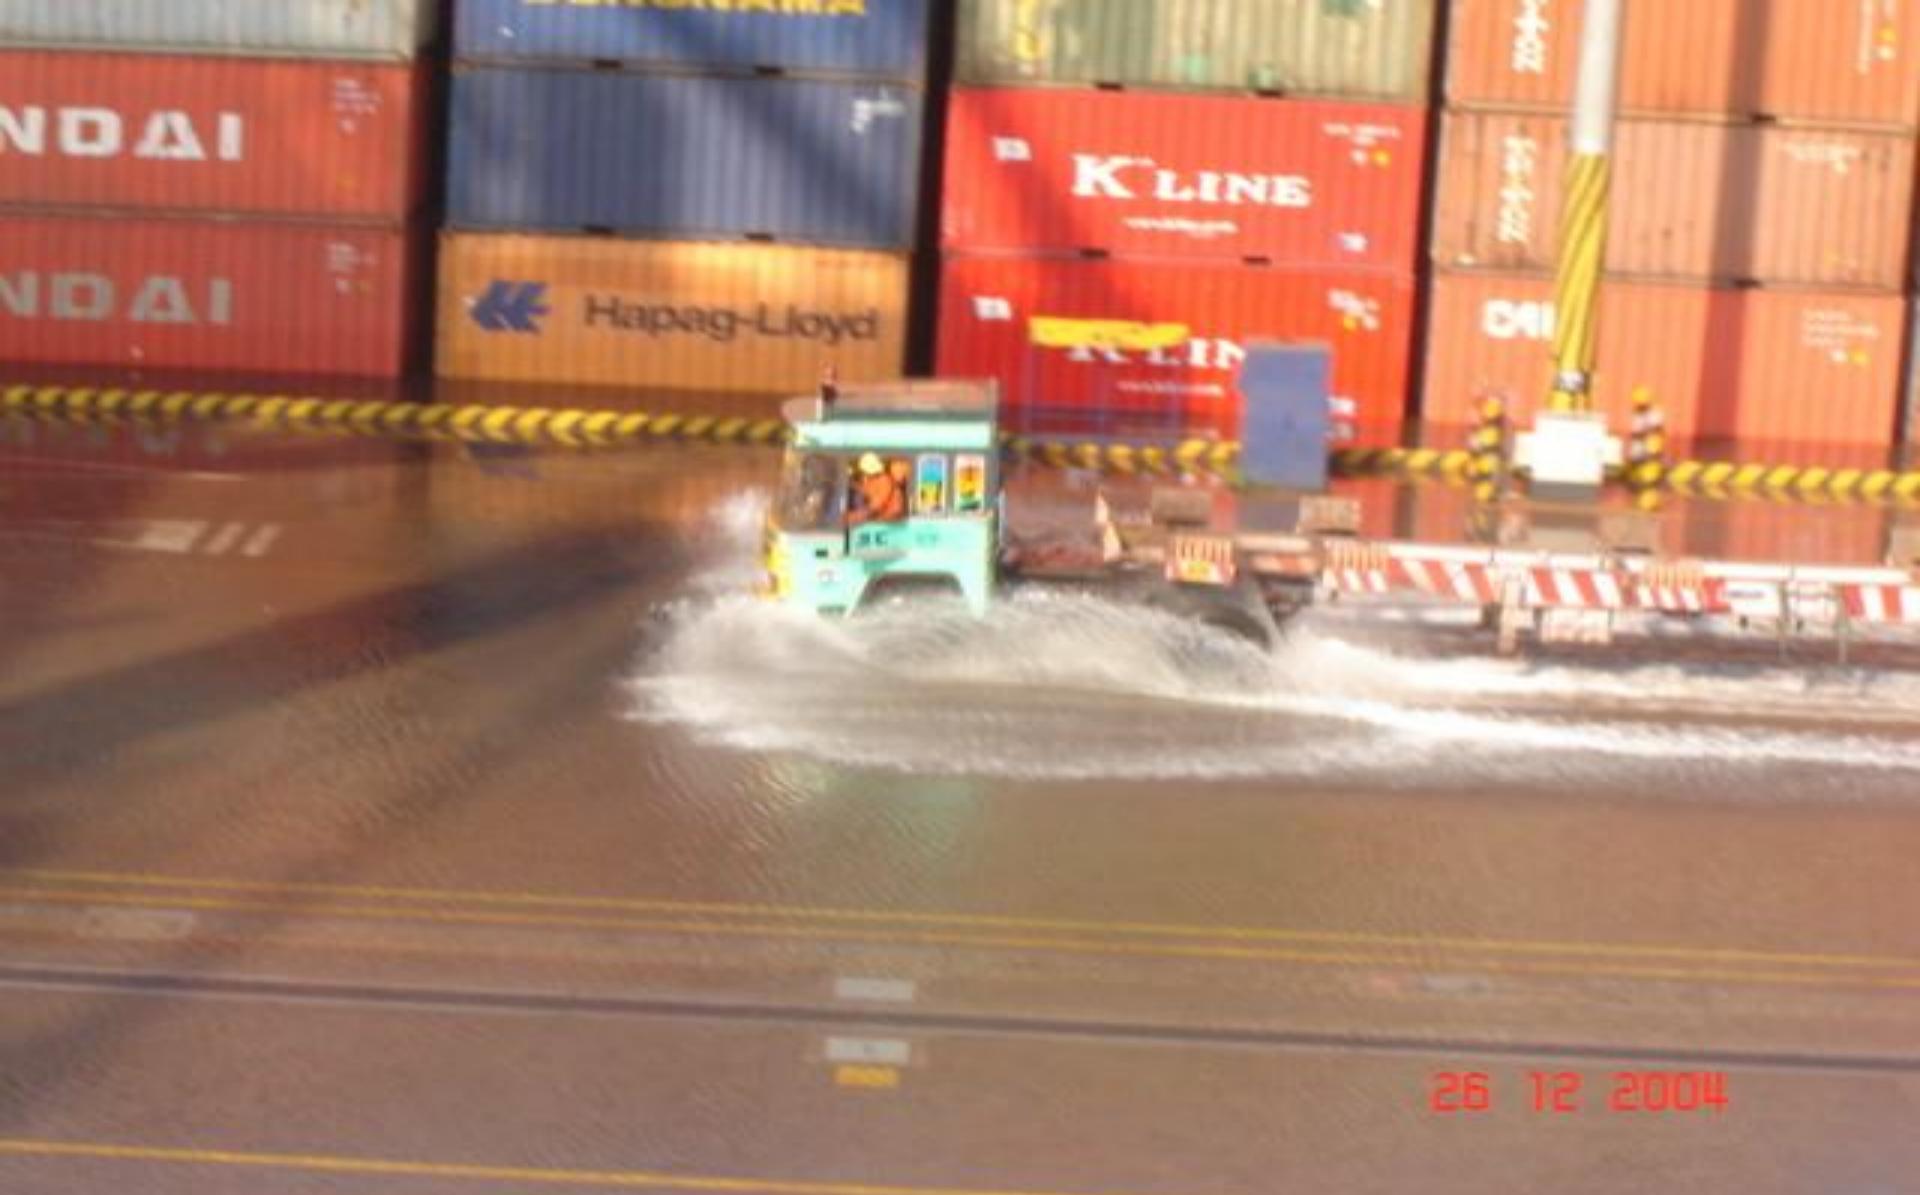
**Water receded from the backland.**

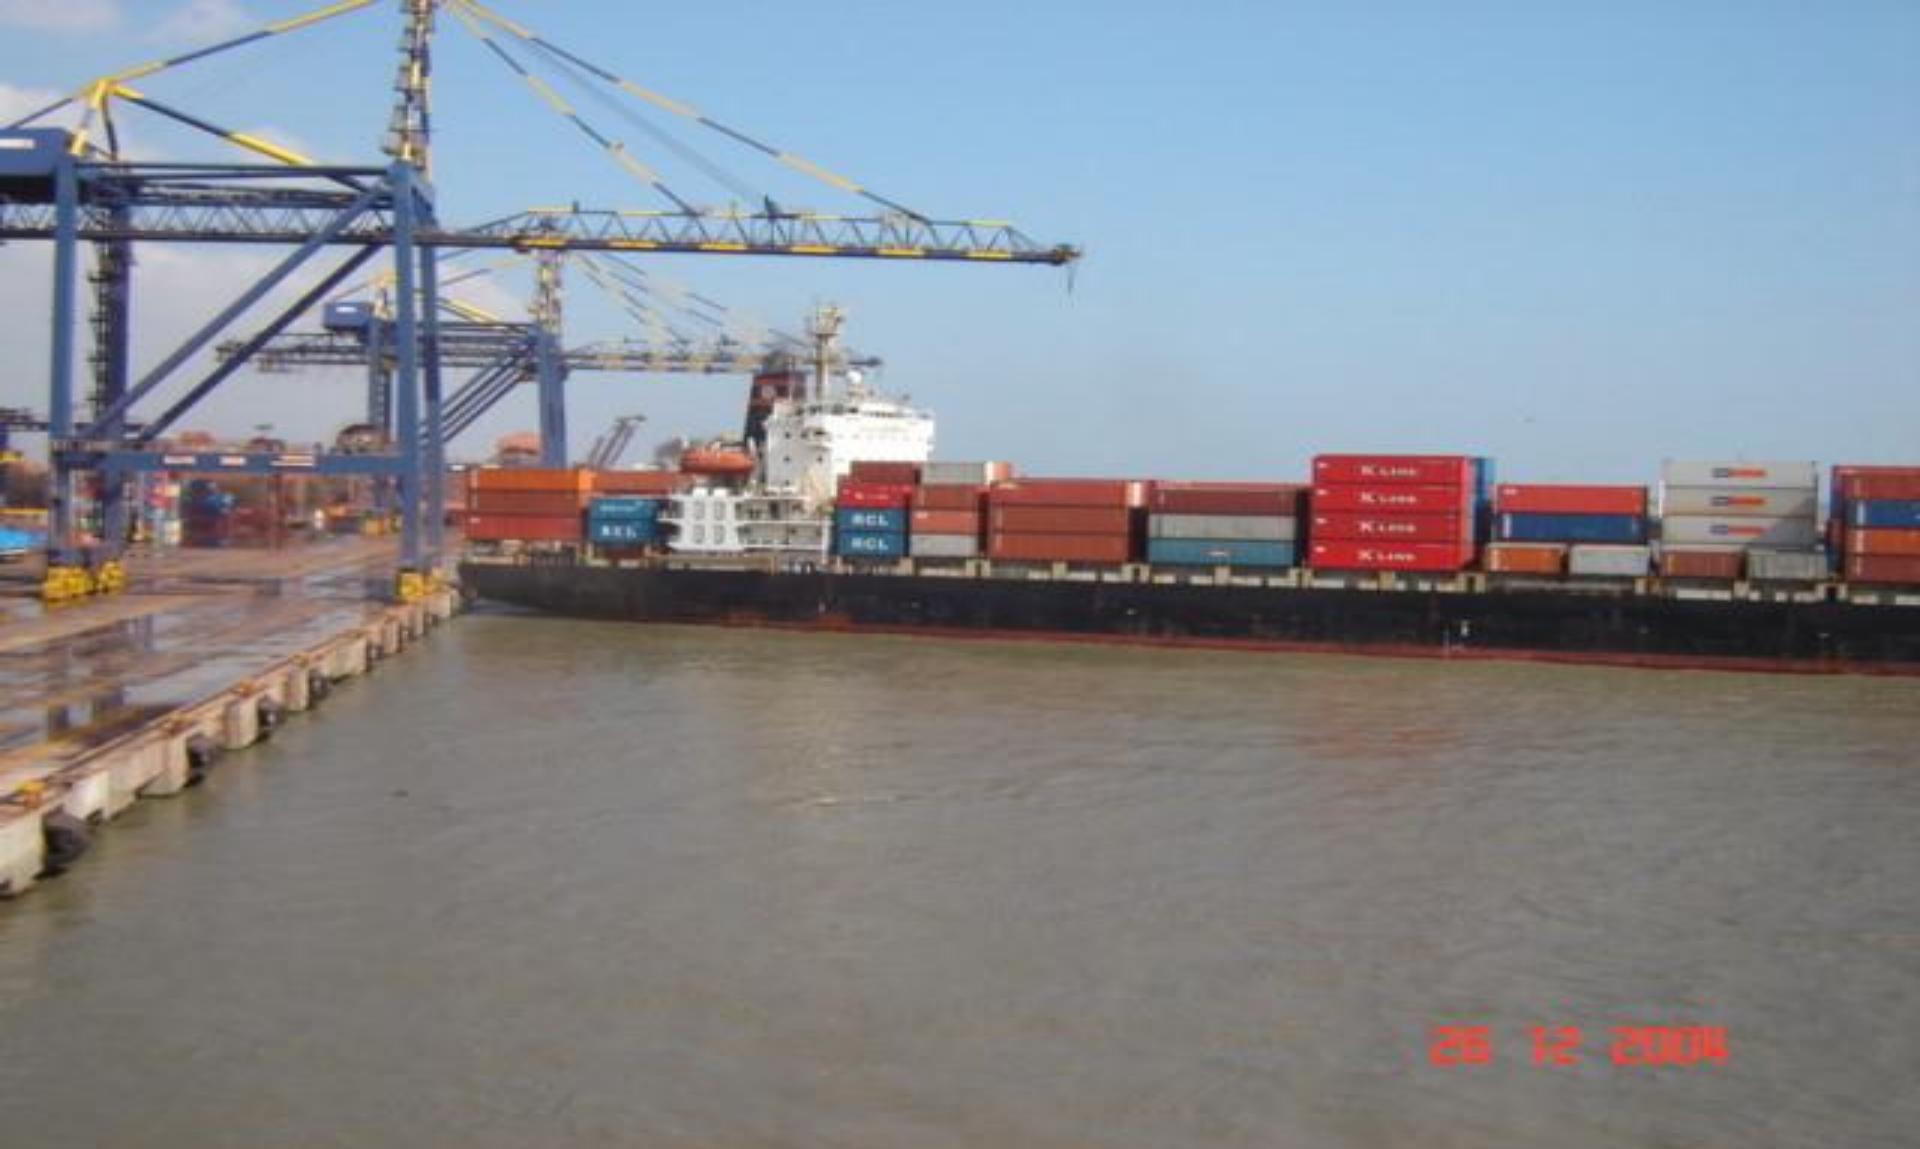
**Despite the broken mooring line and high water level, wharf structures suffered no damage.**
