# *Overview of Performance of Ports, Harbors, Infrastructures and Buildings in Sri Lanka and India*

*By Peter Yin, Port of Los Angeles  
ASCE-COPRI Reconnaissance Team Member*

*January 31- February 11, 2005*

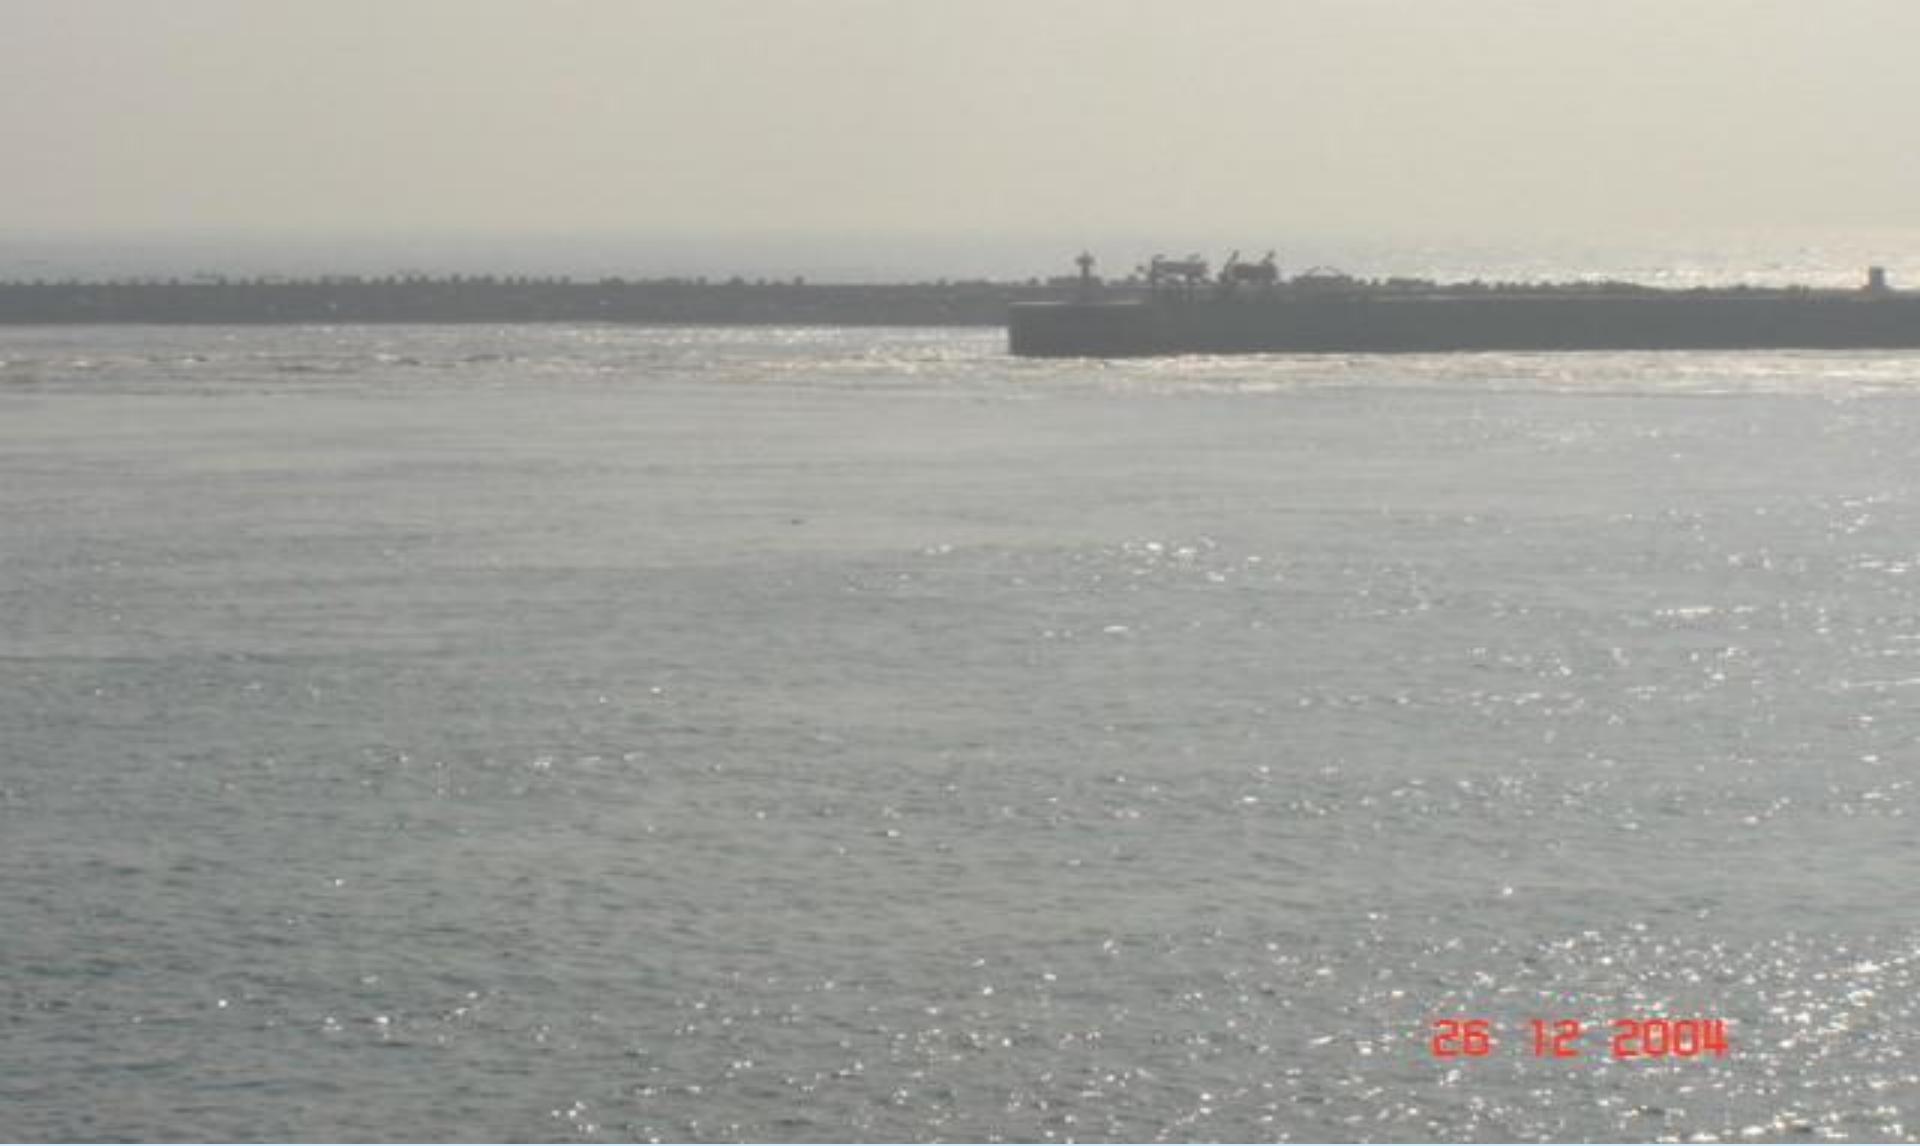
**Strong current is clearly visible inside the harbor.**

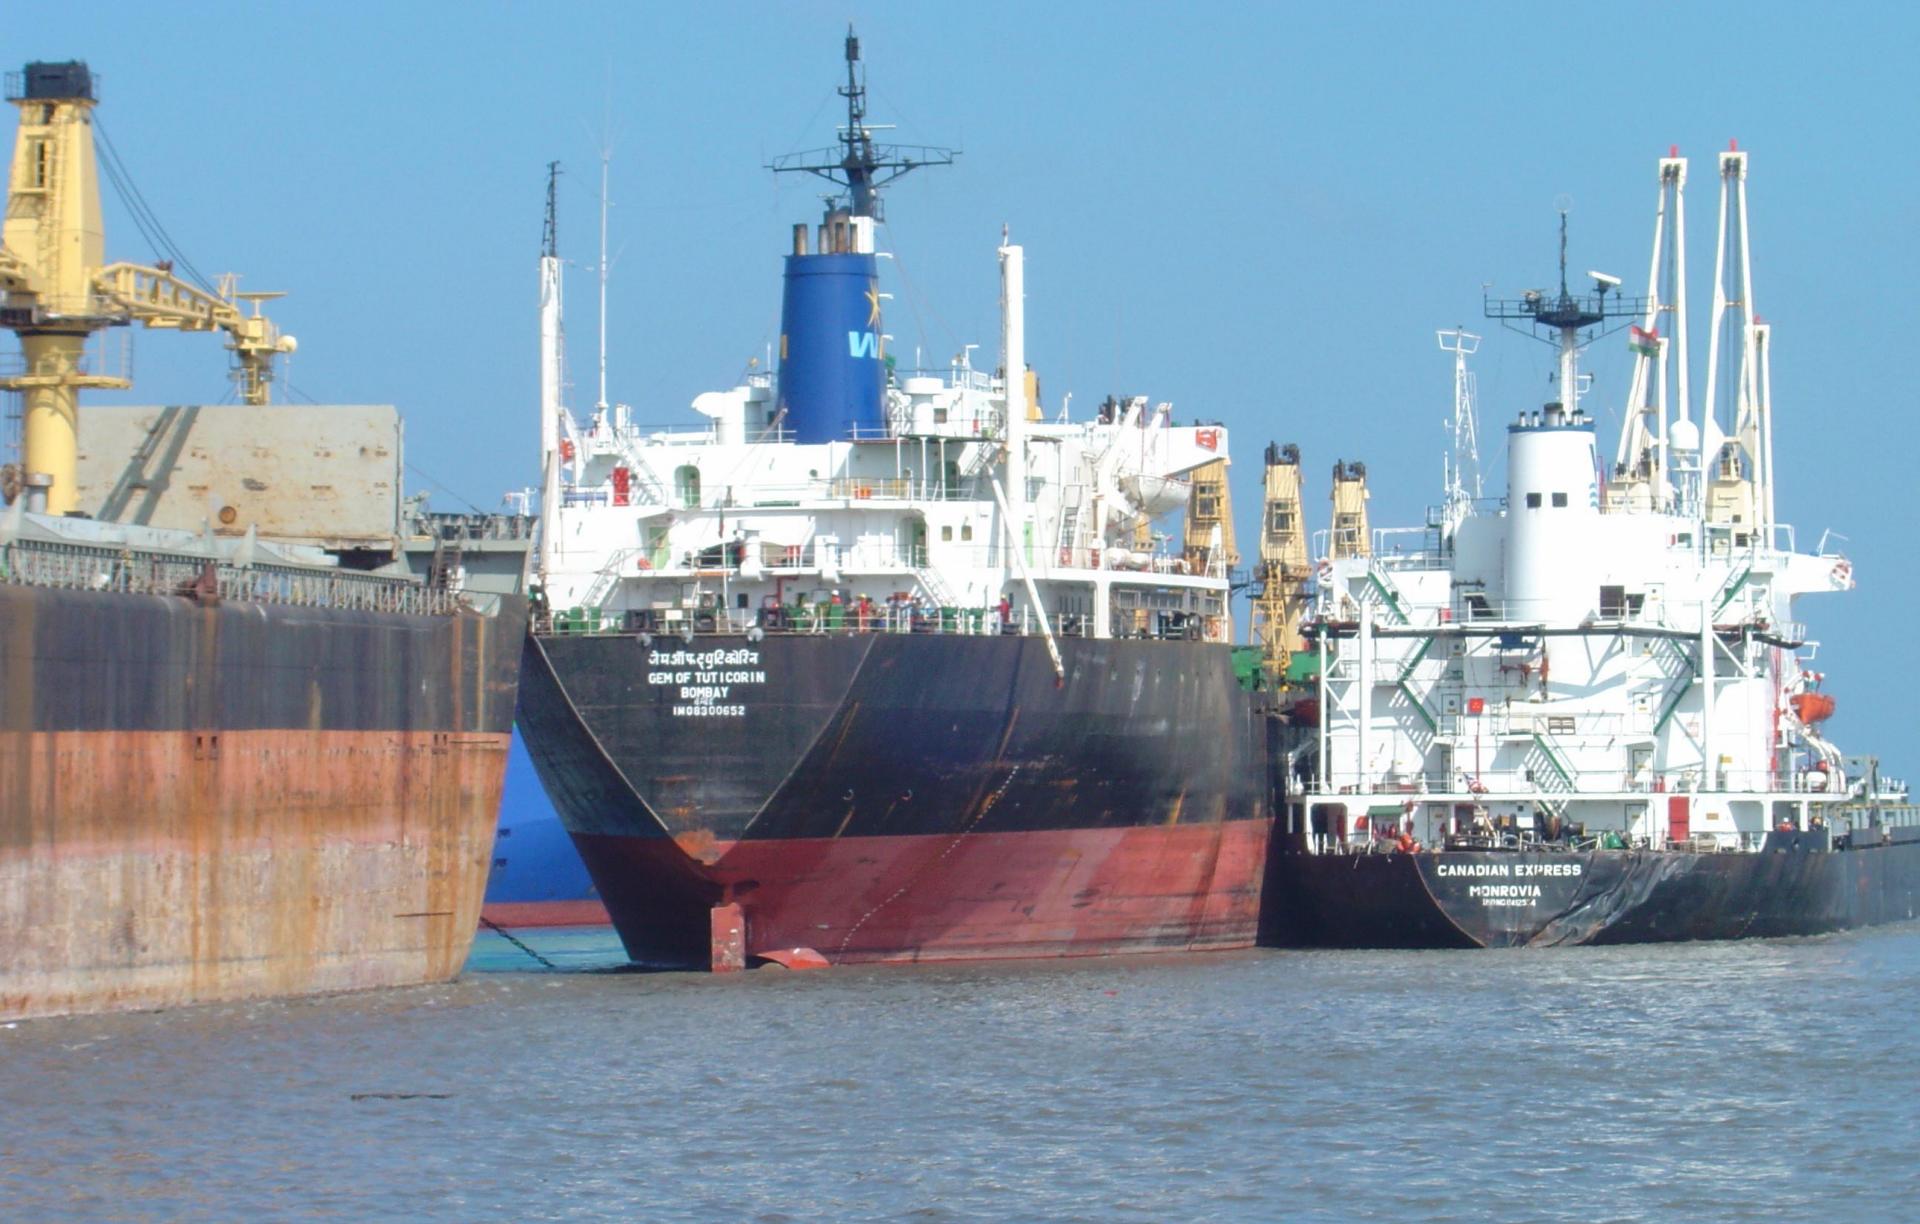
**Water current circled and swirled around these vessels inside the harbor.**

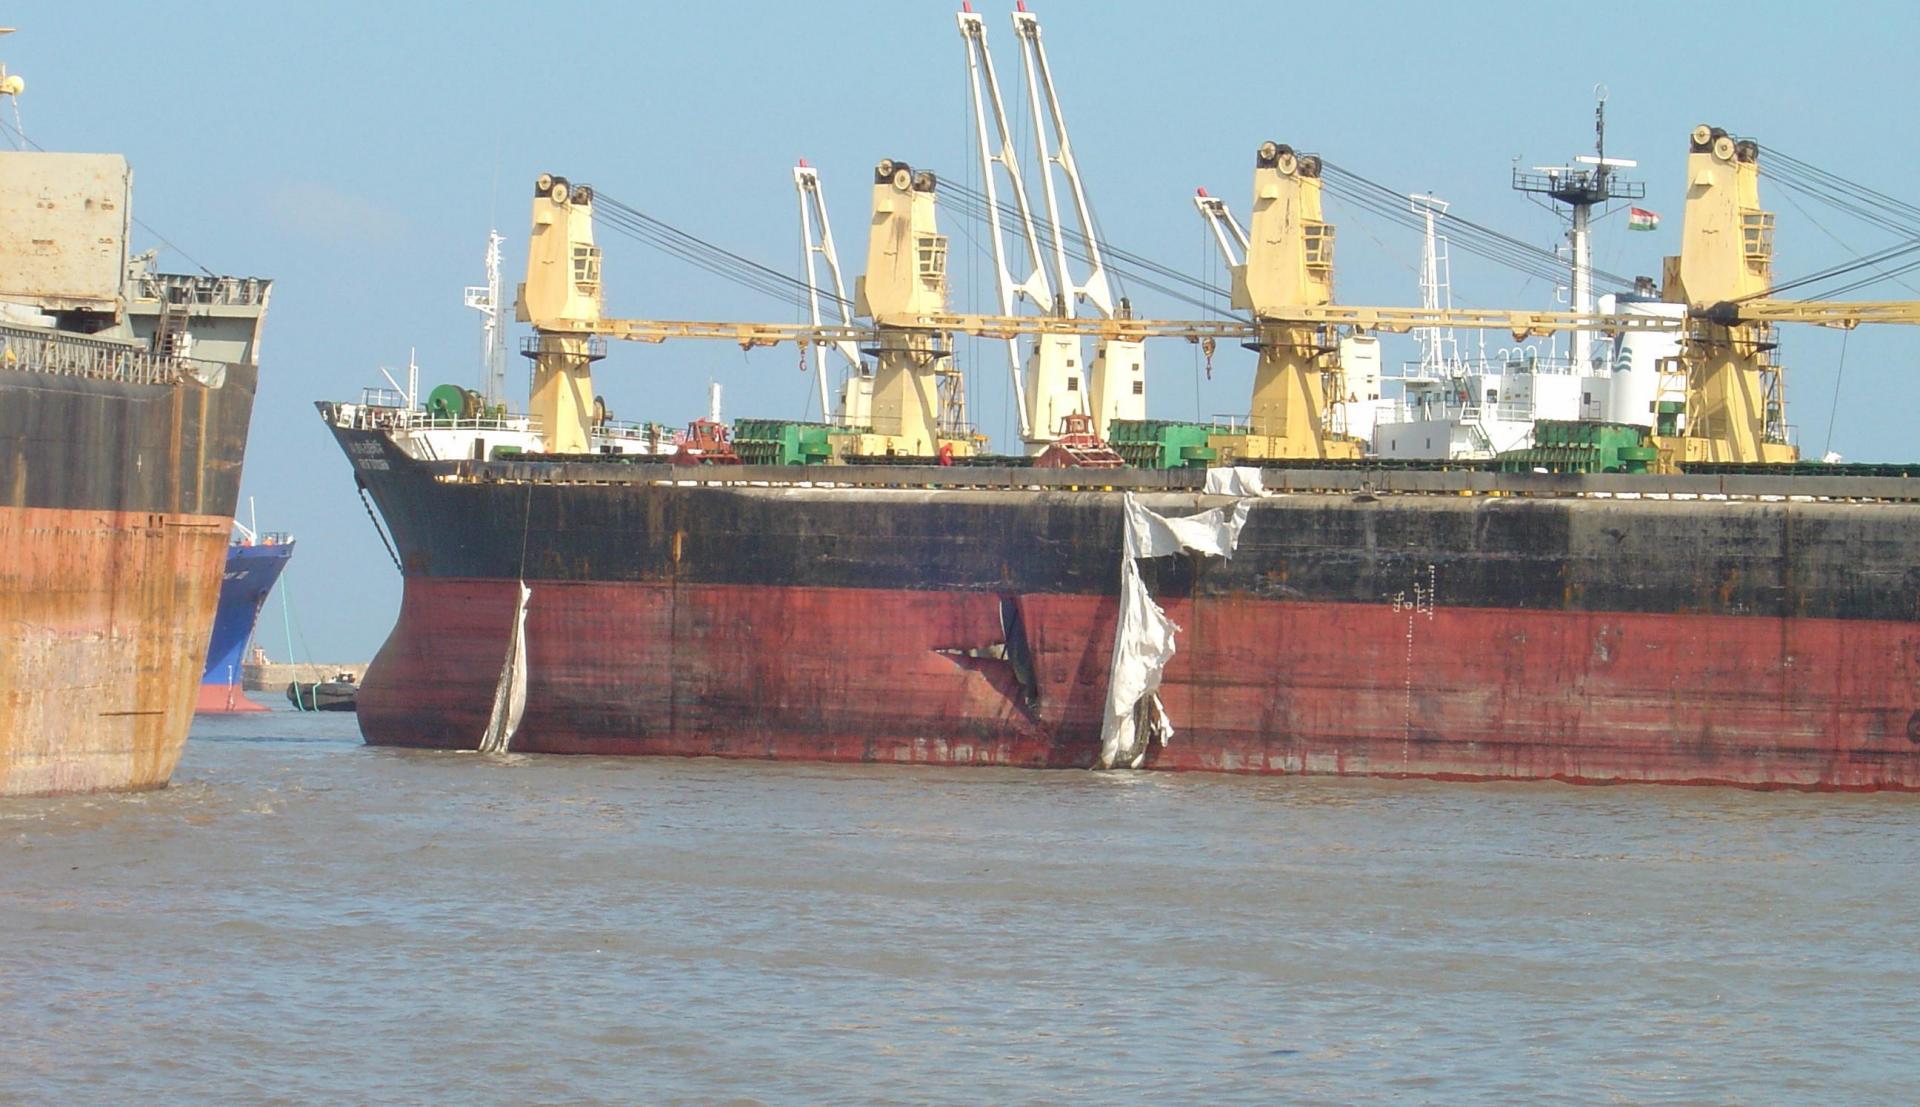
**Damages caused by collision of floating ship.**

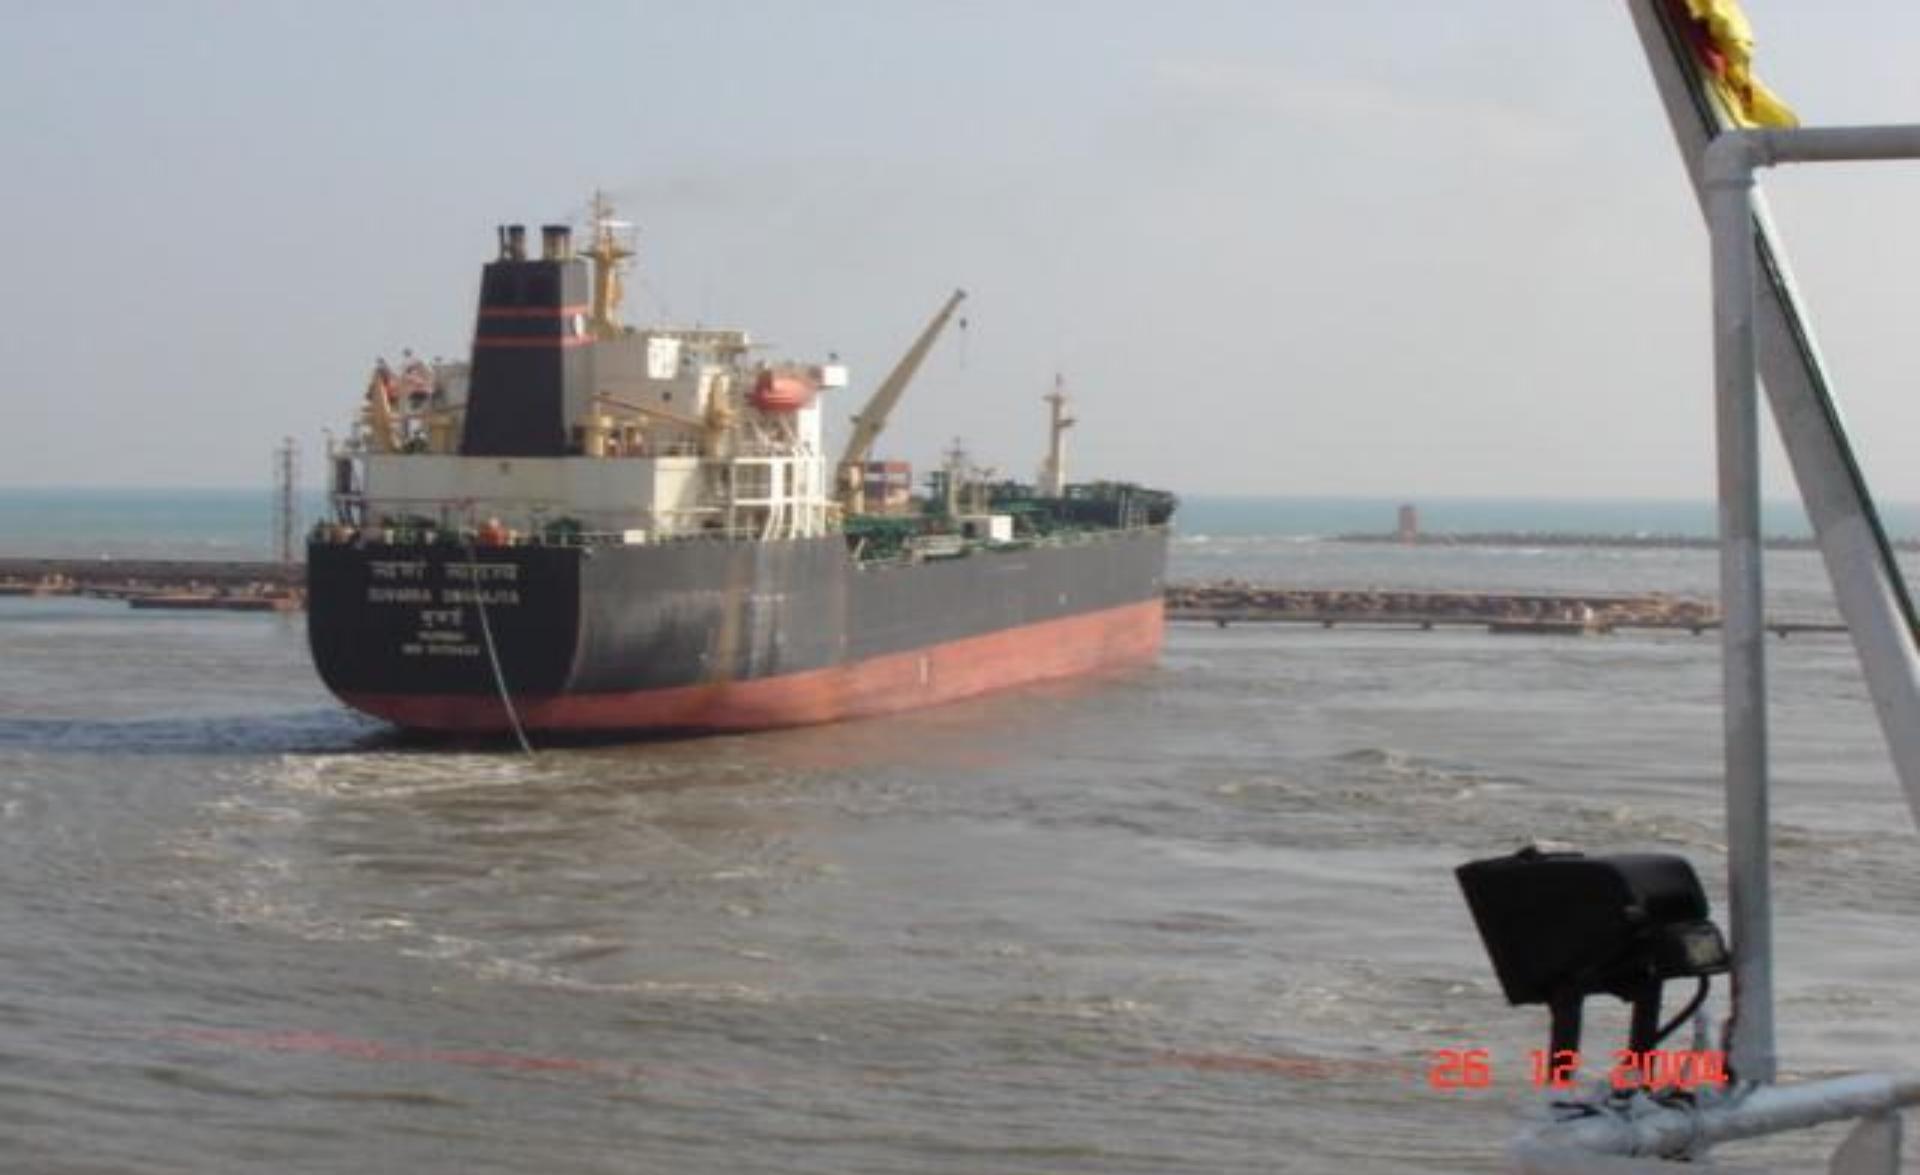
**Ship floating with the receding water. Broken mooring line is visible.**

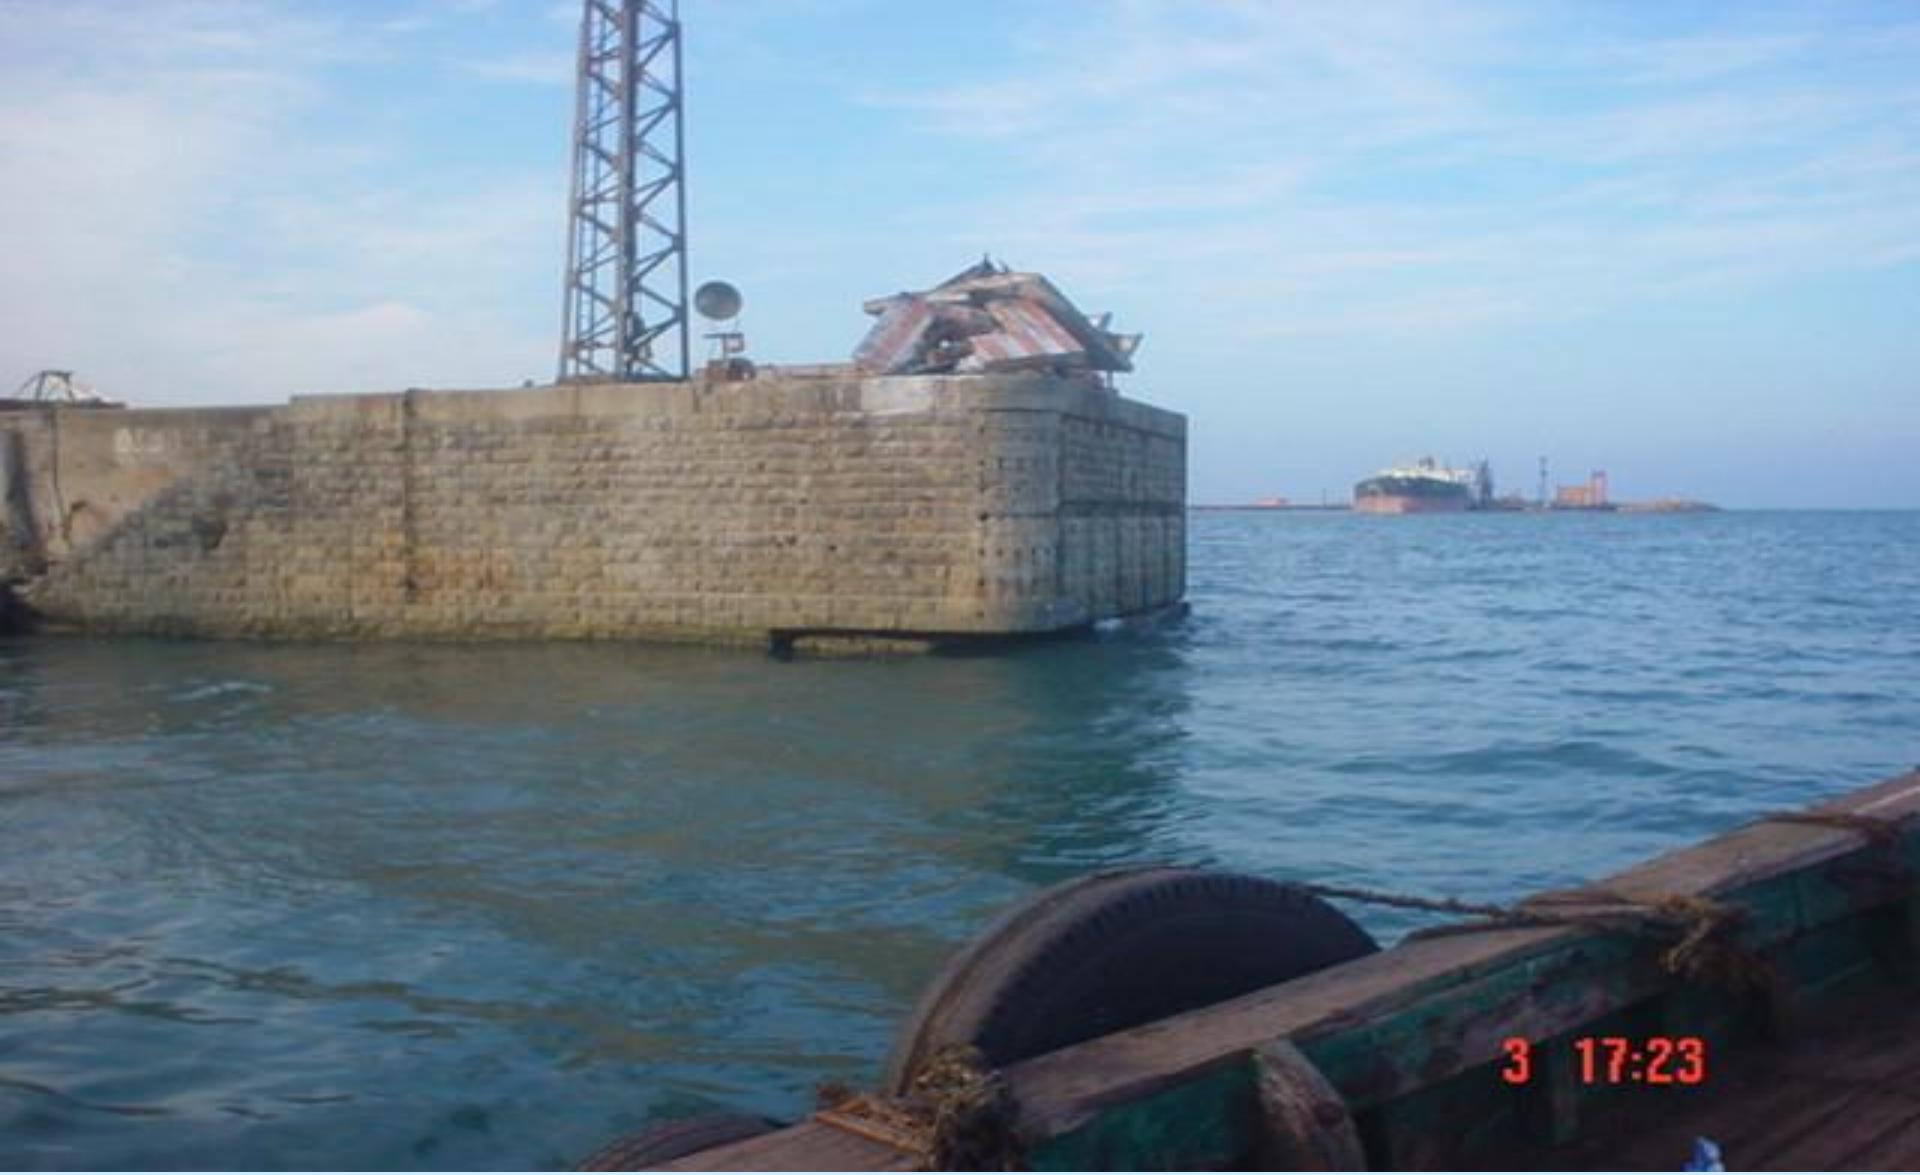
**Receding water scoured the foundation, and deepened the channel by several feet.**

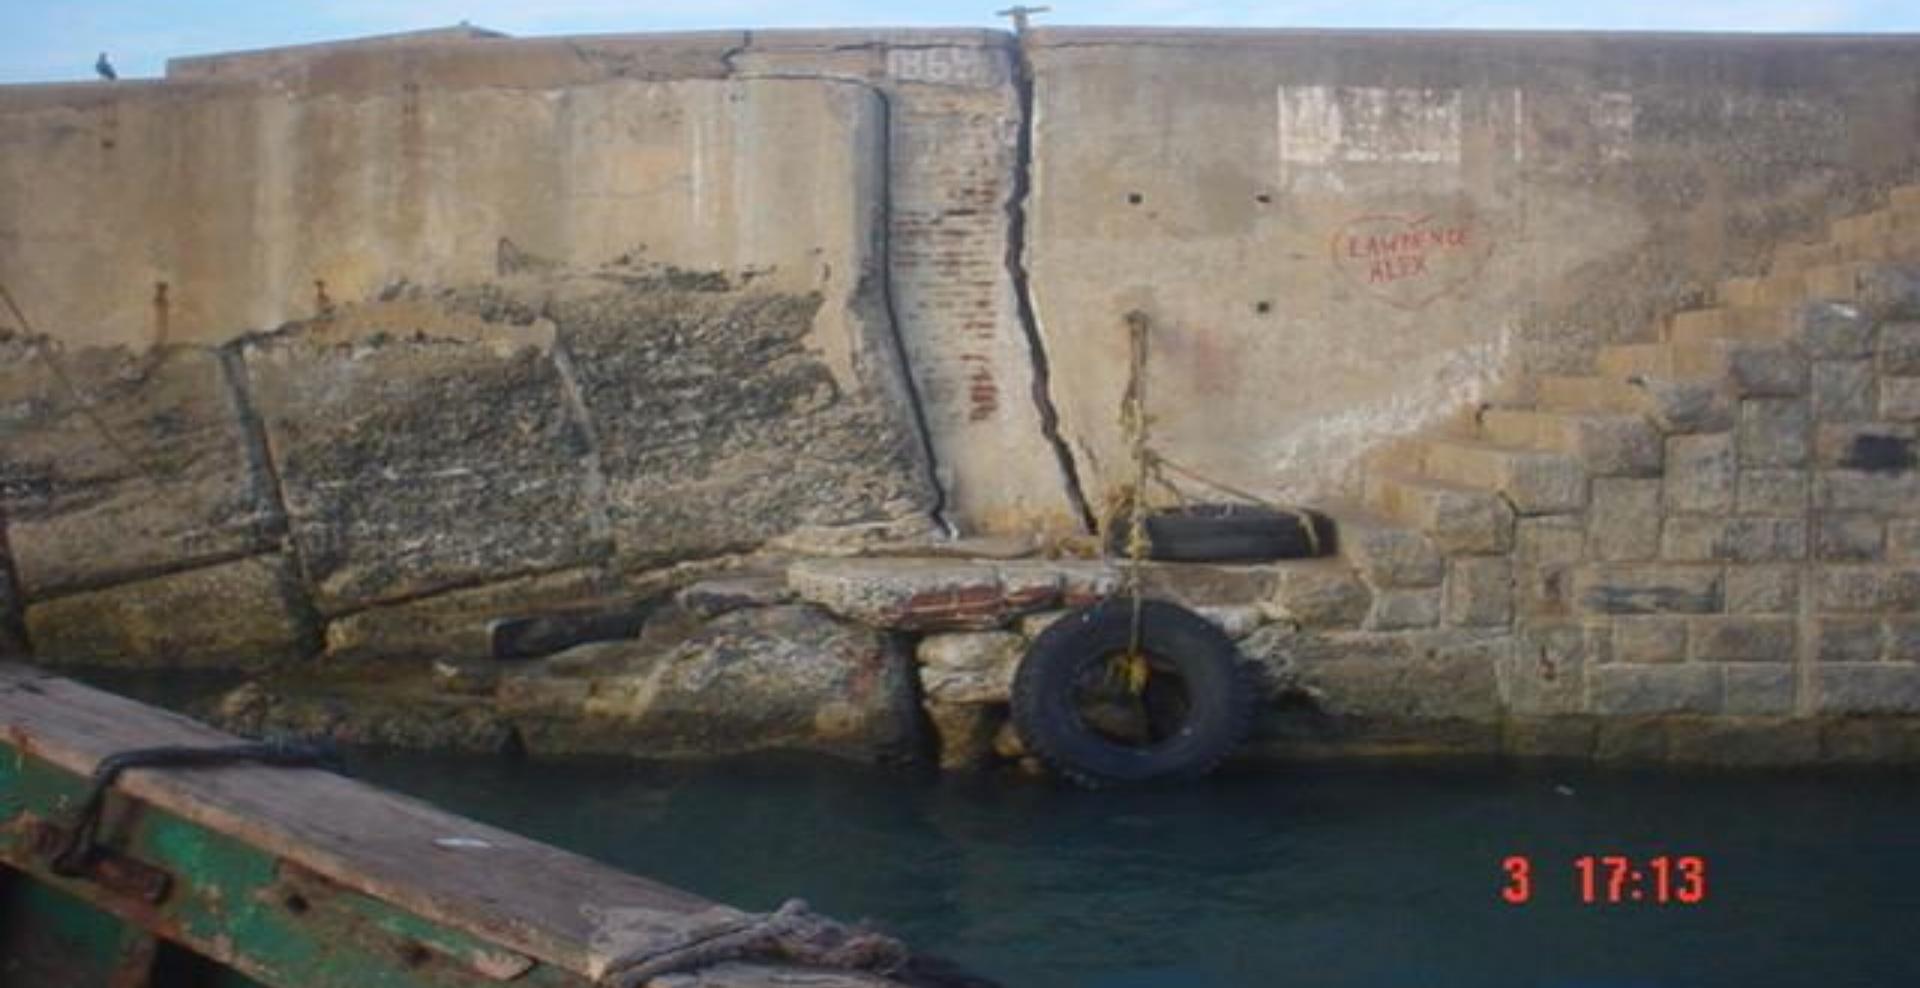
Pier settlement due to scouring.

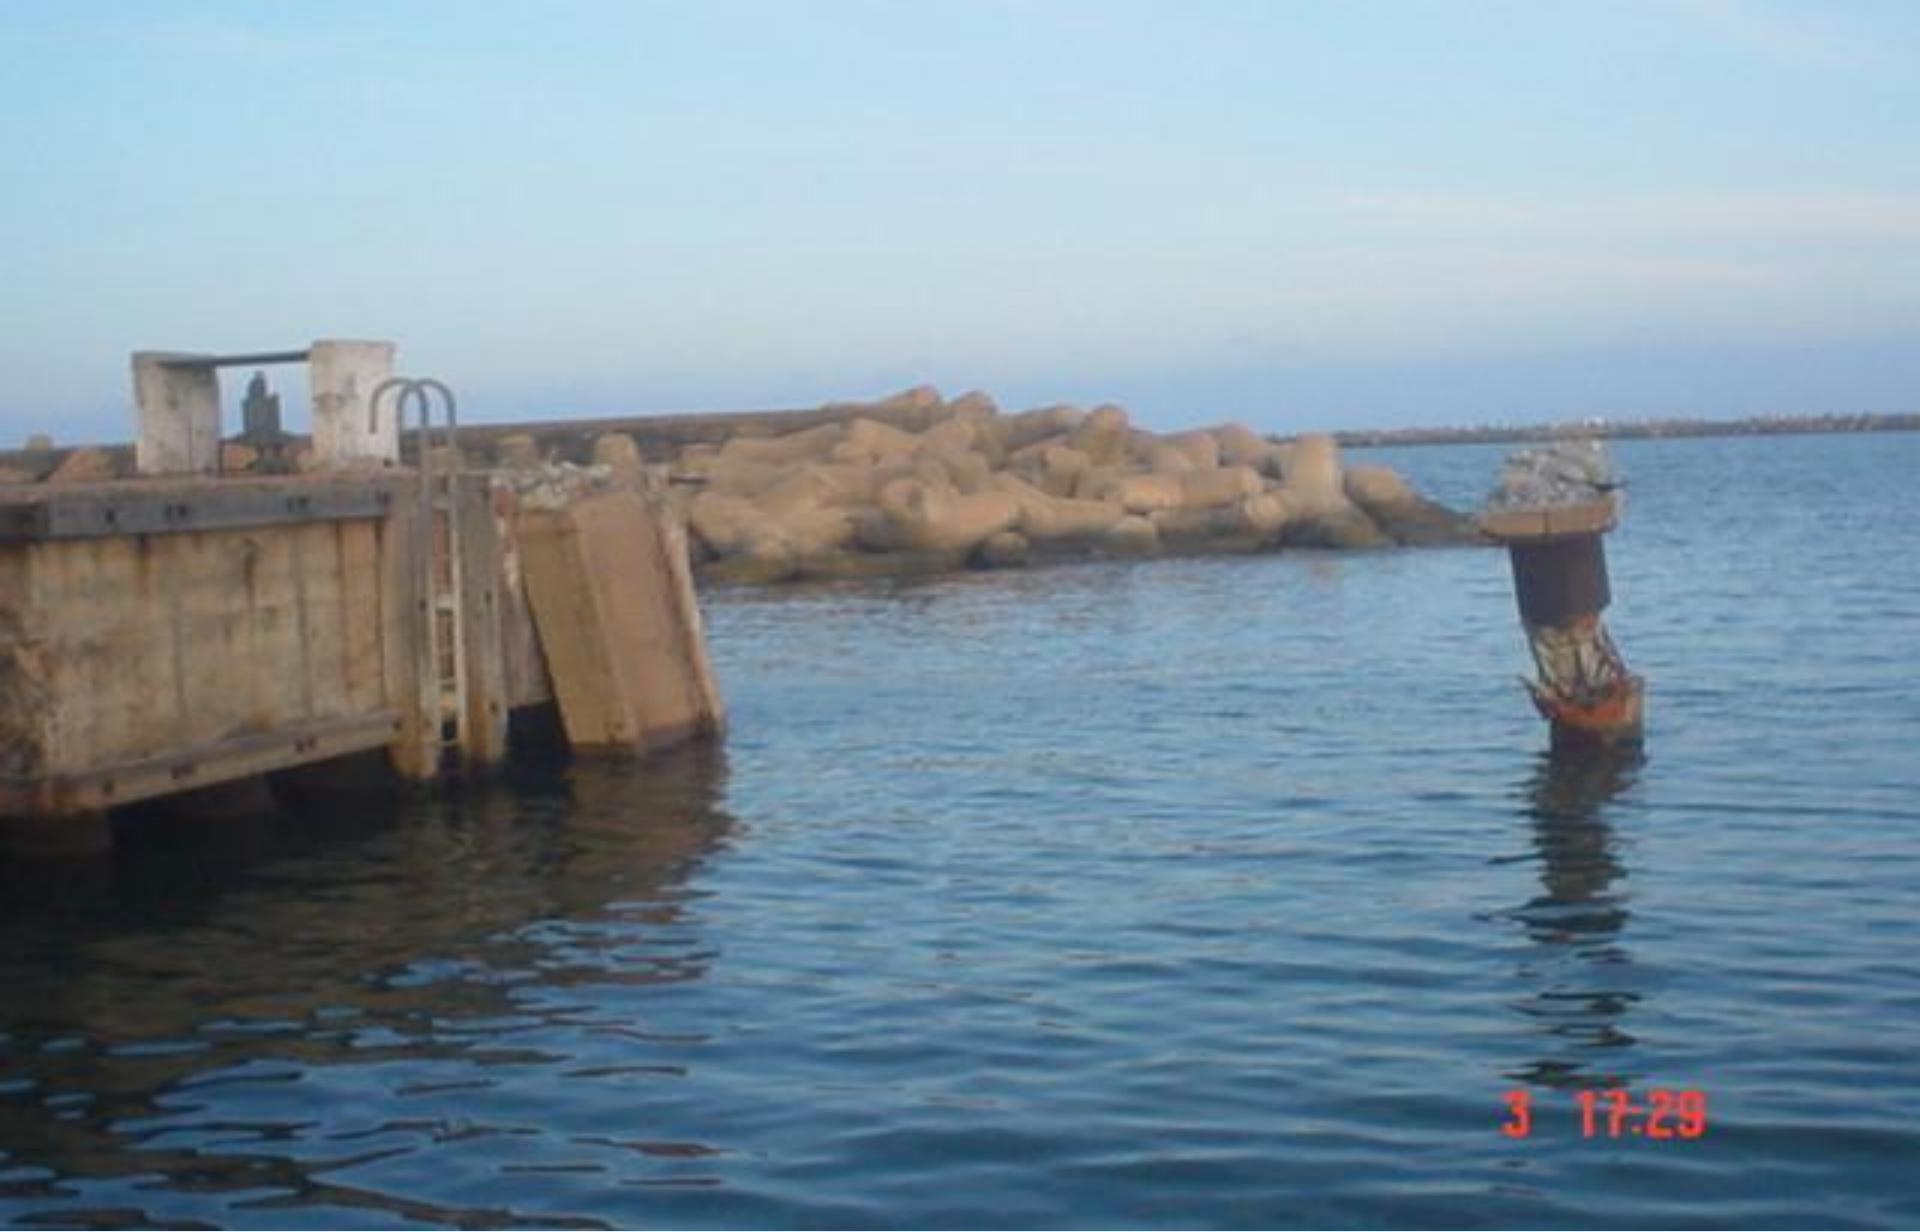
**Catwalk and dolphin were knocked out by floating vessel.**

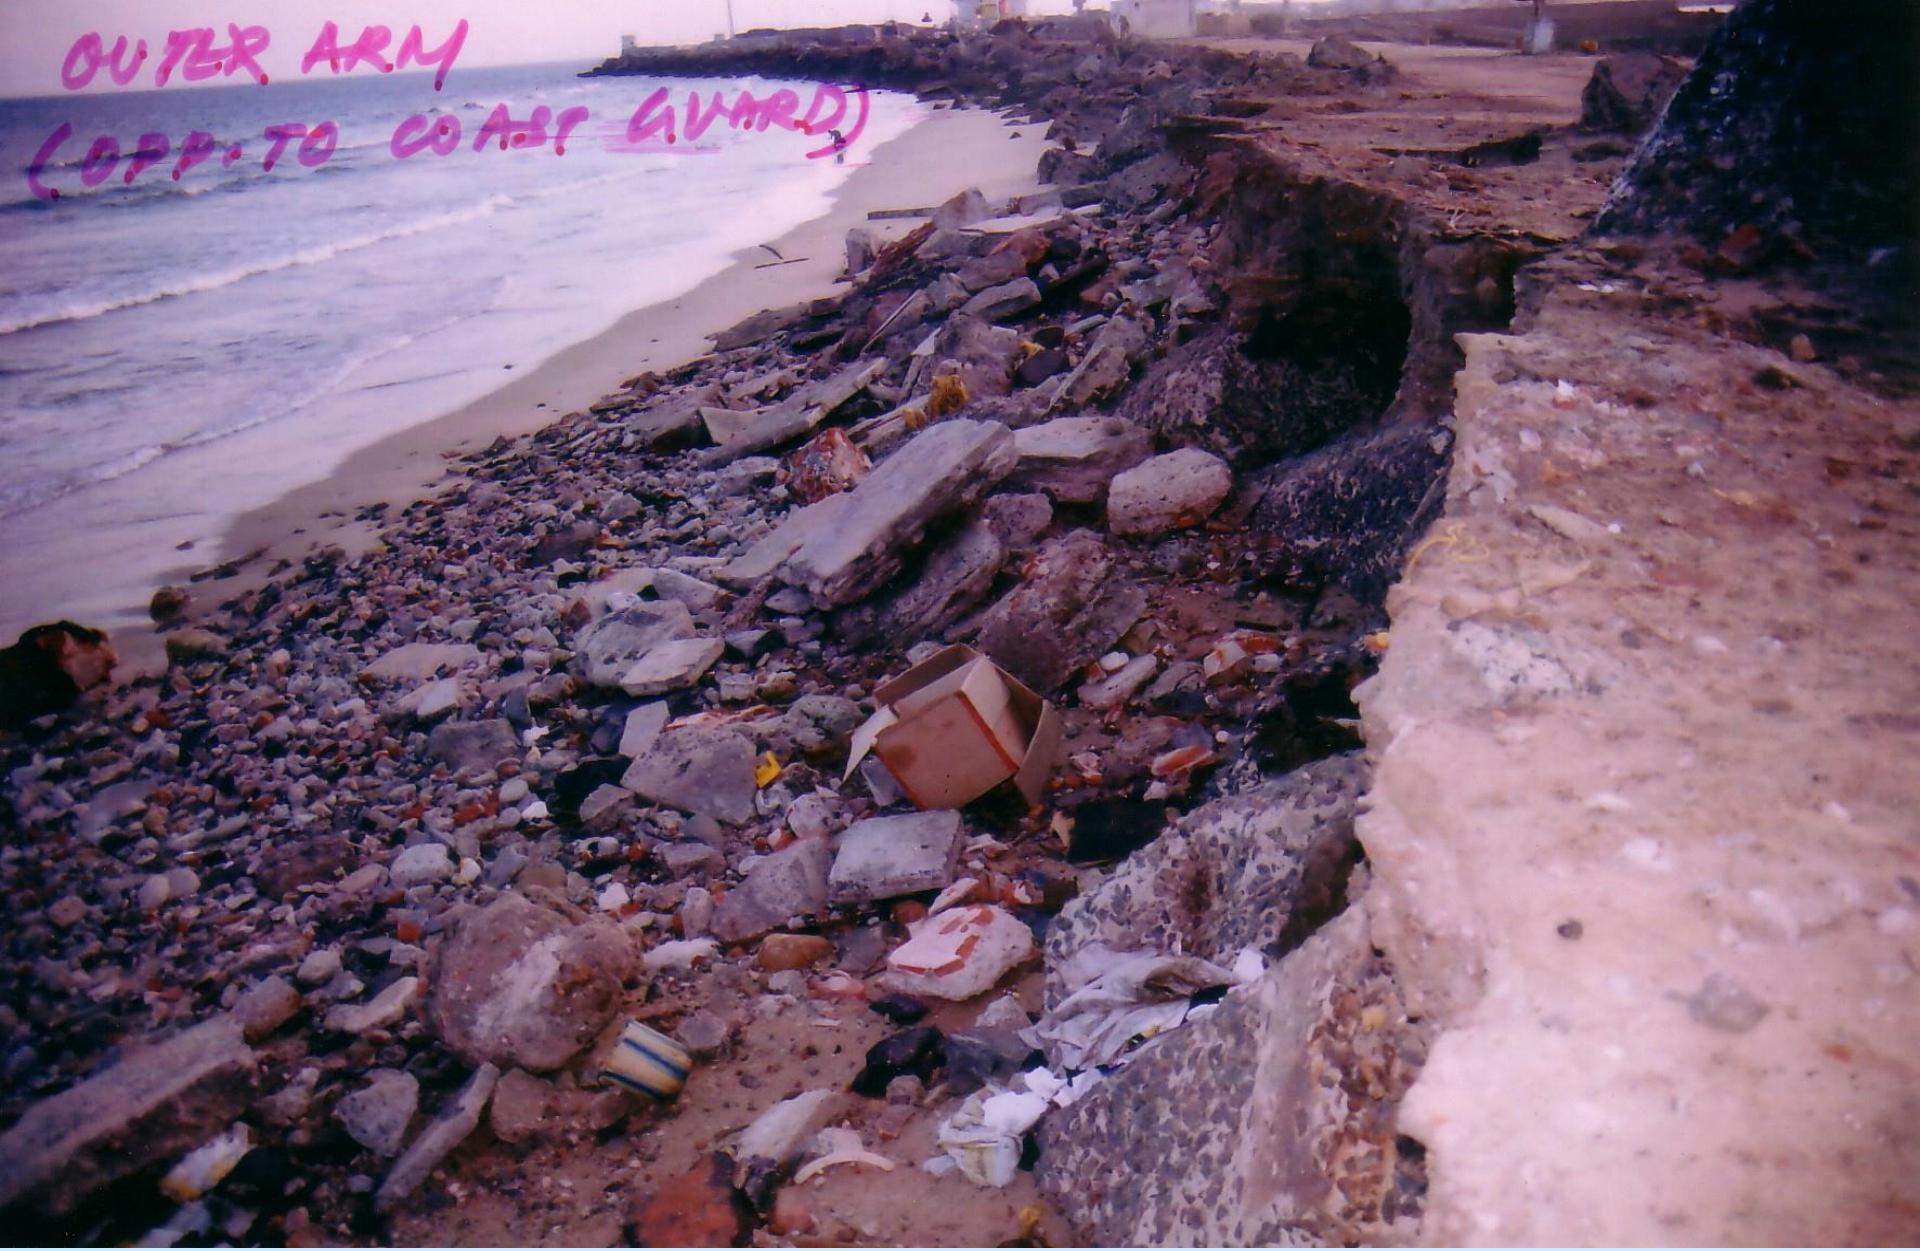
OUTER ARM  
(OPP. TO COAST GUARD)

Most damages on breakwater occurred at the inner side.

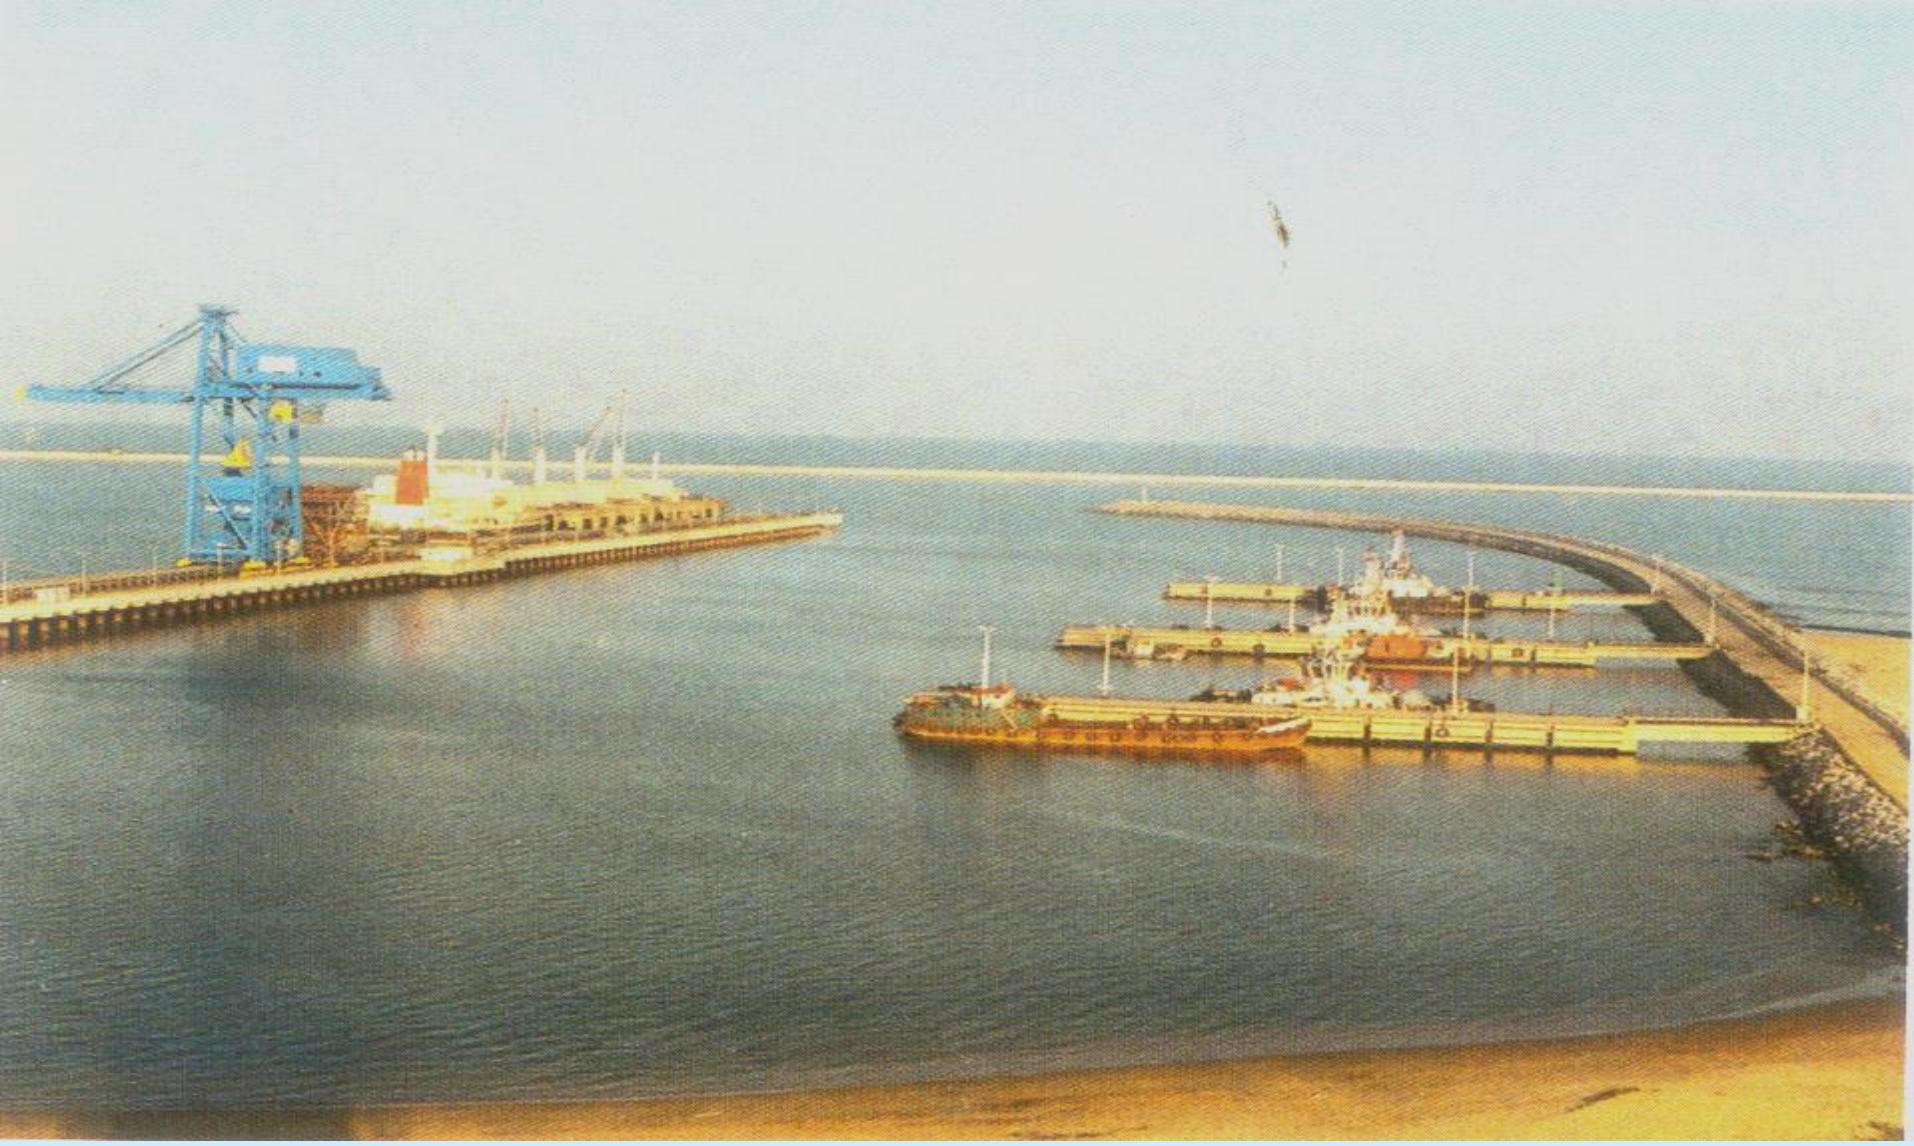
**Ennore, the Port for energy, located 24 km north of Chennai.**

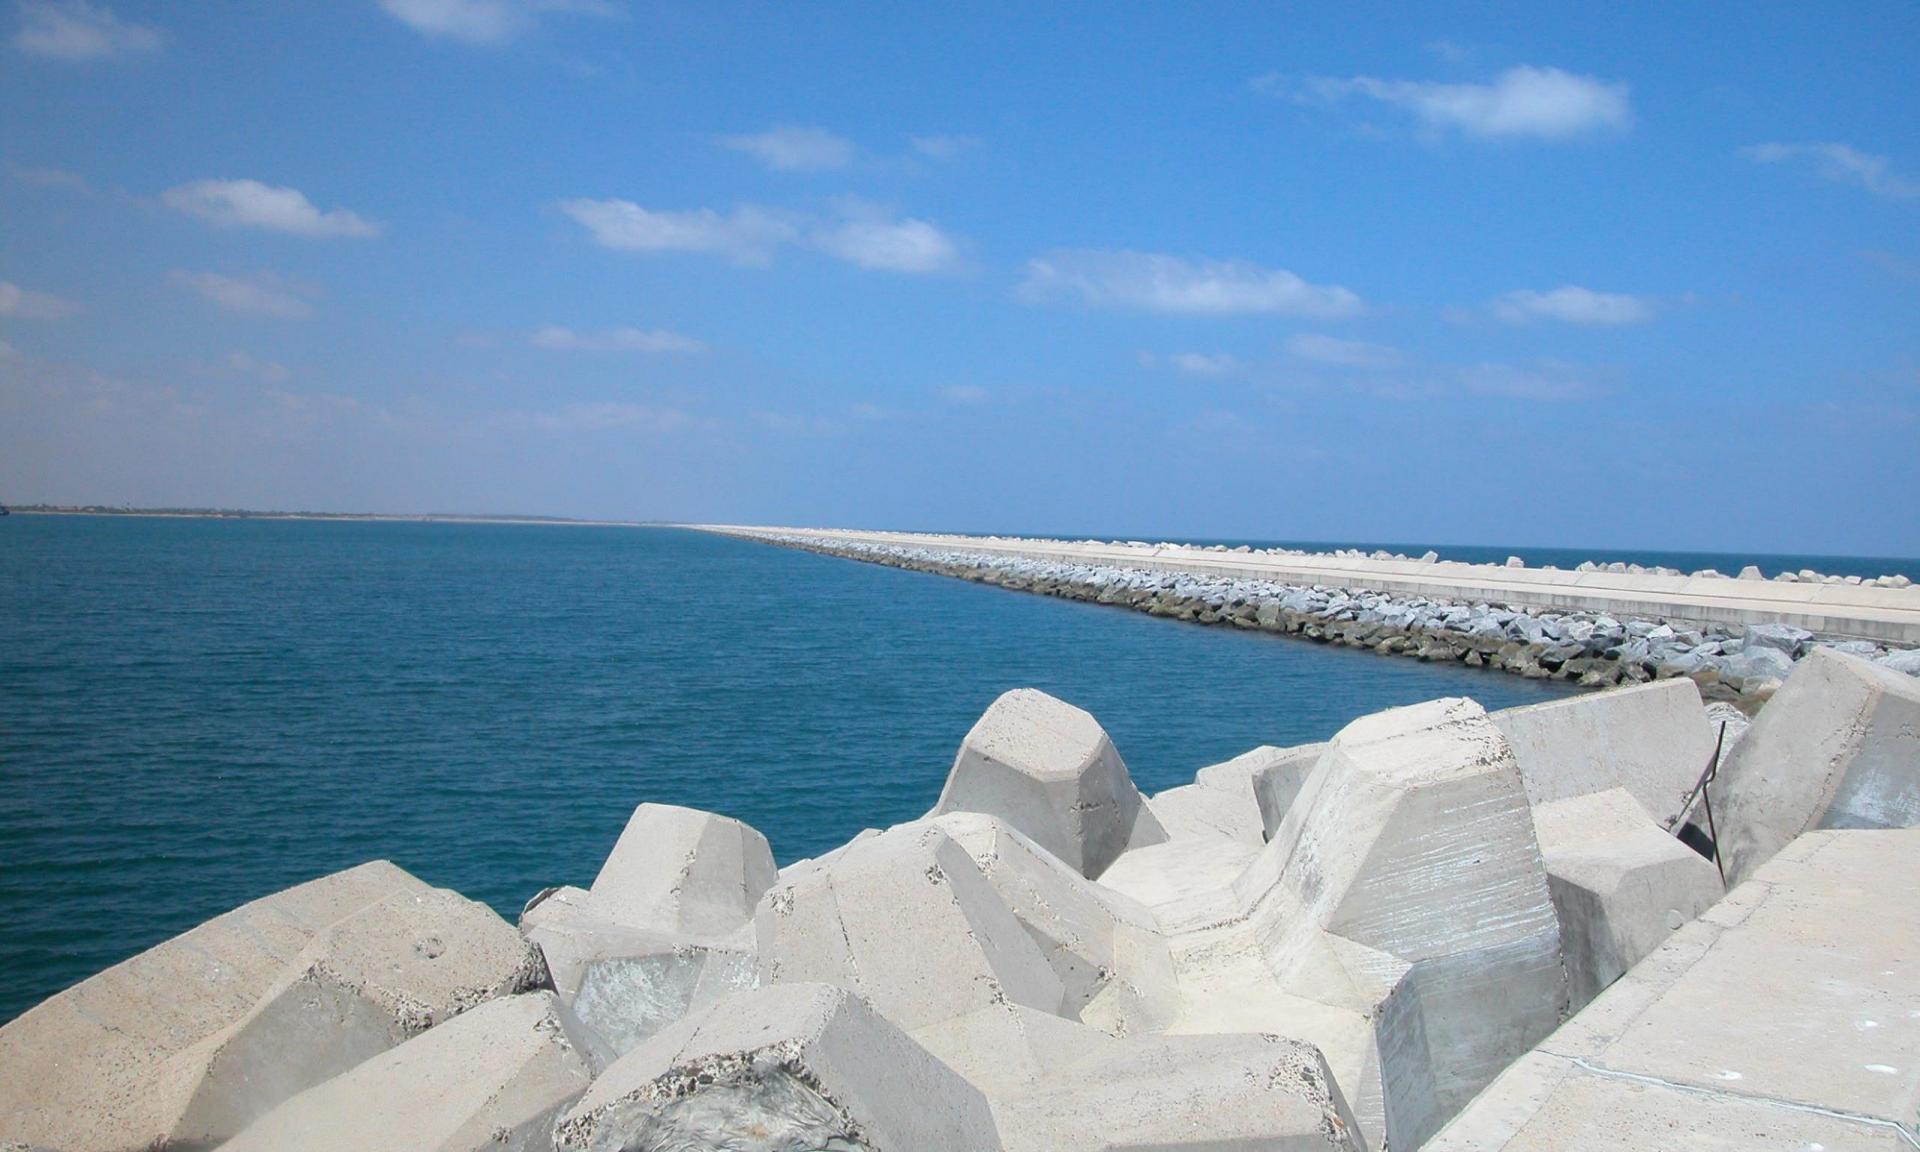
**Breakwater shows no damage.**
