# *Overview of Performance of Ports, Harbors, Infrastructures and Buildings in Sri Lanka and India*

*By Peter Yin, Port of Los Angeles  
ASCE-COPRI Reconnaissance Team Member*

*January 31- February 11, 2005*

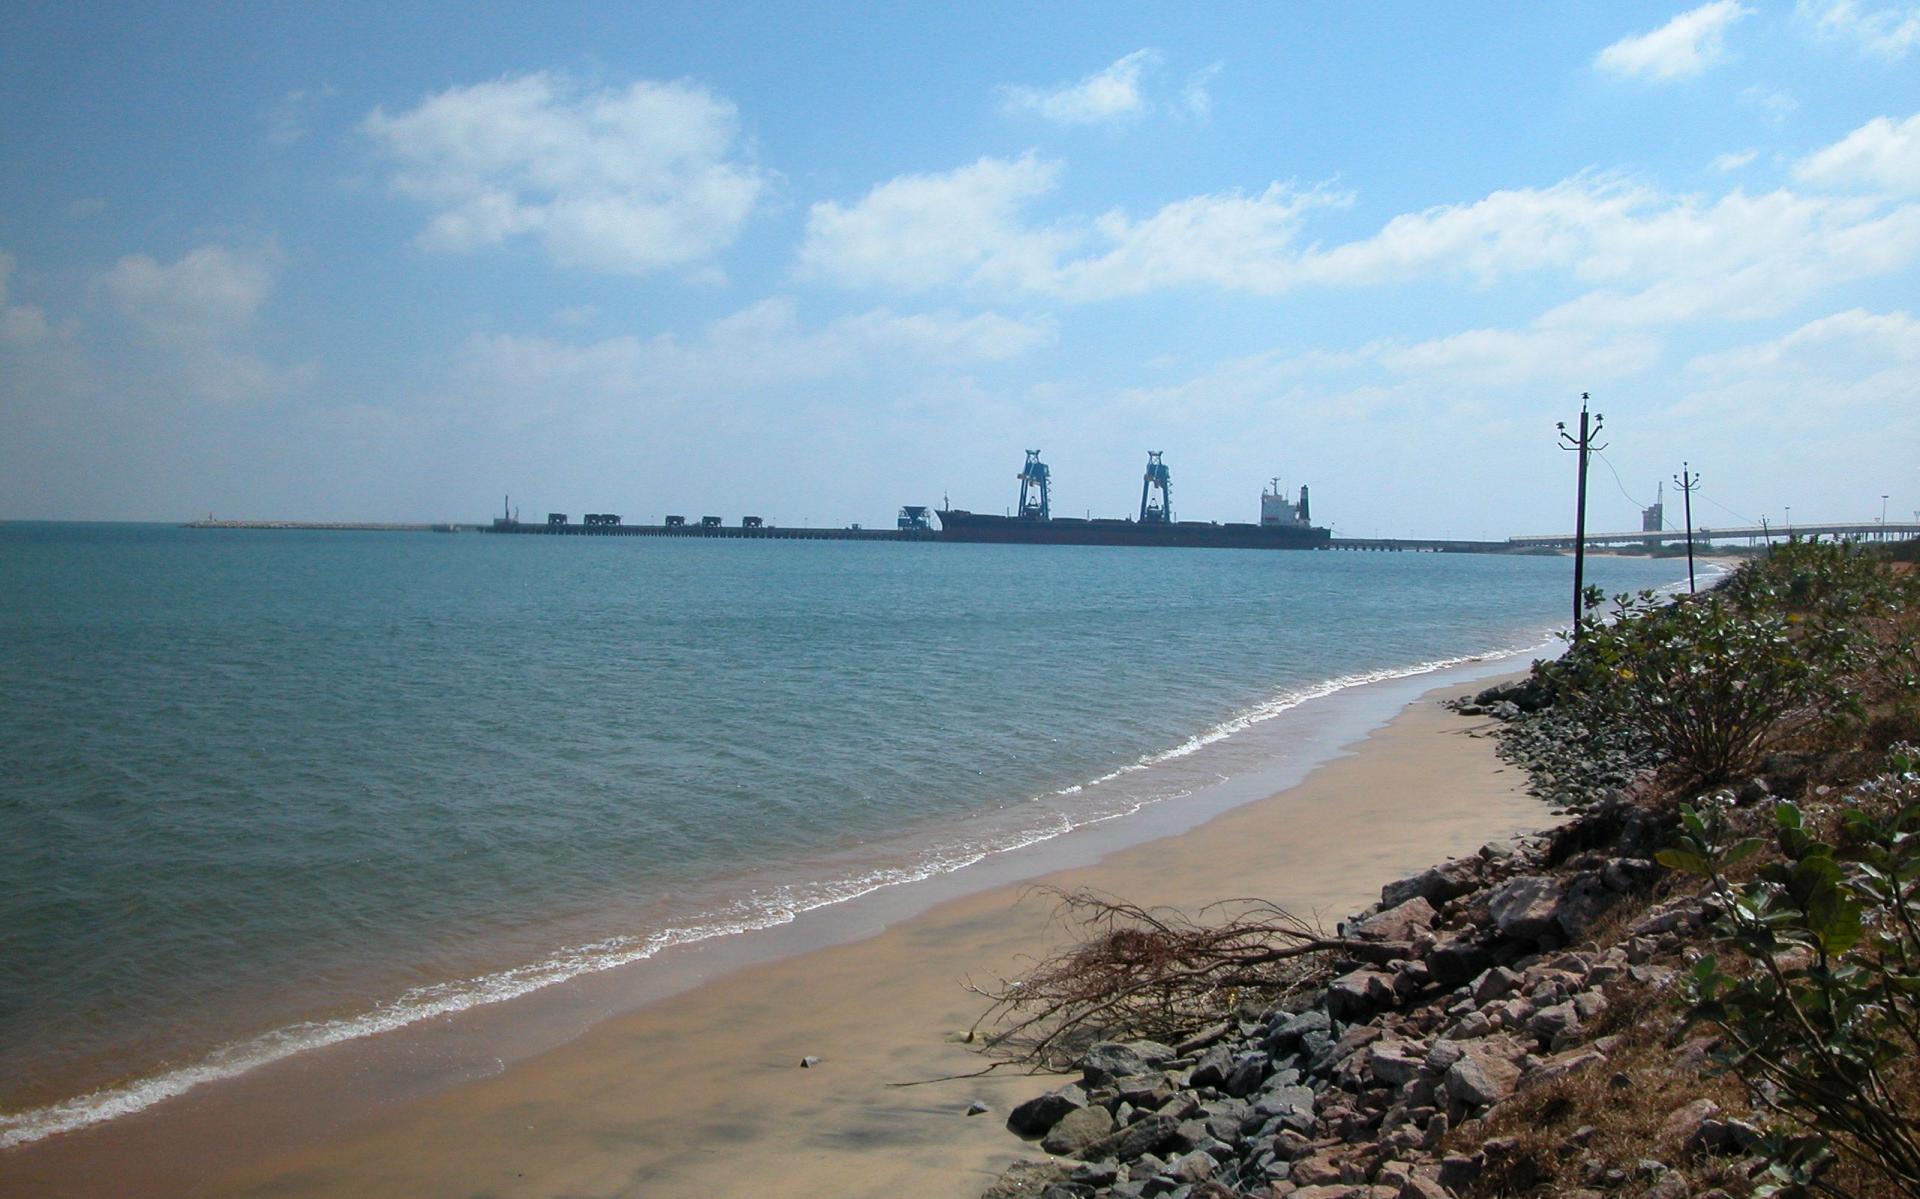
**Port staff was well prepared when Tsunami threat was noticed.**

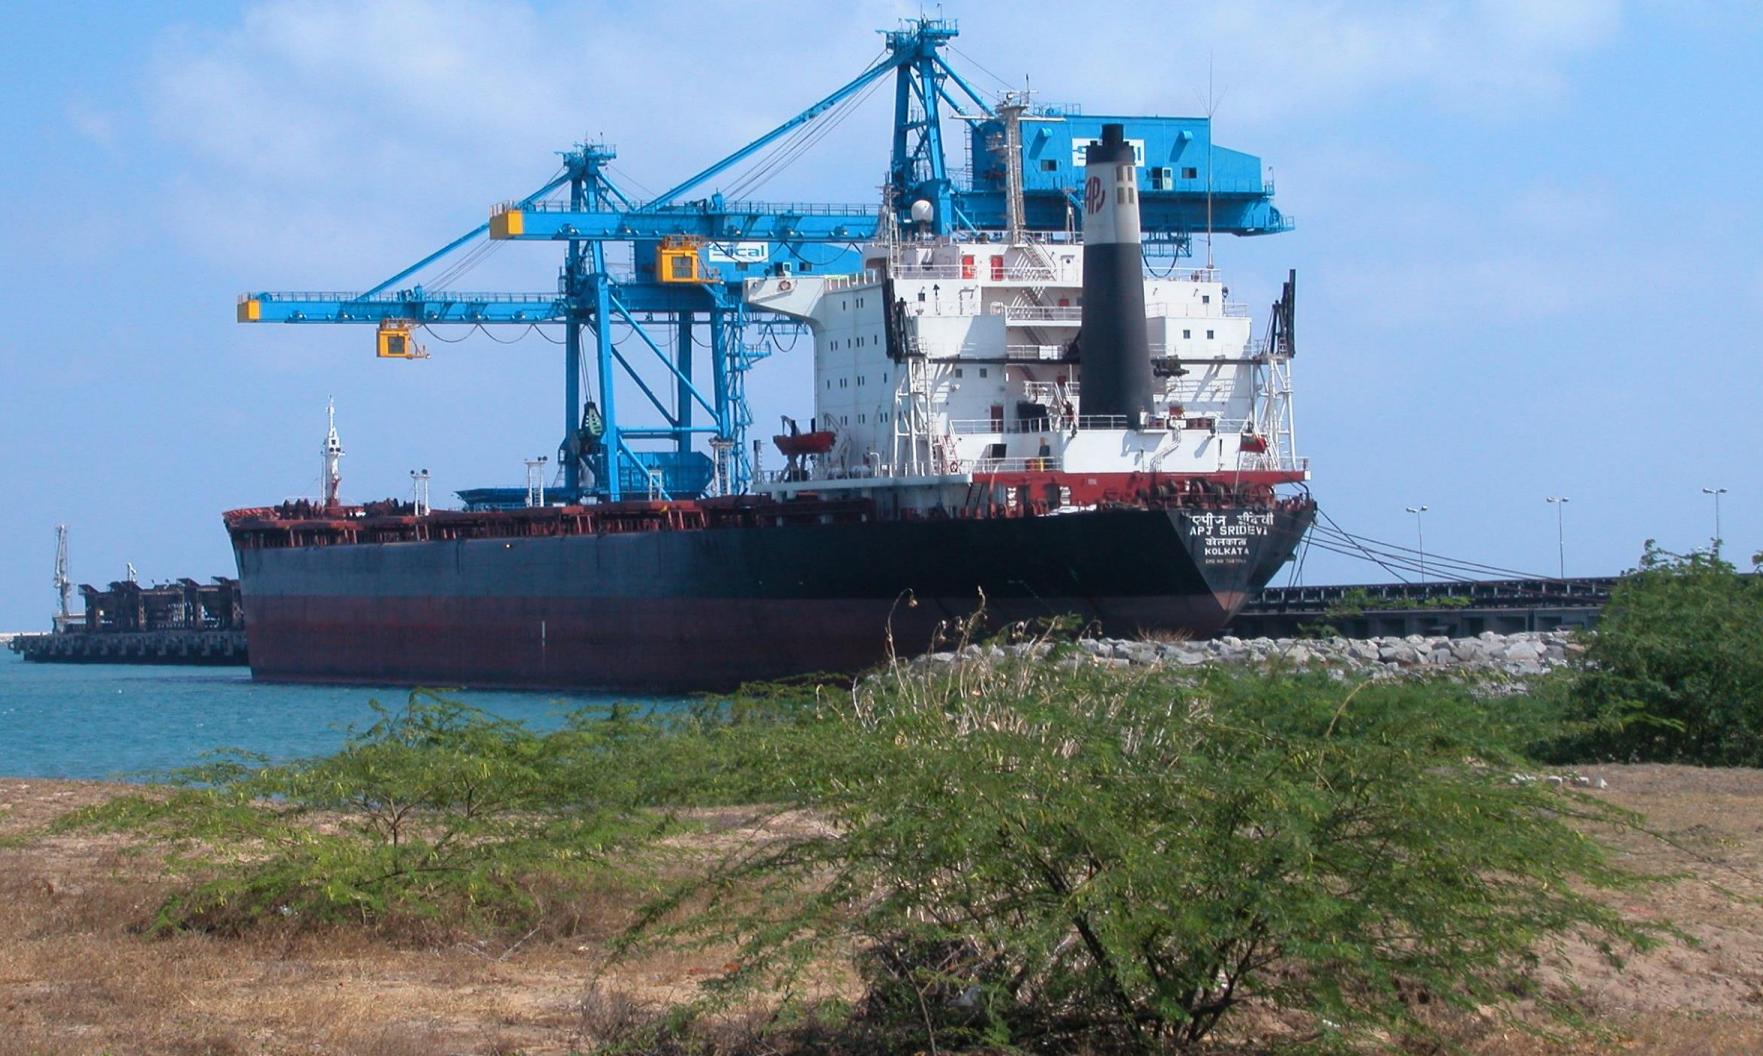
**Tug boats were used effectively to keep the ship from floating around the harbor.**

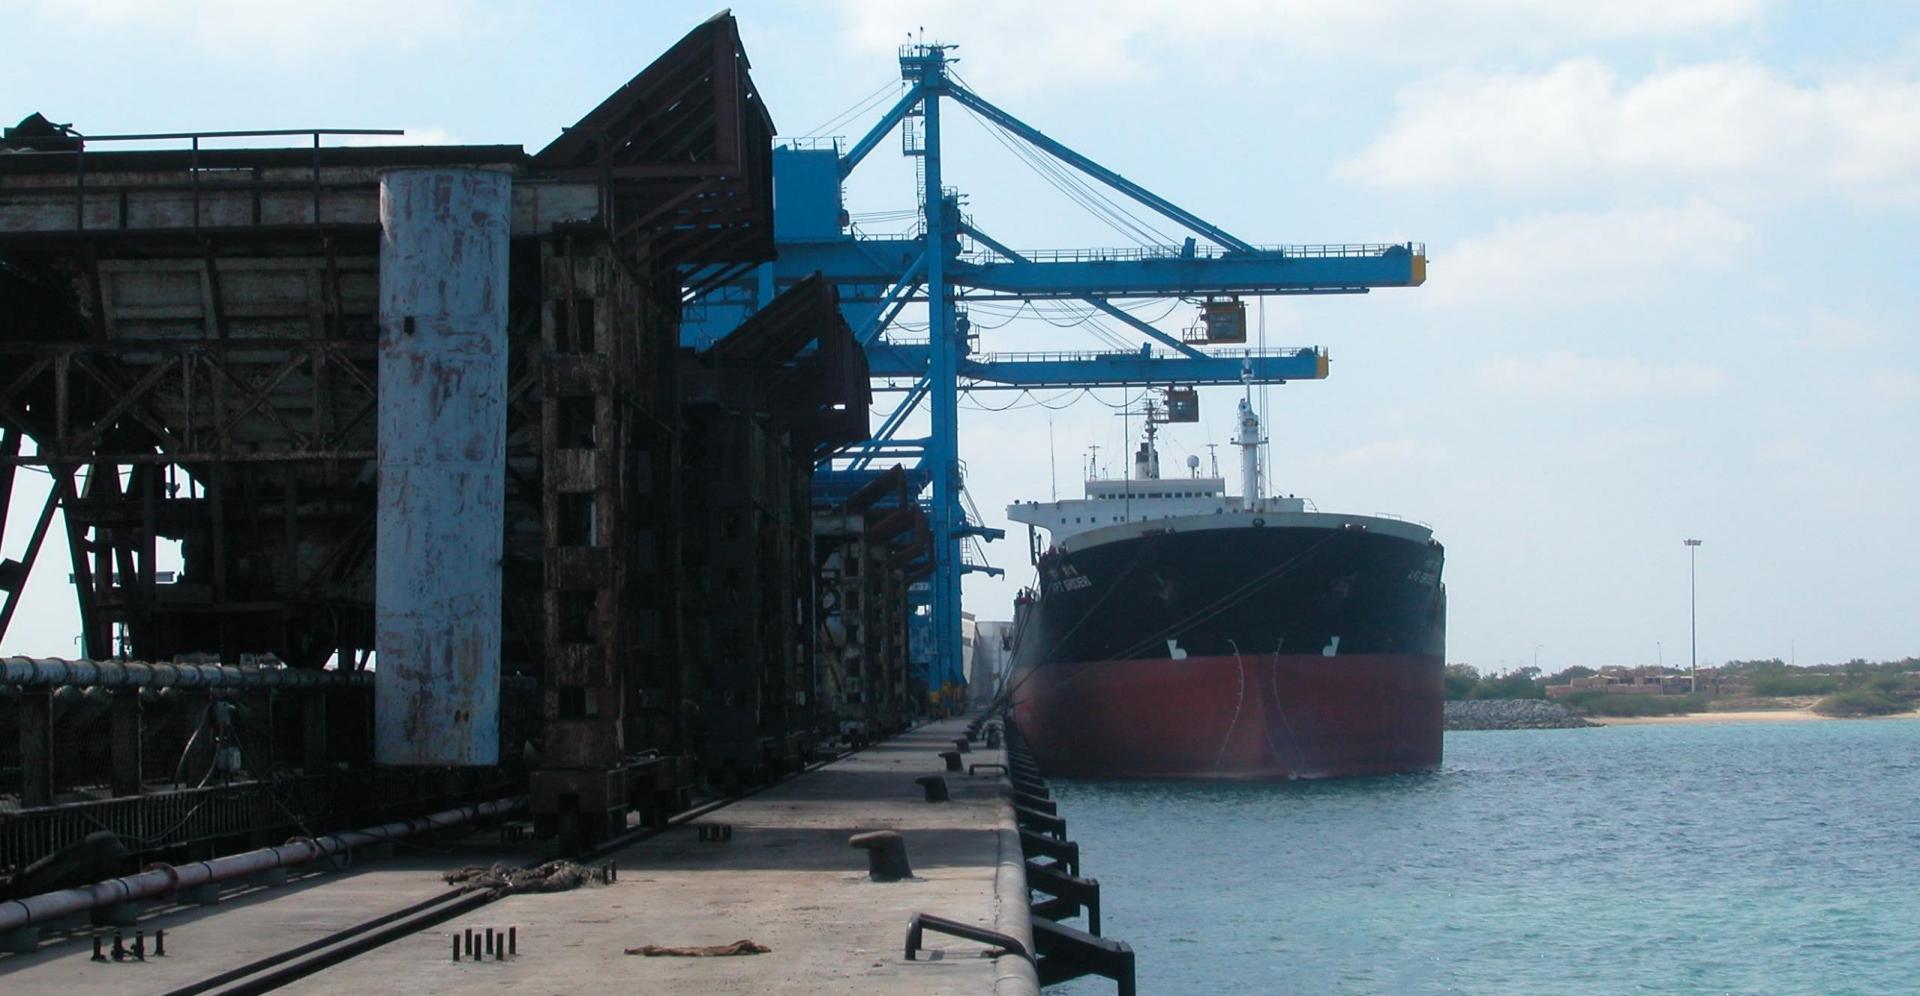
**Sound judgment and timely response averted potential damages at this port.**
