# HUMBER BAY PARK EAST MAJOR MAINTENANCE PROJECT

## Concept Brief

February 2021

| PROJECT NAME | Humber Bay Park East Major Maintenance Project |

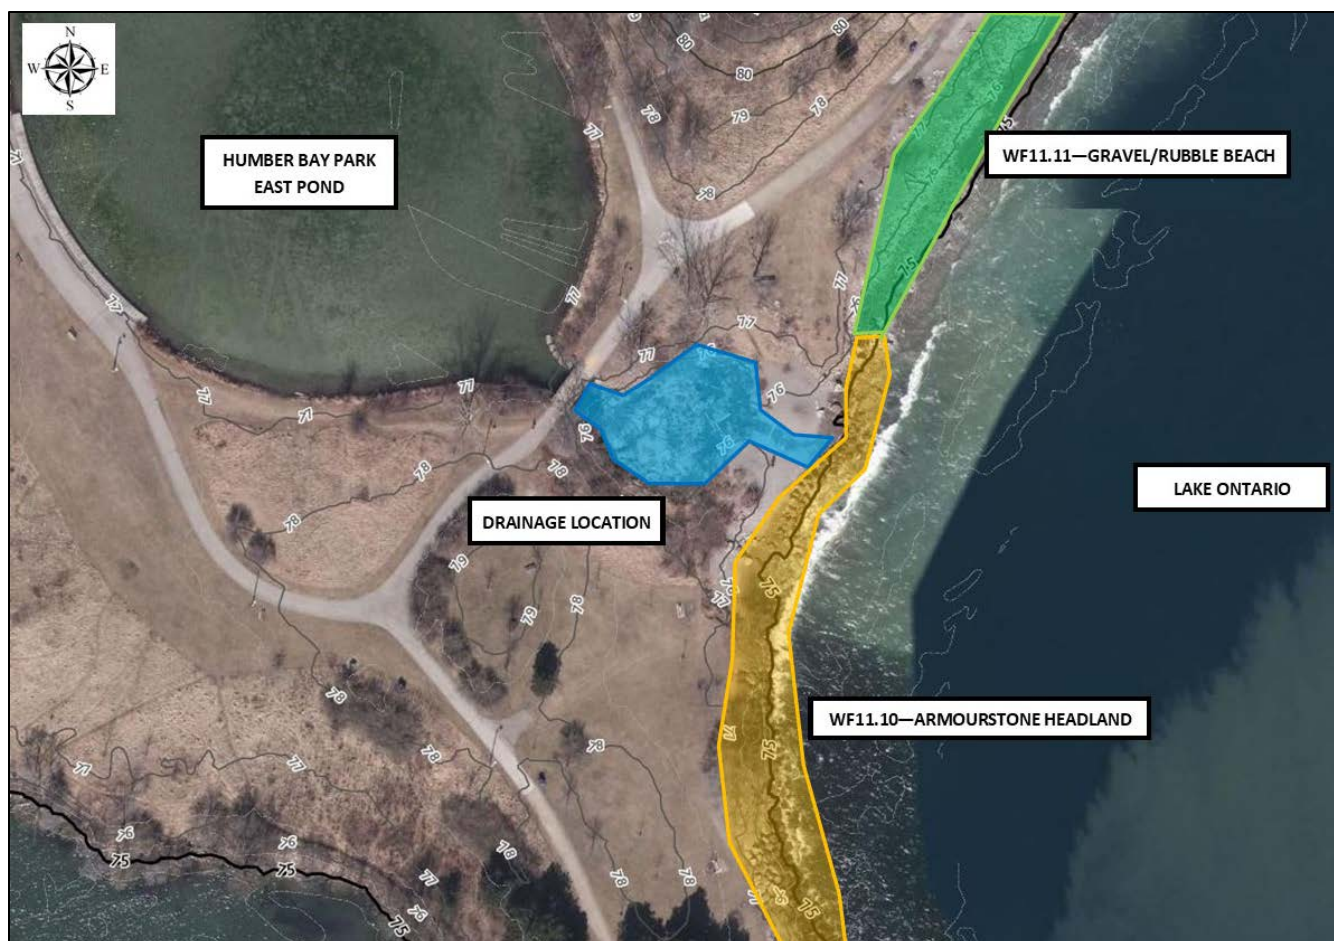
The area adjacent to the structures is parkland and includes formal and informal trails that run parallel to the shoreline. The park features a system of streams and ponds, one of which drains at the eastern limit of the western headland (WF11.10) as shown in **Figure 2**.

**Figure 2.** Location of pond drainage at eastern limit of Armourstone Headland WF11.10. Source: TRCA, 2021.

At its eastern limit, the headland transitions into beach WF11.11. At this transition point, the concept design includes the creation of a berm, consisting of 2-3 tonne armourstone, to create a formal outlet area for the ponds (**Figure 16** and **Figure 17**). The elevation of the treatment will be 78.5 m.a.s.l. (**Figure 17**). The pond will drain into the lake through a plug of loosely placed armourstone that will have crevices to allow the water to filter through. The design was developed with consideration of maximum outflow conditions, which were calculated to be 1000 g/minute. This treatment will also facilitate the creation of a backwater or wetland area between the pond and the outlet since water will naturally pool behind the berm. The design also includes the presence of scattered stone in front of the berm to help hold in the toe of the adjacent beach (**Figure 18**).

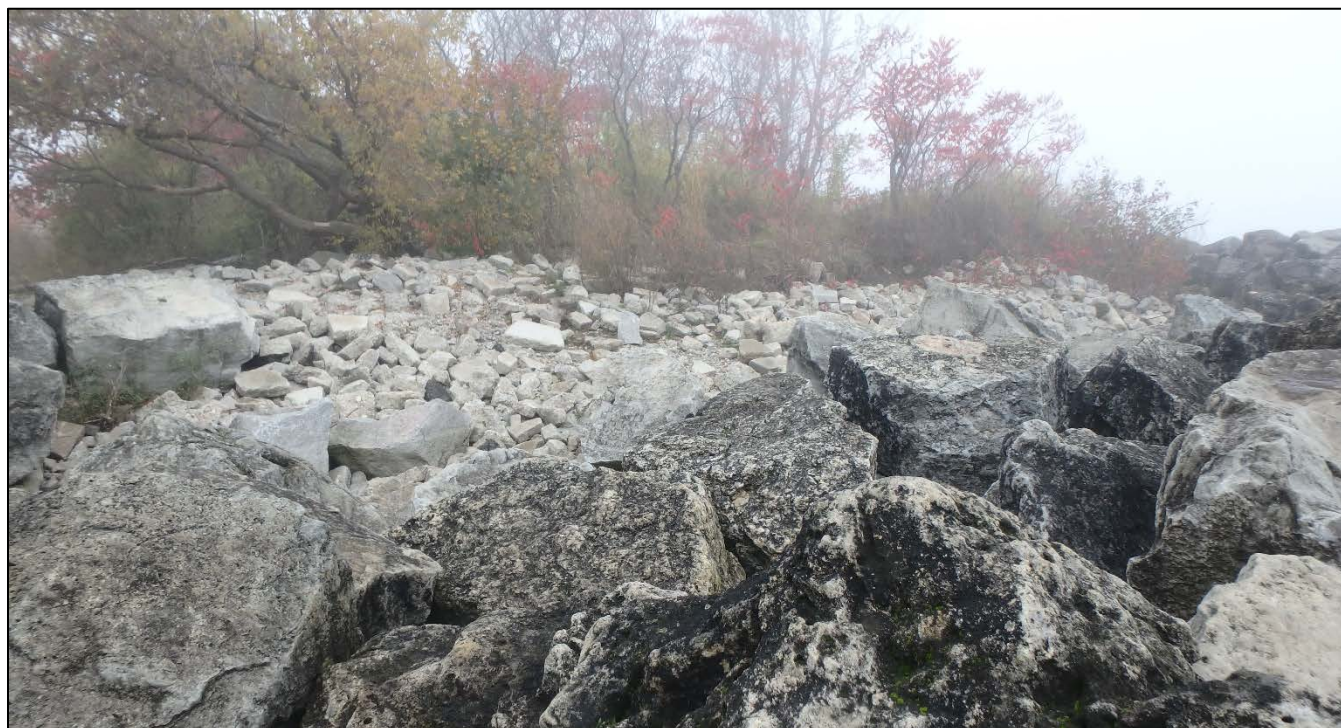
**Figure 3.** Area of backshore scouring due to overtopping. Temporary rip rap treatment installed in damaged area. Source: TRCA 2019.

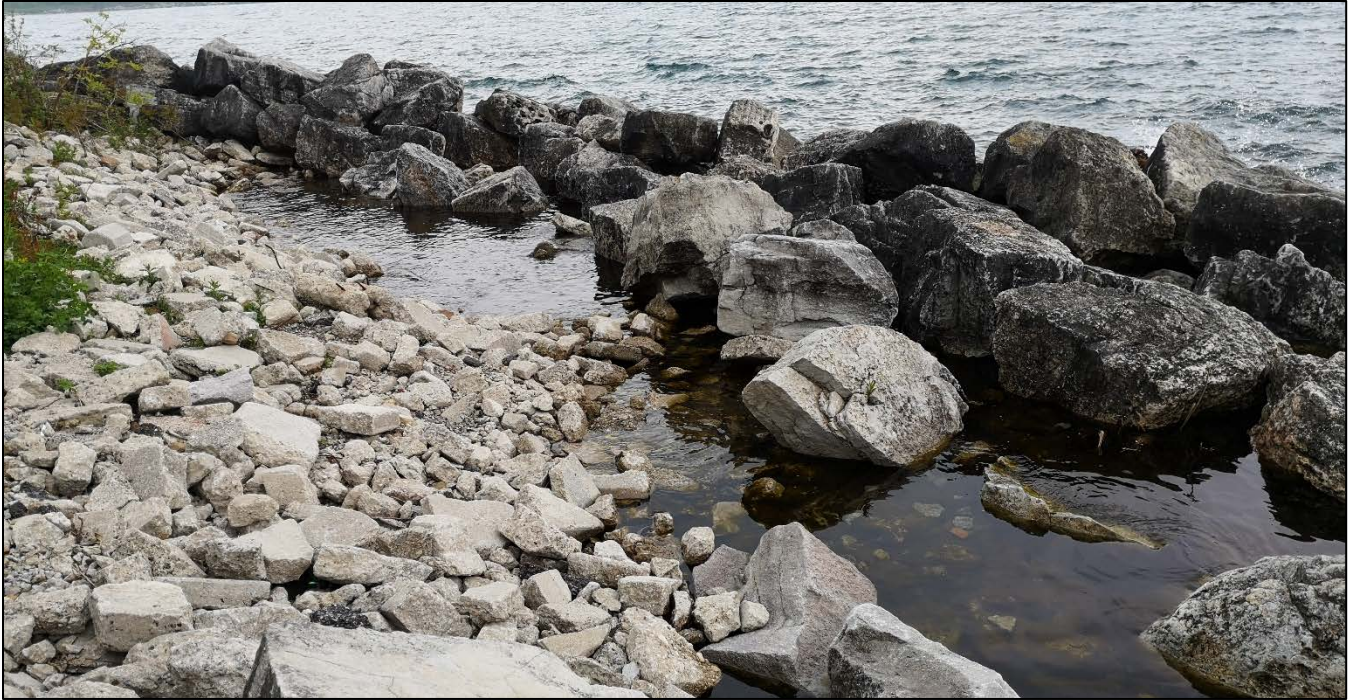
**Figure 4.** Irregular armourstone crest profile with areas of flooding behind the structure during the high Lake Ontario water level event in 2019. Source: TRCA, 2019.

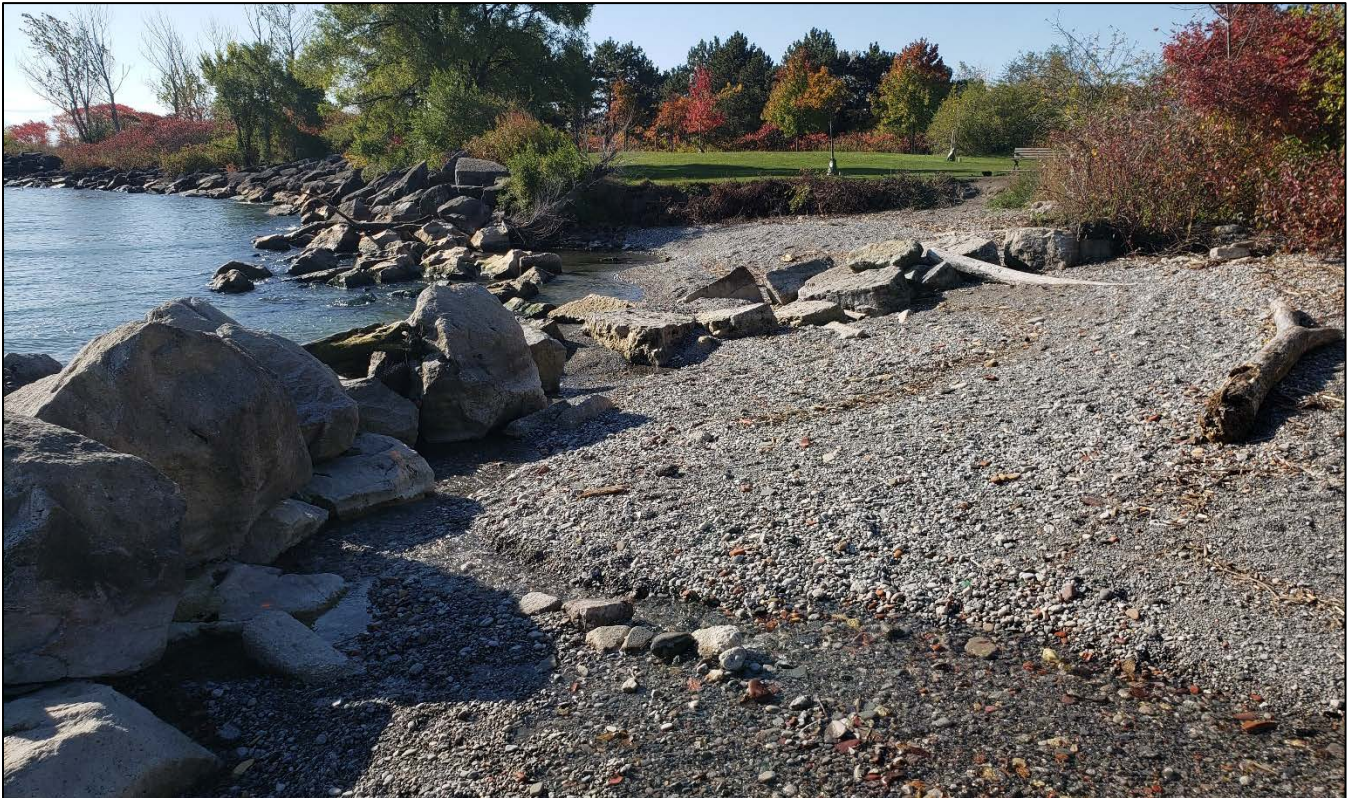
**Figure 5.** Condition of eastern limit of the structure with visible displacement of armourstone material. The pond drainage can be seen behind the armourstone. Source: TRCA, 2019.

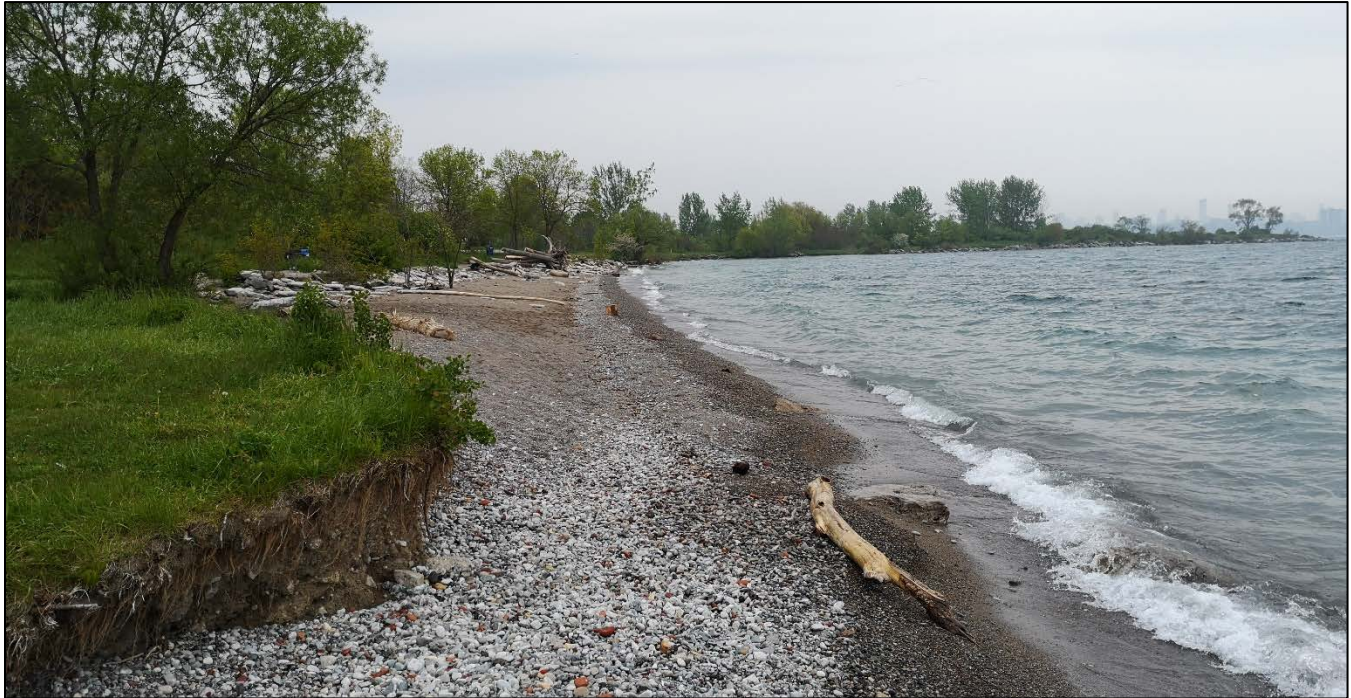
**Figure 7.** Condition of the cobble/gravel beach (WF 11.11), with visible scouring and undercutting. Source: TRCA, 2019.

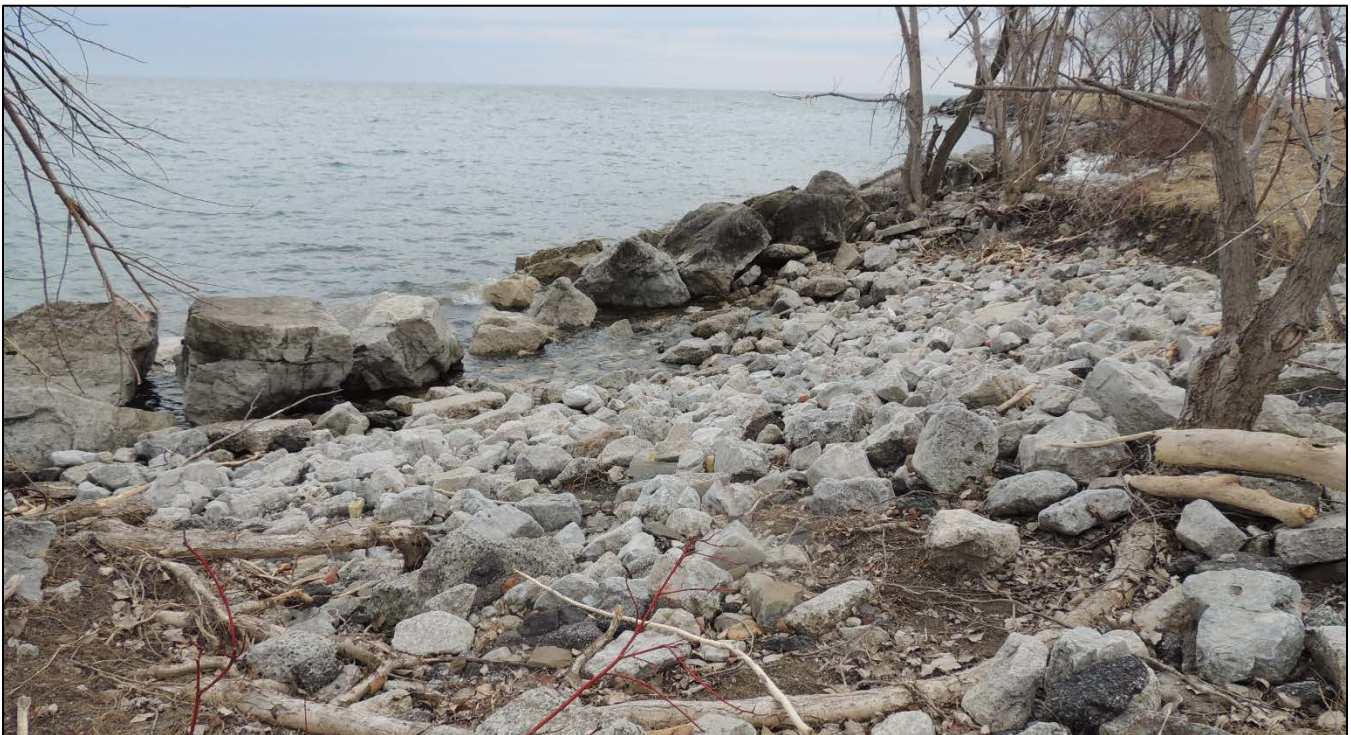
**Figure 11.** Scouring and armourstone displacement along eastern section of structure WF11.12. Source: TRCA, 2019.
