### 2021 Guangzhou greenway Investigation Report

Survey time: 2021.3-2021.8

Survey subject: Evaluation of Greenway use in Guangzhou, China

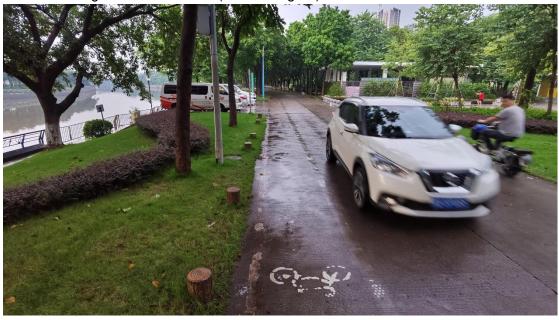
36.71% with signs and no facilities (attached figure)

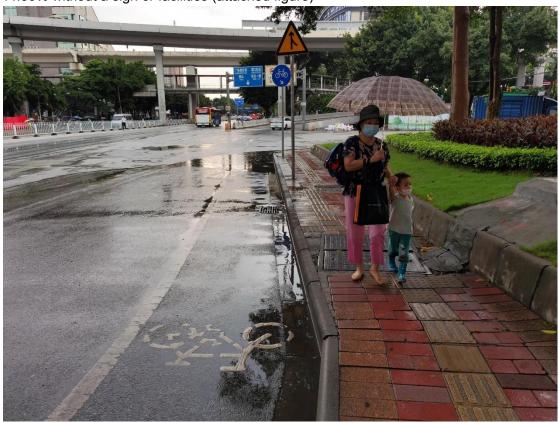
44.30% without a sign or facilities (attached figure)

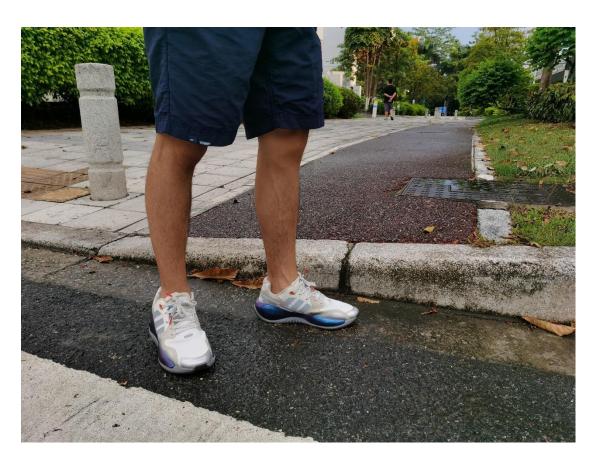
2) Flatness of connection between greenway and pavement (with photos)

In 18.92% of the sections, the junction between the greenway and the highway is uneven, and there is a steep drop between the curb and pavement.

Analysis: Safety signs are present in 53.17% of the data, nearly half of the safety signs are unclear, and there is a lack of clear guidance for traffic participants. 16.46% of the safety guarantee facilities are seriously insufficient. There are serious potential safety hazards due to the random entry of electric vehicles on greenways and the mixed traffic of some greenways and motor vehicles. 18.92% of the sections have height differences at the junction of greenway and highway, and single vehicle

passing may cause safety hazards. The overall safety needs to be rectified and improved from the aspects of: marking systems, entrance and exit facilities, and pavement connections.
