# Cloth Mask — Filter Tests 4/3/2020 & 4/4/2020

Brian Eggart & Mark Klein

#### Overview:

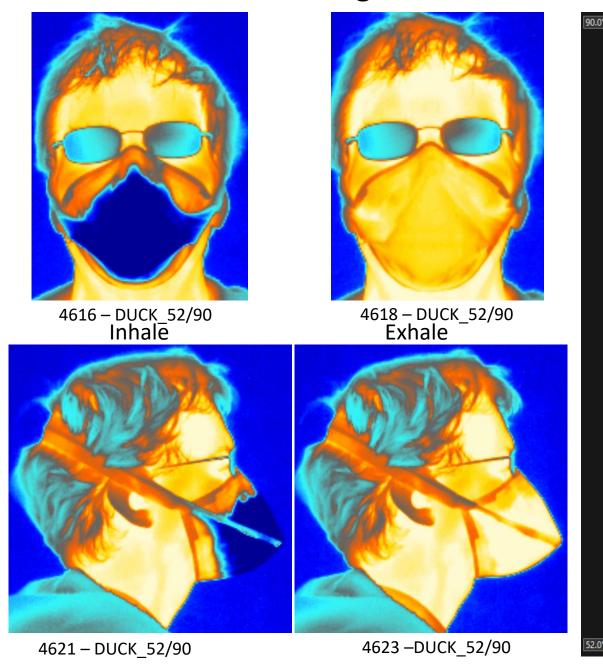
The mask is very easy to fit to the face and provides an excellent seal around the full perimeter. This is probably the best design for allowing an easy, low leak fitment.

It is not a washable material.

Breathing was very easy due to the large surface area.
