# Great Kids Farm

Physical Needs Assessment Report of Findings

September 10, 2015

Great Kids Farm  
Green Houses 1, 2, & 3  
6501 Baltimore National Pike  
Catonsville, MD 21228

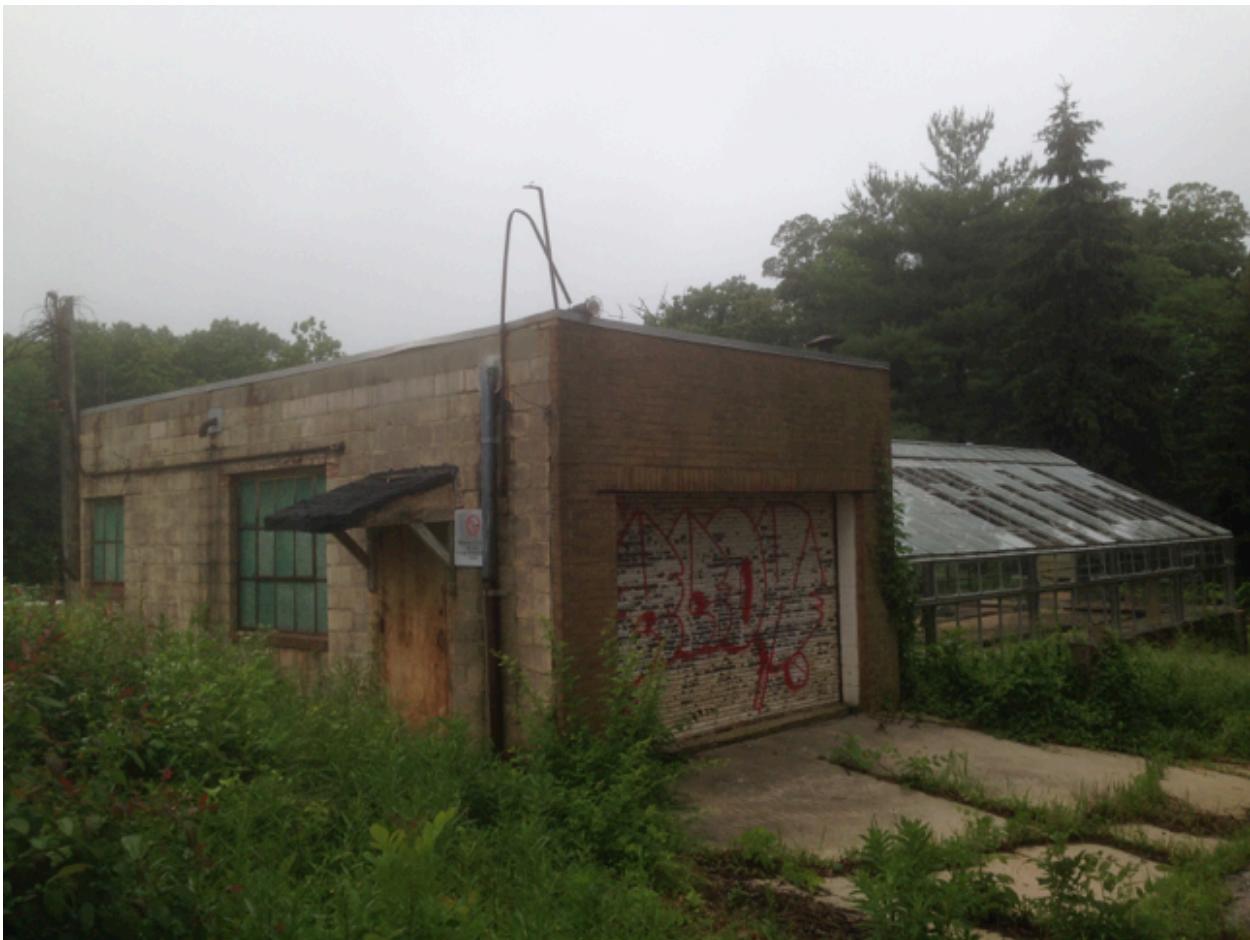
Northeast corner of Head House with Greenhouse in background and potential parking area to the right of the Head House beyond the existing driveway.

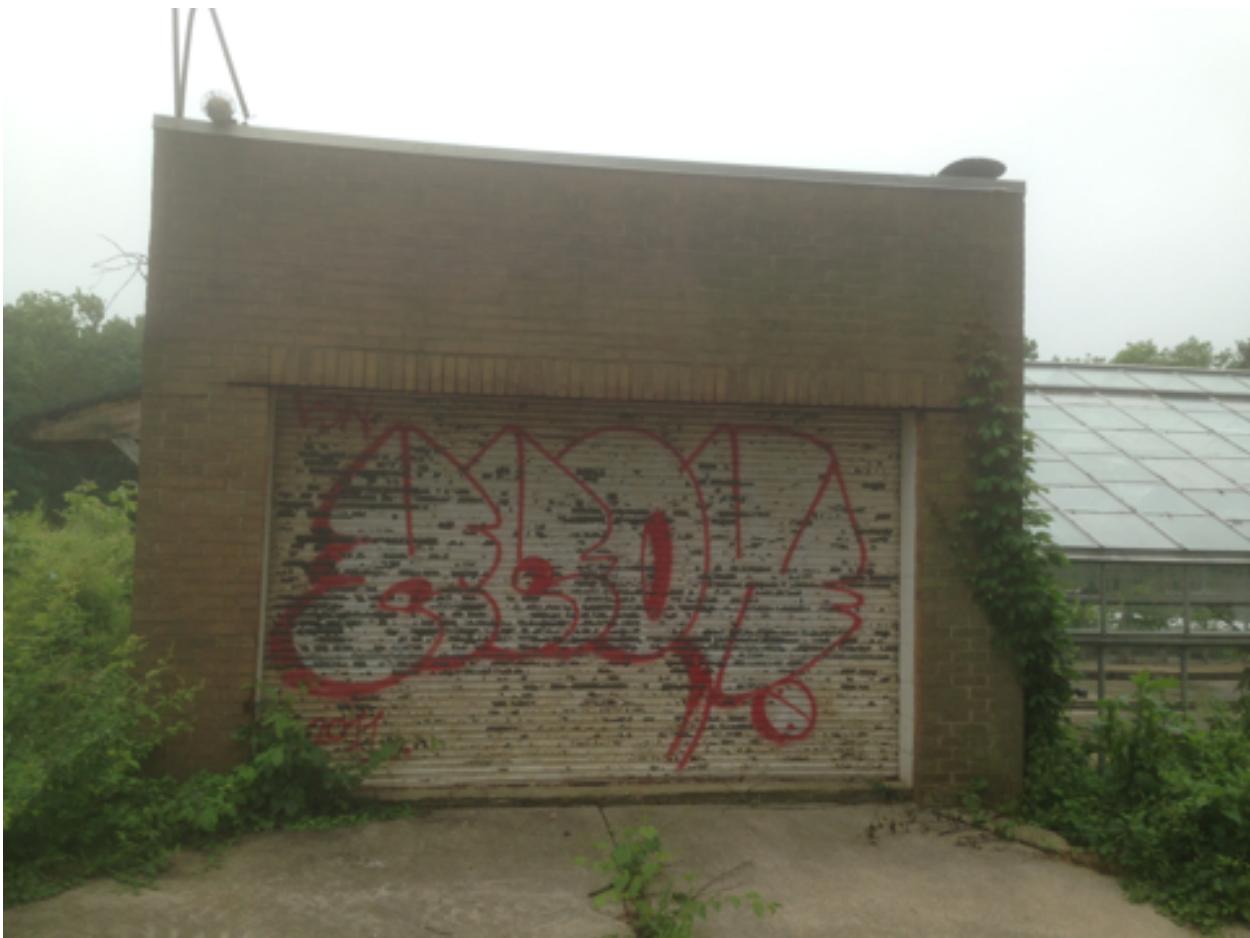
North-facing wall of Head House with roll-up door.

The garage door needs to be replaced with a similar rollup model that fits better into the garage door opening as a gap of 1-2" was observed. Ensuring a snug fit is better for energy efficiency, comfort, moisture management, pest control and security.

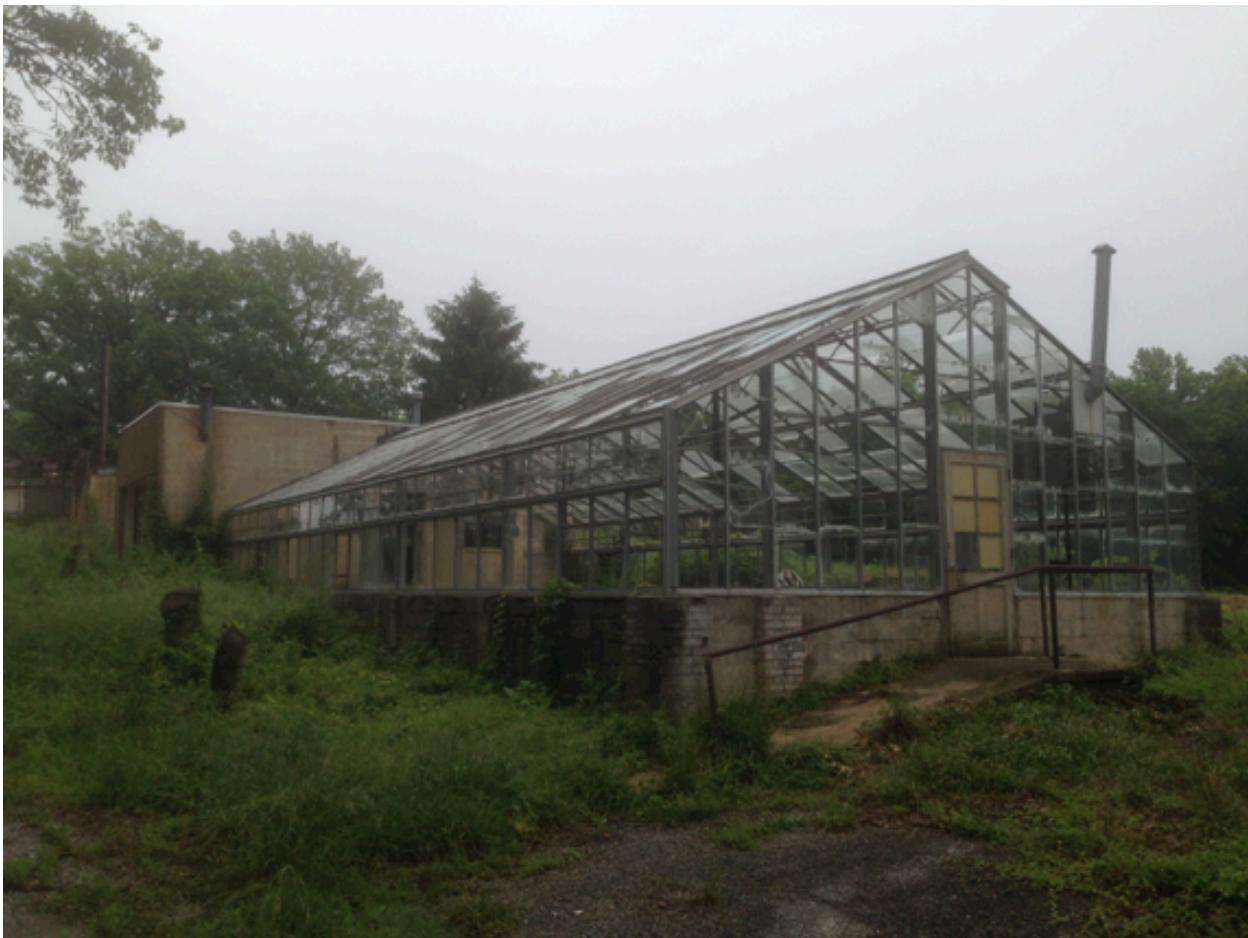
Note broken glass panels, the parking area, the furnace exhaust flues (in head house as well as the greenhouse) and the foundation disrepair.

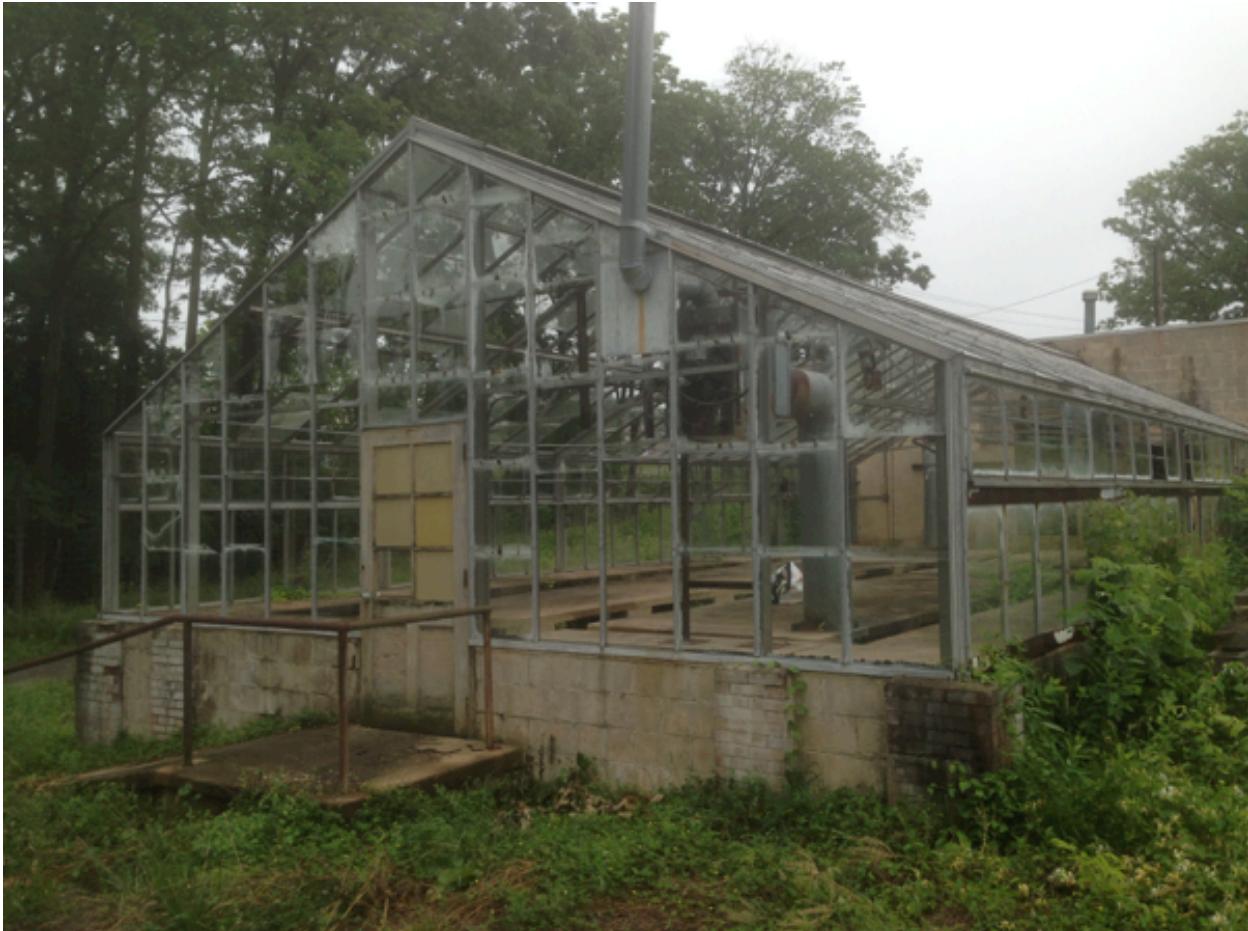
West wall of Greenhouse 3 - New door and extensive masonry work needed. The metal framework is in good condition throughout, and is usable for the foreseeable future as the recommended replacements are lighter than plate glass. Some preparation of the framework will be required to avoid damaging (i.e. puncturing or cutting) the polyethylene or polycarbonate.

The head house and foundation walls of the greenhouse have significant deterioration. The blocks themselves present in salvageable condition, but the entire structure needs mortar to be reinstalled.

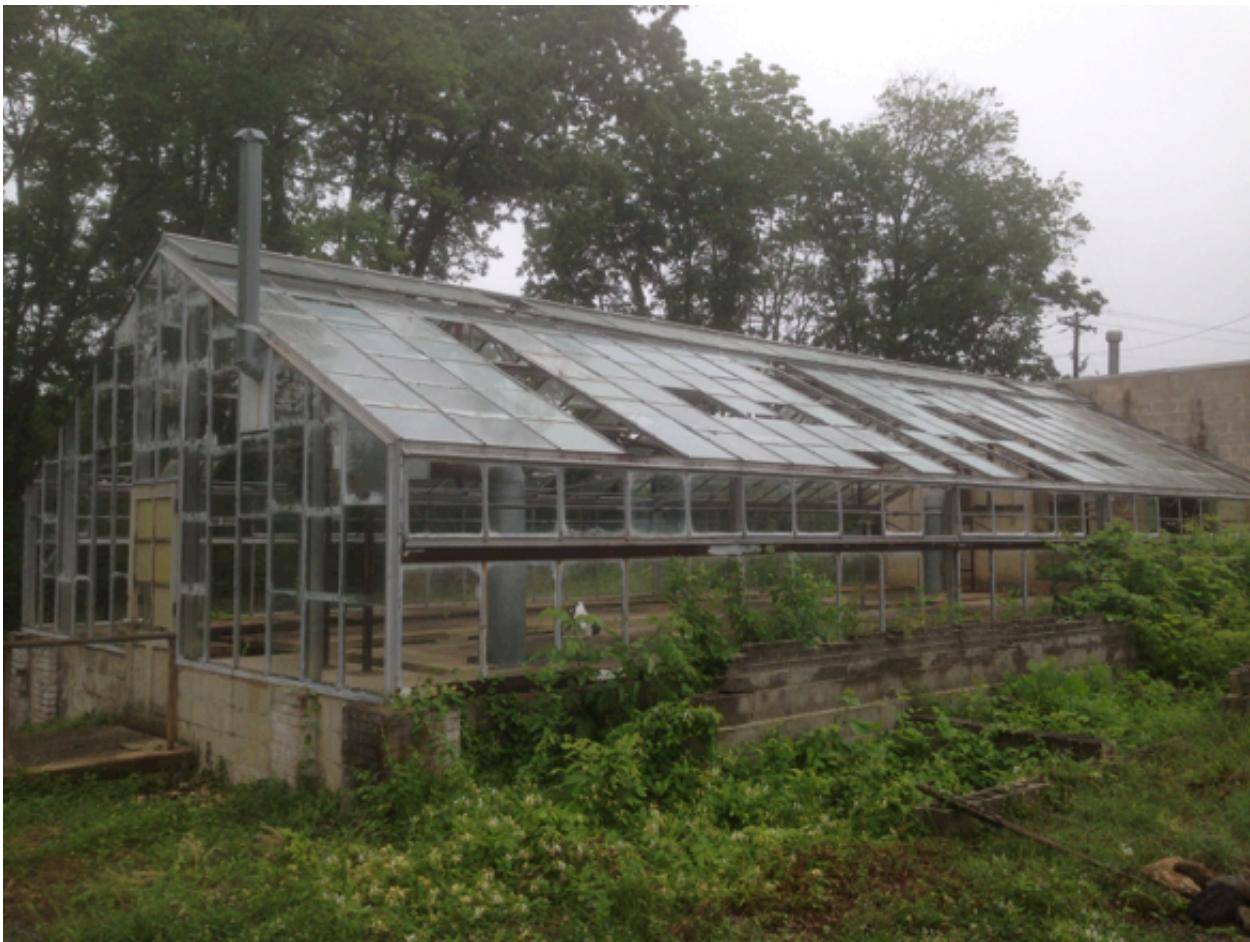
Southwest corner of Greenhouse - The lower right corner shows the cinder block edge of a "cold frame" planter used to cultivate plants tolerant of ambient conditions. GKF will need to determine if the cold frames will be used as they are potentially dangerous vis a vis trips and falls as they are several feet deep. Alternately, short barriers and/or signage could be installed to minimize accidents.

The planter boxes for outdoor sprouting and growth known as the cold frames are excavated and could present a fall hazard. The holes could be filled in with soil, and the pricing is presented for comprehensiveness.

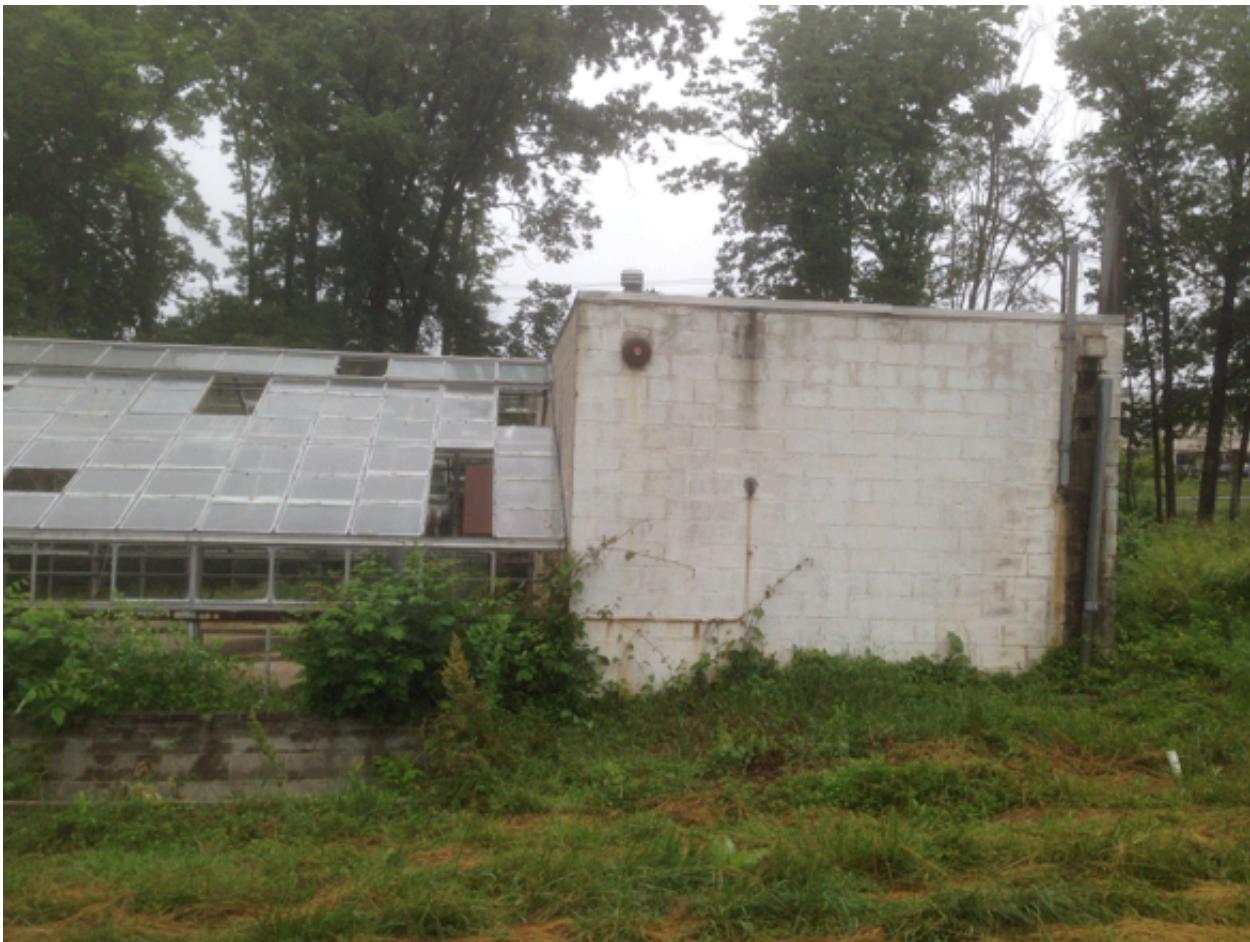
North wall of Greenhouse 3 shows broken glazing, deteriorated masonry (especially at the right margin of Head House).

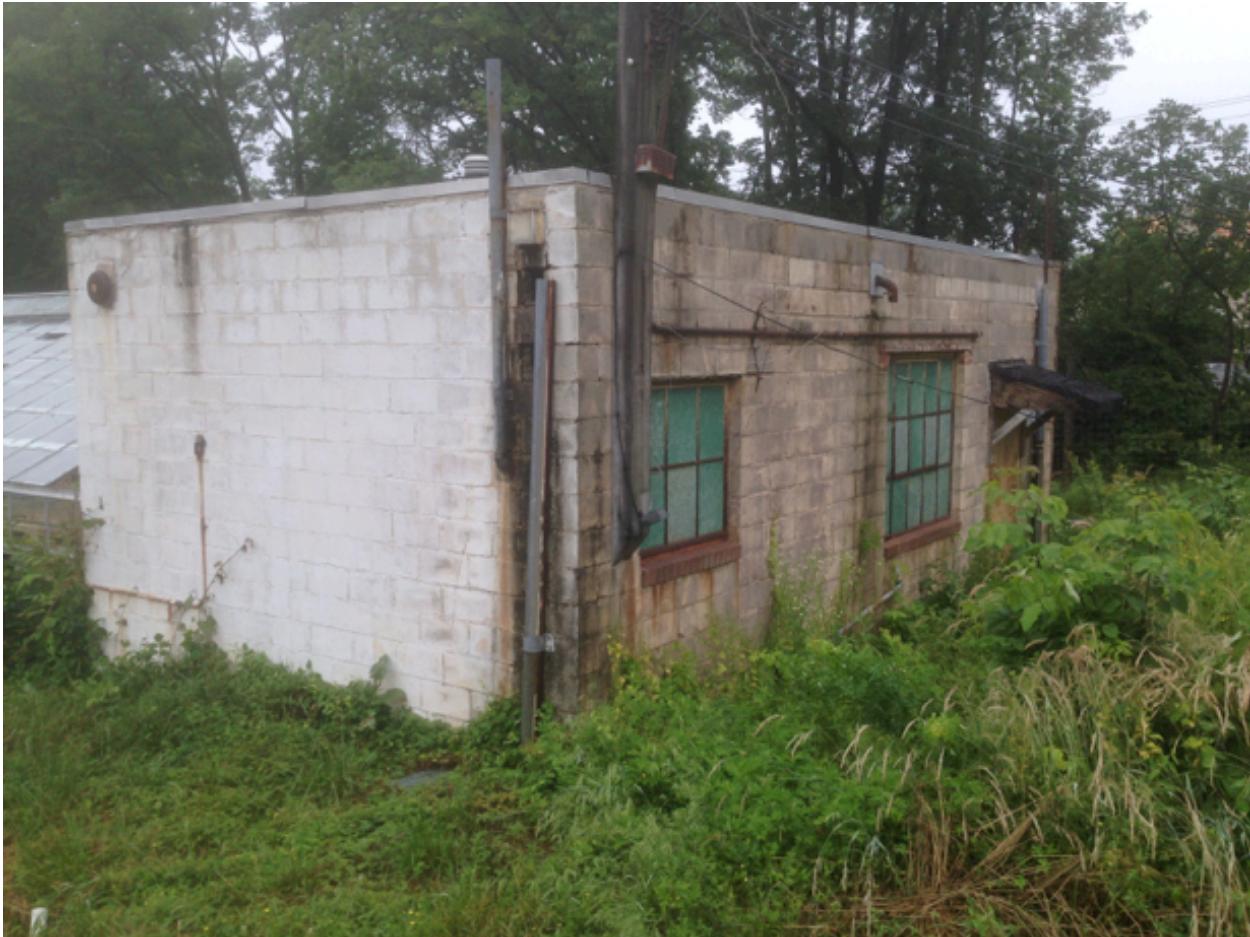
Masonry Issues in Head House.
