Route VT15 /
Structure #00020 / (Routine)

VT 00015 ML over LAMOILLE RIVER

Team Lead: Stephen Piro, Inspection Date: 09/27/2023

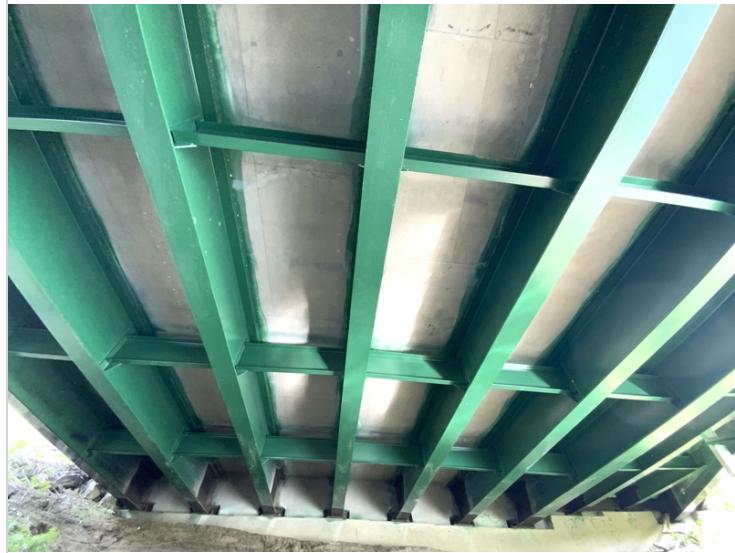
Span 5 abutment 2 beams 5, 6, 7 & upstream superstructure

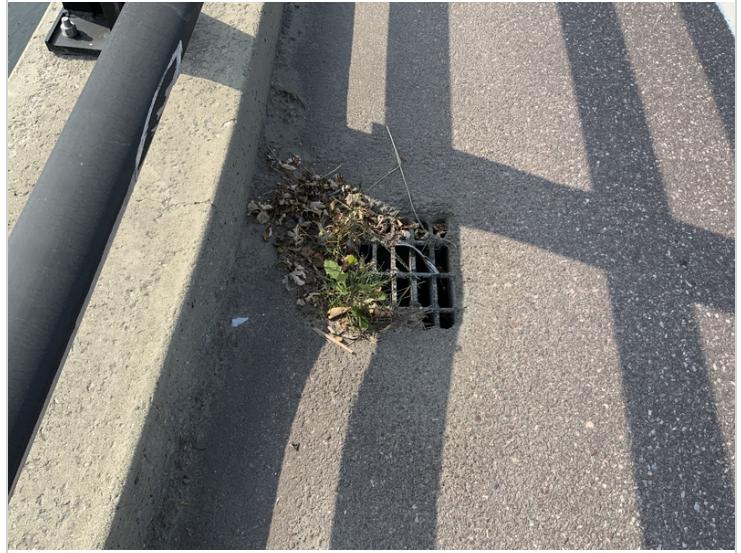
Grated deck drains with steel tube downspouts are in fairly good condition having some light surface corrosion along the lower portions.

Drain near abutment 1 upstream

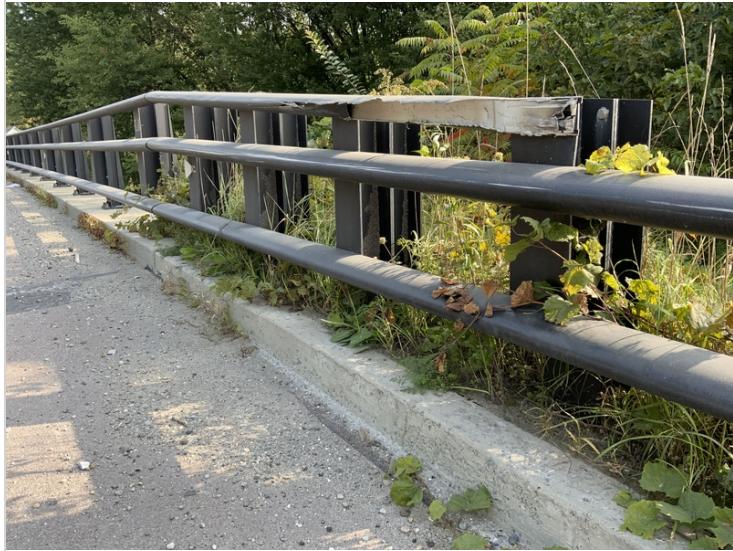
Deck from abutment 1

Reinforced concrete deck is in fairly good condition. Deck soffit has multiple hairline transverse shrinkage cracks present.

Asphalt is in fairly good condition having some light wearing in the wheel paths.

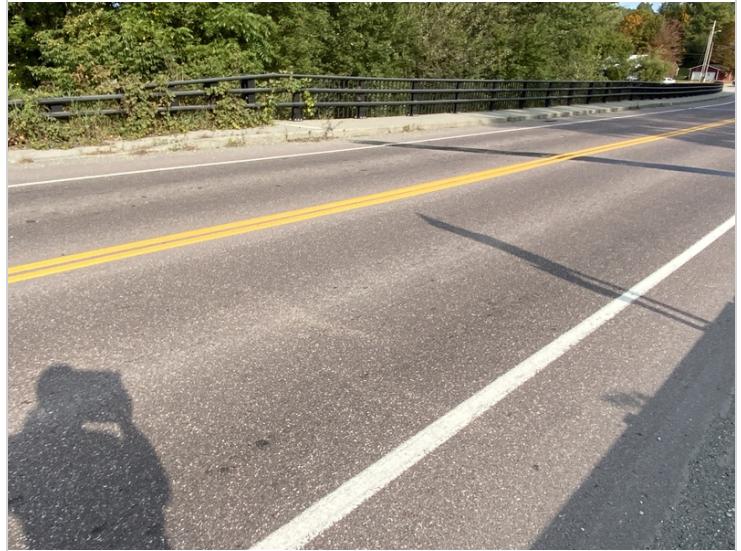
Approach rail abutment 1

Galvanized steel beam rail is in fairly good condition.

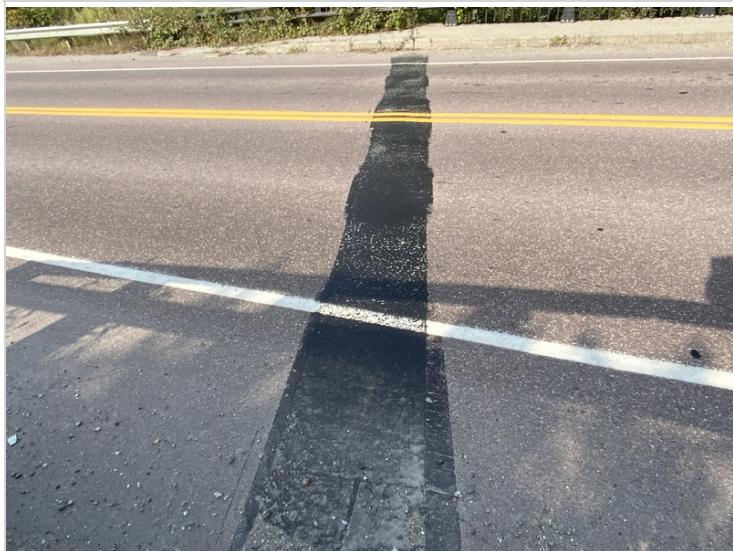
Downstream rail & sidewalk from abutment 1

Concrete sidewalk is present along the downstream side only having some very light surface scaling and a few hairline transverse cracks scattered throughout.

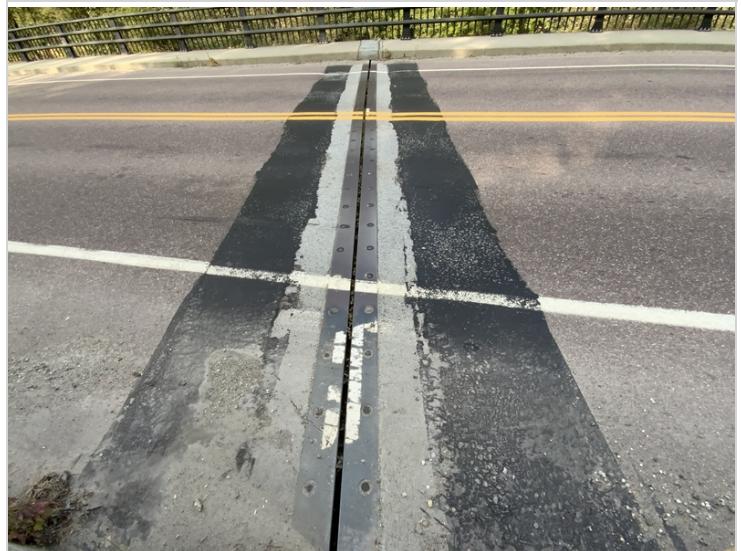
Joint abutment 1

Asphaltic plug joints are present over both abutments and are in fairly good condition. Vermont type joints are present over pier #1 and pier #2 being in fairly good condition. Concrete headers have some minor wearing in the concrete (mainly in the wheel paths) and some hairline cracking present. Due to wearing in concrete headers the steel plates have some wearing in the wheel paths with some minor scrapes and gouges present along the edges of steel plating. Vermont type joint measures ~1-3/4" over pier #2 and ~1" over pier #1 for separation at 52 degrees at time of inspection.

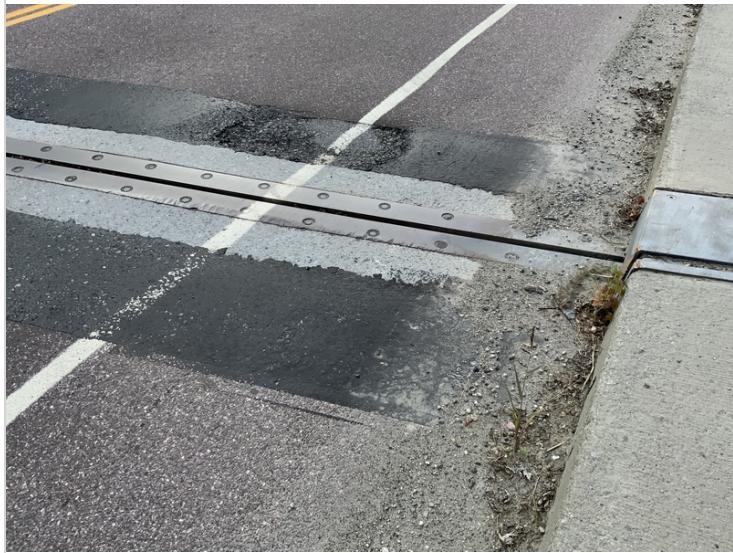
Pier 1 joint

Fabric troughs are present at pier #1 and pier #2 and are in fairly good condition however are full of debris and have vegetation growth present.

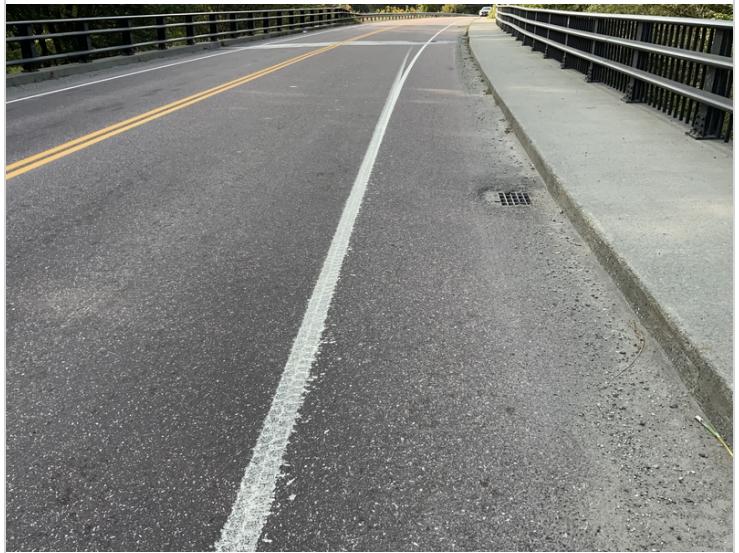
Deck along sidewalk from pier 2 facing abutment 1

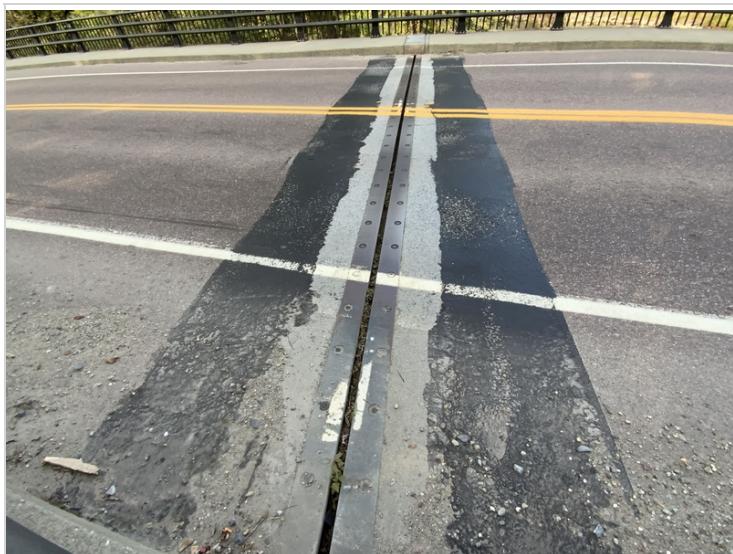
Joint over pier 2

Structure is in fairly good to satisfactory condition. Both Vermont type joint troughs over pier #1 and #2 are full of debris and sediment with vegetation growth and are in need of cleaning. Areas of bridge rail have impact damage on the upstream side along the upper tiers of aluminum tear drop rail and along the offsets. Offsets have areas of gouges and scrapes with some offsets being bent in the direction of traffic (eastern direction). The upper tiers of rail have areas of large gouges, scrapes and even some tearing present. Due to the flooding in July of 2023 pier #3 has localized scouring along the upstream end exposing the footing and should see some channel repairs.

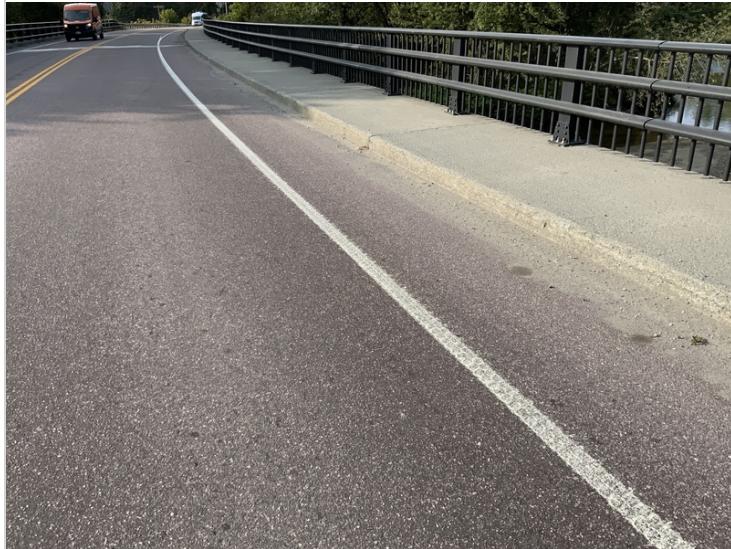
Sidewalk facing abutment 1

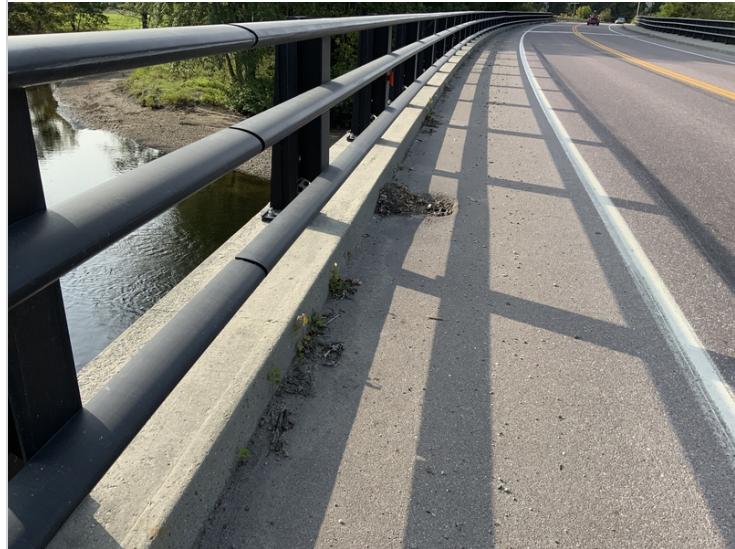
Along upstream curb facing abutment 1

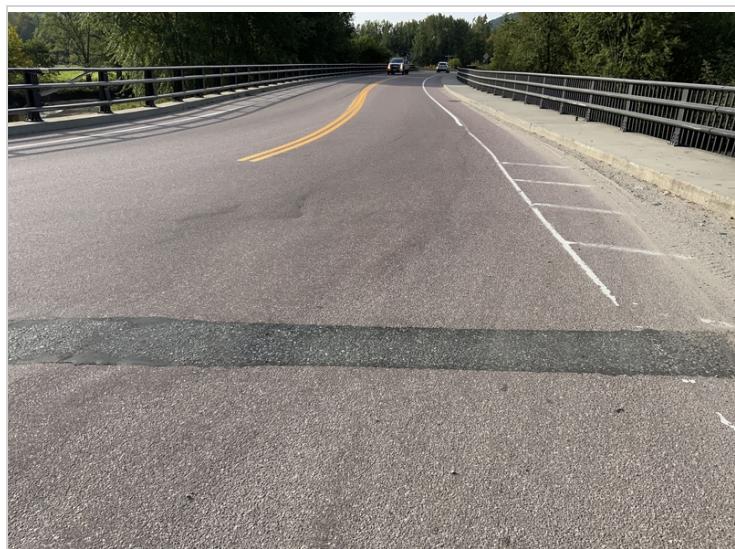
Deck from abutment 2

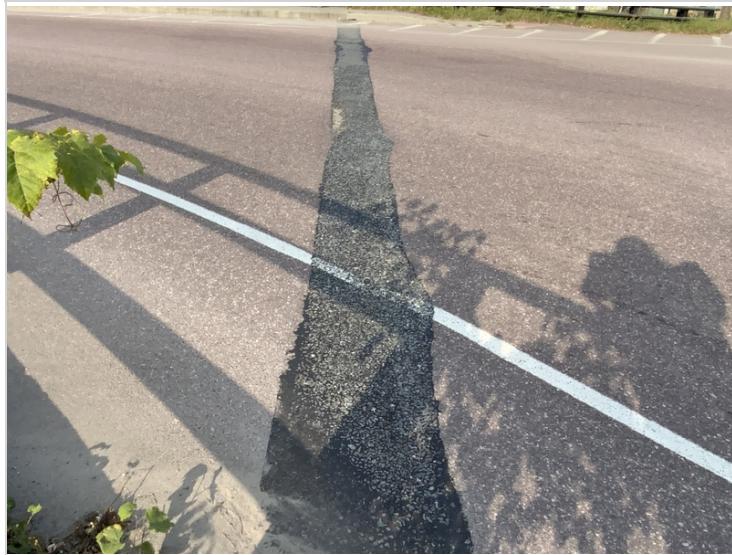
Joint abutment 2

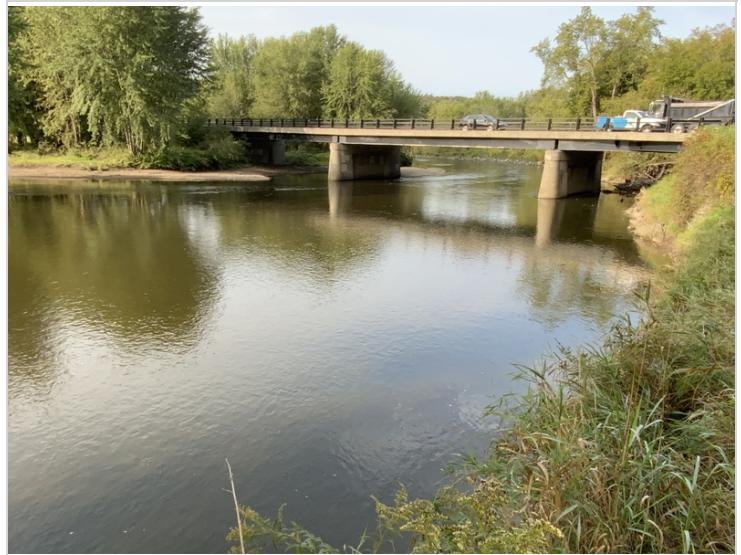
Upstream elevation

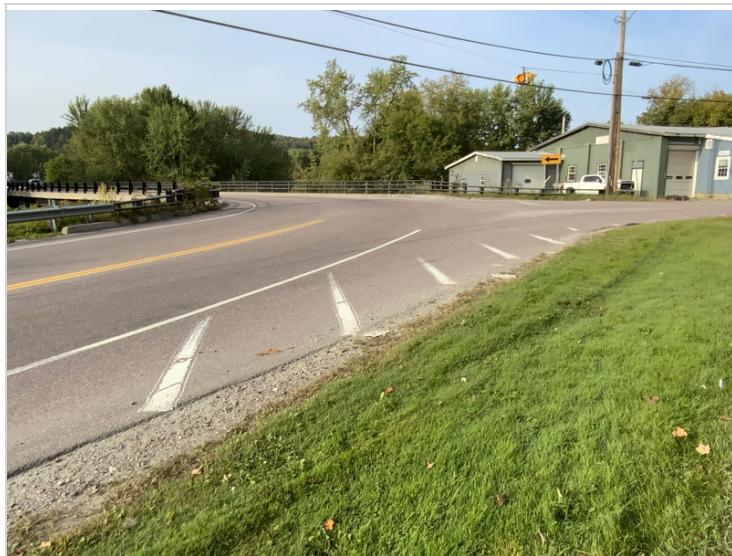
Approach abutment 2

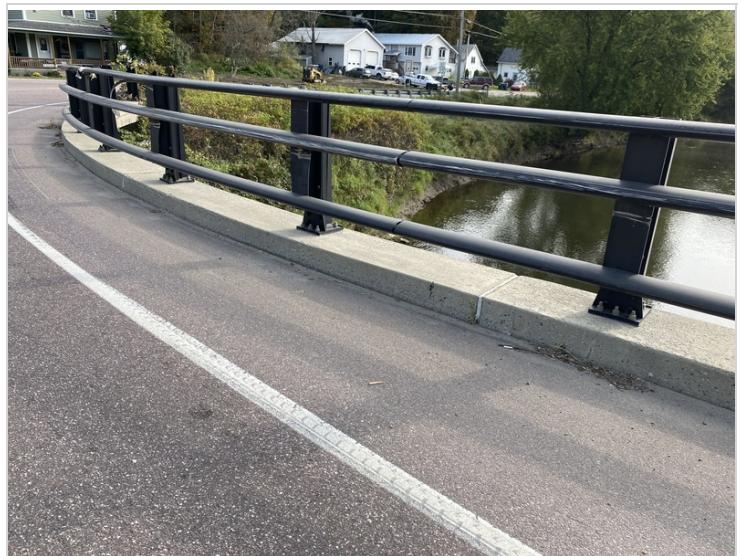
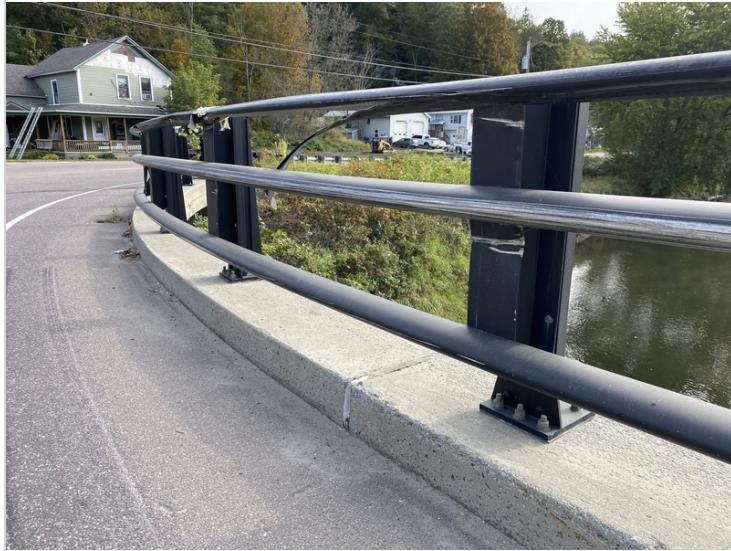
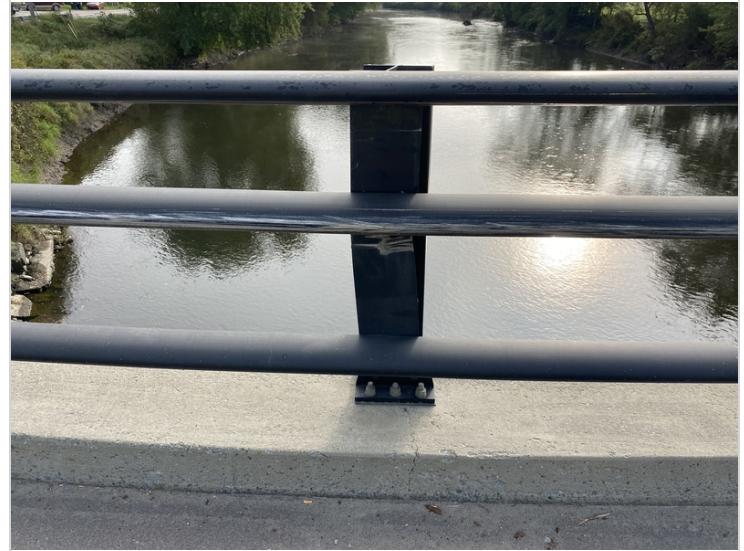
Triple painted aluminum tear drop bridge rail is in fairly good condition having some various scrapes and gouges along the front face. Heavier damage is present with dents and tears present in span #5 on the upstream side and in span #2. Pedestal mounted painted aluminum posts have offsets along the upstream side only and are in fairly good condition. Upstream posts in span #2 and #5 have impact damage with offsets and posts have heavy to significant twisting, minor to moderate scrapings and gouges and some tears in the offset blocks due to impact damage from vehicles.

Damaged Bridge Rail in Span #5 on Upstream Side over Deck Flare

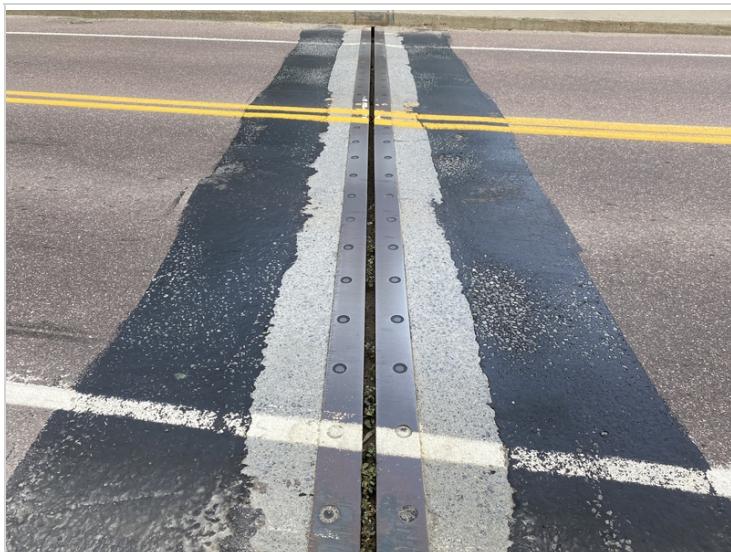
Vermont Type Joint over Pier #2

Both vermont type joint troughs over pier #1 and #2 are full of debris and sediment with vegetation growth and are in need of cleaning.

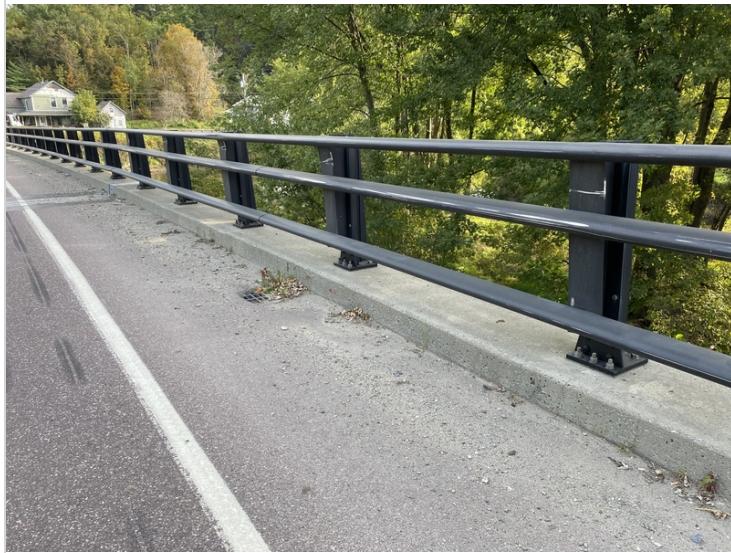
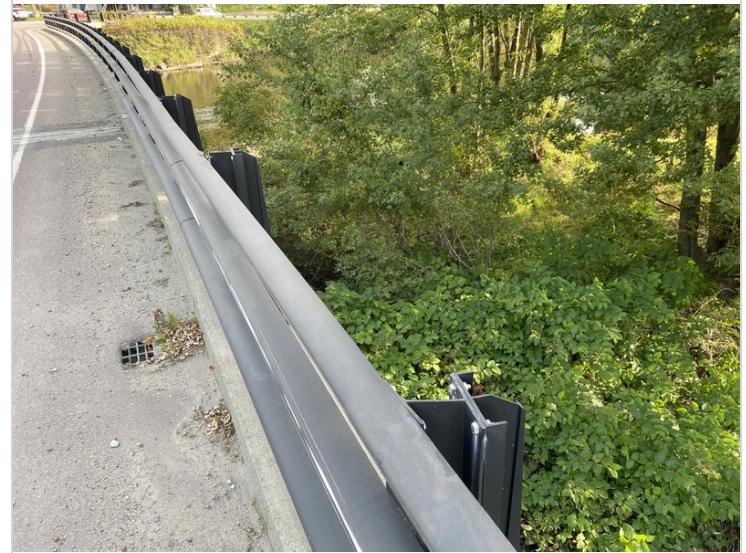
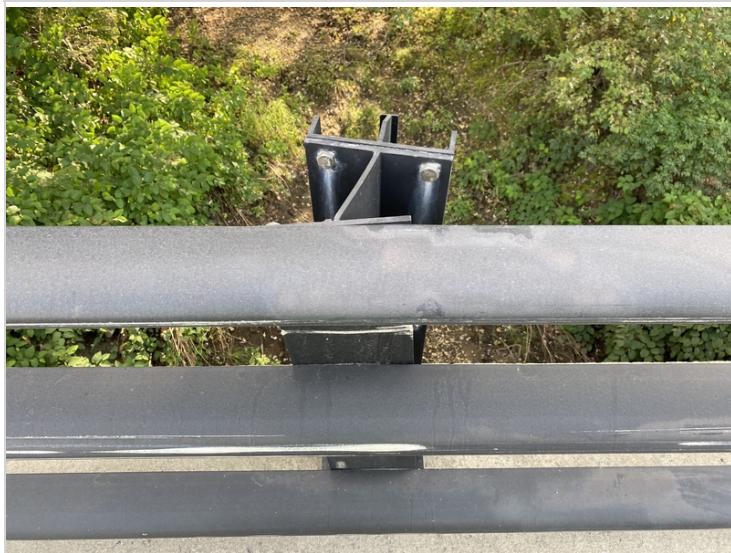
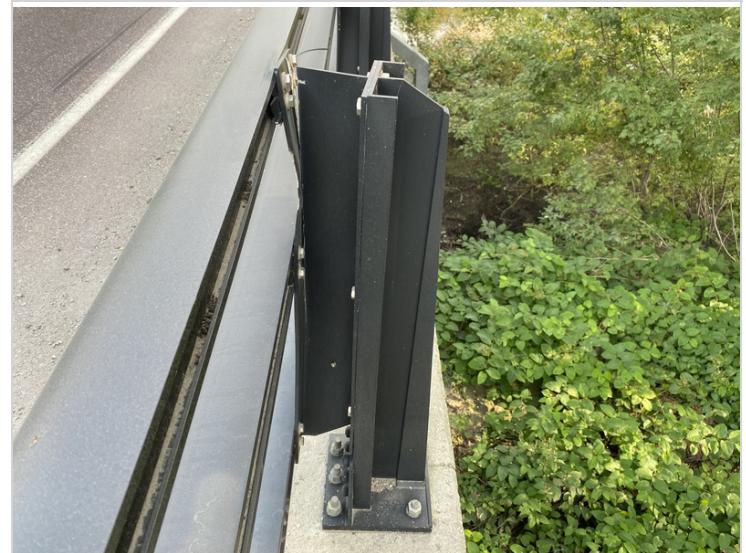
Damaged Bridge Rail in Span #2 on Upstream Side

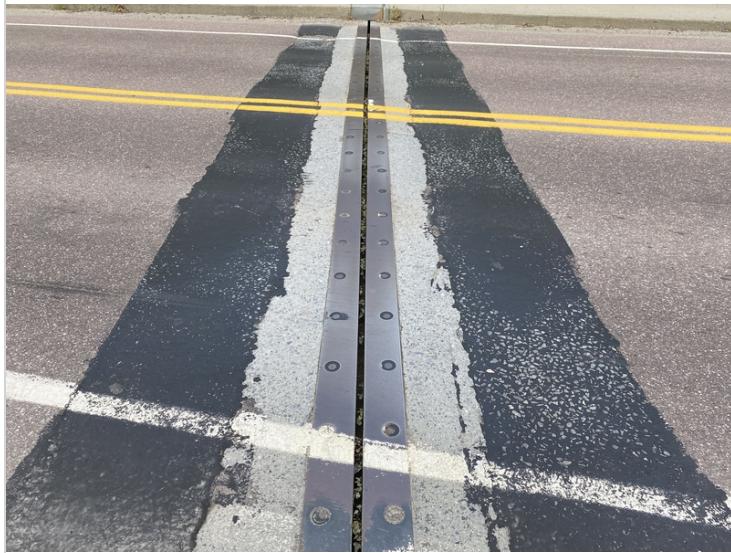
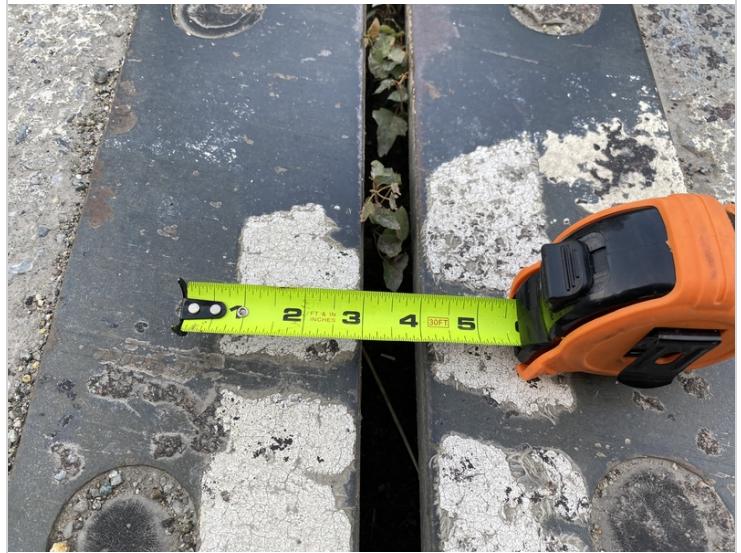
Vermont Type Joint over Pier #1

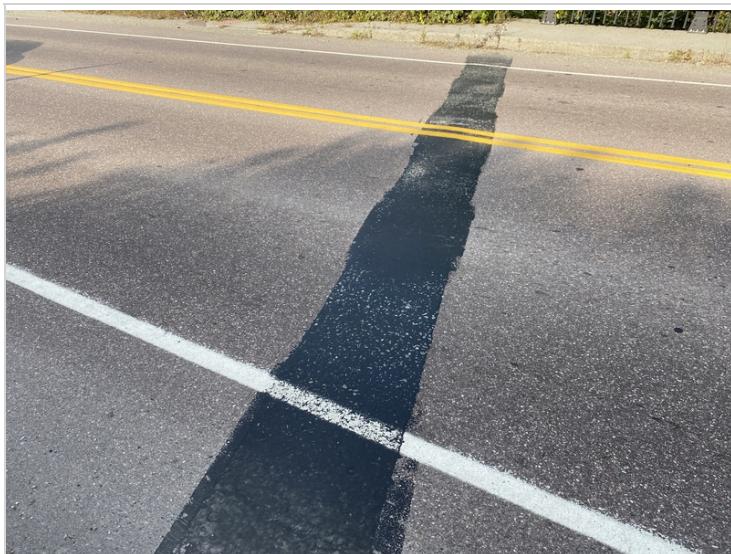
Asphaltic Plug Joint over Abutment #2

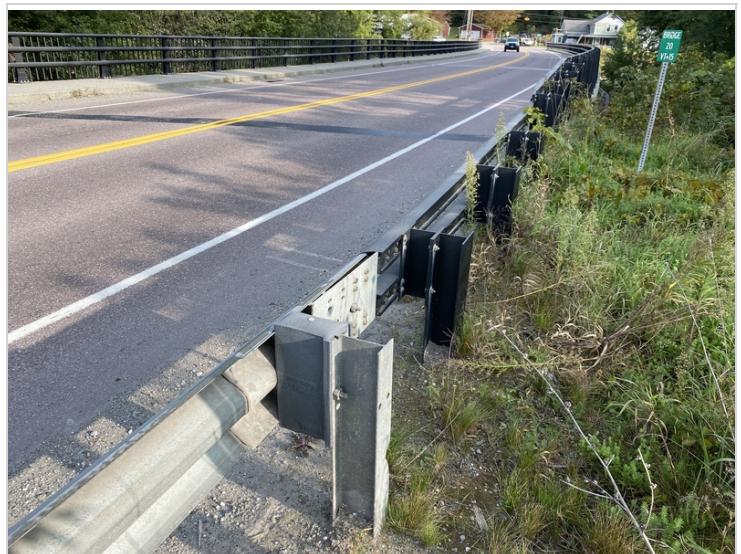
Typical Transition Rail

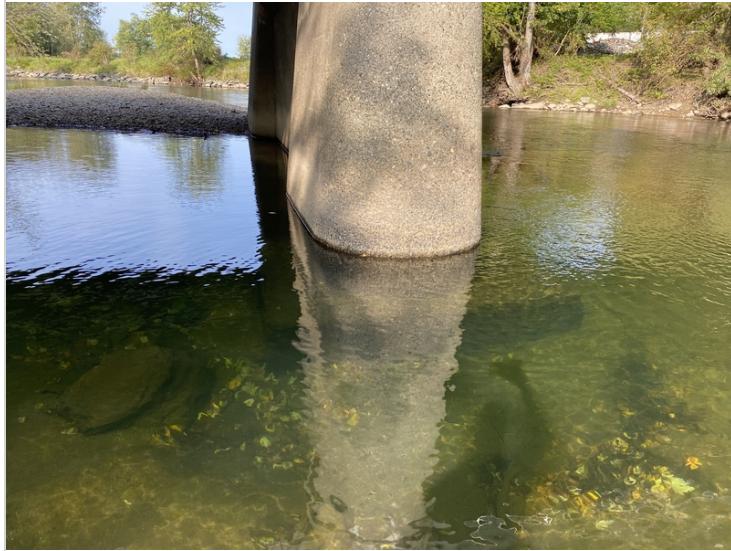
Pier #3 footing is exposed along the upstream side and is in fairly good condition. Depths vary up to ~2'-0" to the top of footing along the upstream nose of pier #3. Pier #4 also has the top of footing exposed and should be considered to be dived.

Piers have varying levels of scouring present with upstream end of pier #1, pier #3 and pier #4 having moderate scouring. The upstream footing along pier #3 and #4 are exposed due to heavier scouring present with depths of up to ~2'-0" on pier #3 to top of footing.

Upstream Pier #3 Footing

Pier 3 footing along the upstream end has localized scouring that has exposed the bottom of footing. Large stone should be added to protect this area so that scour does not continue grow in this area.

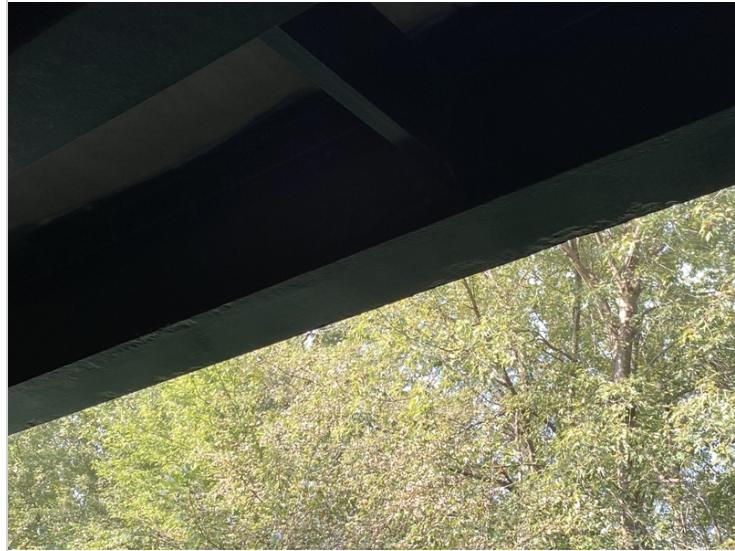
Seven (7) painted steel rolled beams are in satisfactory condition having scattered minor to moderate previous pitting along the flanges and webs throughout. Superstructure was painted in 2008 and is holding up fairly well with a few areas where the top layer of paint is starting to peel.

Beam #1 in Span #2 Typical Pitting

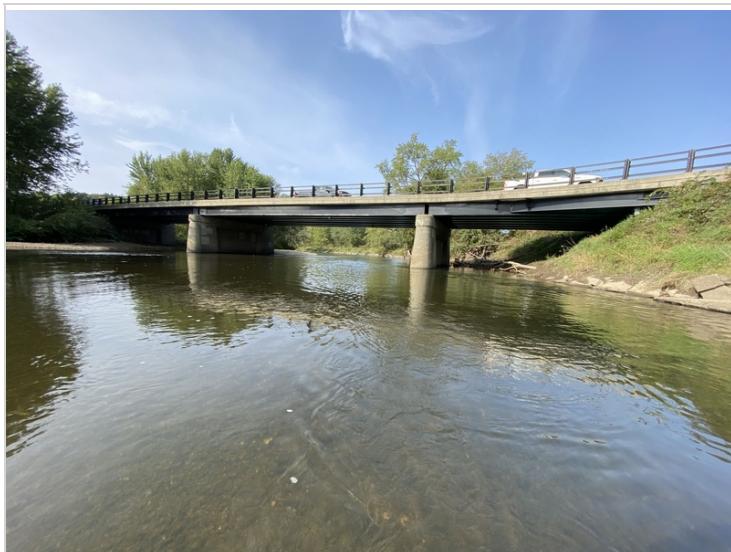
Upstream Elevation from Abutment #2

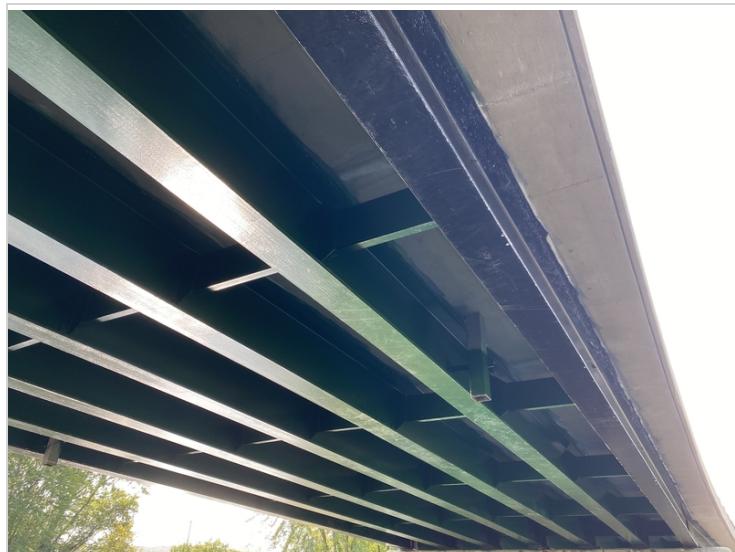
Span #4 Superstructure from Pier #4

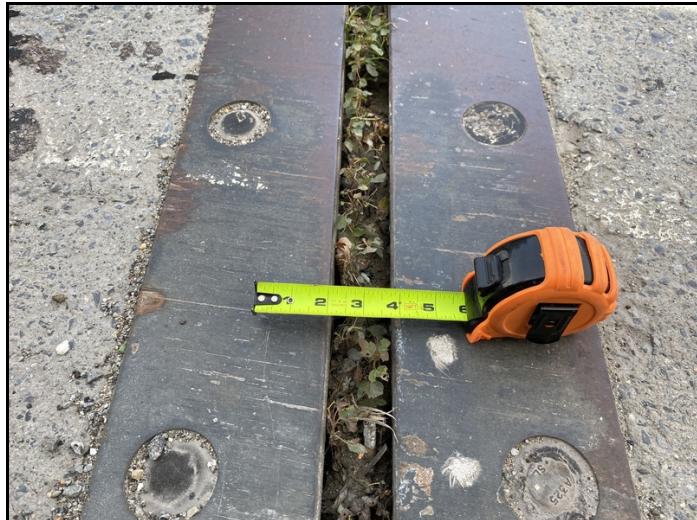
Vermont Type Joint over Pier #2

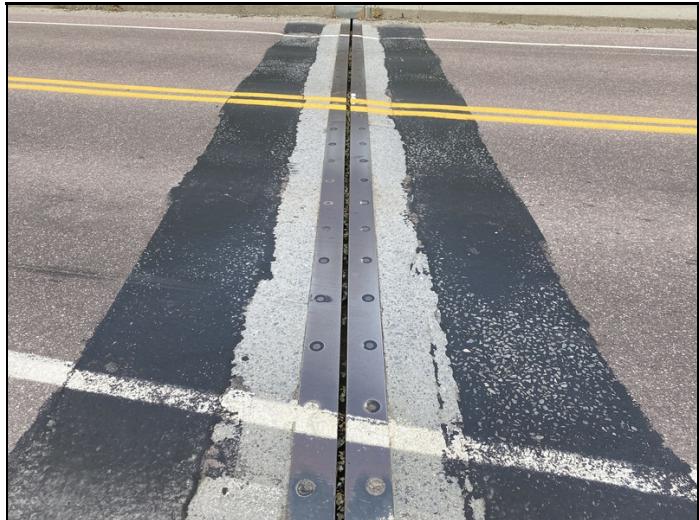
Vermont Type Joint over Pier #1
