Bearing damage and failure analysis

SKF®

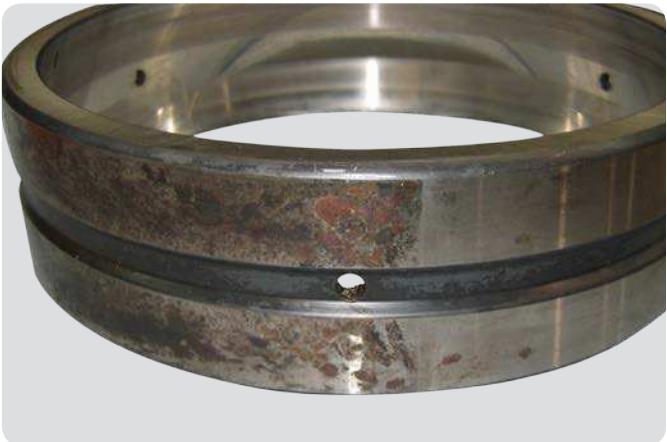
Spherical roller bearing outer ring
Inadequately supported ring

- Select appropriate fits
- Make sure the bearing seats are adequately machined
- Make sure the bearing seats conform to dimensional and geometrical specifications (even after overhaul of the machine)
- In the case of loose fits, consider applying an anti-fretting paste or coatings on one of the bearing surfaces

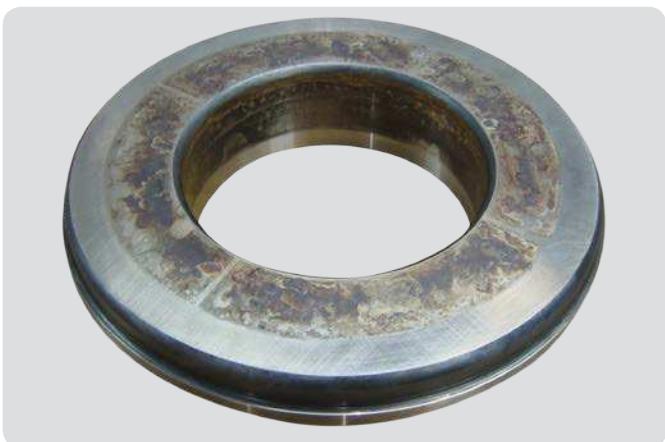
Spherical roller thrust bearing shaft washer
Inadequate seat

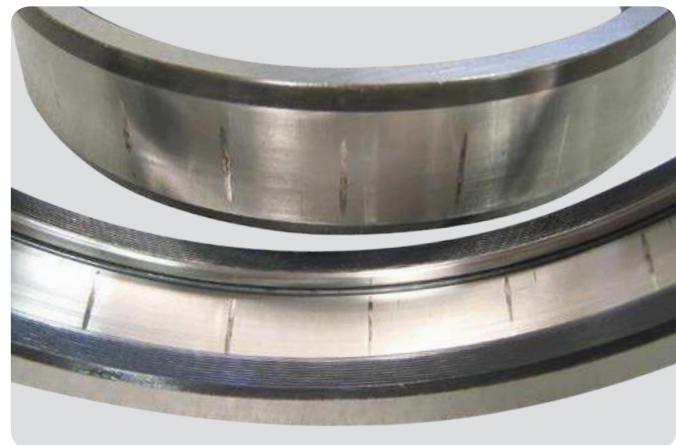
Cylindrical roller bearing inner and outer rings
Exposure to vibrations at standstill, false brinelling marks at roller pitch

- Do not expose bearings to vibrations at standstill
- Consider installing vibration damping pads
- Apply lubricant with anti-brinelling properties
- Rotate standby machines at regular intervals
- Use adequate bearing designs for vibratory applications

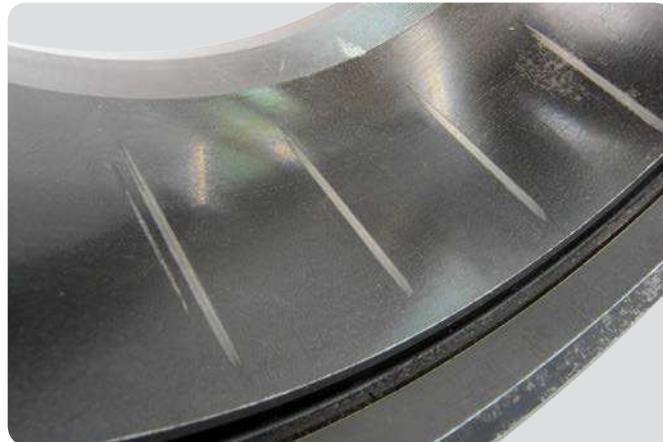
Double row tapered roller bearing outer ring
Exposure to vibrations at standstill, false brinelling marks at roller pitch

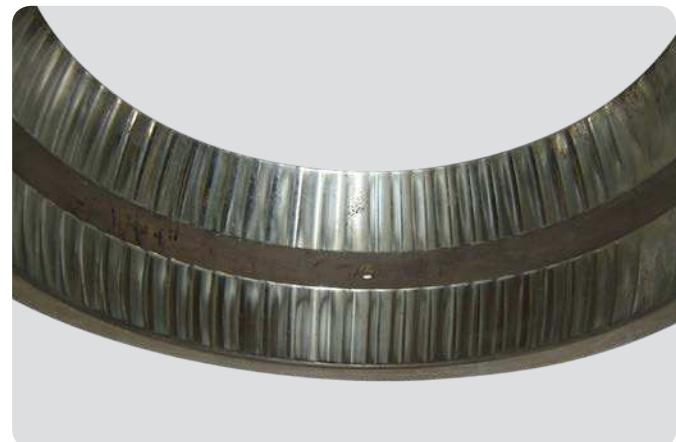
CARB toroidal roller bearing inner ring
Exposure to vibrations at standstill with small oscillatory movements, false brinelling marks at roller pitch

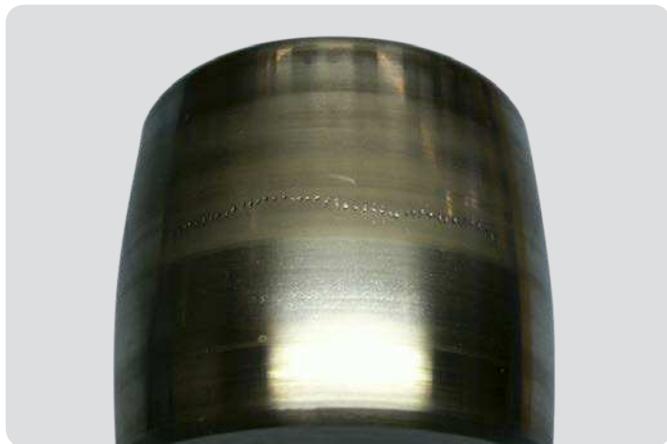
Spherical roller bearing – roller

Excessive current resulting in a large number of craters in a bead-like formation

- Make sure earthing connections are installed properly
- Use insulated bearings (INSOCOAT or hybrid bearings)

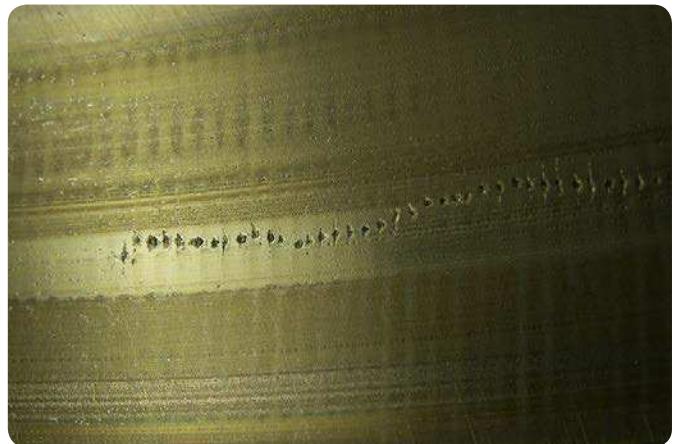
Spherical roller bearing – roller

Enlarged view of craters in a bead-like formation

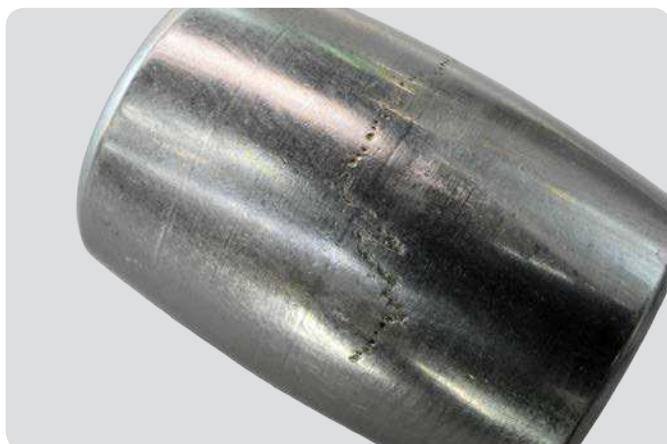
Spherical roller bearing – roller

Excessive current resulting in a large number of craters in a zig-zag formation

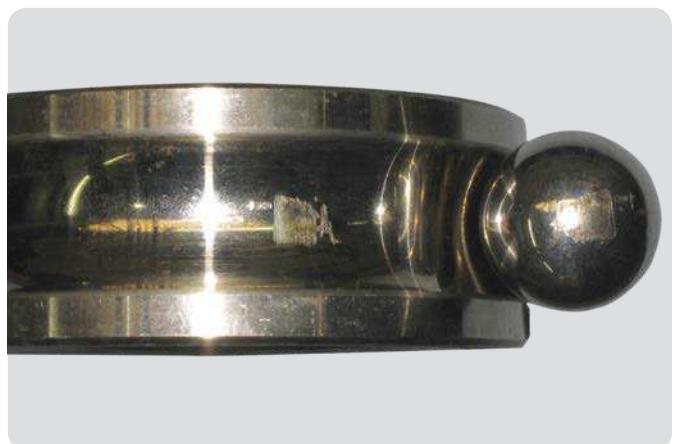
Deep groove ball bearing inner ring and ball

Excessive current resulting in a number of craters in zig-zag formation on the ball and raceway

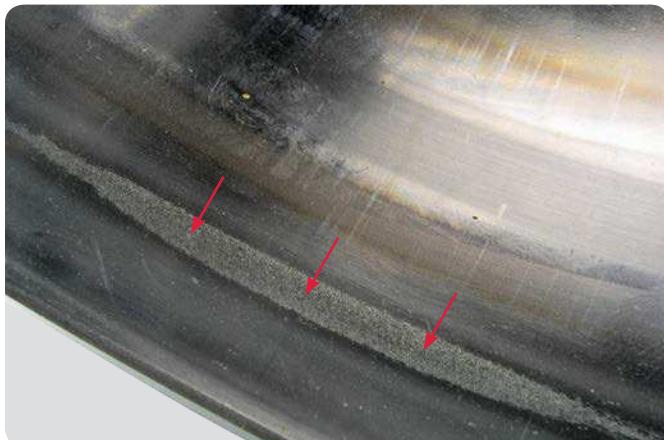
Spherical roller bearing outer ring
Damage in early stage: dull grey zone with small shallow craters

- Use symmetric cabling
- Make sure the stator and rotor are properly aligned
- Use insulated bearings (INSOCOAT or hybrid bearings)
- Make sure earthing connections are installed properly

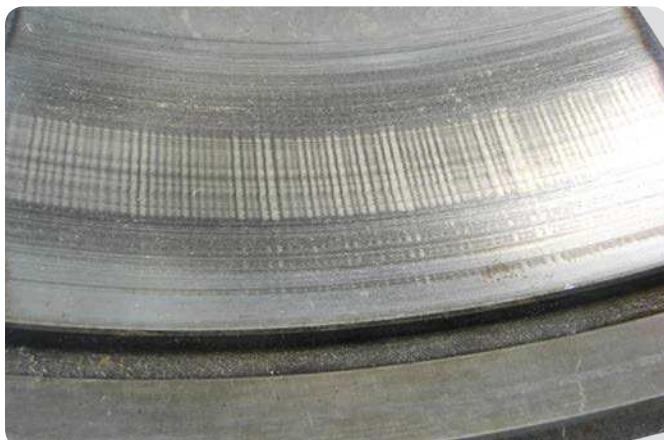
Tapered roller bearing outer ring
Early stage of washboarding

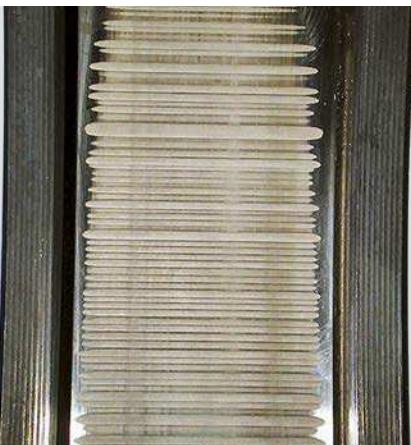
Cylindrical roller bearing outer ring
Advanced stage of washboarding

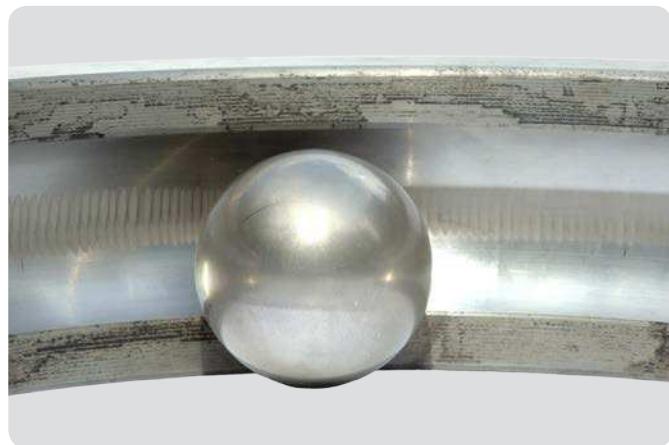
Deep groove ball bearing outer ring and ball
Washboarding in the outer ring and dull ball surface

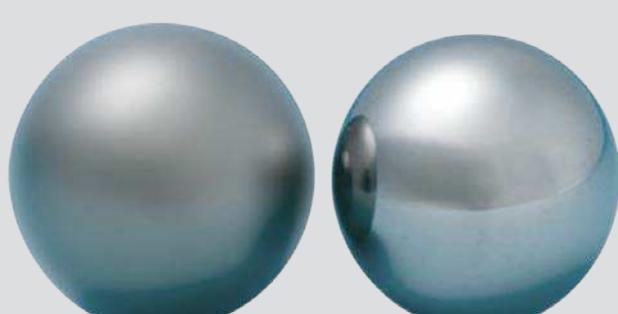
Deep groove ball bearing – balls
Left: damaged ball – dull surface
Right: new ball – shiny surface

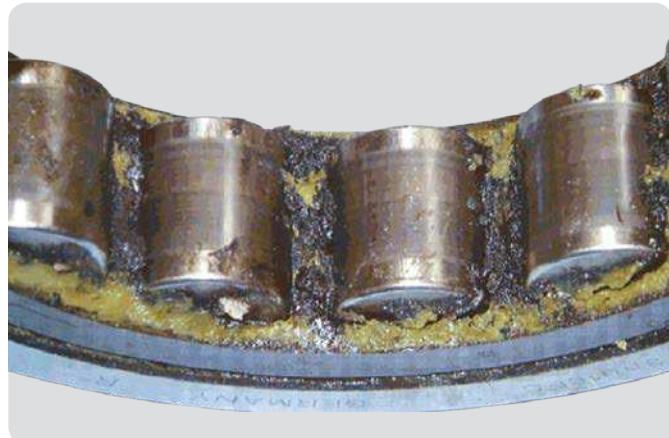
Cylindrical roller bearing outer ring with cage, rollers and grease
Current leakage resulted in burnt grease (black) on the cage bars

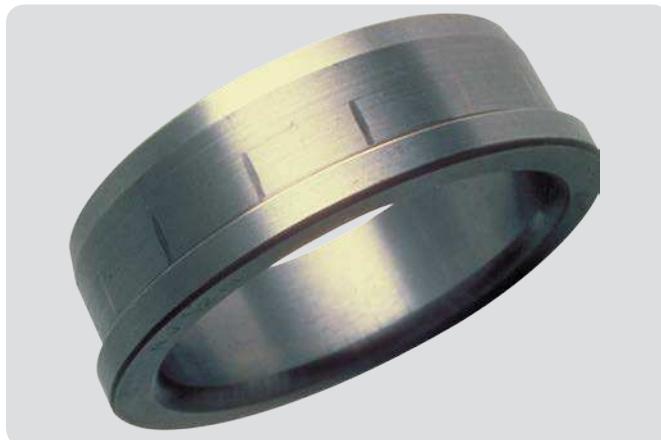
Cylindrical roller bearing inner ring

During mounting, inner and outer rings were not aligned properly. Axial marks at roller pitch.

- Use appropriate methods for mounting bearings
- Use appropriate tools or mounting dollies as required
- Follow mounting procedures and instructions carefully

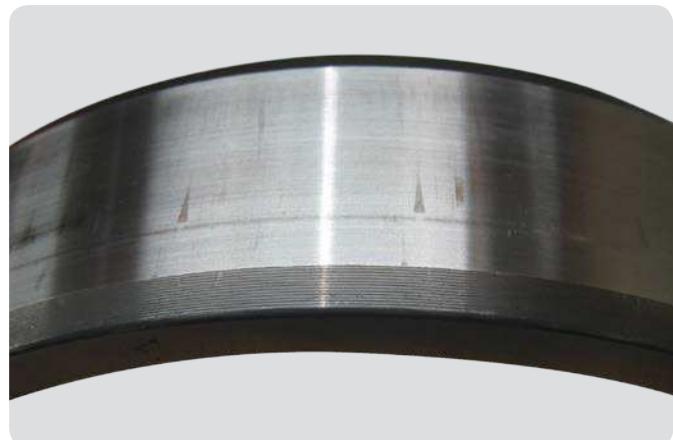
Cylindrical roller bearing inner ring

During mounting, inner and outer rings were not aligned properly. Axial marks at roller pitch.

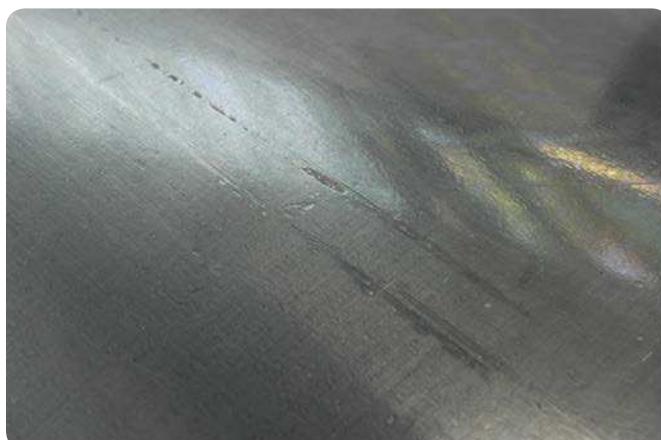
Tapered roller bearing outer ring

Scoring during handling

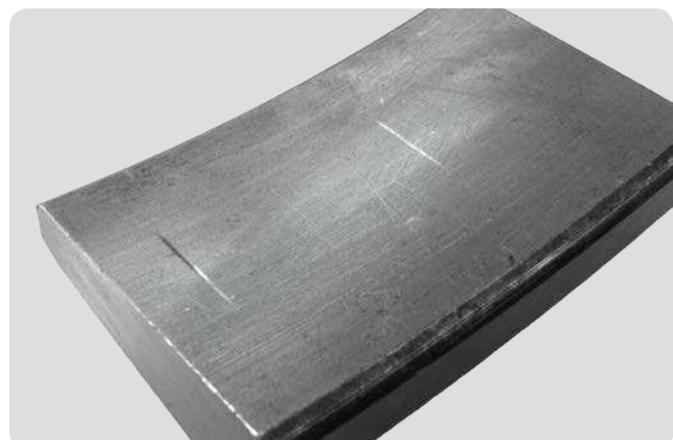
Tapered roller bearing outer ring

Scoring during mounting

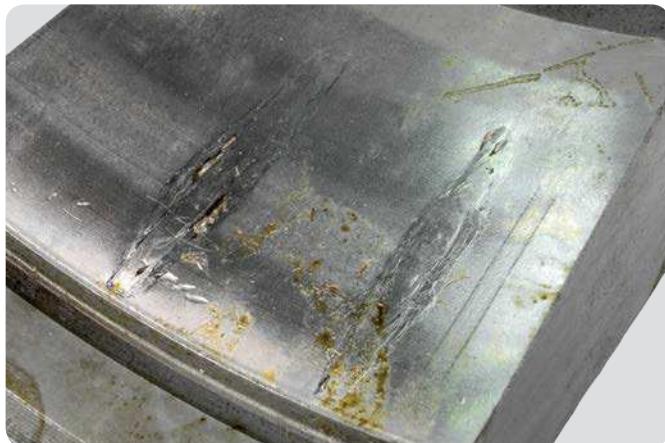
Double row tapered roller bearing outer ring

Overload impact and misalignment at standstill, resulting in deformation and subsequent spalling at roller pitch

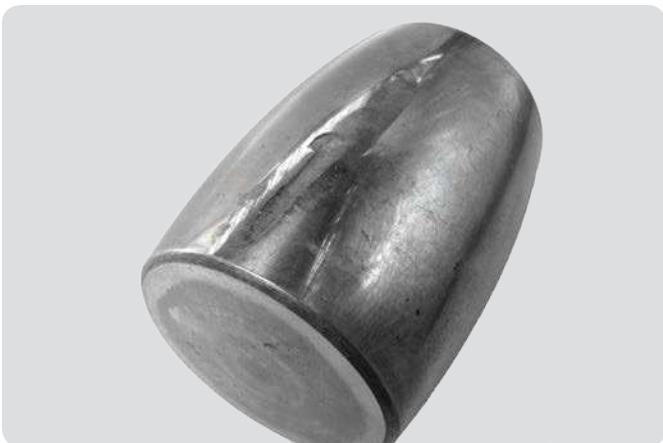
Spherical roller thrust bearing – roller

Heavy impact, plastic deformation

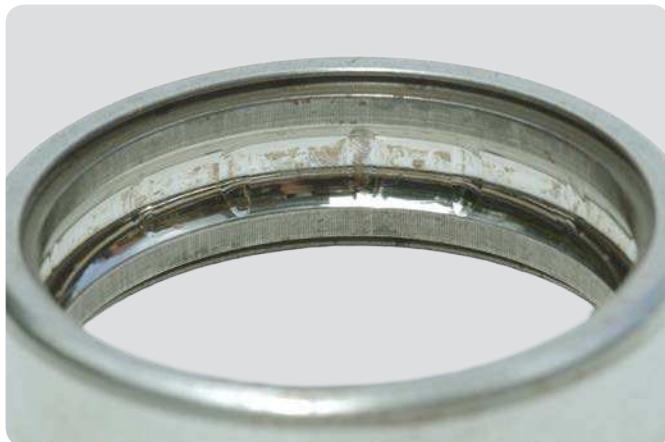
Deep groove ball bearing outer ring

Plastic deformation at ball pitch from applying mounting force to the wrong ring

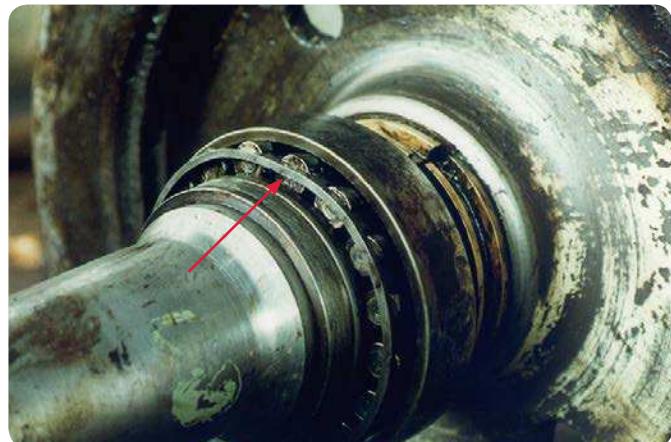
Tapered roller bearing mounted on a railway wheel set

Cage was hit directly during mounting, resulting in permanent deformation (flattening)

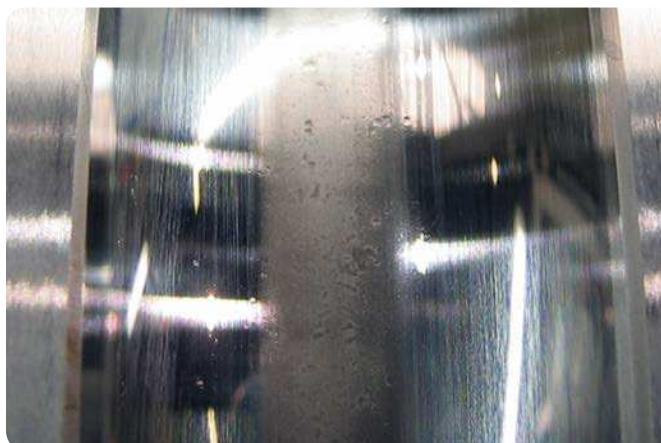
Deep groove ball bearing inner ring

Dents resulting from overrolling of hard particles – inadequate sealing arrangement

- Make sure to work in clean conditions
- Use adequate sealing to protect the bearing
- Make sure the lubrication is adequate: right lubricant, right quantity, right time
- Never drop a bearing
- Treat bearings carefully

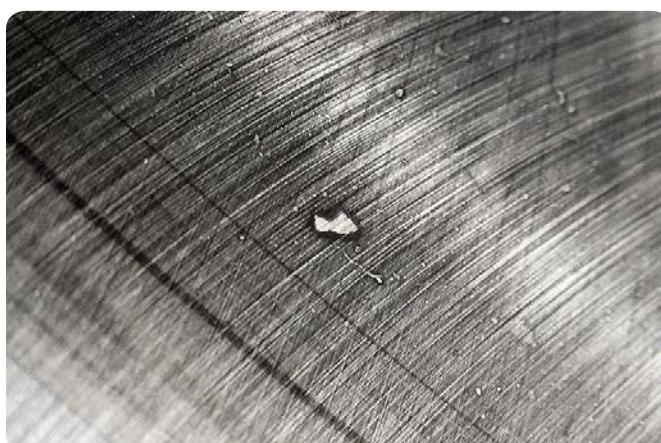
Spherical roller bearing outer ring

Overrolling of hard particles that entered the bearing during mounting – lack of cleanliness

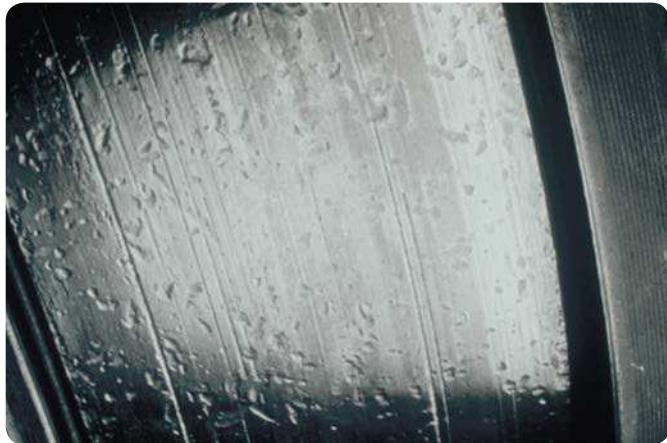
Overrolled swarf/chip will lead to spalling

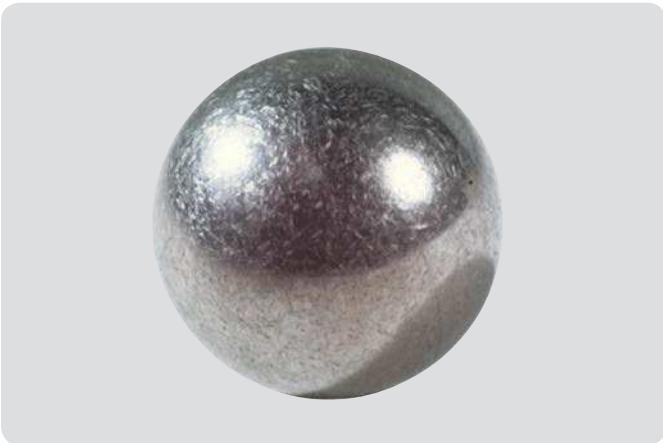
Deep groove ball bearing – ball

Damage resulting from hard particles in very contaminated lubricant

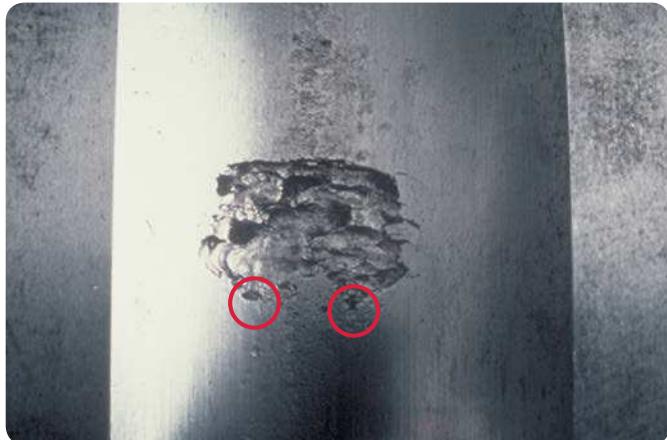
Deep groove ball bearing inner ring

Overrolling of particles with sequential spalling starting at the back of the dents

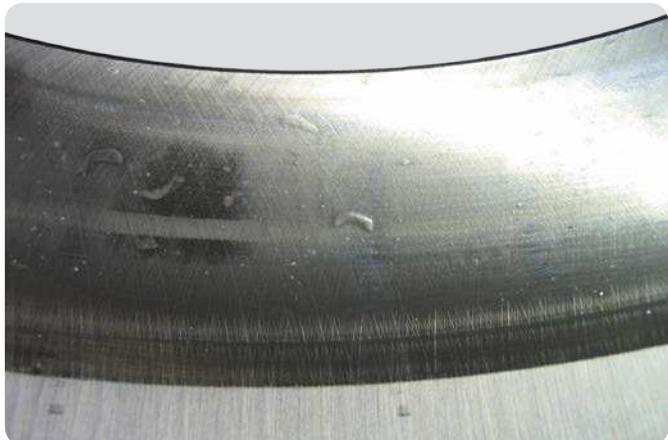
Spherical roller bearing outer ring

Overrolling of swarf entered during mounting – lack of cleanliness

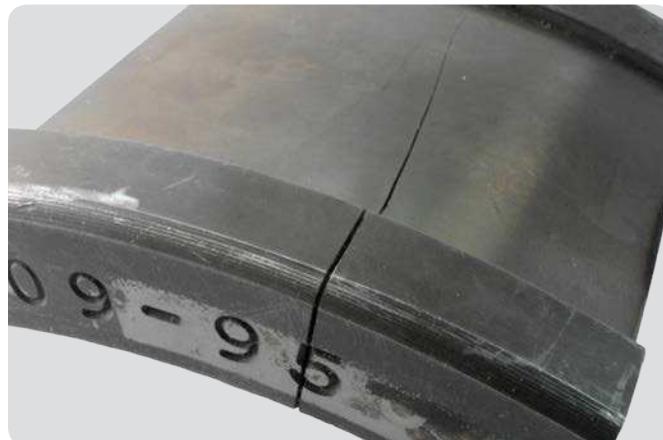
Tapered roller bearing inner ring
The bearing was fitted to an oversized shaft

- Select appropriate fits
- Use appropriate methods for mounting bearings
- Use appropriate tools or mounting dollies as required
- Follow mounting procedures and instructions carefully
- Never use brute force on bearings or apply mounting forces through the rolling elements

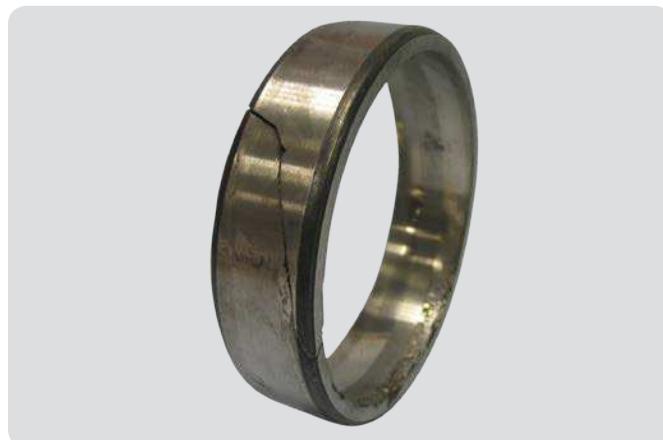
Self-aligning ball bearing outer ring
Fracture resulting from excessive misalignment and balls running over the raceway edge

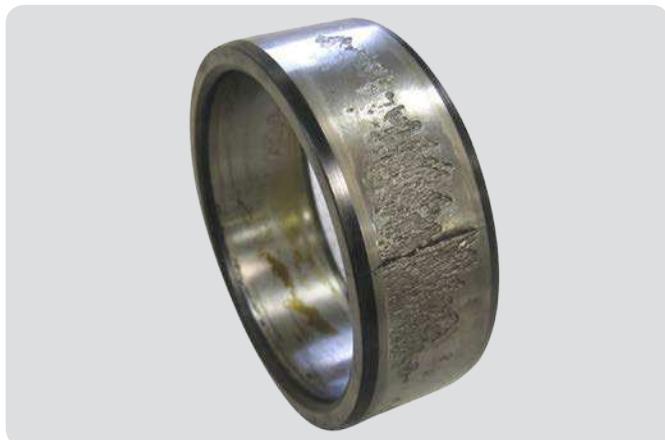
Cylindrical roller bearing inner ring
Very heavy spalling – fatigue fracture as sequential damage

- Make sure bearing seats conform to geometrical specifications
- For split housings, make sure the two halves join correctly
- Bearing seats should be clean (no swarf or chips, which could create local stress rise)
- Use appropriate tools and methods for mounting

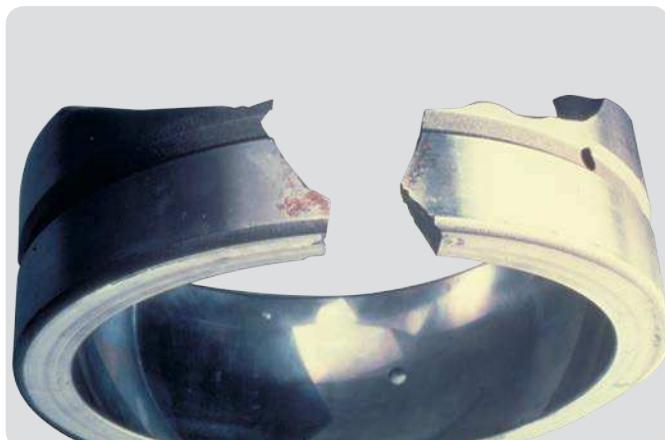
Spherical roller bearing outer ring
Fatigue fracture resulting from inadequate housing seat (swarf trapped at the bottom of the housing)

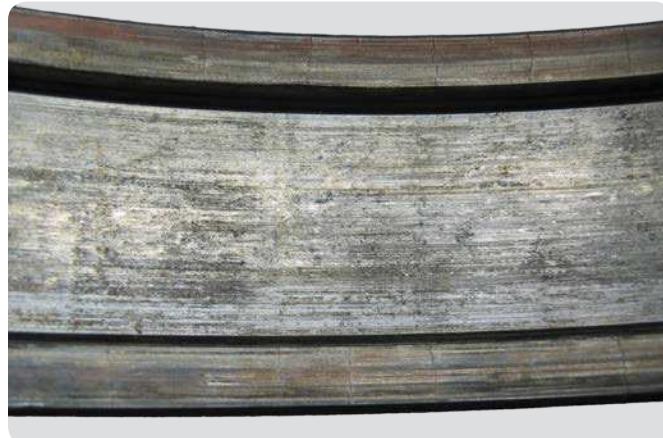
Cylindrical roller bearing outer ring

Thermal cracks at both shoulder-cage contact due to inadequate lubrication

- Lubricate sliding surfaces or apply coatings to reduce local peak temperatures
- Make sure the lubrication is adequate: right lubricant, right quantity, right time
- Check for application specific solutions with the SKF application engineering service

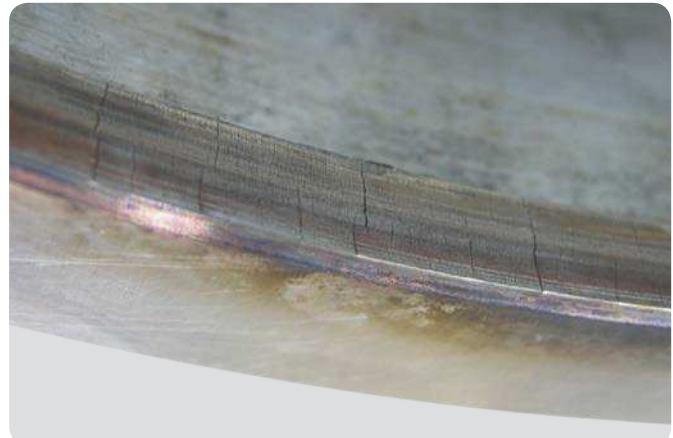
Cylindrical roller bearing outer ring

Thermal cracks at shoulder-cage contact due to inadequate lubrication

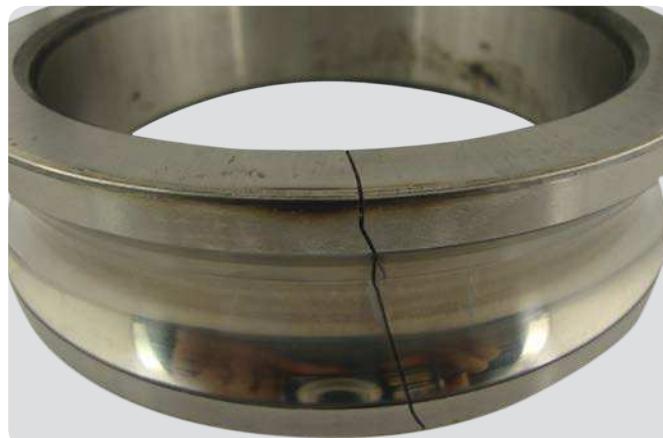
Deep groove ball bearing inner ring

Ring fractured due to excessive friction against a stationary part of the bearing assembly

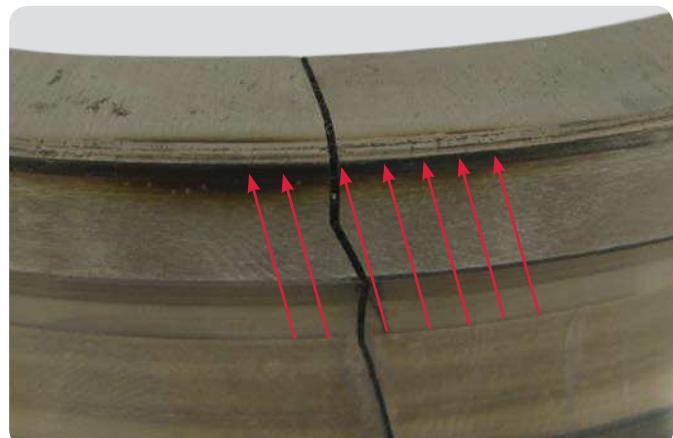
Deep groove ball bearing inner ring

Enlarged view of fractured ring, with many heat cracks along the inner ring shoulder

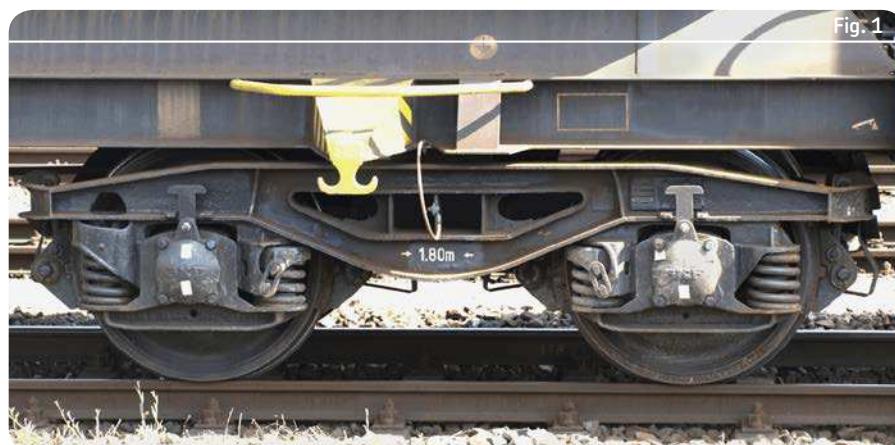
Fig. 1

But, 35 km later, the train derailed. The axle of a wheelset had broken. The wagon in question had been overhauled not long before by an authorized railway repair shop.

Goods wagons equipped with “Y-25” bogies, incorporating axleboxes with a double spring suspension

Apparently, the shorter spacer was installed during the overhaul. As a result, the bearing inner rings were not properly axially clamped and able to move on their shaft seat towards the outboard side, which increased shaft bending. Also the outer rings were not properly positioned in the axle box housing, leading to axial contact in the labyrinth seals. This resulted in high frictional heat, bearing seizure, shaft fracture and derailment.

The customer reviewed and improved the maintenance instructions, to make sure such accidents would not reoccur.

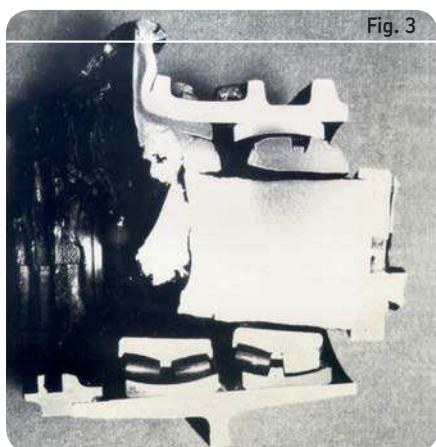
Remains of the failed axlebox (cut), as presented for the failure analysis

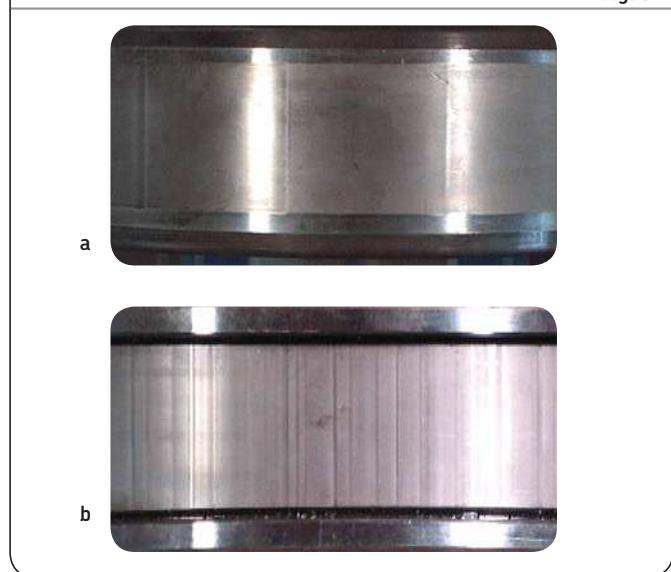
Fig. 5

There was heavy wear on the raceway. The wear was irregular; some flats were observed. The raceway was dull and grey in colour (→ fig. 5a).

There was heavy wear on the raceway (load zone). The wear was irregular. Marks similar to those caused by vibration (washboarding) were visible. The raceway was dull and grey in colour (→ fig. 5b).

The visual inspection only revealed an irregular waviness pattern, which looked like heavy wear from vibration.

Heavy wear and vibration marks on the inner ring (a) and outer ring (b) raceways of the cylindrical roller bearing

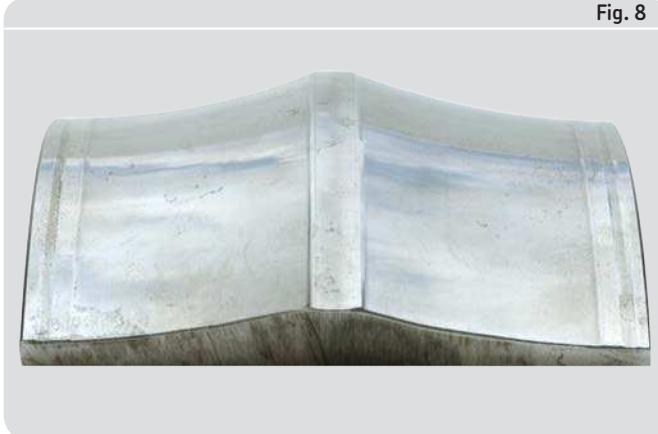
Fig. 8

The bore showed no signs of fretting corrosion and the side faces were undamaged. The raceways showed severe abrasive wear. On both raceways, the cages had cut a groove at the edge of the raceway, indicating that the cages were making contact with the raceways. The raceways were dull and grey in colour (→ fig. 8).

Inner ring: Heavy abrasive wear on the raceways and a circumferential groove at both raceway edges

There was a huge amount of abrasive wear in the bearing. The cage pocket clearance had increased substantially, making the cage drop and cut a groove at the edge of the raceway.

The customer improved the sealing arrangement and reduced lubrication intervals.

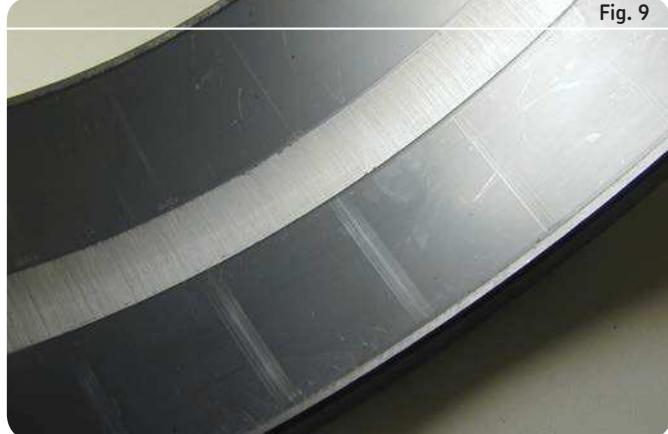
Fig. 9

The raceways showed heavy abrasive wear, and were dull and grey in colour (→ fig. 9). There were also transverse smearing marks (at roller pitch) from dismounting.

Outer ring: Heavy abrasive wear on the raceways and transverse smearing marks

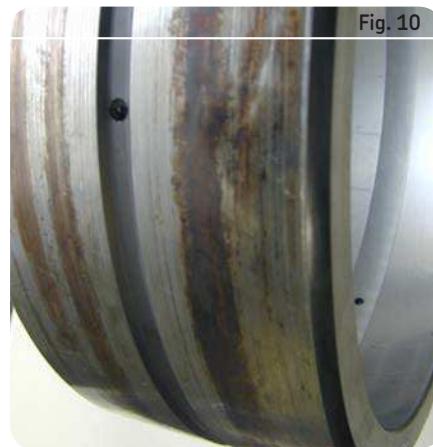
Outer ring: Fretting corrosion on the outside surface

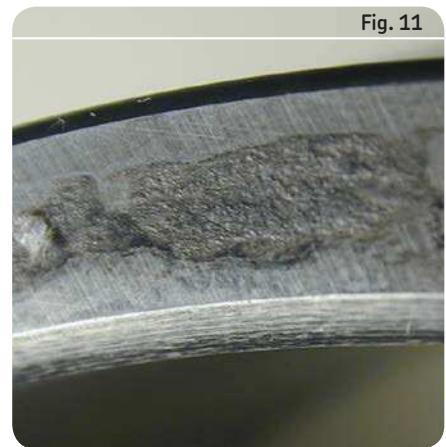
Outer ring: Fretting corrosion on the side face

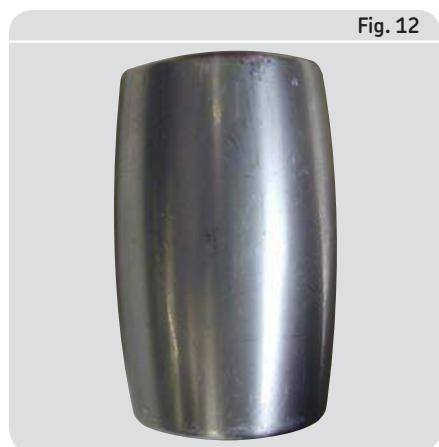
Fig. 12

The rollers were dull and grey in colour. Smearing marks from dismounting were visible (→ fig. 12).

Roller: Dull and grey colour

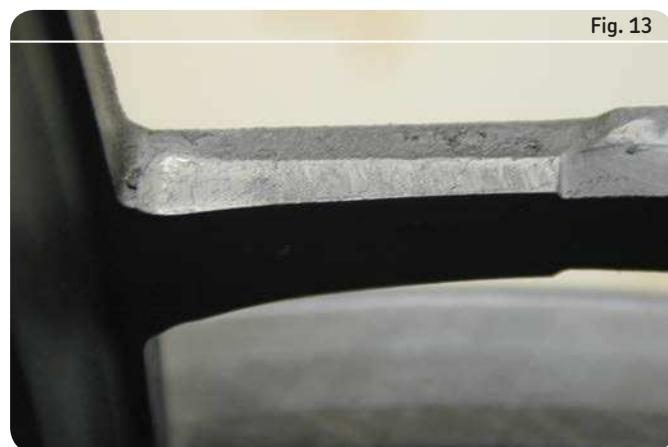
Cage: Pocket wear

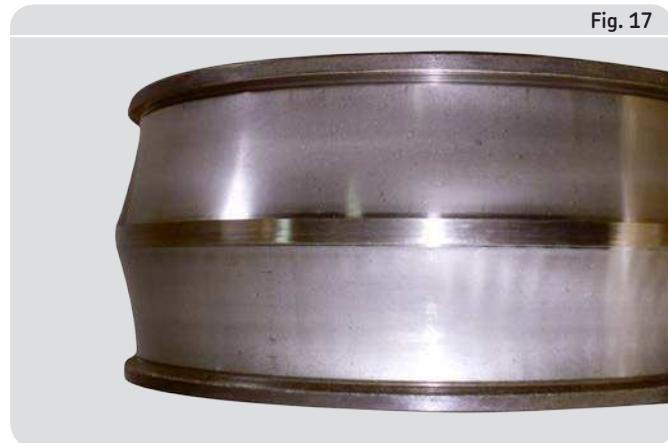
Fig. 17

There was heavy abrasive wear on the raceways (→ fig. 17). No other marks were visible.

The abrasive wear on the inner ring raceways was probably secondary damage due to the spalling, as the condition of the lubricant was found to be unacceptable.

Inner ring: Abrasive wear on the raceways

- 1) Check the bearing seat in the housing.
Repair if needed.
- 2) Locate the source/cause of vibration during operation.

During a planned shutdown, the bearing seat was repaired and the discharge end of the crusher redesigned. Since the modifications, no further problems have been reported.

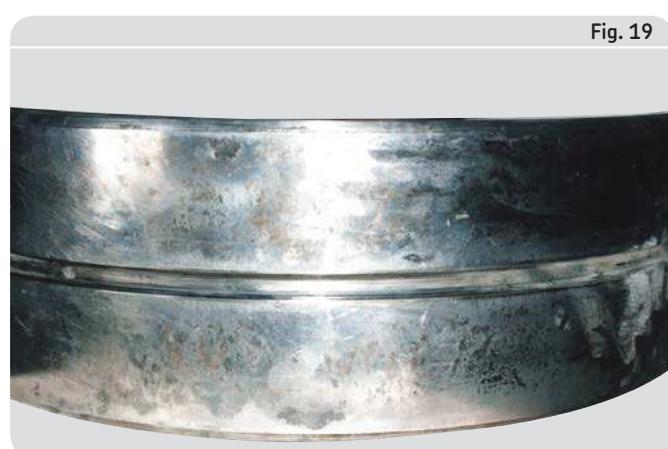
Fig. 19

Outer ring: Load zone spalls and vibration marks on the raceways, at the bottom of the ring
