Lubrication

Bearing Failure Patterns and Trouble-shooting

## Bearing Failure analysis

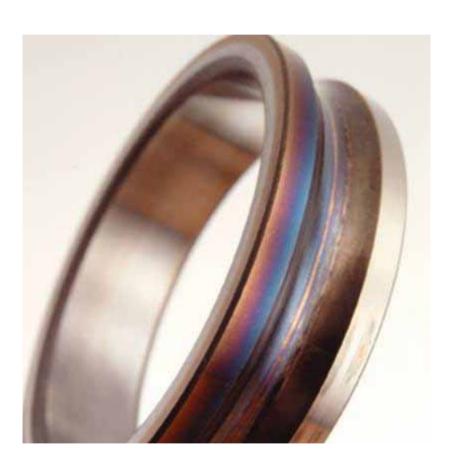
- Discoloration of the rings, rolling elements and cages from gold to blue
- Temperatures in excess of 200°C can anneal ring and rolling element materials, reducing the bearing capacity and causing early failure

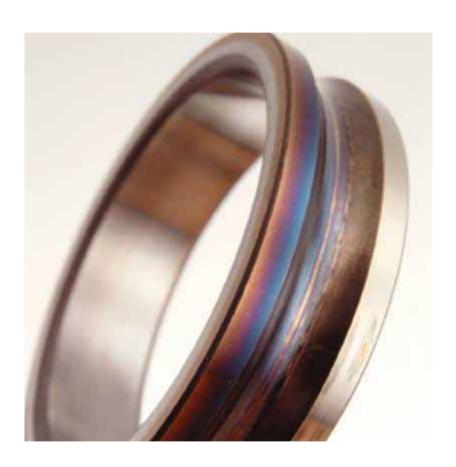
- In extreme case, the bearing components will deform
- Temperature rise can also degrade or destroy **lubricant**

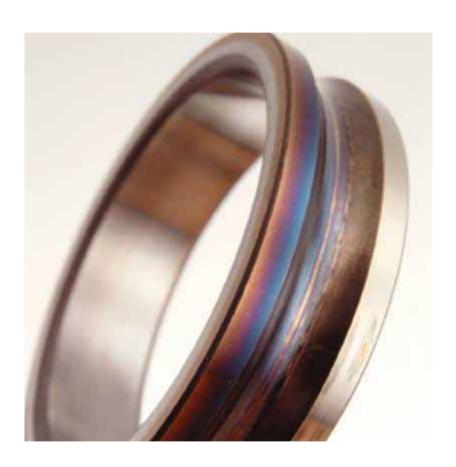
- Heavy electrical heat loads
- Inadequate heat paths
- Insufficient cooling or lubrication when loads and speed are excessive

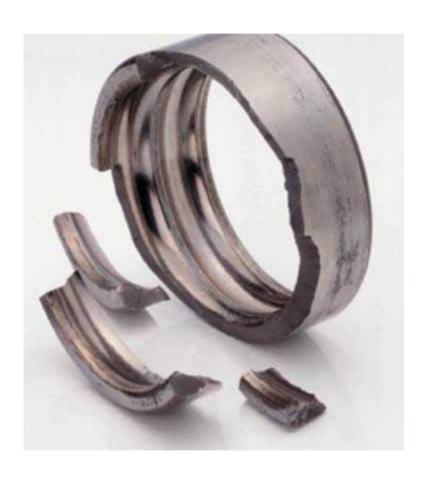
## Outer Ring Fracture

- Typically a crack spreads evenly in the circumferential direction, with several fractured pieces often originating
- With axial load, fractures usually occur a little beyond the middle of the raceway
- Outside outer ring shows irregular load pattern

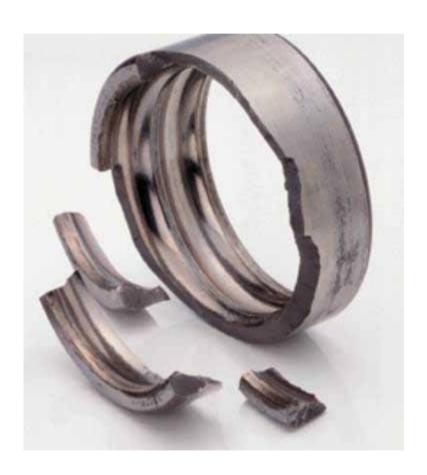
# Outer Ring Fracture

Poor support of the rings in the bearing housing

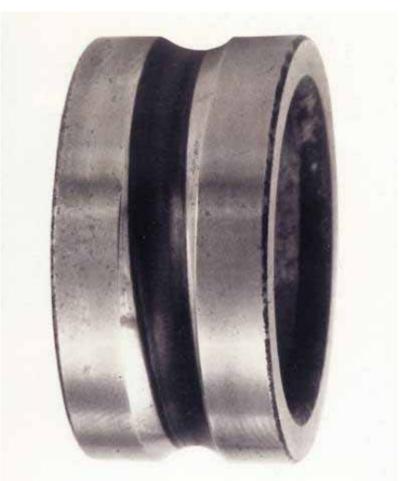
## Misalignment

A wear path not parallel to raceway edges on the raceway of the no rotating ring

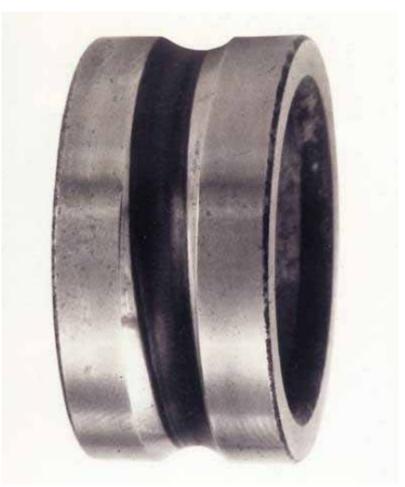
## Misalignment

- Bent shafts
- Burrs or dirt on shaft or housing shoulders
- Shaft threads that are not square with shaft seats
- Locking nuts with faces that are not square to the thread axis

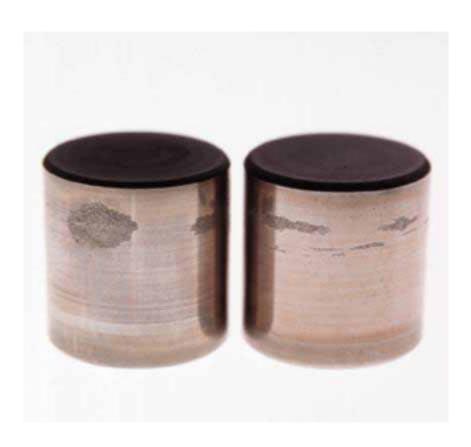
# Slippage Tracks

- Spotted smear marks
- Roughening of rolling elements or raceways

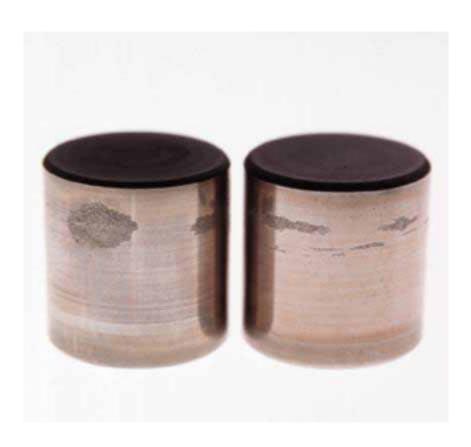
## Slippage Tracks

- Rolling elements slide on the raceways when the load is low and lubrication is poor
- Occasionally occurs if load zones are too short, causing rolling elements to
- Also, fast changes in speed brake in the unloaded zone and accelerate again when entering the load zone

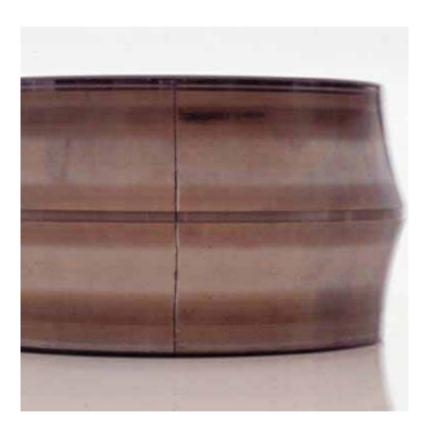
### **Axial Cracks**

- Inner ring partly or completely cracked in the axial direction
- Slightly rounded fractured edges indicate that the fracture originated during operation and was cycled (cracked edges may break off after prolonged operation)
- Sharp edged cracks indicate fracture during dismounting

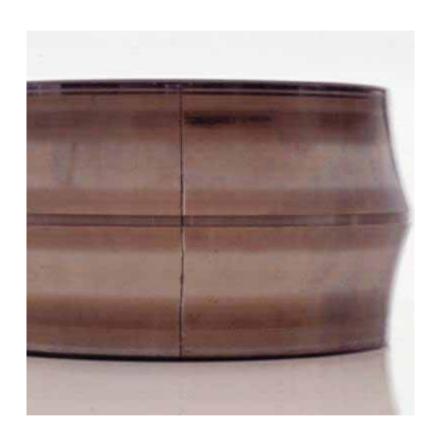
### **Axial Cracks**

- Bearing slippage
- Rotation of inner ring on the shaft
- Inadequate lubrication
- Too tight of fit to shaft
- Grooved shaft
- Out-of-roundness
- Grazing against surrounding parts

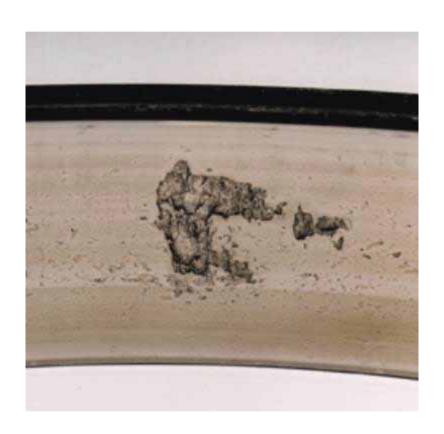
## Normal Fatigue

- Often referred to as spalling; indicated by the fracture of the running surfaces and subsequent removal of small discrete particles of material from the inner ring, outer ring or rolling elements
- Spalling is progressive, and once initiated will spread with continued operation
- Always accompanied by a noticeable increase in vibration

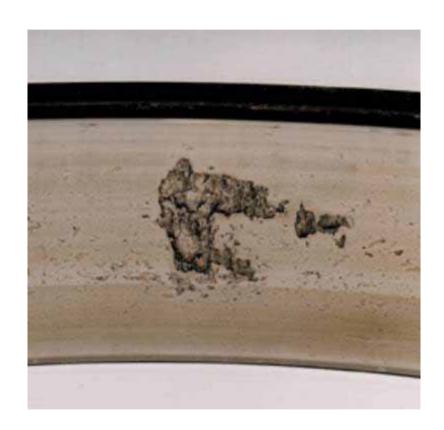
## **Normal Fatigue**

Bearing has remained in operation beyond its calculated fatigue life

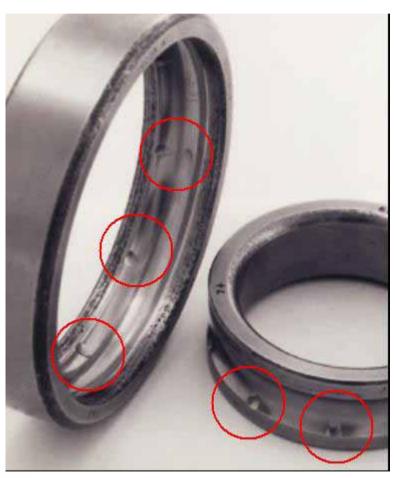
## True Brinelling

- Brinell marks appear as indentations in the raceways, increasing bearing vibration (noise)
- Severe brinell marks can cause premature fatigue failure

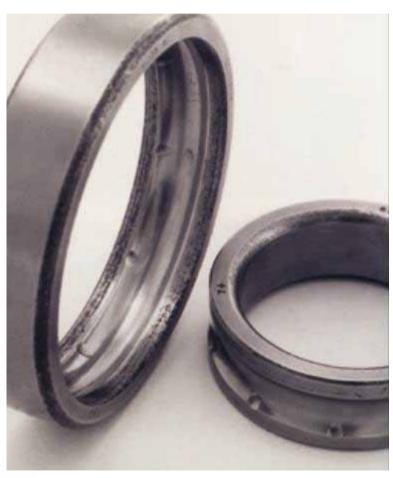
## True Brinelling

- Static overload of the bearing
- Severe impact to the bearing
- Using a hammer to install the bearing
- Dropping or striking assembled equipment
- Pressing a bearing onto the shaft by applying force to the outer ring

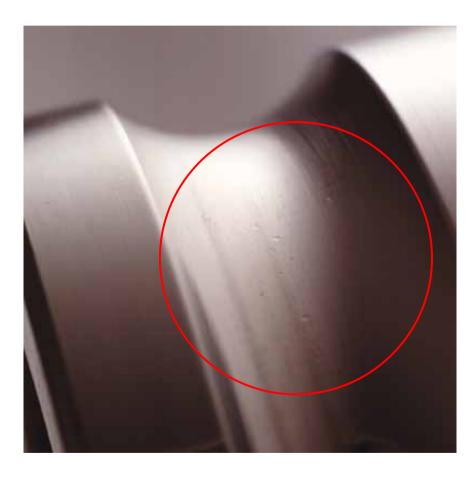
### Contamination

Denting of rolling elements and raceways, causing vibration

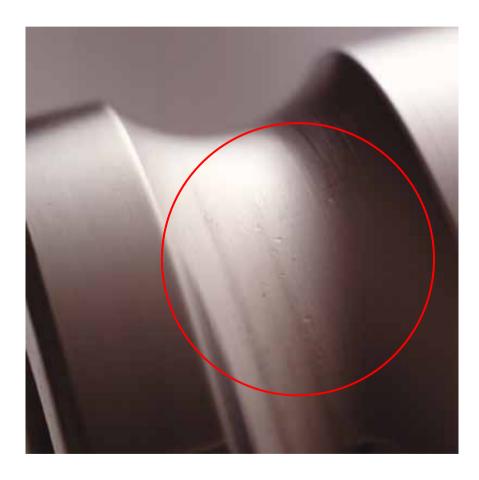
### Contamination

- Air-born dust, dirt or abrasive substances from contaminated work areas
- Dirty hands or tools
- Foreign matter in lubricants or cleaning solutions

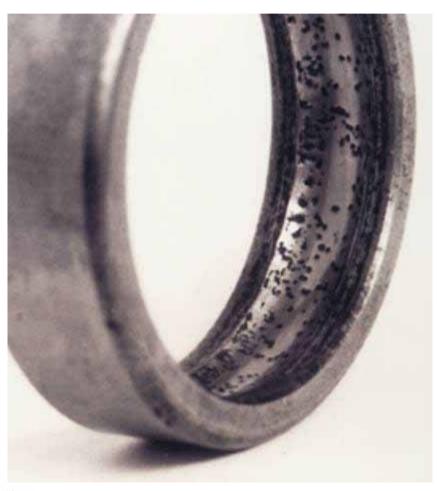
## Corrosion

- Corrosion results from the chemical attack on bearing materials by hostile fluids or atmospheres
- Red/brown stains or deposits on rolling elements, raceways or cages
- Increased vibration followed by wear
- Increase in radial clearance or loss of preload

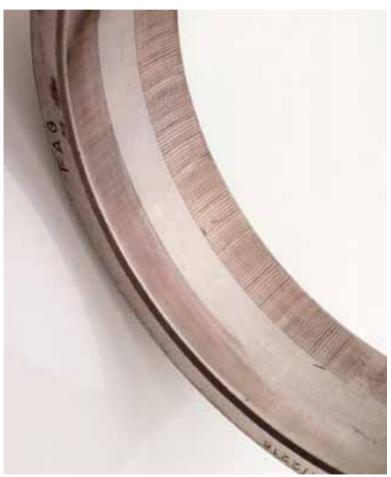
# Fluting

Brownish marks parallel to the axis on a large part of the raceway, or covering the entire raceway circumference

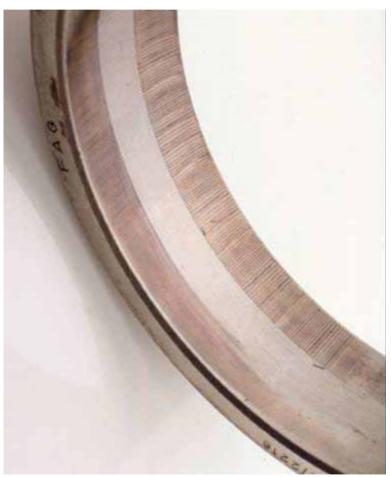
## **Fluting**

- Electrical Fluting occurs when a current is passed through the bearing, instead of to a grounded source.
- Constant passage of alternating or direct current
- Even low currents

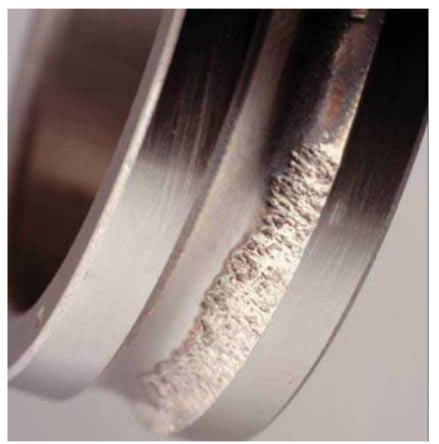
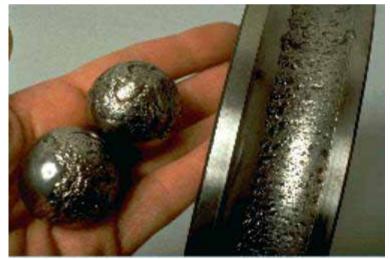
## **Excessive Loads**

Excessive loading of the bearing

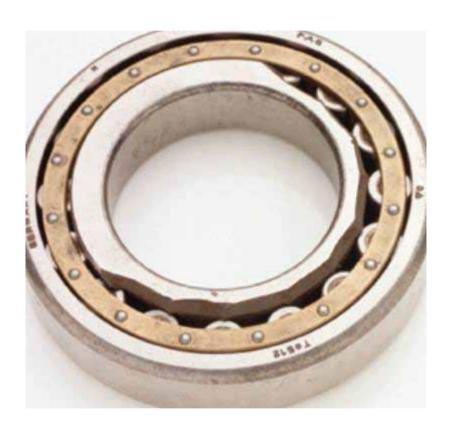
# Lip Fractures

Supporting lips are partly or completely broken off or cracked

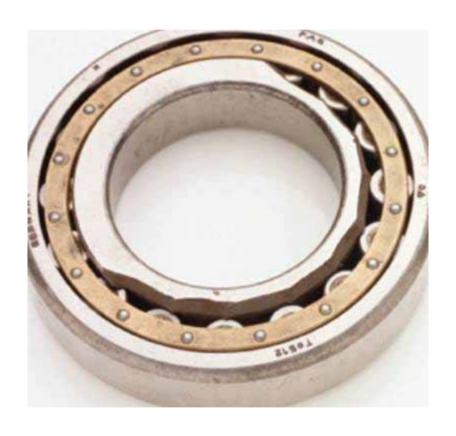
# Lip Fractures

- Axial load unacceptably high
- Lip insufficiently supported
- Axial shock load
- Mounting damage

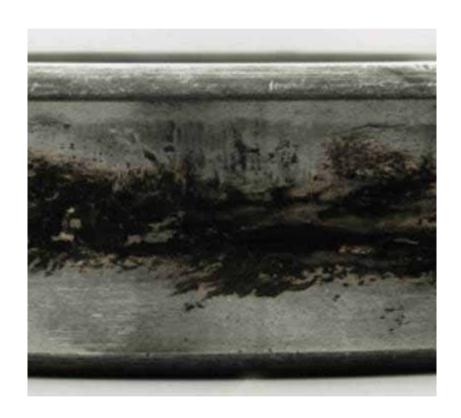
## Fretting

- Fretting, the generation of fine metal particles which oxidize, leaving a distinctive brown color
- Wear at the fitting surfaces causing noise & runout problems
- Possible fatigue fracture
- Possible disturbance of floating bearing function

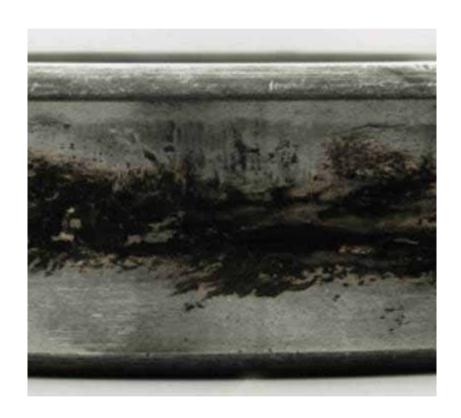
# Fretting

Micro motion between fitted parts where the fits are too loose in relation to the acting forces

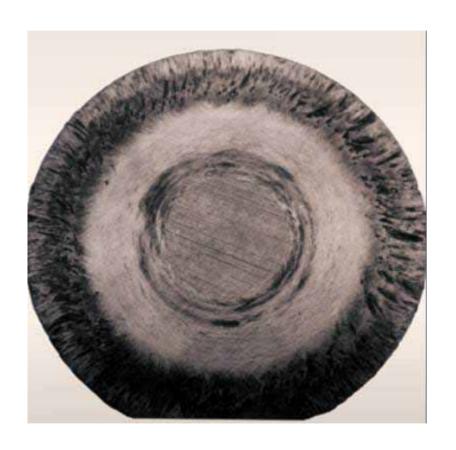
- Partial or large-area welding and deep scratches in the lip and roller face areas
- Also lubricant coking in this area

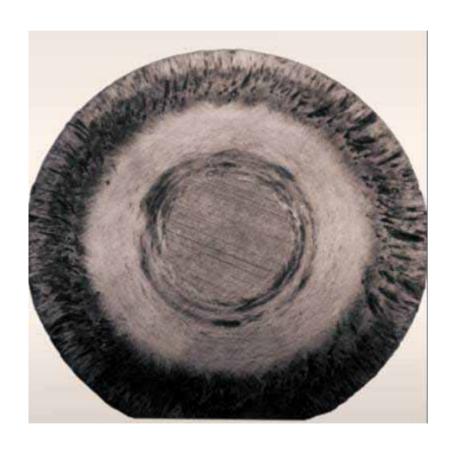
- Inadequate lubrication with high loads and high speeds (quantity or operating viscosity of lubricant too low)
- Inadequate lubrication
  with high loads
  and low speeds (when
  there is no hydrodynamic
  lubricating film between
  the roller face and lip)

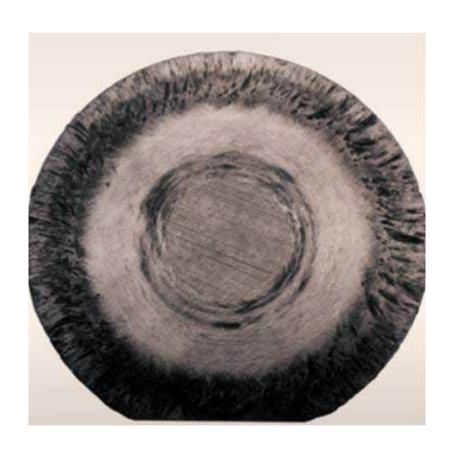
- Detrimental preload due to heat expansion
- Skewing of rollers due to raceway wear or ring tilting
- Axial load too high on cylindrical roller bearings
- Axial preload too high for out-of-square mating surfaces

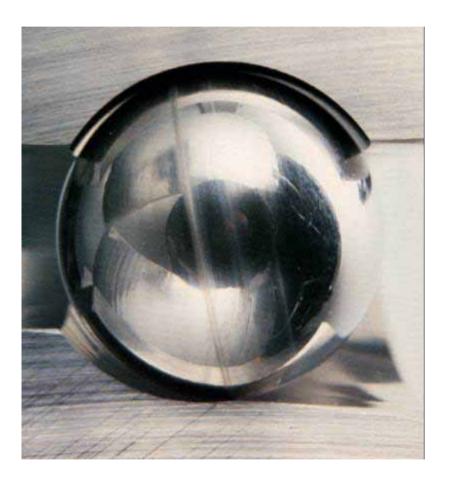
- Balls will show a grooved wear band caused by the ball riding over the outer edge of the raceway
- Failure mode is very similar to that of heavy interface (tight) fits.

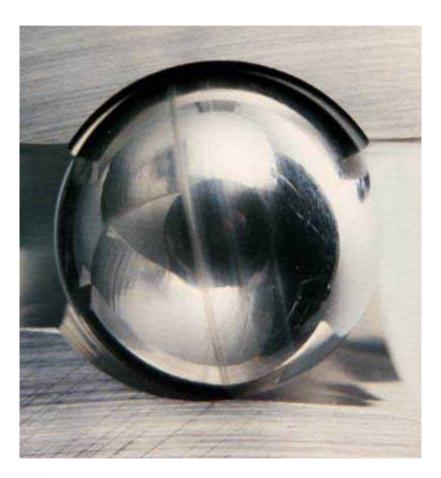
- Angular contact ball bearings are designed to accept an axial load in one direction only
- When loaded in the opposite direction, the elliptical contact area on the outer ring is truncated by the low shoulder on that side of the outer ring

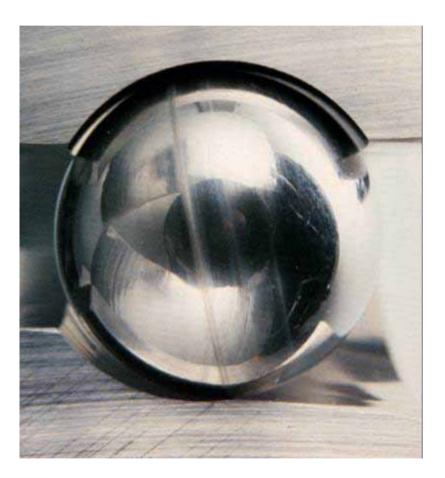
- Result is excessive stress and an increase in temperature, followed by increased vibration and early failure
- A thrust load applied to the wrong bearing face results in a wear band on the balls.
