Above the Flood: **ELEVATING YOUR FLOODPRONE HOUSE**

FEDERAL EMERGENCY MANAGEMENT AGENCY

MITIGATION DIRECTORATE

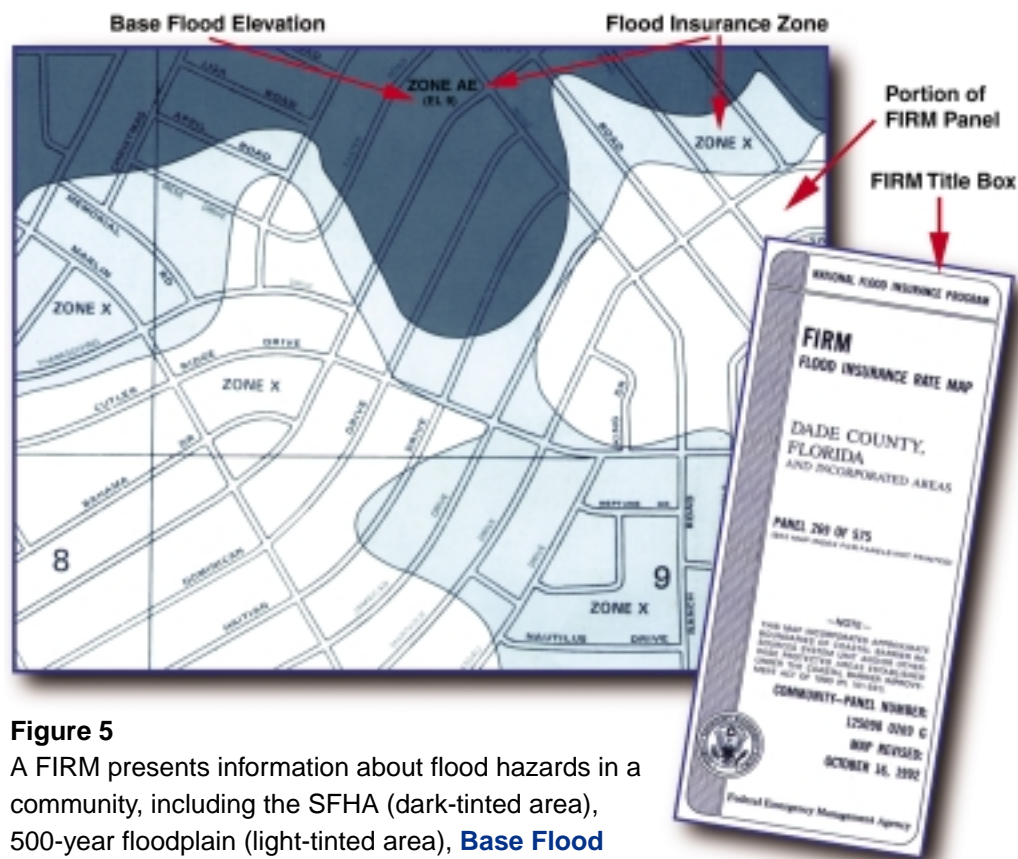
A FIRM presents information about flood hazards in a community, including the SFHA (dark-tinted area), 500-year floodplain (light-tinted area), **Base Flood Elevations**, (BFEs) (number in parentheses), and flood insurance zones (AE and X in this example).

Note that the SFHA in the example in Figure 5 is designated Zone AE. This zone is only one of several applied to SFHAs under the NFIP, including V, VE, V1-V30, A, AE, A1-A30, AO, and AH. These zones indicate differences in the types and severity of flood hazards in SFHAs. For the purposes of this publication, it is sufficient to focus on the basic differences between the two main types of SFHA zones—V zones and A zones. The distinction is important because regulatory requirements associated with V zones and A zones differ significantly. As explained later in this chapter, these requirements affect the types of building elevation techniques that may be used under the NFIP.

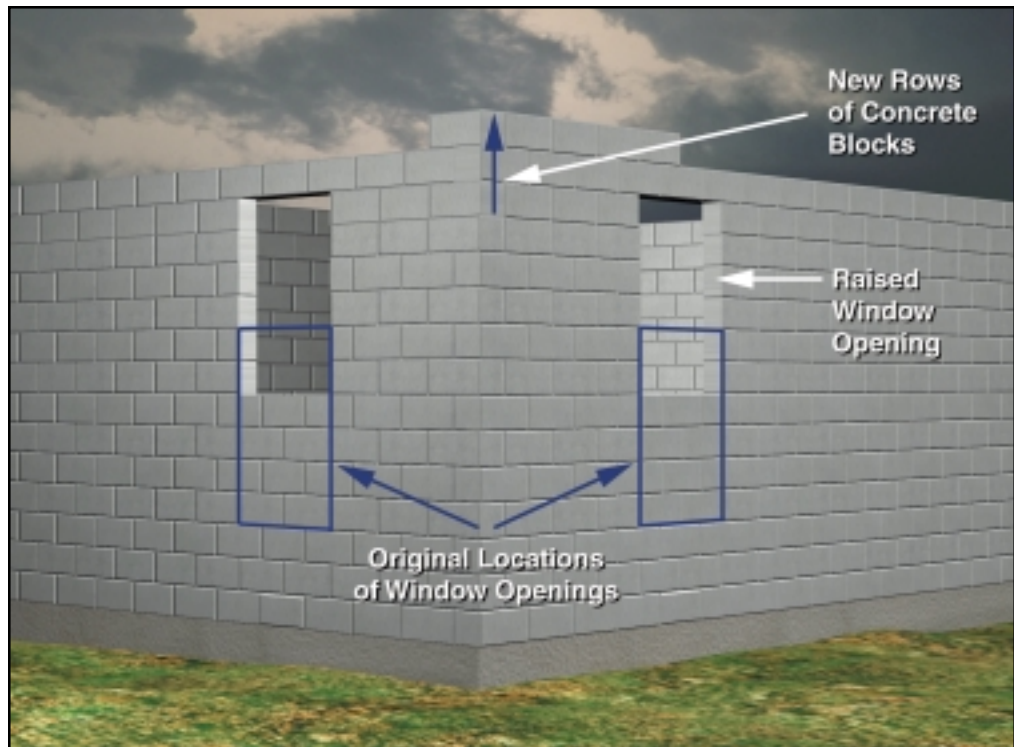
The tops of the walls and bottoms of the window openings are raised with concrete blocks.

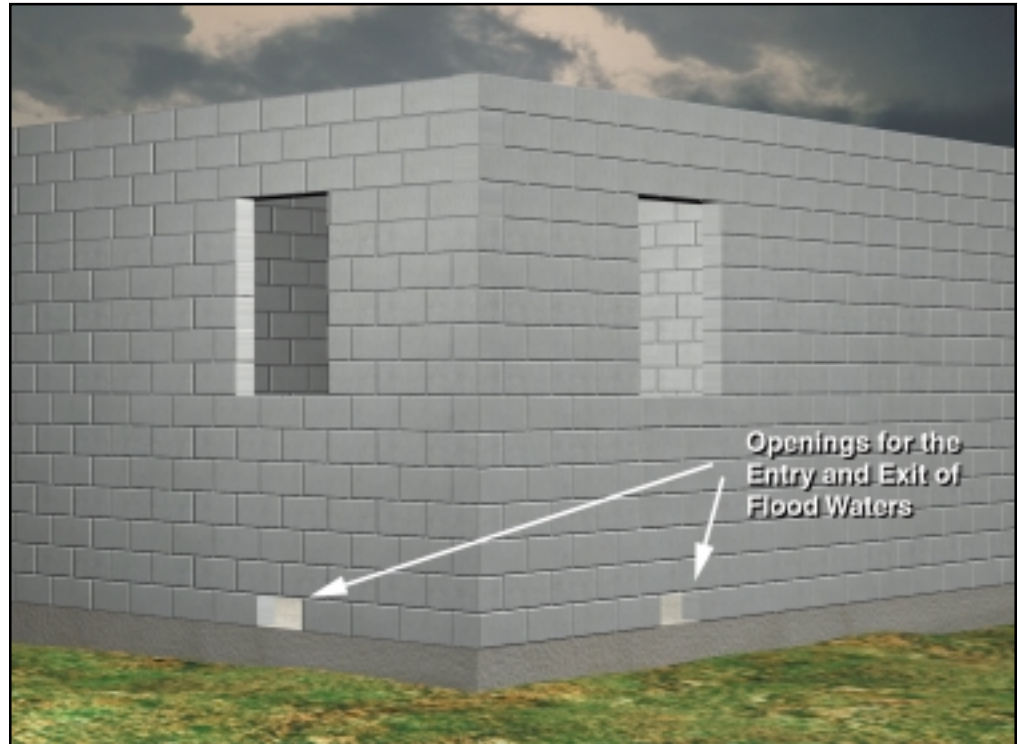
Figure 12
Openings are created in the walls near the ground.

Blocks are removed from the walls of the house at selected locations within 1 foot of the ground (Figure 12). The resulting openings will allow flood waters to flow into and out of the lower area of the house so that the water pressures on both sides of the walls will remain the same. The roof and windows are then replaced, and a new wood-frame floor is constructed above the flood level (Figure 13).

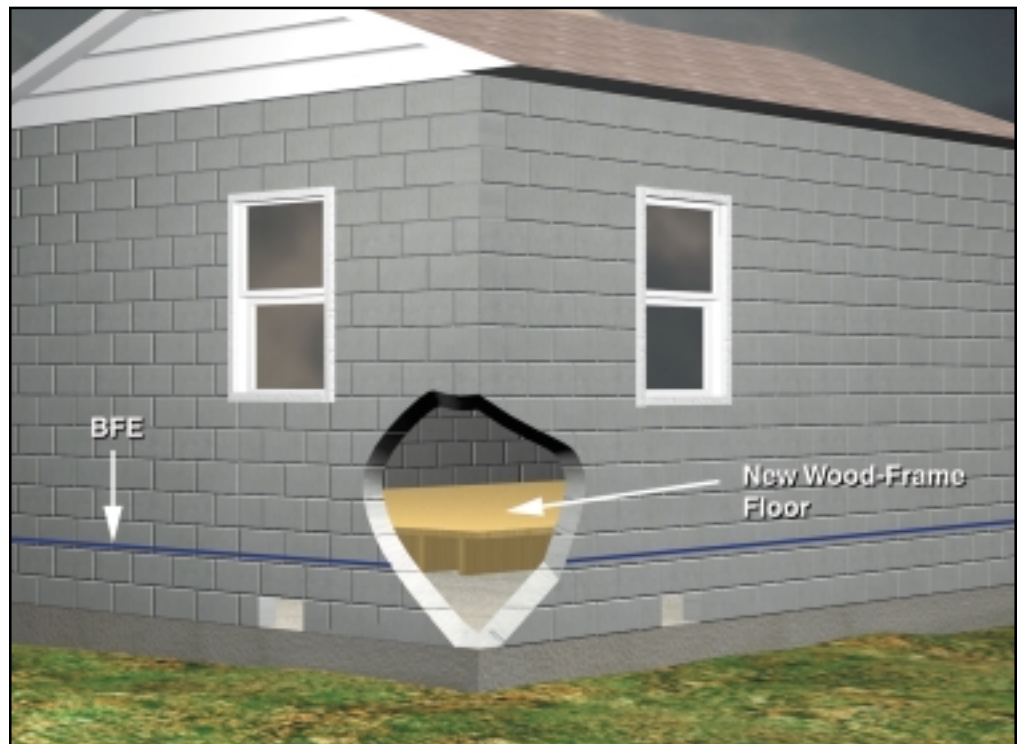
Figure 13
A new wood-frame lowest floor is constructed above the flood level, and the roof, windows, and doors are reinstalled.

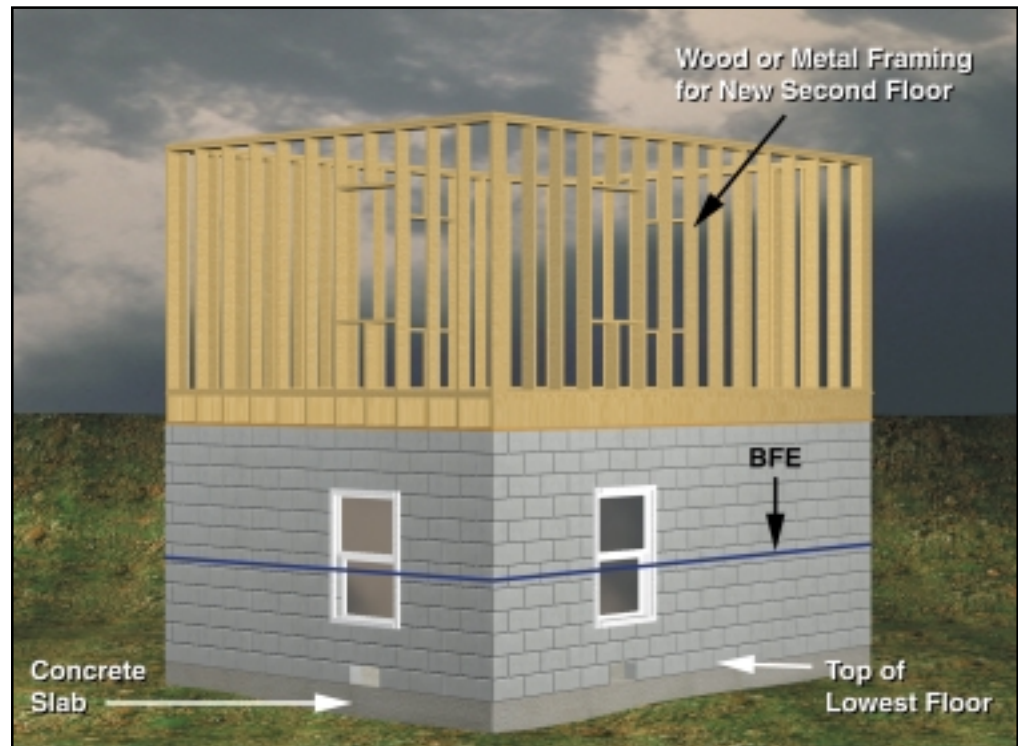
The new second-story floor and walls are built on top of the existing lower story.

As in Technique 1, the repairs begin with the temporary removal of the roof and roof framing (Figure 10). After the roof is removed, construction of the new second story begins. First, a new wood-frame floor is built on top of the existing lower-story walls. The second-story walls are framed with metal or wood studs and set in place on the floor (Figure 15).

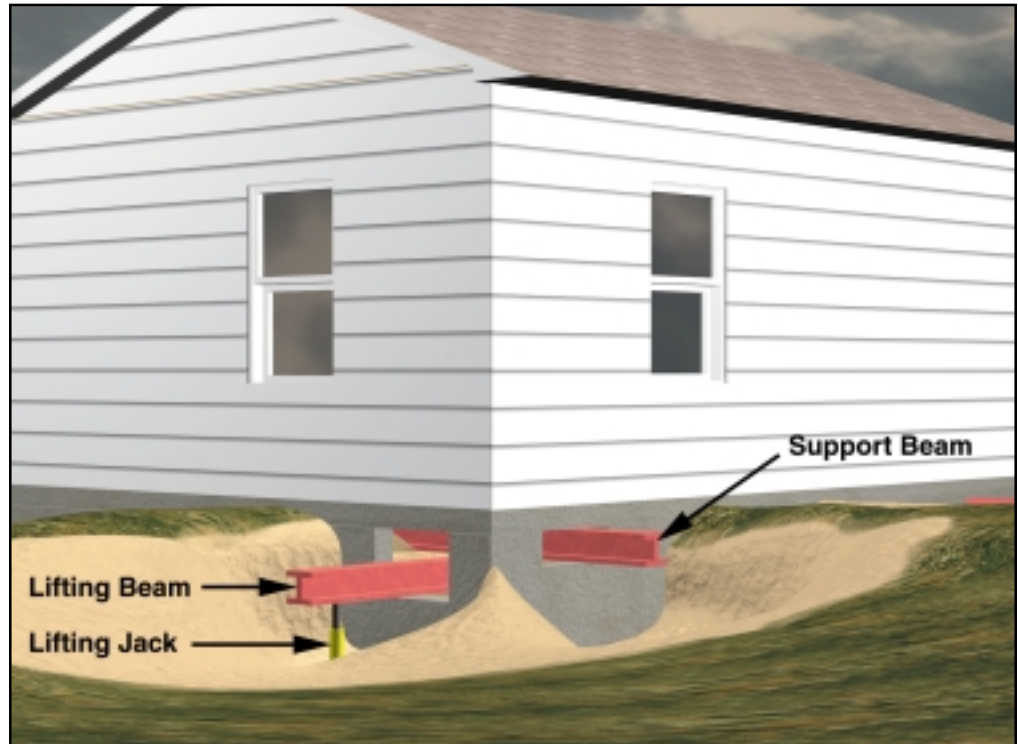
Figure 18

With I-beams and jacks in place, the house is ready to be lifted.

First, trenches are dug to expose the foundation walls immediately below the slab. Holes are then cut in the foundation walls at intervals around the house, and tunnels are dug under the slab (Figure 17). Jacks are placed in the trenches and large I-beams are inserted through the tunnels and allowed to rest on the jacks. Smaller I-beams are then inserted through the tunnels at right angles to the larger beams and positioned on top of them. The smaller beams support the slab when the house is raised (Figure 18).

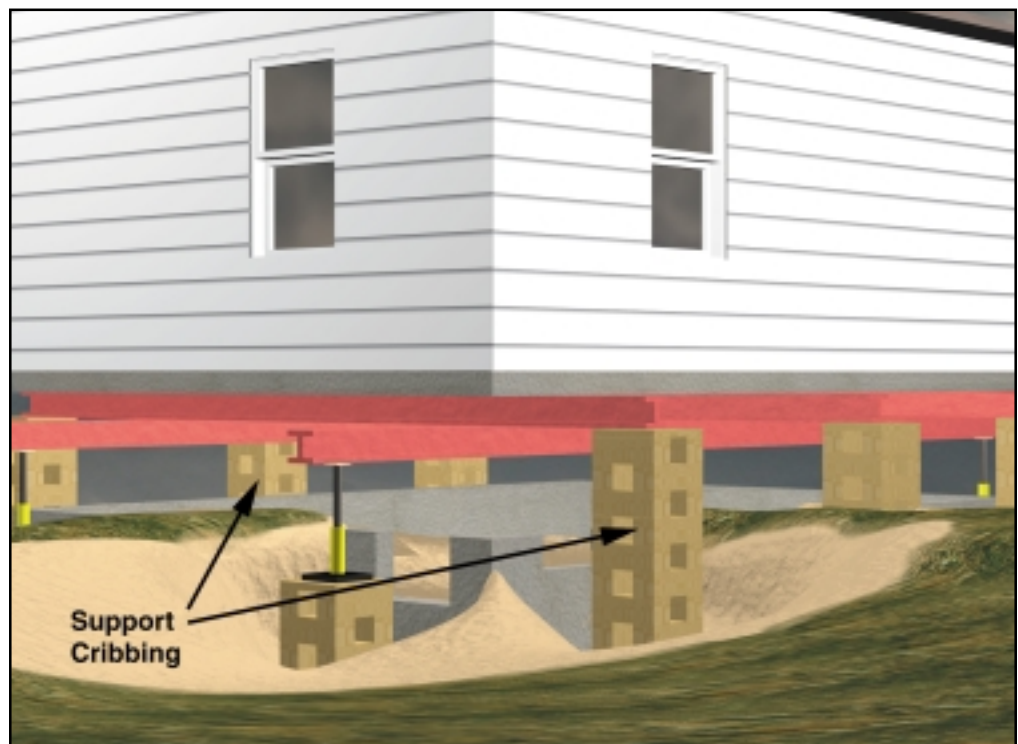
The house is temporarily supported on cribbing.

The house is then jacked up. When the jacks have extended as far as possible, the house must be supported temporarily while the jacks are raised. Both the house and the jacks are usually supported on “cribbing”—temporary piles of crisscrossed timbers (Figure 19). The jacks are then used to raise the house higher.

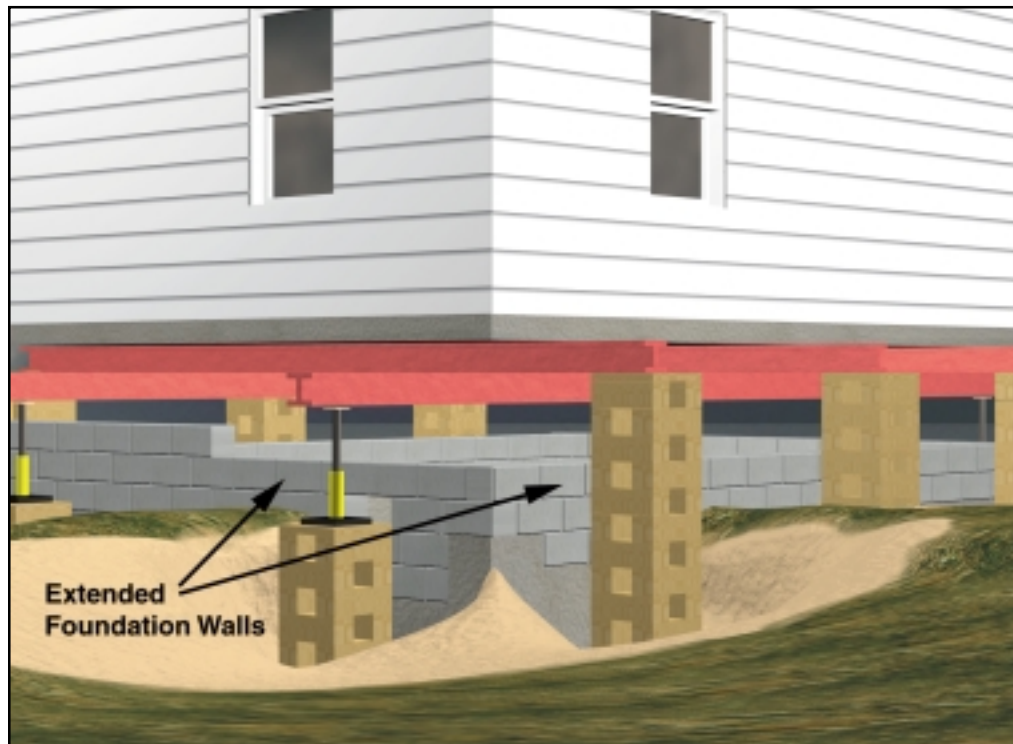
Figure 20
New, extended
foundation walls are
constructed with
concrete blocks.

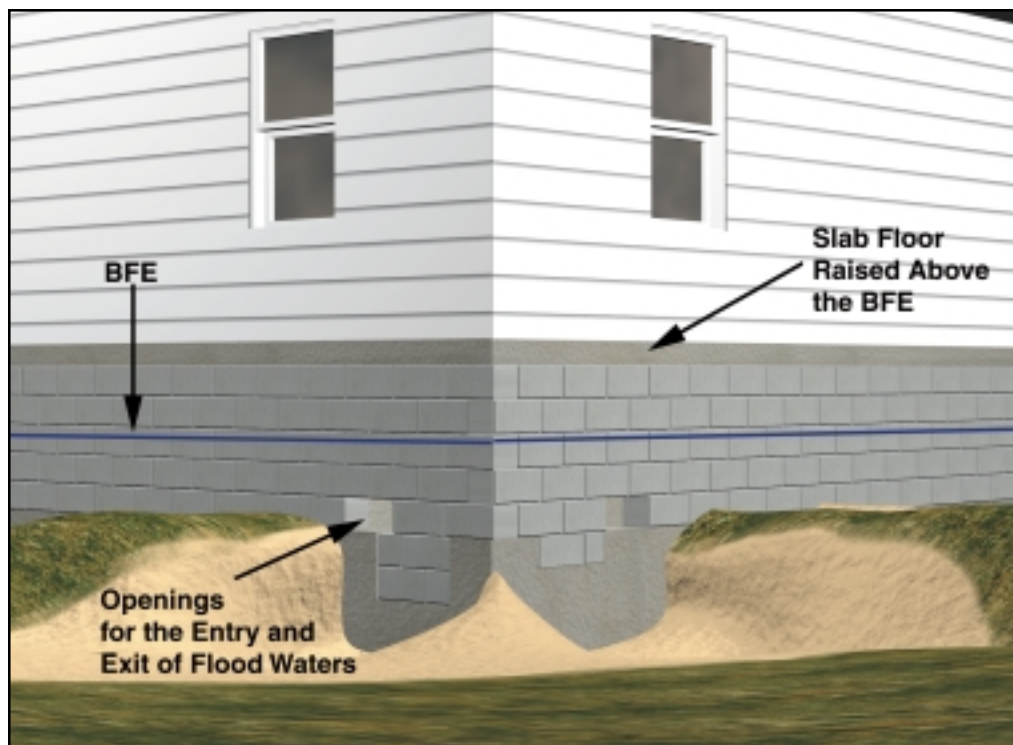
Figure 21
Elevated house and
slab on new, extended
foundation walls.

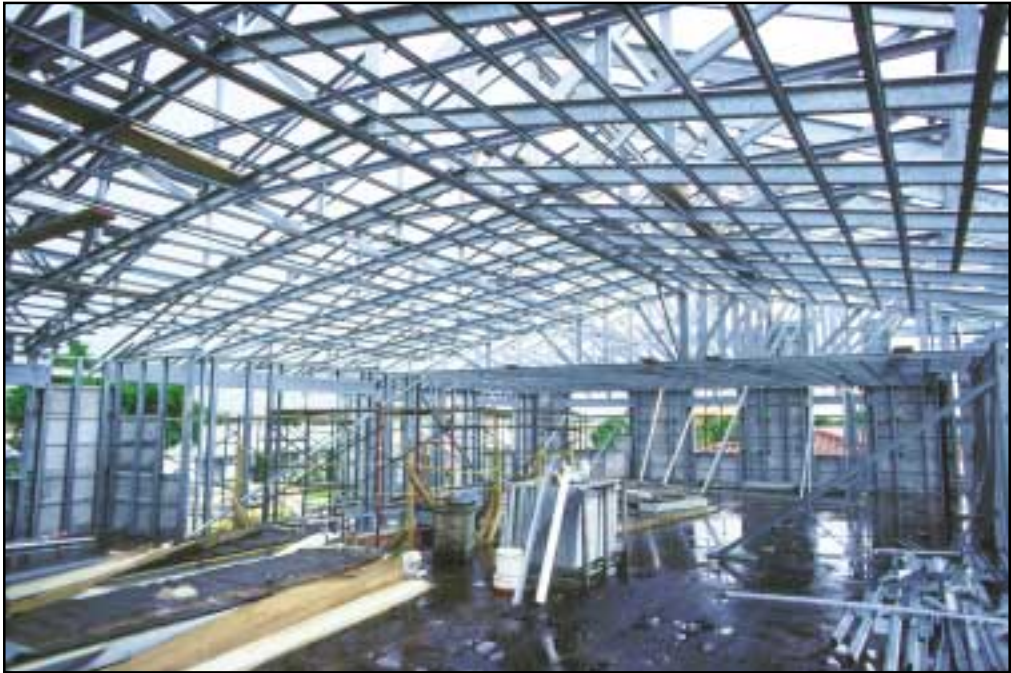
Metal framing is used for the new second story, including the walls and roof support system.

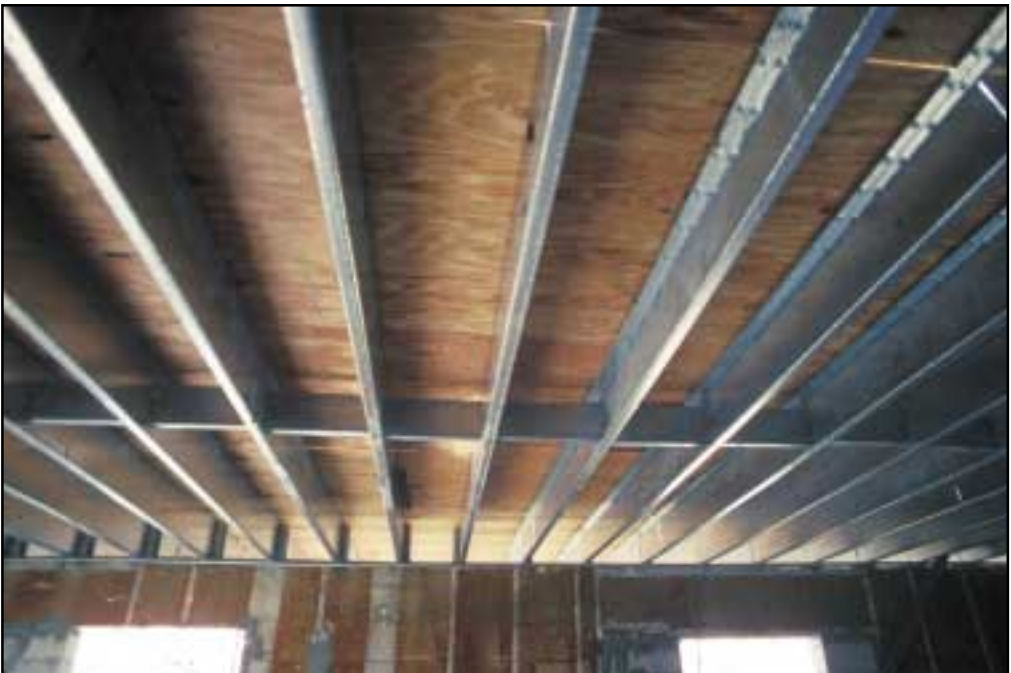
Figure 55

Metal framing also supports the floor of the new second story.

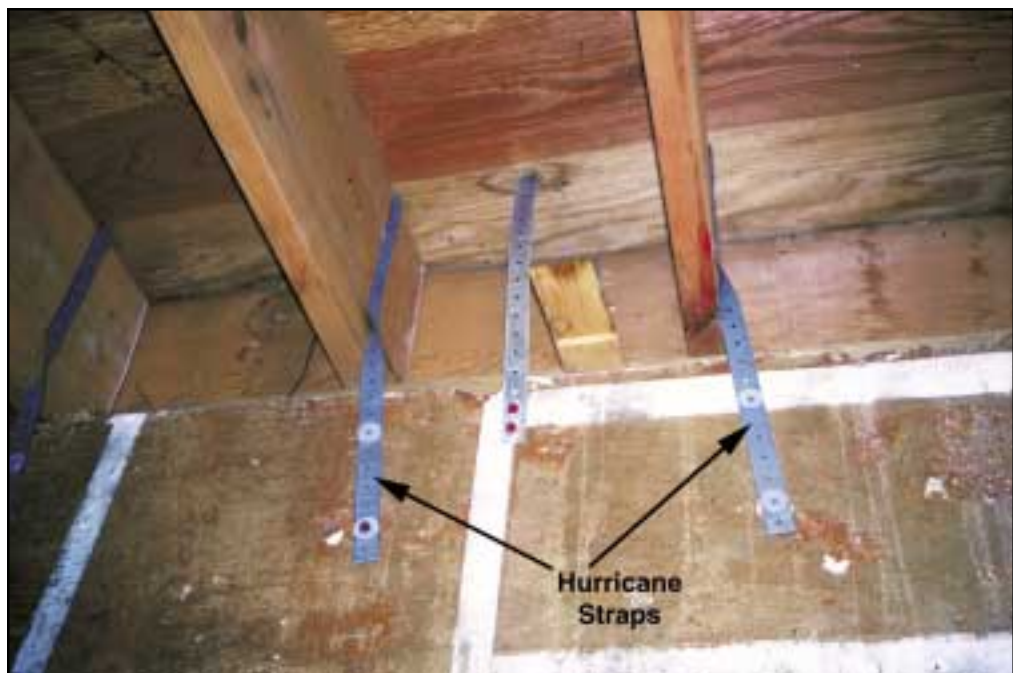
Figure 63

The new second-story walls are securely connected to the original first-floor walls with galvanized metal hurricane straps.

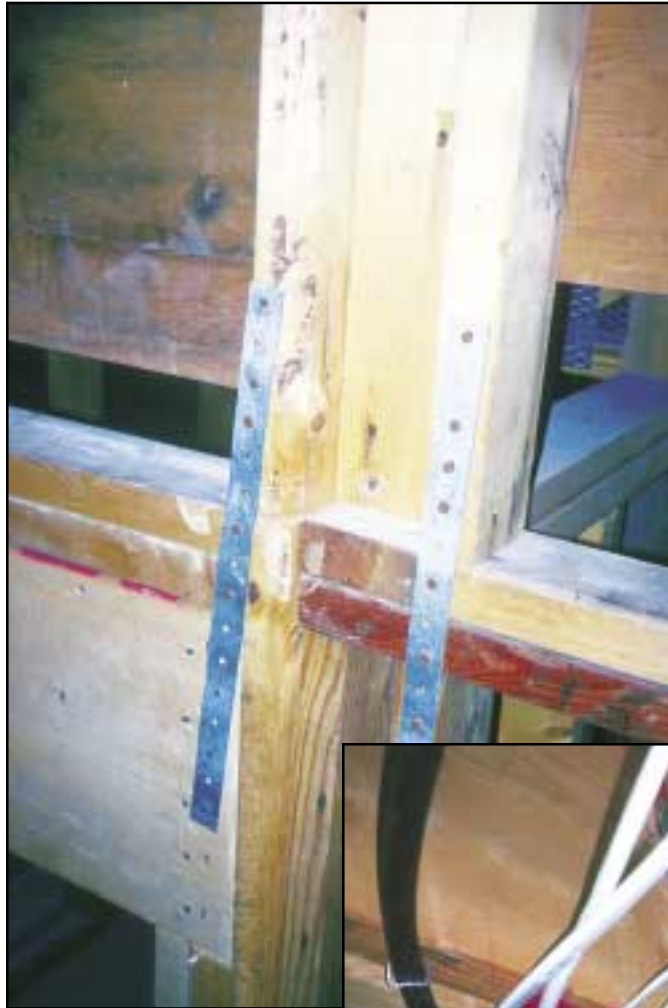
Figure 70

Metal hurricane straps are used to tie the structural members together and create a continuous load path from the roof to the foundation.

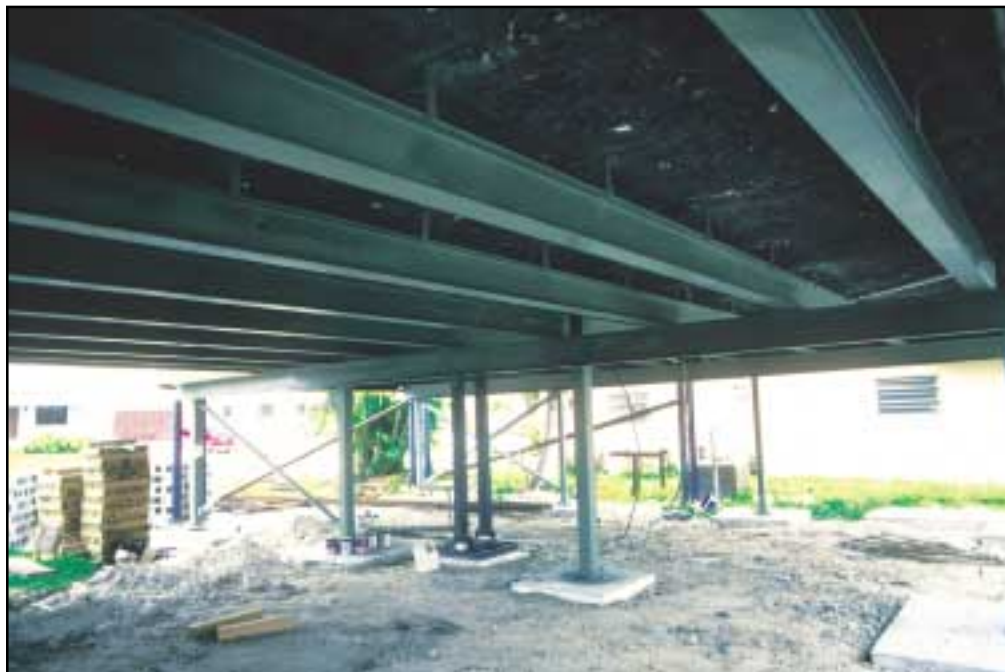
Figure 82

While the jacks and beams supported the house, new steel foundation members were installed below.
