Learning from Costa Concordia

The tragic events surrounding the grounding of the Costa Concordia provide an opportunity for maritime students to witness the potentially devastating consequences of navigational errors. The following research paper from the University of Ljubljana, Faculty of Maritime Studies and Transport shows how real life situations can be incorporated into maritime simulation

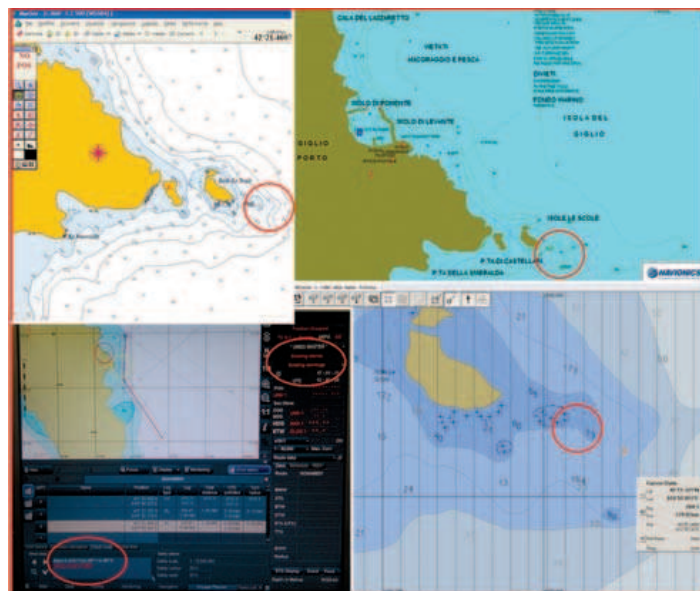
Figure 1 – Different electronic charts and the ECDIS system identify shallow water area and several alarms are activated

The captain was reported to have said that the rock or rocks the vessel hit were not on his charts. This was a good opportunity to put our students to work, having them collect as many charts of the waters off Giglio as possible.

They found that the rocks are charted on even the lowest resolution charts, and

particularly on the chart and the ECDIS system that they were actually using on the Costa Concordia. In fact, the students could not find a chart that did not clearly indicate the rocks.

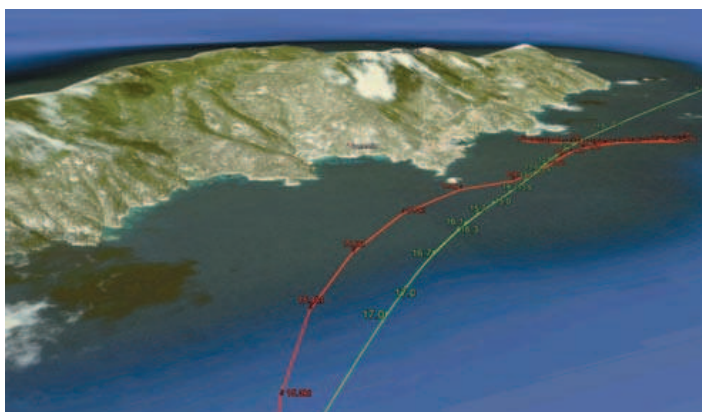
Figure 2 – Show-off passage (Green dated August 14th 2011)

Further, we found that in the last year only one (the same vessel) passenger vessel passed near the island, presumably performing a 'salute manoeuvre', but did so on what appears to be a pre-established course, aiming toward the island all the way from Civitavecchia.

The Costa Concordia, on the other hand, had plotted a course like all previous courses through the straits, only deviating as it neared a position parallel to the island.

This deviation led to a contradiction that increased the likelihood of an accident: 1) while the steering was on what is known as a 'tourist' setting - that is, as gentle a turn as possible, as people may still be dining and so on, 2) the turn required was much more acute than it would have been had the 'salute manoeuvre' route been followed (see Figure 2, previous page).

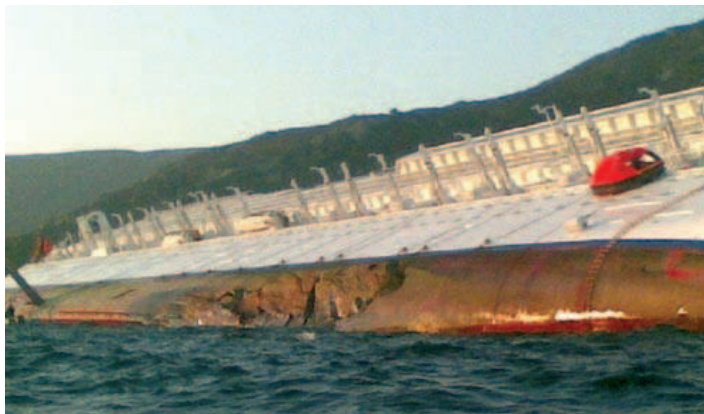
Figure 5 – Port side aperture at engine room location

Our theory is that the ship was not sinking. First of all, when we took note of the size of the hole in the hull caused by the grounding, some 40 to 50 meters max-

imum, and the location, towards the stern, it seemed likely that the ship had lost propulsion because of the flooded engine room, but that it would not have sunk – for one thing there are no transversal bulkheads in this engine room.
