(Mini) MIPS ISA Implementation

EECE 3324: Computer Architecture

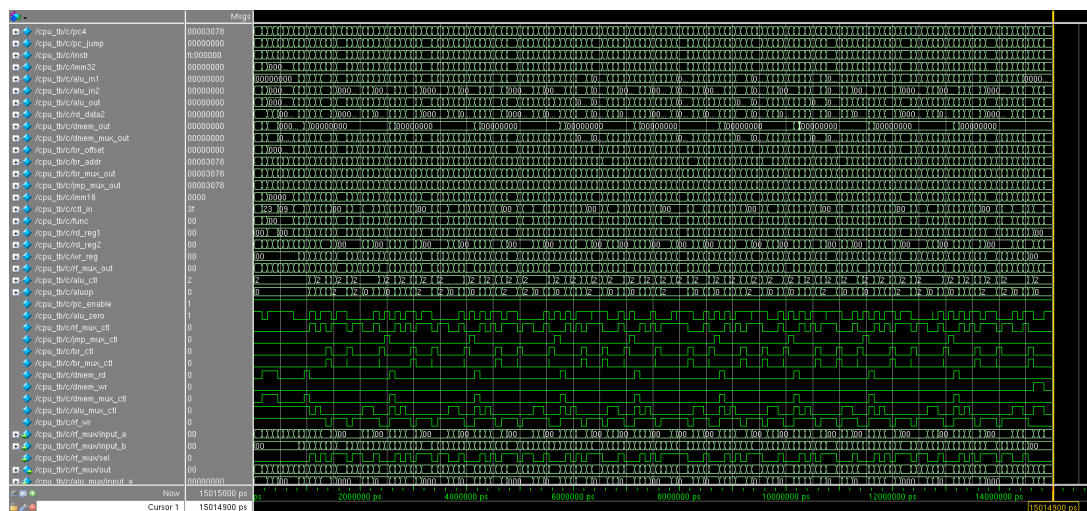
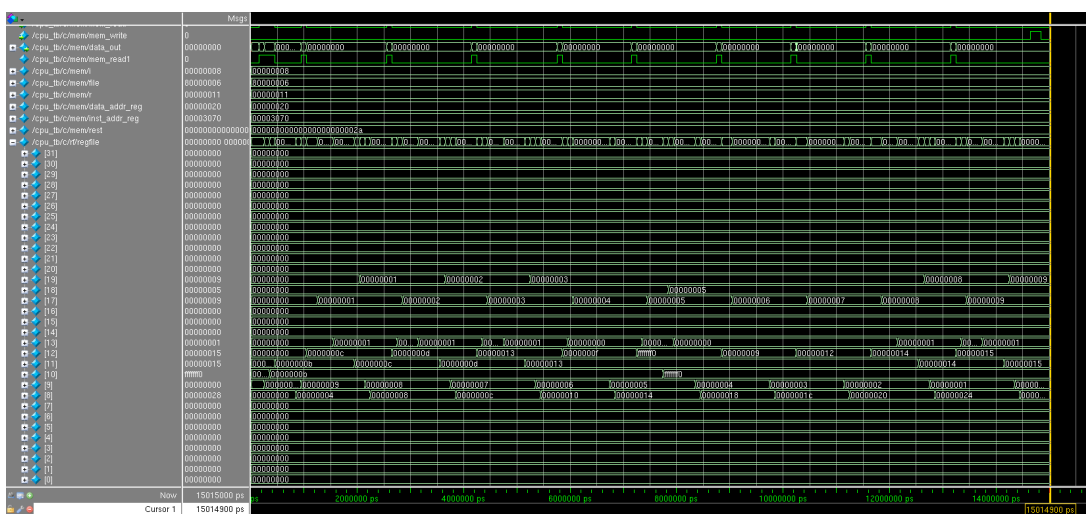
Screenshots:

Our results matched the given results, except for the cycle/instruction count which is 151 instead of 149.

- Total Cycles: 151
- Total Instructions: 151
- CPI: 1
