Bolster - Side - Seat - 2nd Row - LH (Remove and Replace)

FRT No: 13024002

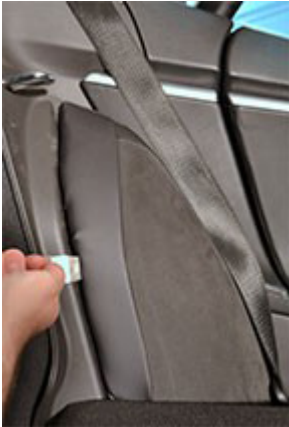
1. Fully open the LH rear door.
2. Release the LH rear seat back rest lock and push the rear seat back rest flat for access.
3. Insert a wedge tool behind the bolster to provide outward pressure.

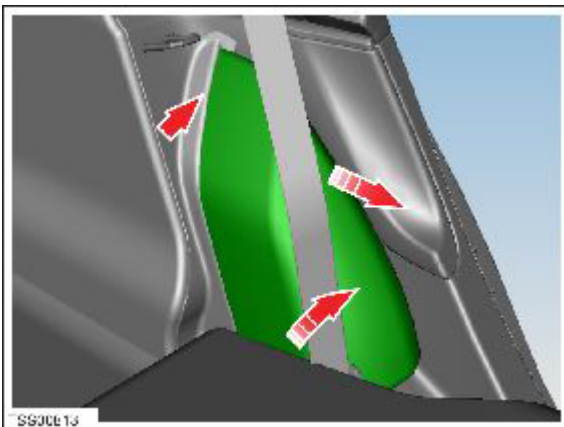
4. Use a long screwdriver or long pliers to disengage the upper grommet.
5. Release the seat side bolster from the grommet.

Caution: If the bolster cannot be removed easily, do not force it. This might bend the bolster structure, permanently damaging the bolster.

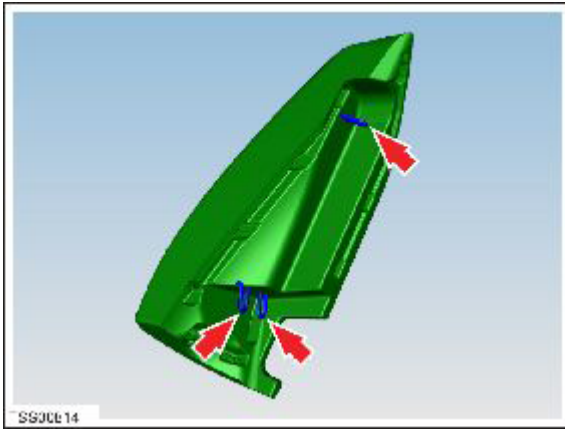
6. Repeat steps 4-5 on the lower grommet.
7. Remove the seat side bolster.
