# General Study Case Description of TMV 23: A Multi-Storey Office Building and Living Lab in Denmark

**Technical Report No. 306**

January 2023

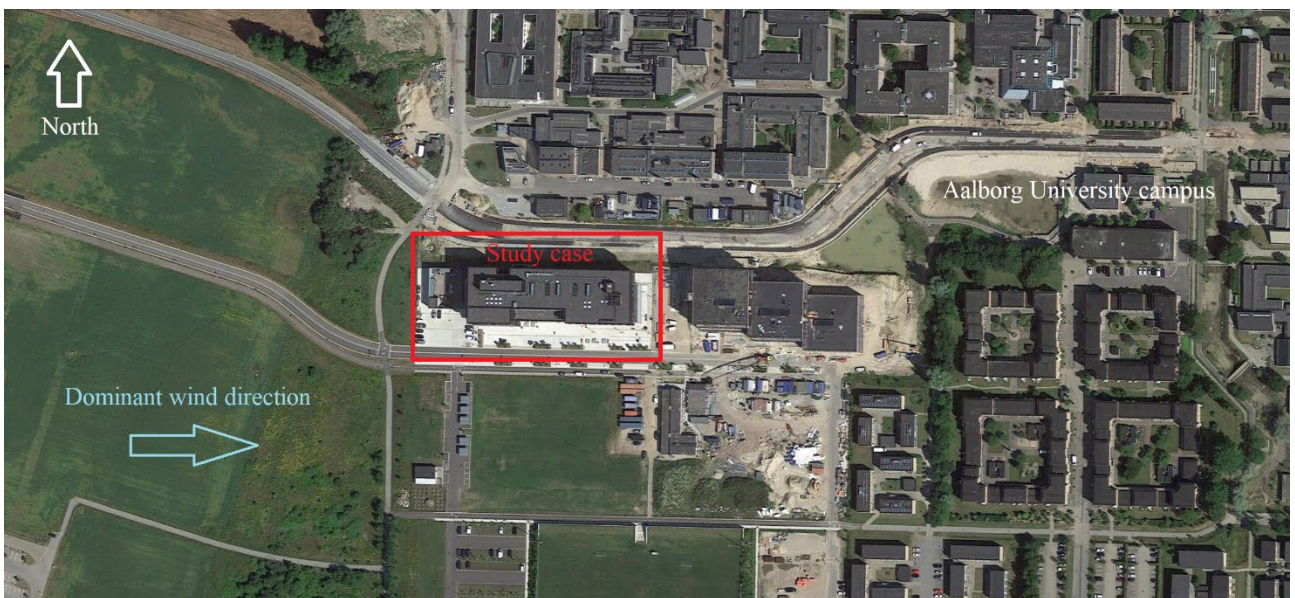
The building is surrounded by low-rise (2-3 floors) office buildings to the north, medium-rise office buildings to the east (5 floors) and flatland open fields to the south and west (see Figure 3).

**Figure 3:** Aerial view of the TMV 23 building in its surrounding environment on the Aalborg University main campus.

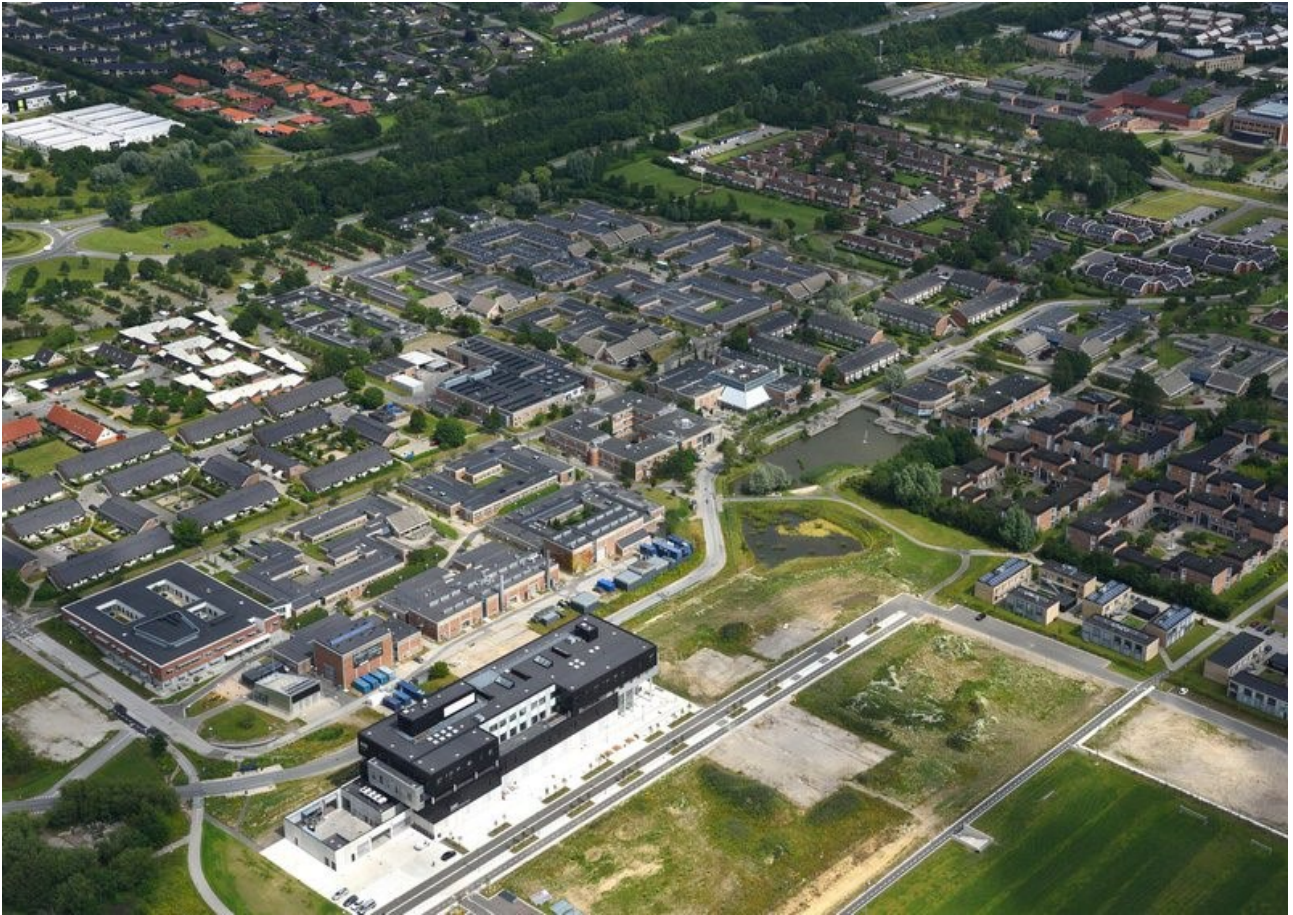
**Figure 9:** Aerial view of the TMV 23 building in its surrounding environment on the Aalborg University main campus. The South façade, the West façade and the roof of the building are visible. In 2022, a new building was built on the East side of the TMV 23 building (the upper right corner of the TMV 23 building in the picture) but was not visible yet in that aerial view (credit to Aalborg University).

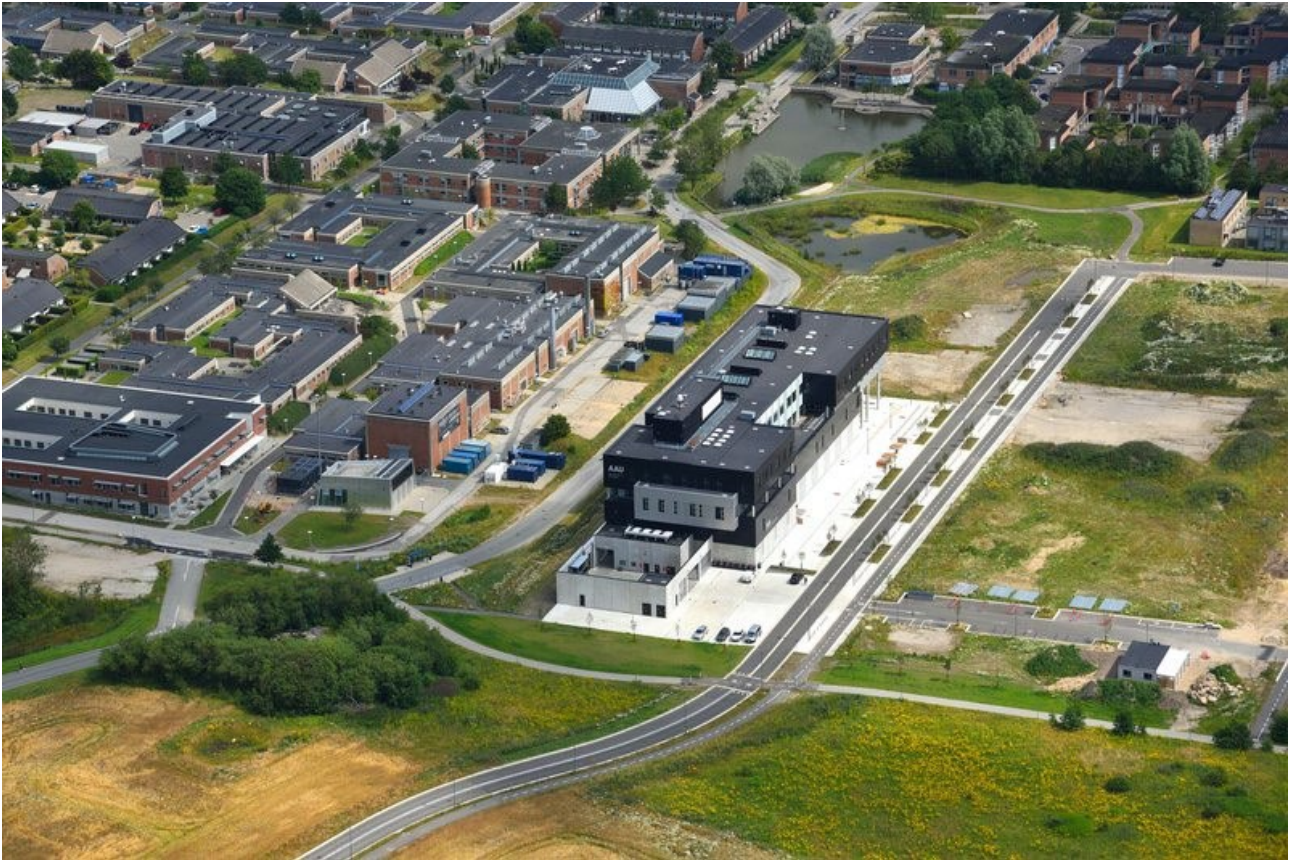
**Figure 10:** Aerial view of the TMV 23 building in its surrounding environment on the Aalborg University main campus. The South façade, the West façade and the roof of the building are visible. In 2022, a new building was built on the East side of the TMV 23 building (the upper right corner of the TMV 23 building in the picture) but was not visible yet in that aerial view (credit to Aalborg University).

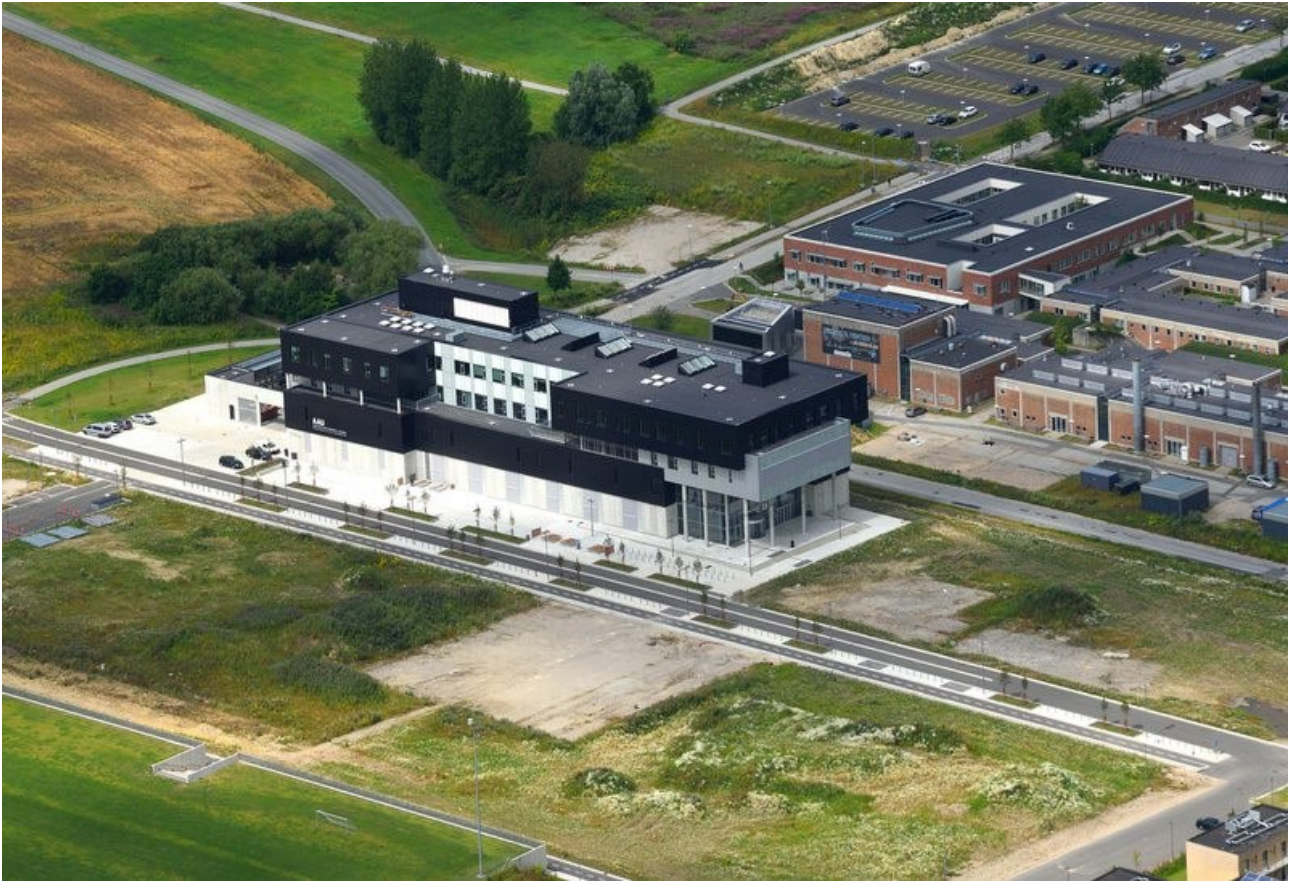
**Figure 11:** Aerial view of the TMV 23 building in its surrounding environment on the Aalborg University main campus. The South façade, the East façade and the roof of the building are visible. In 2022, a new building was built on the East side of the TMV 23 building (the right side of the TMV 23 building in the picture) but was not visible yet in that aerial view (credit to Aalborg University).
