**TIS
Information
Tool**

Name: ASHOK LEYLAND

Tool designation: number die

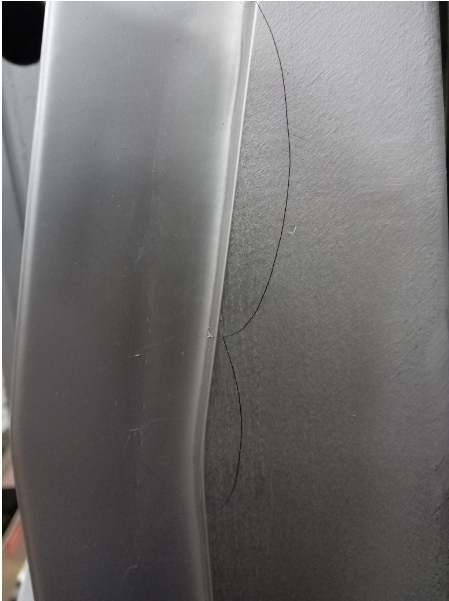
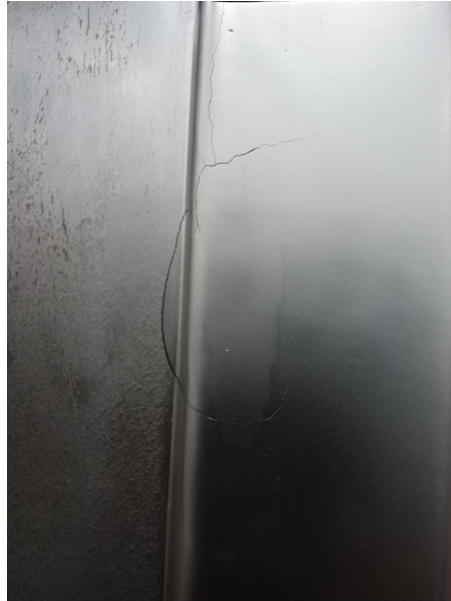
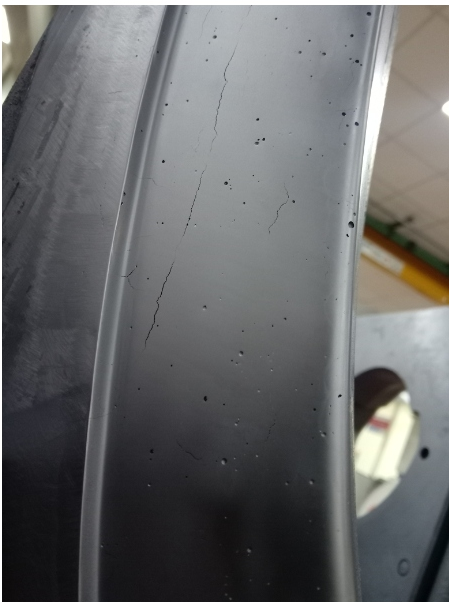
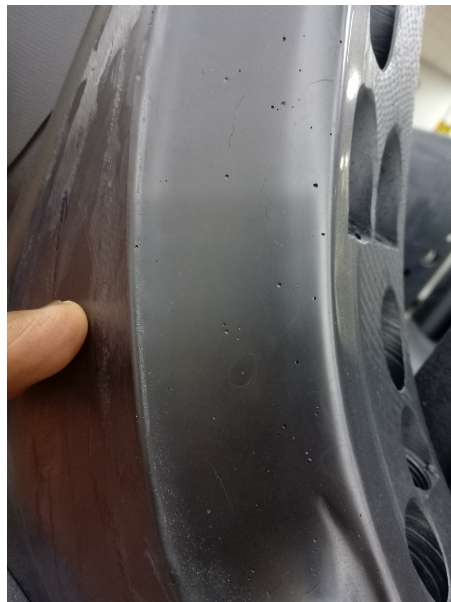
6. Tool Sketch

Cracks, Surface Damage, Welded Zones

Comment: many does having welding, cracks , and pitting on surface.

Coating: BALINIT LUMENA DUPLEX

Pre-Polish Requirements: Mirror Polish

Post coating polish requirements: post polishing
