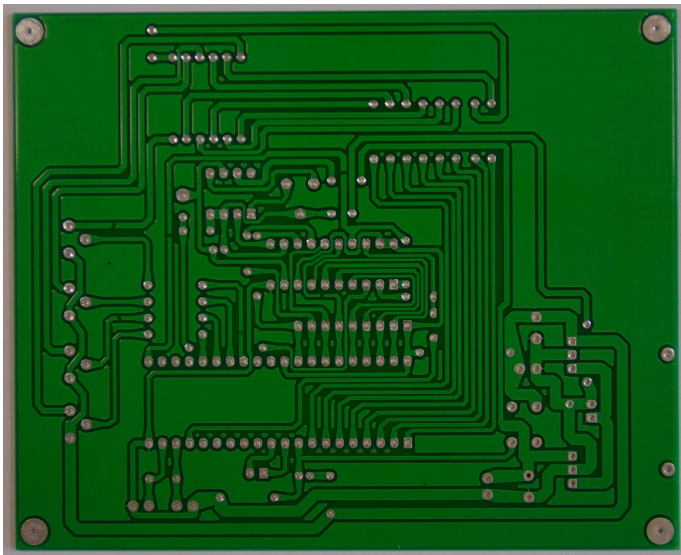
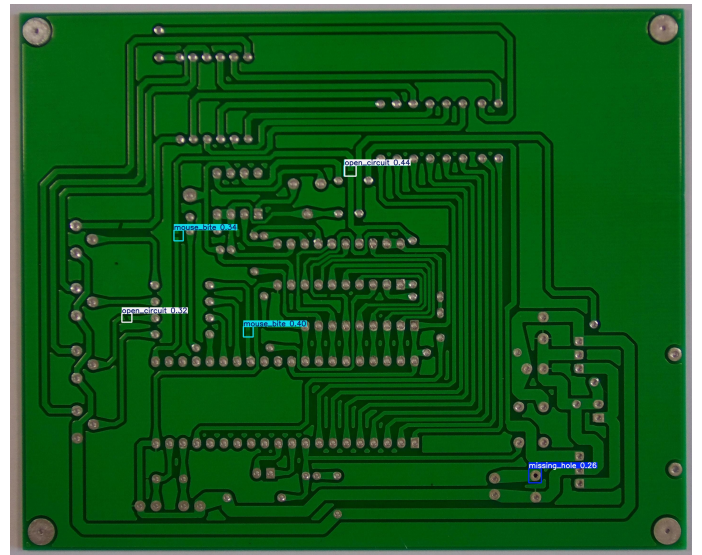
Detected Defects:

1. Mouse bite: Small, semi-circular patterns along the edge of a PCB, typically caused by improper drilling or poor material quality. (Detected 2 times)
2. Missing hole: Occurs when a required hole is not drilled or punched through the PCB, often due to errors in the drilling process or issues with the drill files. (Detected 3 times)
