## Quality Notice

### **Jumbos for Flowstrip – Splices (instruction WI07A-043)**

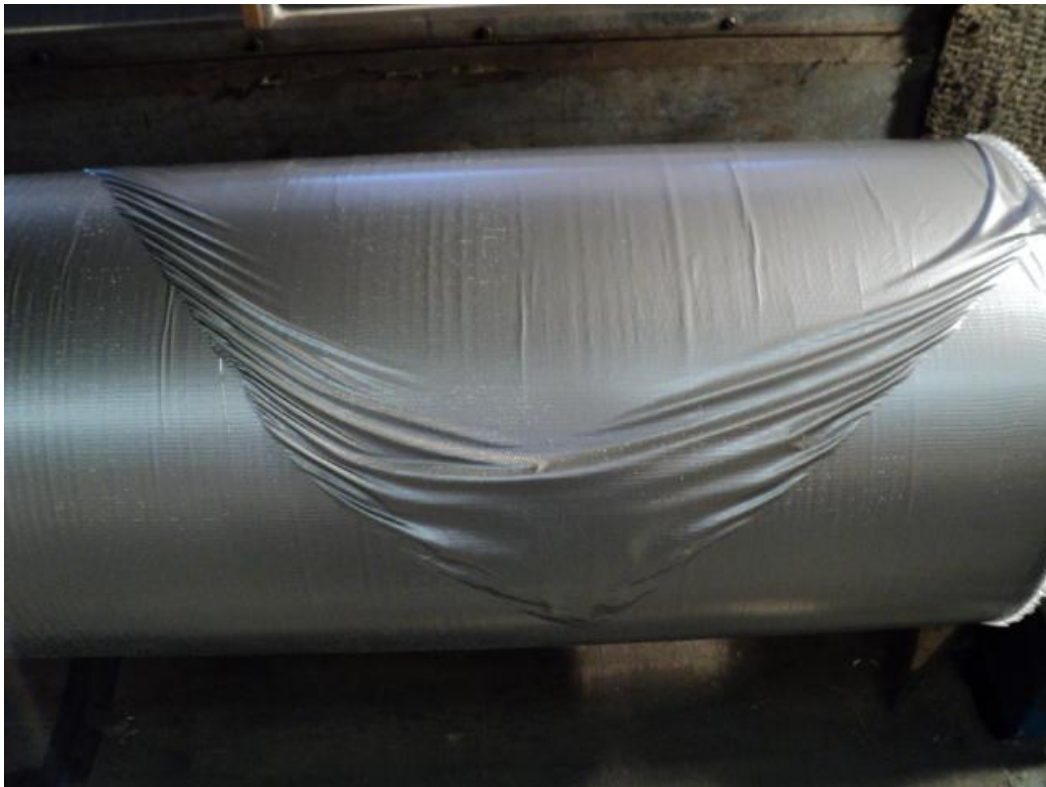
We have had a recent complaint from Flowstrip, due to delamination, material ripping out and poor appearance. The complaint relates to a 50 metre section that was found in jumbo roll batch 14775/4 made on 01/06/2011. It is understood that the affected material was found in the vicinity of a splice contained within this jumbo roll. Below photo refers:

**Can sufficient material be pulled through, prior to making the splice.**
