Surface crack detection by flash thermography on concrete surface

F C Sham, Nelson Chen and Liu Long

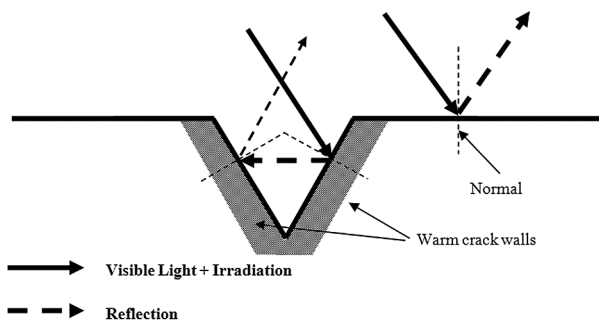
predictable manner that depends on factors including the surface roughness, colour, optical reflectivity and IR emissivity. Figure 1 illustrates the process.

Figure 1. Reflectivity of radiation on cracked surface

Inspected surfaces are excited by a flash-light and there are instantaneous reflections of visible light and IR radiation that can be recorded by an infrared camera. After the flash has been exerted on the inspected area, with high capturing frequency, immediate reflection of IR radiation can be recorded and hence surface cracks can be indicated. This is due to the fact that, because of the steeper slope of crack walls, incident light (from the flash lamp) bounces against the walls several times. Each bounce heats up the crack walls slightly. The net effect of the multiple reflections, or bounces, causes the crack to act as a cavity with warmed walls, which is basically similar to a small black body. The incident radiation is reflected, absorbed and/or transmitted from the surface in a

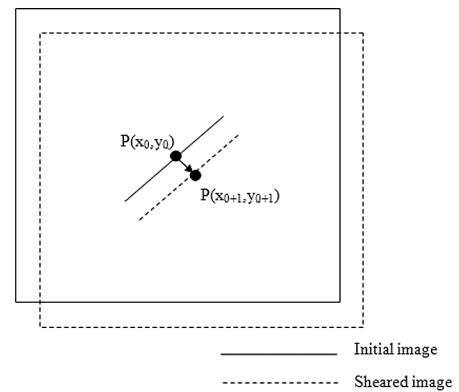
As mentioned in the introduction, this study proposes a traditional method, sheared image subtraction method, which has been widely used in shearography for defect detection⁽¹¹⁾. The image is subtracted by its shifted image in x- and y-directions. Shear image subtraction is dealing with the temperature difference relative to the nearby intact region. Therefore, the contrast of cracks with broken temperature field distribution is significantly increased. The basic algorithm of this method is presented in the schematic diagram Figure 2.

Figure 2. Schematic diagram on sheared image subtraction method

A sharper edge is obtained by calculating the intensity gradient of the adjacent pixels. The new edge intensity is expressed by the following equation:

$$L(x, y) = [P(x_0, y_0) - P(x_{0+1}, y_{0+1})] \dots \dots \dots (1)$$

where $L(x, y)$ is the light intensity in x, y coordinate obtained by subtracting the diagonal pixels (sheared image) and the results are presented.

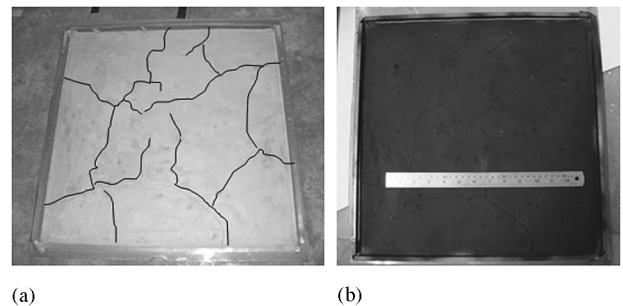
It is difficult to observe surface cracks by the unaided eye, as shown in Figure 3(a), and it is even more difficult to observe after black paint is sprayed on the cement panel, as shown in Figure 3(b). The black painted panel surface is used to simulate the concrete slabs in tunnels where upper slabs are usually painted in black.

Figure 3. (a) Cement panel with surface cracks. (b) Cement panel painted in black

The experiments were carried out by applying flash thermography on a cement panel with artificially made surface cracks. Surface cracks ranging from 0.1 mm to 1 mm width were made for inspections. The cement panel was made with cement paste and surface cracks were produced by attaching tiles at the back of the cement panel without absorbing water. Therefore, the water from the cement paste diffused quickly to the dry tile underneath, and hence natural shrinkage cracks were produced on the cement panel. The cement panel was then sprayed with black emulsion paint which has an emissivity close to 1. It allows better measurement by reducing the differences on thermal absorption due to emissivity difference.

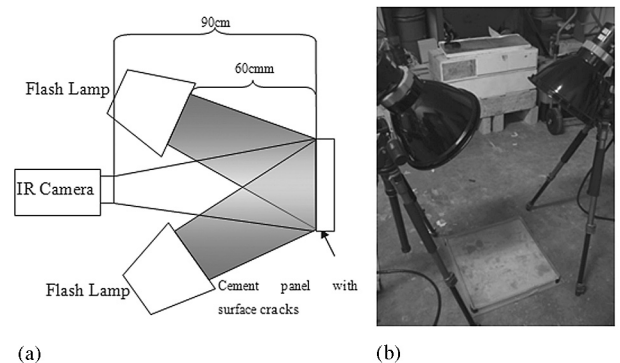
In the experiment, the panel was stimulated by a flash pulse produced by two 4.8 kJ powered xenon flash lamps with full width at half maximum (FWHM) duration of 3 ms. Surface thermograms after pulse are captured by the infrared camera SC3000 with a 320x240 pixel quantum-well infrared photon detector (QWIP) focal plane array. It has a sensitivity of 0.02°C and maximum frame rate of 50 Hz. The distance between the infrared camera and cement panel is 90 cm at which distance surface cracks cannot be observed by the unaided eye. The flash lamps are set at the location where the whole cement panel can be covered by the flash lamp, and 60 cm is selected as the excitation distance. Figure 4(a) shows the photo and Figure 4(b) illustrates the schematic diagram of the experimental set-up of flash thermography for surface crack detection on the cement panel. The distance between flash lamps and IR camera is 60 cm and 90 cm respectively.

Figure 4. (a) Schematic diagram of surface crack detection by flash thermography and (b) photos of the set-up

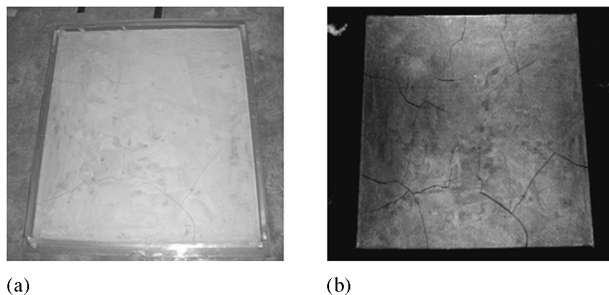
The results in Figure 5 show that major surface cracks (0.5 mm-0.1 mm width) can be observed successfully by applying flash, yet the system fails to detect micro-cracks (0.1 mm to <0.5 mm). Figure 5(a) is a photo of the cement panel taken by digital camera and (b) is the second thermal image captured after pulse, which is after 0.04 s since the capturing frequency is 50 Hz.

As shown in Figure 5(b), major cracks with crack width 0.5 mm-1 mm can be clearly seen while it is difficult to be observed in the digital photo, Figure 5(a). However, there is uneven heat distribution which affects the surface crack observation. This uneven heat distribution may be due to the positioning of flash lamps or uneven surface of the cement panel. Therefore, several crack detection techniques are proposed in this study to outline the surface cracks automatically without the influence of uneven heat distribution. Performances of applying the three crack detection techniques on Figure 5(b) are compared and presented in Figure 6. This presents the optimum results obtained by adjusting suitable threshold for edge detections. Edge detecting results obtained by Sobel, Canny and sheared image subtraction are shown in Figures 6(a), (b) and (c) respectively.

Figure 5. (a) Photos of surface cracks; (b) thermal image at 0.04 s after pulse

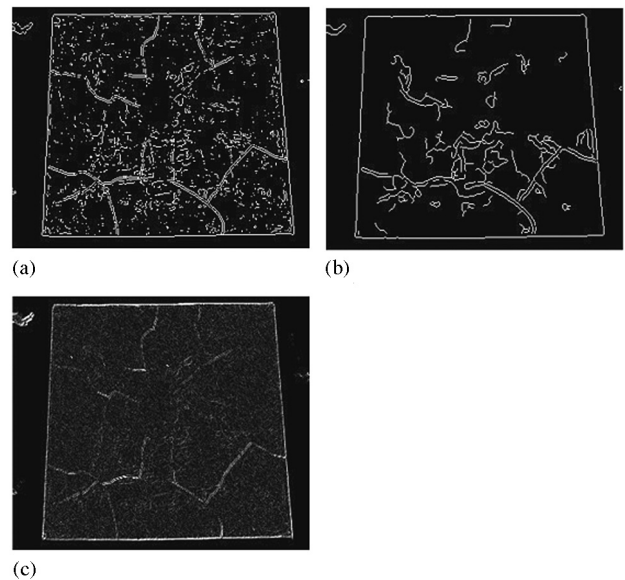
From the results in Figures 6(a) and (b), it is clear that both Sobel and Canny edge detectors are not capable of detecting surface cracks by searching the maximum intensity gradient from a noisy thermal image, while the sheared image subtraction method gives the best result in terms of eliminating image noise and detecting spatial gradient successfully, as shown in Figure 6(c).

Figure 6. Edge detection of Figure 5(b) by (a) Sobel edge detector with threshold of 10; (b) Canny edge detector with threshold of 0.15 and (c) sheared image subtraction method

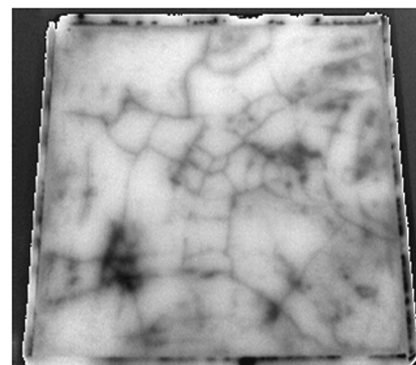
As stated previously, micro-cracks cannot be observed with only pulse excitation. A very simple but effective active thermography is introduced for micro-crack detection, *ie* using water as stimulus. The temperature difference between micro-cracks and intact region is induced by water and the thermal image is recorded by infrared camera. Water can seep through the micro-cracks because water molecules are very small. Water is cooler than the other intact region and hence micro-cracks can easily be shown on the thermal image. A very satisfactory result for micro-crack detection is obtained by this method, as shown in Figure 7.

However, several water ponds and vague micro-cracks are observed in Figure 7. In order to have a clearer image for micro-cracks, another stimulus, *ie* pulse, is applied and the thermal image is immediately captured by infrared camera. Therefore, the micro-cracks are detected by FT with water added on the inspected surface. The instant separation between water along the cracks and

Figure 7. Thermal image captured after water spray

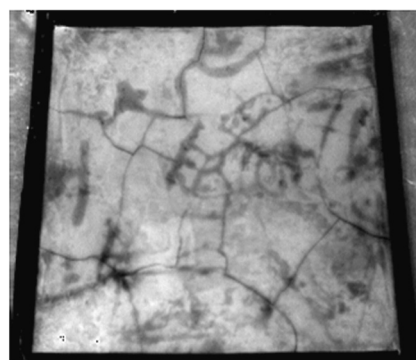
intact region is due to the difference in heat capacity of water. A sharper image of micro-cracks is shown in Figure 8.

Figure 8. Thermal image with water spray followed by pulse

The results in Figure 9 are similar to the major surface crack detection in which sheared image subtraction method gives the best result compared to the other two edge detectors. However, it is not as clear as the pulsed image as shown in Figure 8. In conclusion, the sheared image subtraction method is not suitable to be applied for micro-cracks detection where the image contains much noise but it is superior to the other two common crack detection techniques.

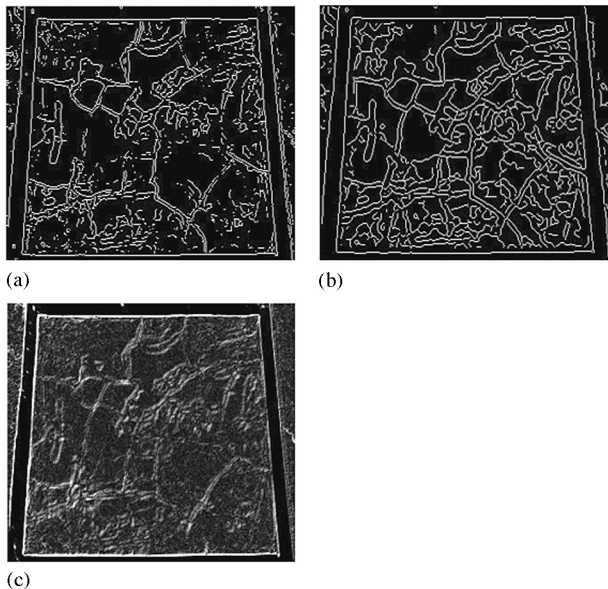
Figure 9. Edge detection of Figure 8 by (a) Sobel edge detector with threshold of 10; (b) Canny edge detector with threshold of 0.1 and (c) sheared image subtraction method

Again, crack detectors Sobel, Canny and the sheared image subtraction method are applied and the results shown in Figure 8 for automatic surface micro-crack detection.
