Title: User Story 16 – Behaviour of OBU after Trip

This operational scenario verifies the behavior of the OBU after a TRIP.

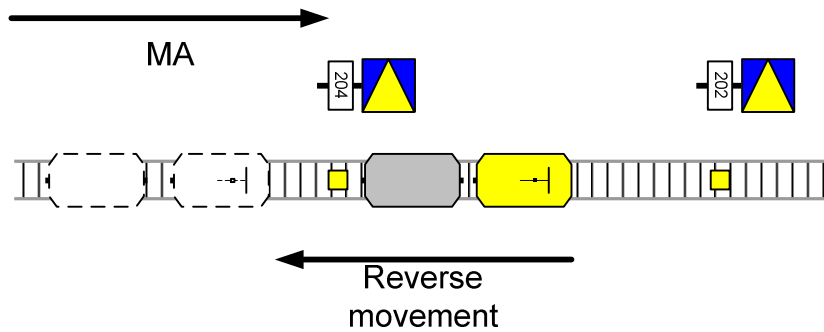
Diagram:

The scenario starts after the train has tripped, e.g. by moving past the EoA of a given MA. In the diagram above the MA was given to SMB204 and the train has moved beyond SMB 204
