TITLE: Subaru\_B\_Harness

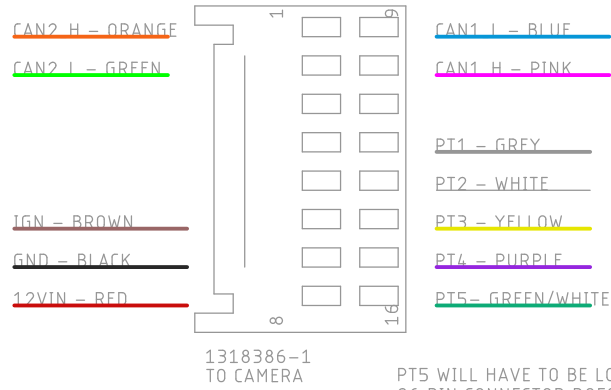
Looking at the back of the connector

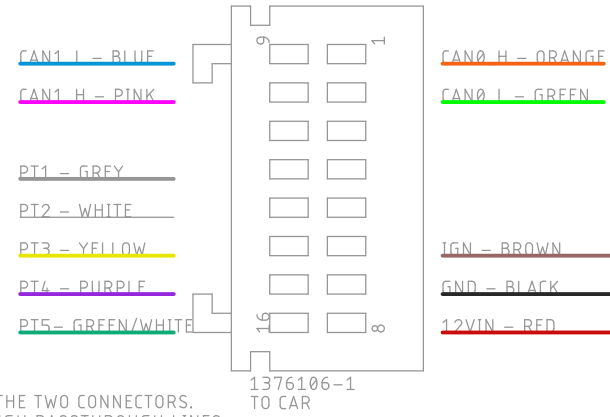
Looking at the back of the connector

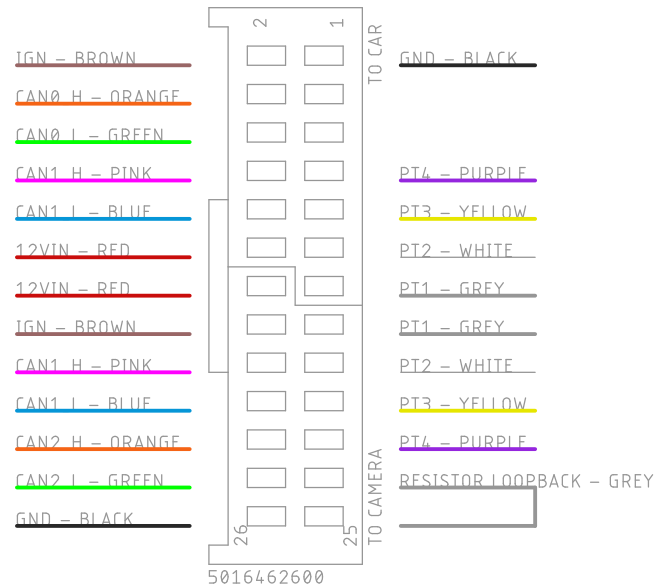
PT5 WILL HAVE TO BE LOOPED BETWEEN THE TWO CONNECTORS.  
26 PIN CONNECTOR DOES NOT HAVE ENOUGH PASSTHROUGH LINES
