High Potential Incident Alert - 192

August 2015

Pulley wheel detaches and falls near worker

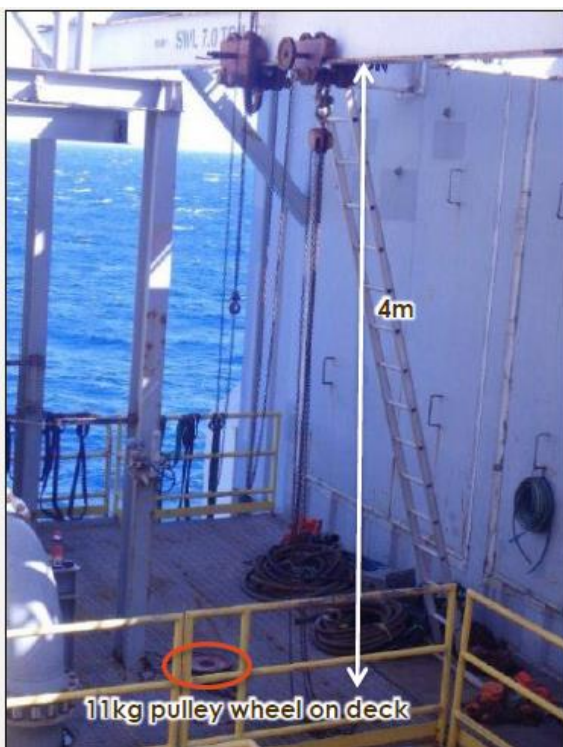
A technician was repositioning a 7 tonne geared beam trolley for inspection. The 11kg chain drive pulley wheel slid off the drive shaft and fell about 4 metres to the deck below. The pulley wheel missed the technician by just 60 centimetres.

The initial investigation of the scene found a damaged split pin on the deck. It was determined that this had been holding the wheel to the drive shaft before it fell.

- The mild steel split pin did not meet original equipment manufacturer specifications.
- The pin conveyed torque to the wheel, not just retention.
- Inspection by vendor six months before this incident did not identify the incorrect pin.
- Scope for vendor inspection didn't include a requirement to check for pin type.

Check all trolleys on facilities and ensure correct pins are installed.

Add an additional retaining safeguard, i.e. a tie wire through the rolled pin and around shaft.

Consider modifying design by using a washer to hold the wheel to the shaft and a castellated nut with a split pin to prevent unwinding.

Review scope of lifting inspections to ensure all items are identified and addressed.
