N/A-SANR

ILS Five 01

Argentina **Santiago del Estero** Termas de Rio Hondo

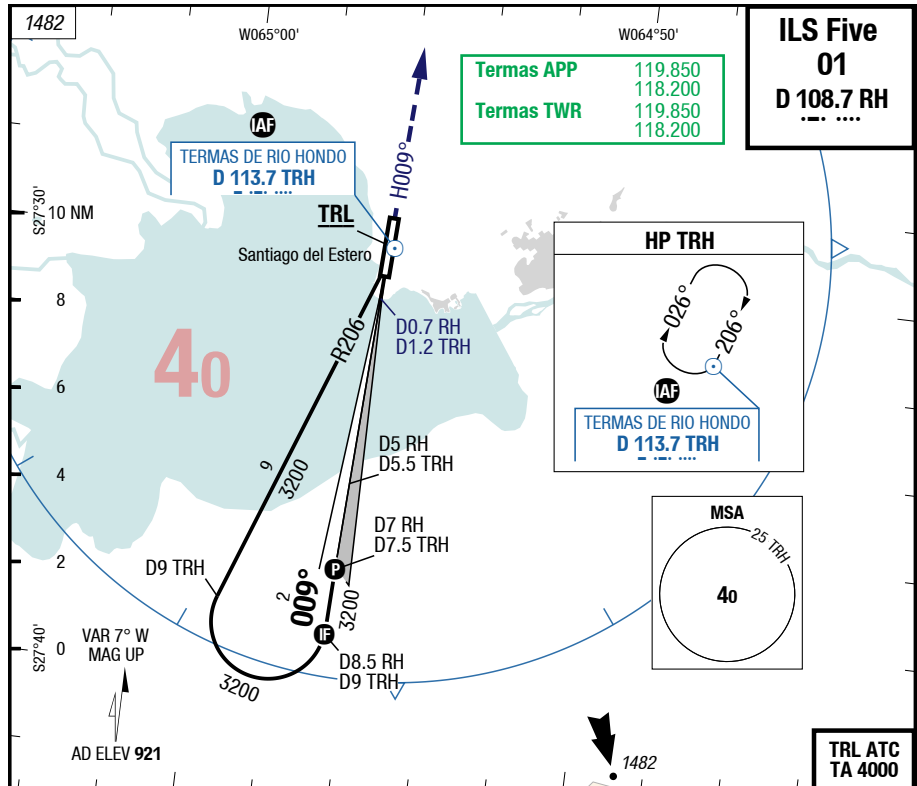
LOC 3.10°		7	6	4	3	2	01	83.0° 60 L	
D RH								2500 x 30	
009°									
RWY 010°		3200	2890	2230	1900	1570		THR 913 (33hPa) / TDZ --- (---%) +0.1%	
D9 TRH		D7.5		D5.5		D1.2 TRH			
D8.5 RH		D7		D5		D0.7 RH			
3200		3200		2550		51		climb on HDG 009°	
3200		009°		GP 3.00°		MDA			
DIST to THR		6.8		5.4		0.5		0	
01		Cat 1 DME		LOC DME					
C		ft - m/km		240 - 1.2V		430 - 2.4V		600 - 3.7V	
		ft		1150		1340		1530	
D		ft - m/km		240 - 1.2V		430 - 2.8V		700 - 4.6V	
		ft		1150		1340		1630	
1) With EVS VIS 800m
