Structural Repair Quality Analysis Report

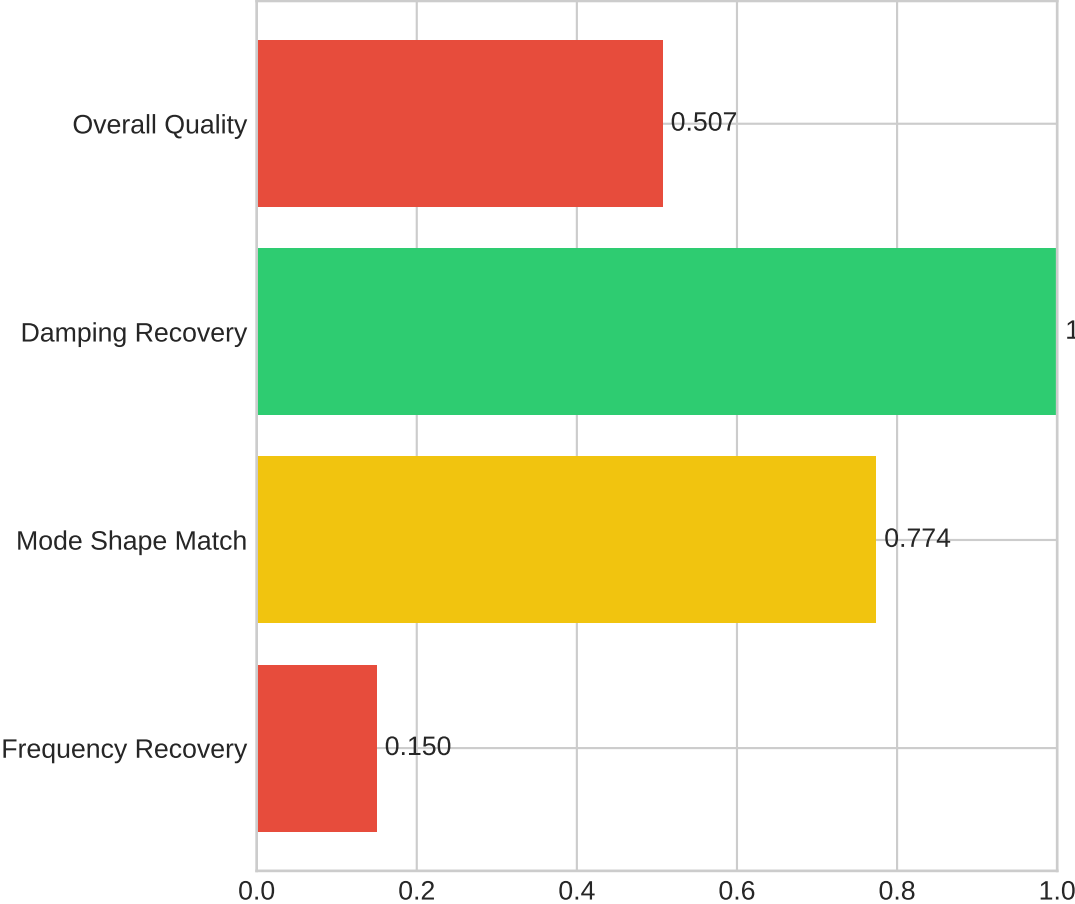
Quality Score Breakdown

0.507

Repair Quality Score

Fair - Partial Improvement
