# Structural Repair Quality Analysis Report

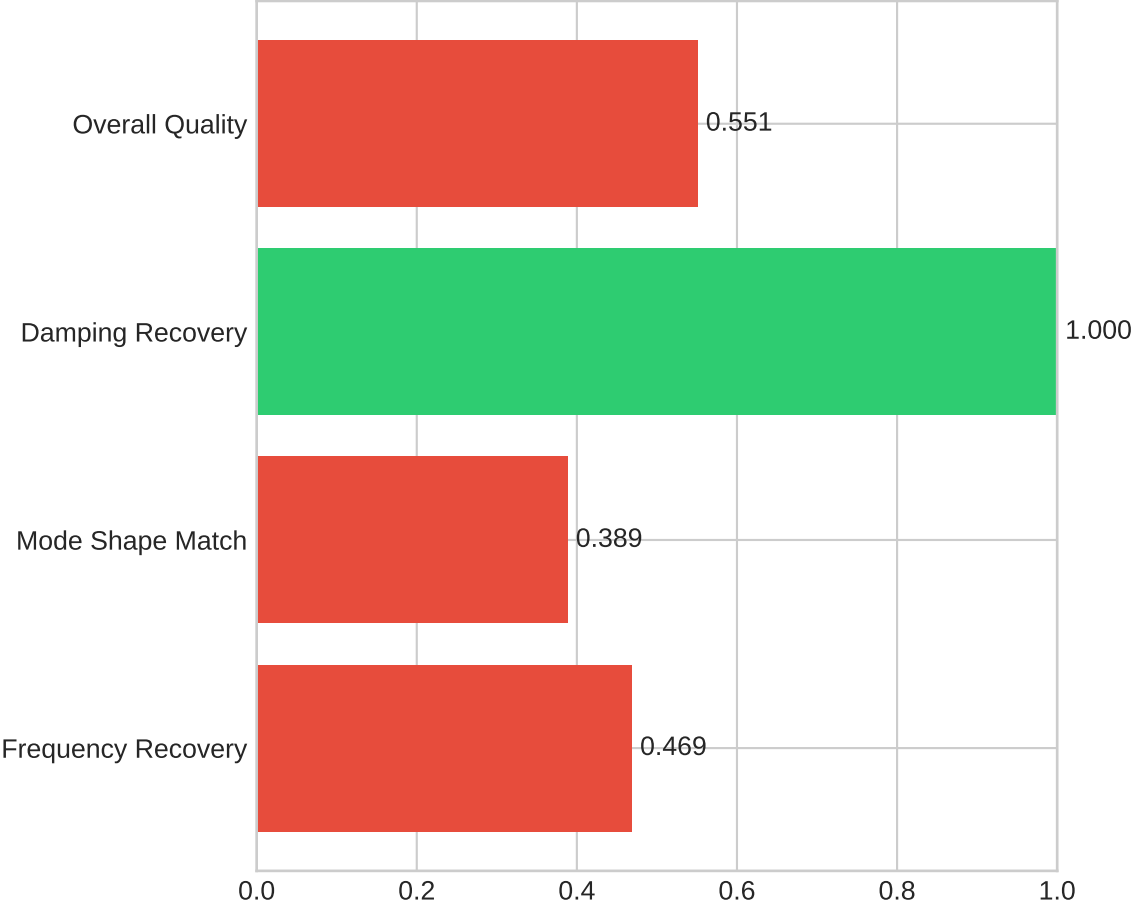
Quality Score Breakdown

0.551

Repair Quality Score

Fair - Partial Improvement
