Structural Repair Quality Analysis Report

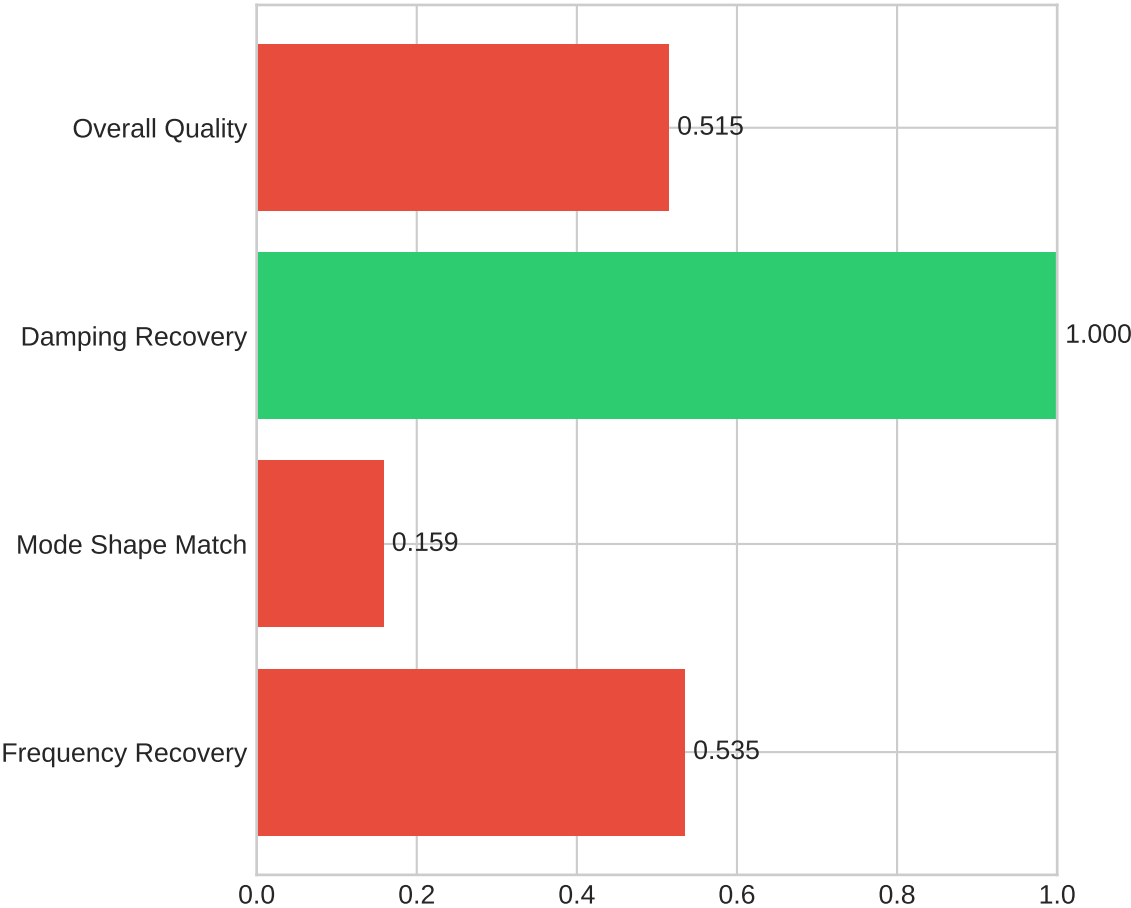
Quality Score Breakdown

0.515

Repair Quality Score

Fair - Partial Improvement
