# Structural Repair Quality Analysis Report

Repair Quality Score

Fair - Partial Improvement

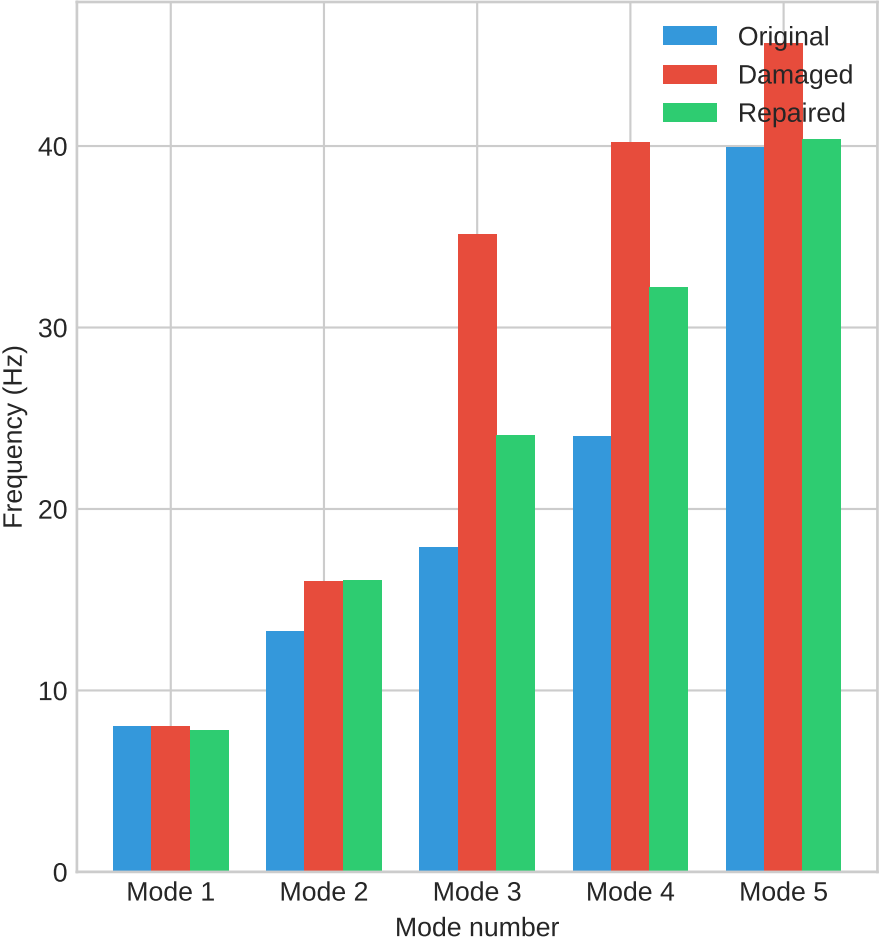
Natural Frequencies Comparison

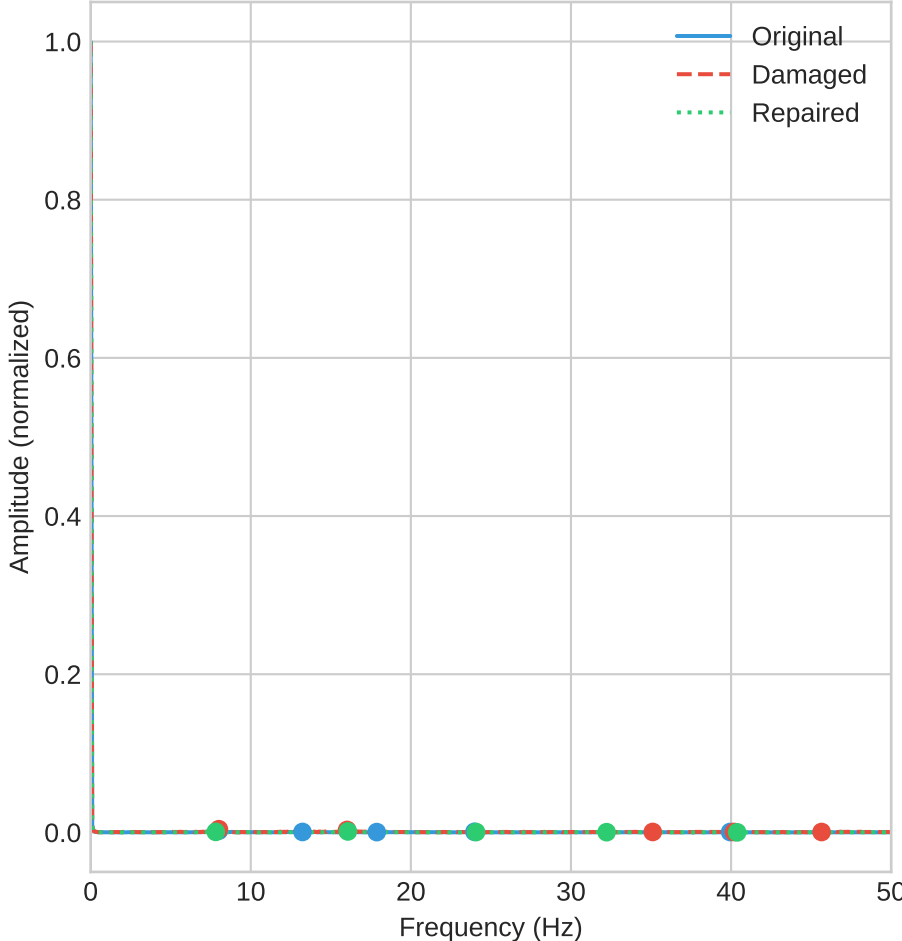
Frequency Response Spectrum

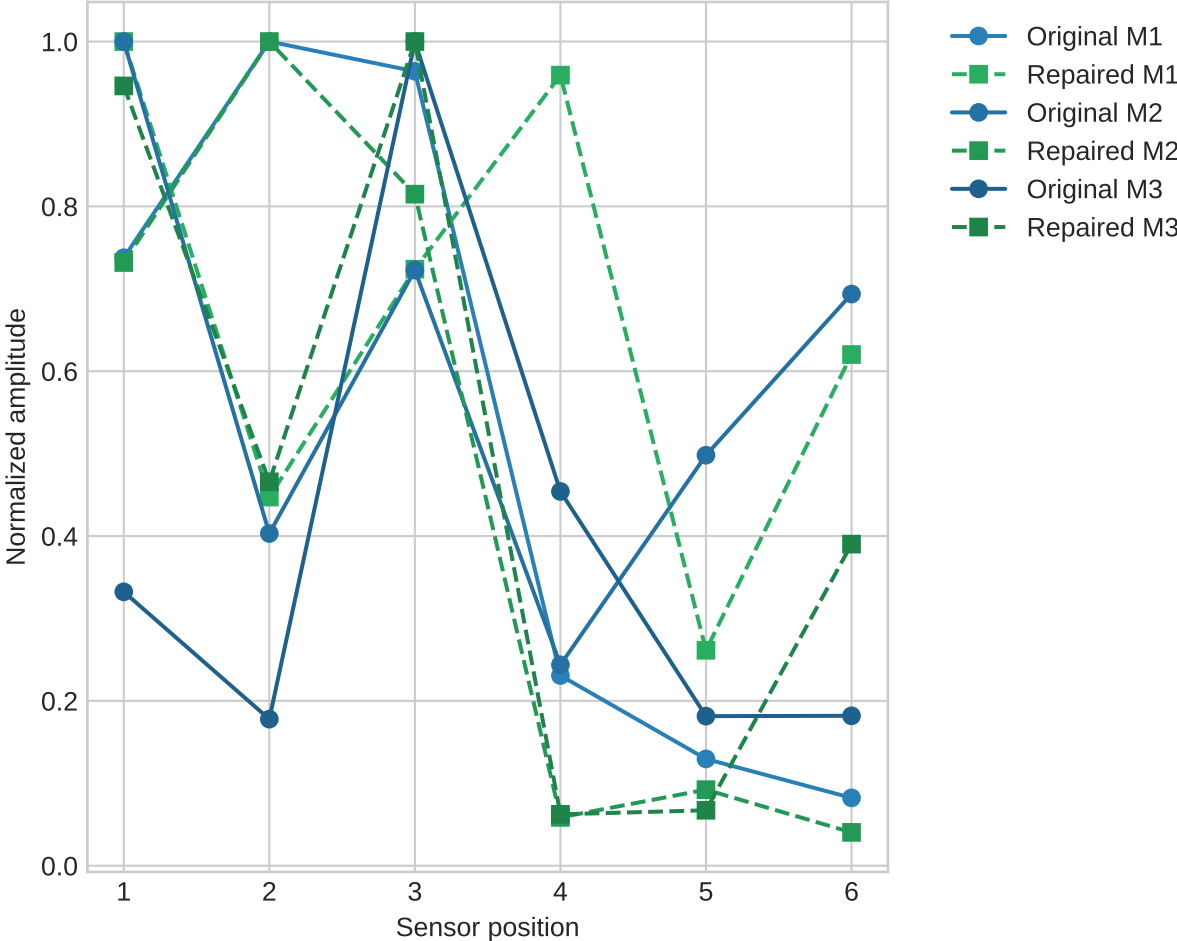
Mode Shape Comparison (First 3 Modes)

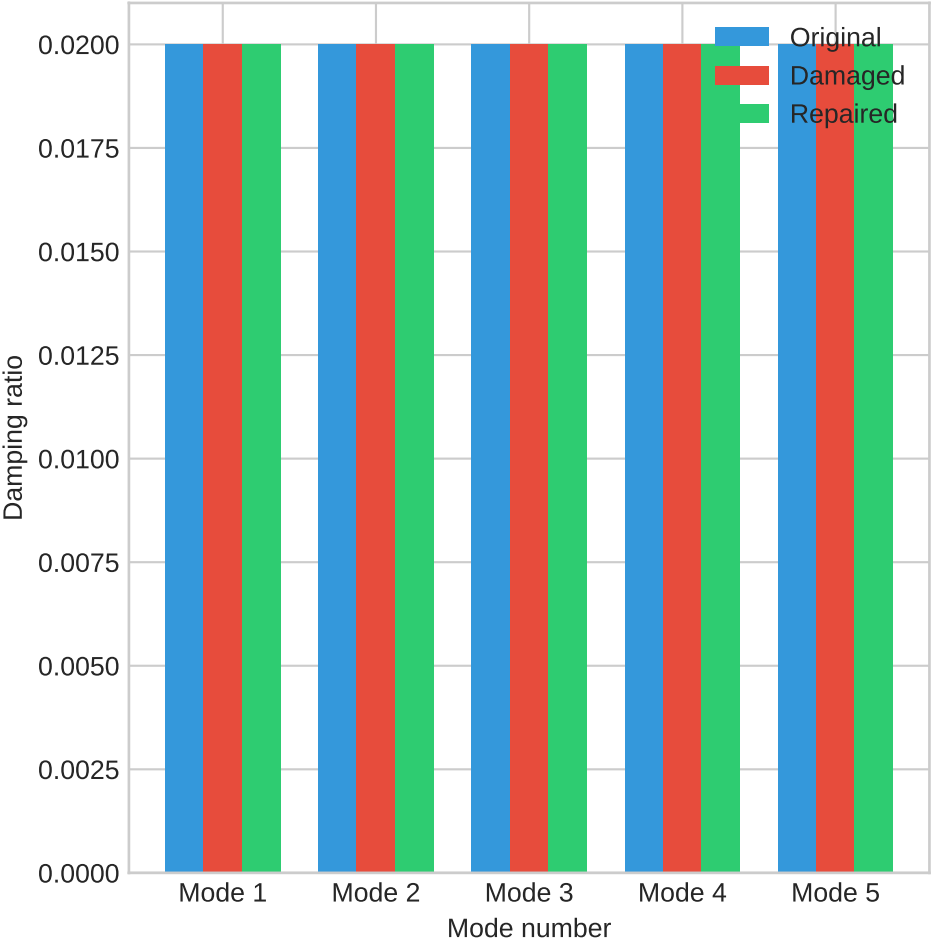
Damping Ratios Comparison

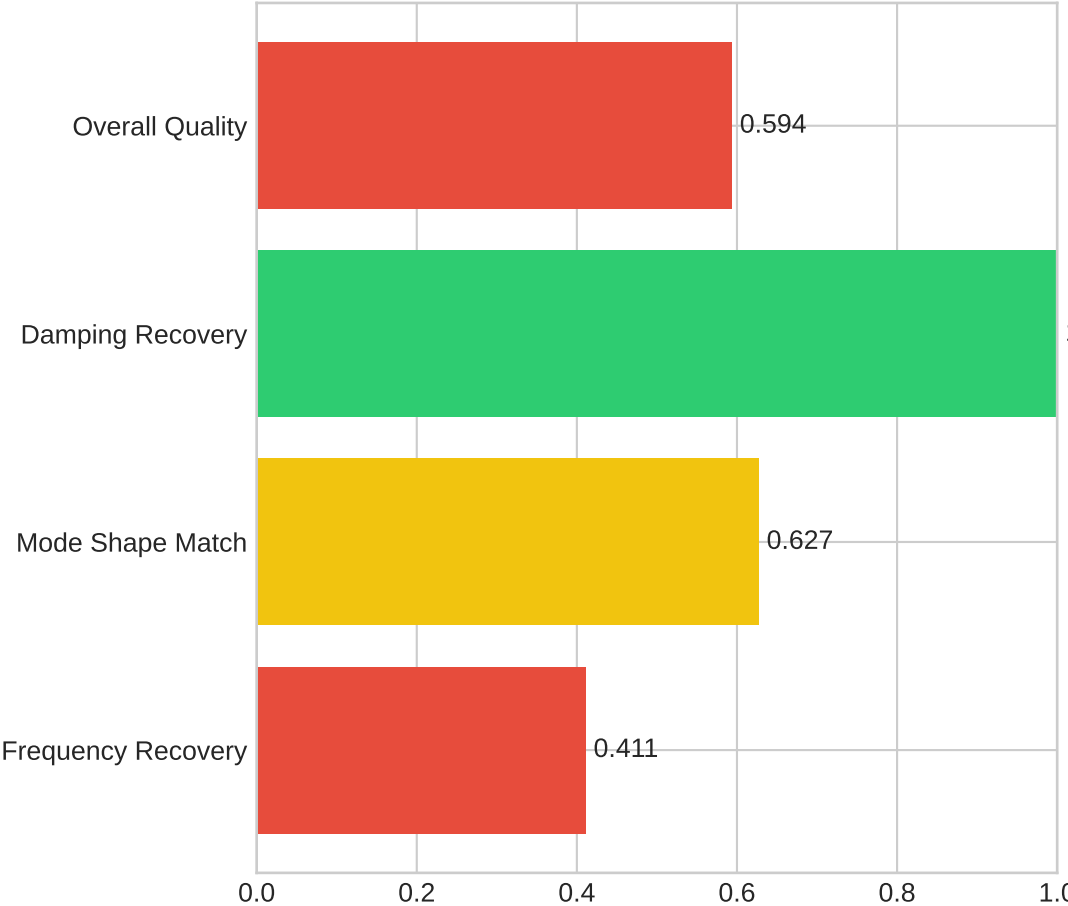
Quality Score Breakdown

0.594
