# **HURRICANE IVAN CHARACTERISTICS and STORM TIDE EVALUATION**

**Robert Wang and Michael Manausa**

**Sponsored by  
Florida Department of Environmental Protection,  
Bureau of Beaches and Coastal Systems**

**Submitted by  
Beaches and Shores Resource Center  
Institute of Science and Public Affairs  
Florida State University**

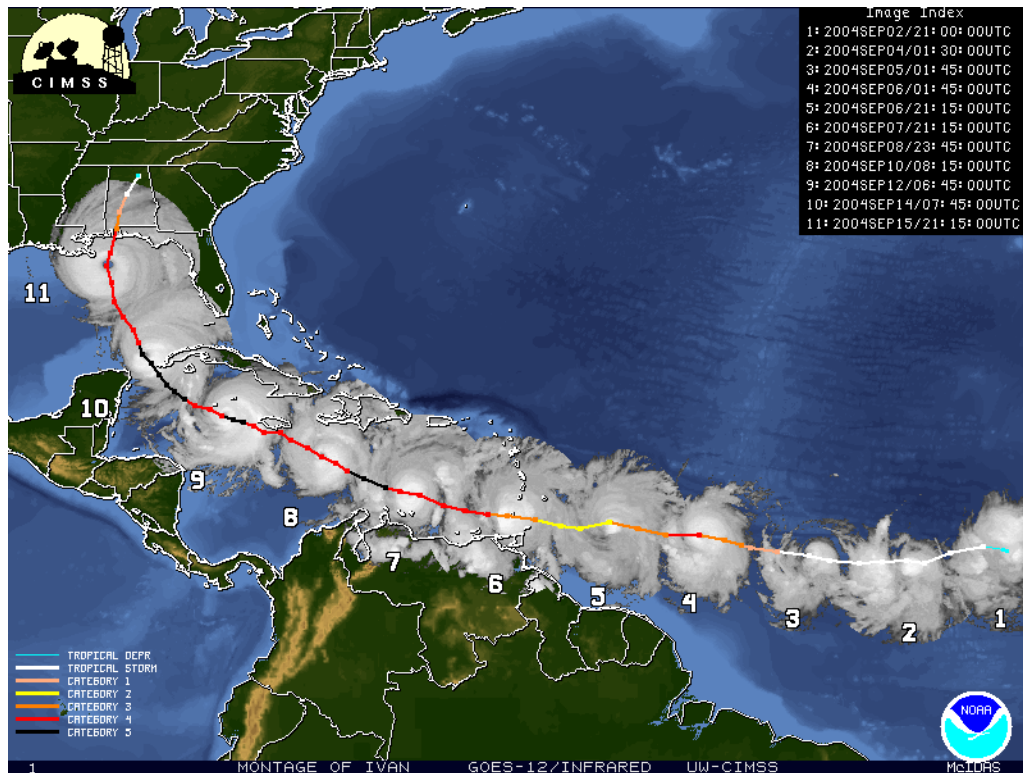
Figure 1. Hurricane Ivan track (Source: CIMSS, UW - Madison).

Hurricane Ivan developed from a large tropical wave that moved off the west coast of Africa on 31 August, 2004. It continued to develop to a tropical depression around 1800 UTC 2 September and became Tropical Storm Ivan at 0600 UTC 3 September. Ivan continued on a generally westward motion and steadily strengthened, becoming a hurricane at 0600 UTC 5 September. Ivan reached the Category 5 strength 3 times in Caribbean Sea before it entered the Gulf of Mexico early on 14 September at Category 4 strength (Figure 1).

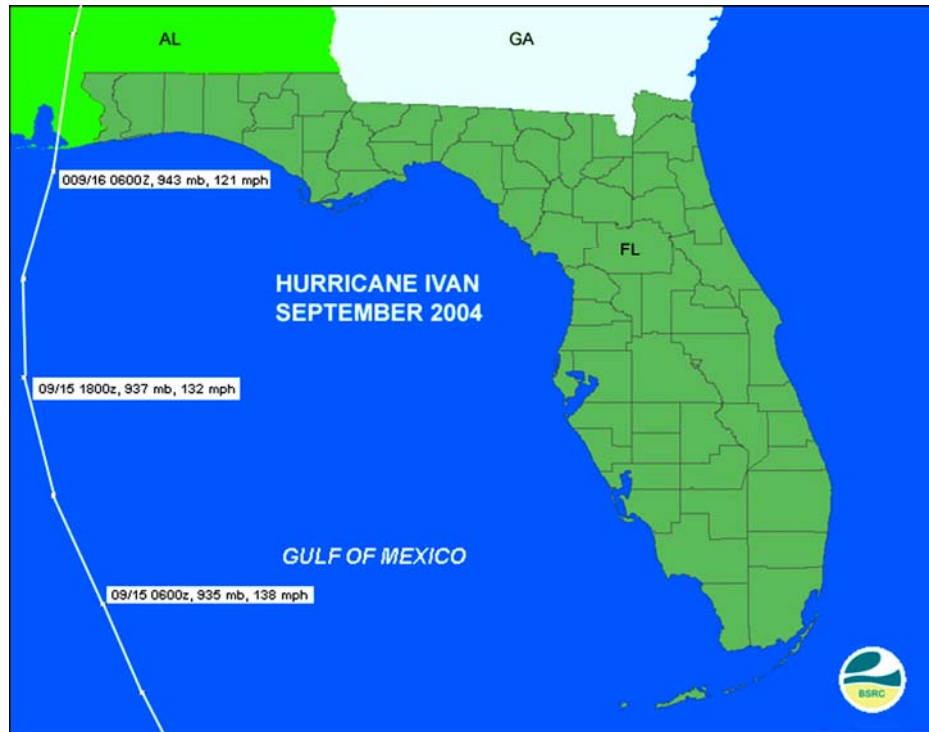
Figure 2. Hurricane Ivan track near the Gulf Coast.

As Ivan neared the northern U.S. Gulf coast, it weakened only slowly and made landfall as a 121 m.p.h. hurricane (Category 3) at approximately 1:50 a.m. CDT (0650 UTC) 16 September, just west of Gulf Shores, Alabama (Figure 2). By this time, the eye diameter had increased to 40-50 n mi. (Figure 3), which resulted in some of the strongest winds occurring over a narrow area near the south Alabama-western Florida panhandle border. The winds of Ivan is presented in the wind swath map show in Figure 4. The data was prepared and provided by the Hurricane Research Division (HRD) at the Atlantic Oceanographic and Meteorological Laboratory (AOML) of the National Oceanographic and Atmospheric Administration.

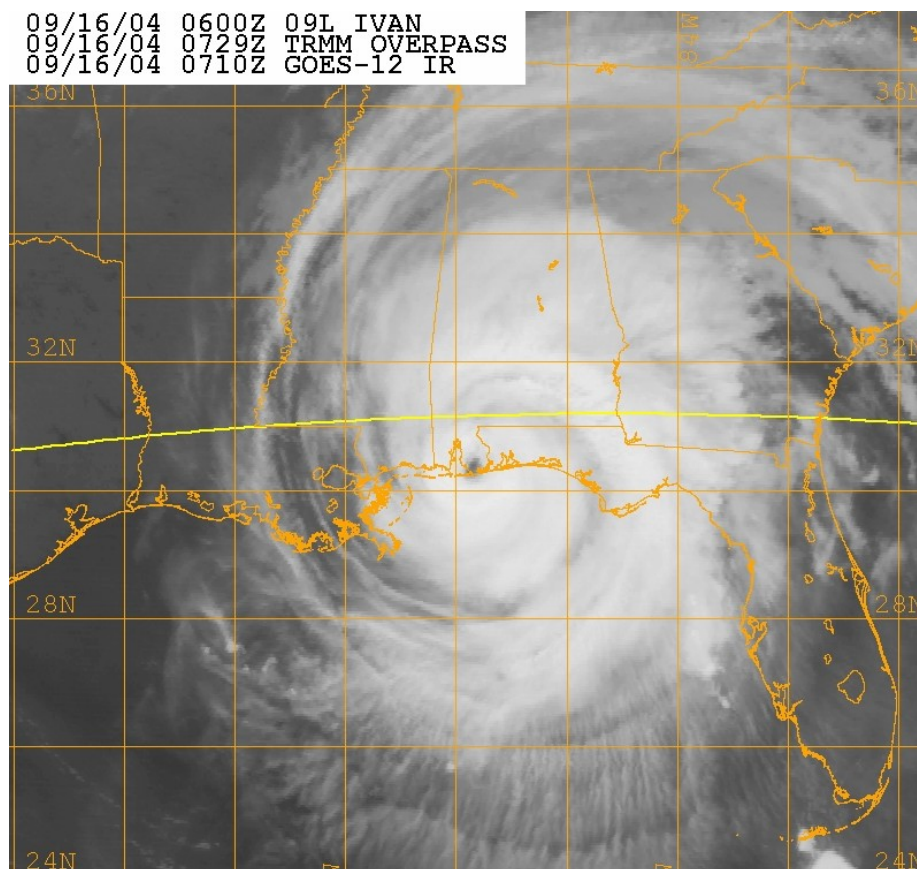
Figure 3. Eye of Hurricane Ivan at landfall (Source: Naval Research Laboratory).

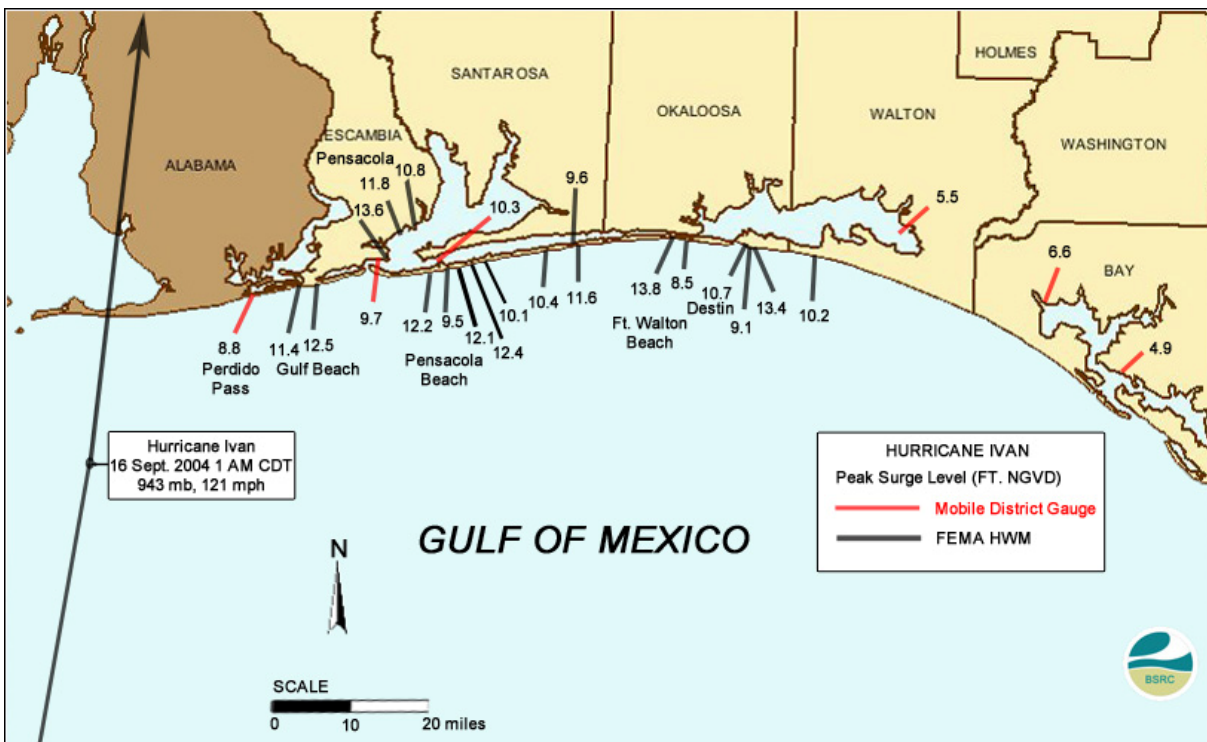
Figure 6. Surveyed Peak Surge Levels along the Panhandle area for Hurricane Ivan.

For the purpose of this report, only the interior High Water Mark (HWM) data from the beach areas or flooded area with wave setup were selected to evaluate the storm tide associated with Hurricane Ivan. Table 1 lists 21 HWM data and their location descriptions which are also shown graphically in Figure 6. Figures 7, 8 and 9 give a more detailed presentation of Figure 6.

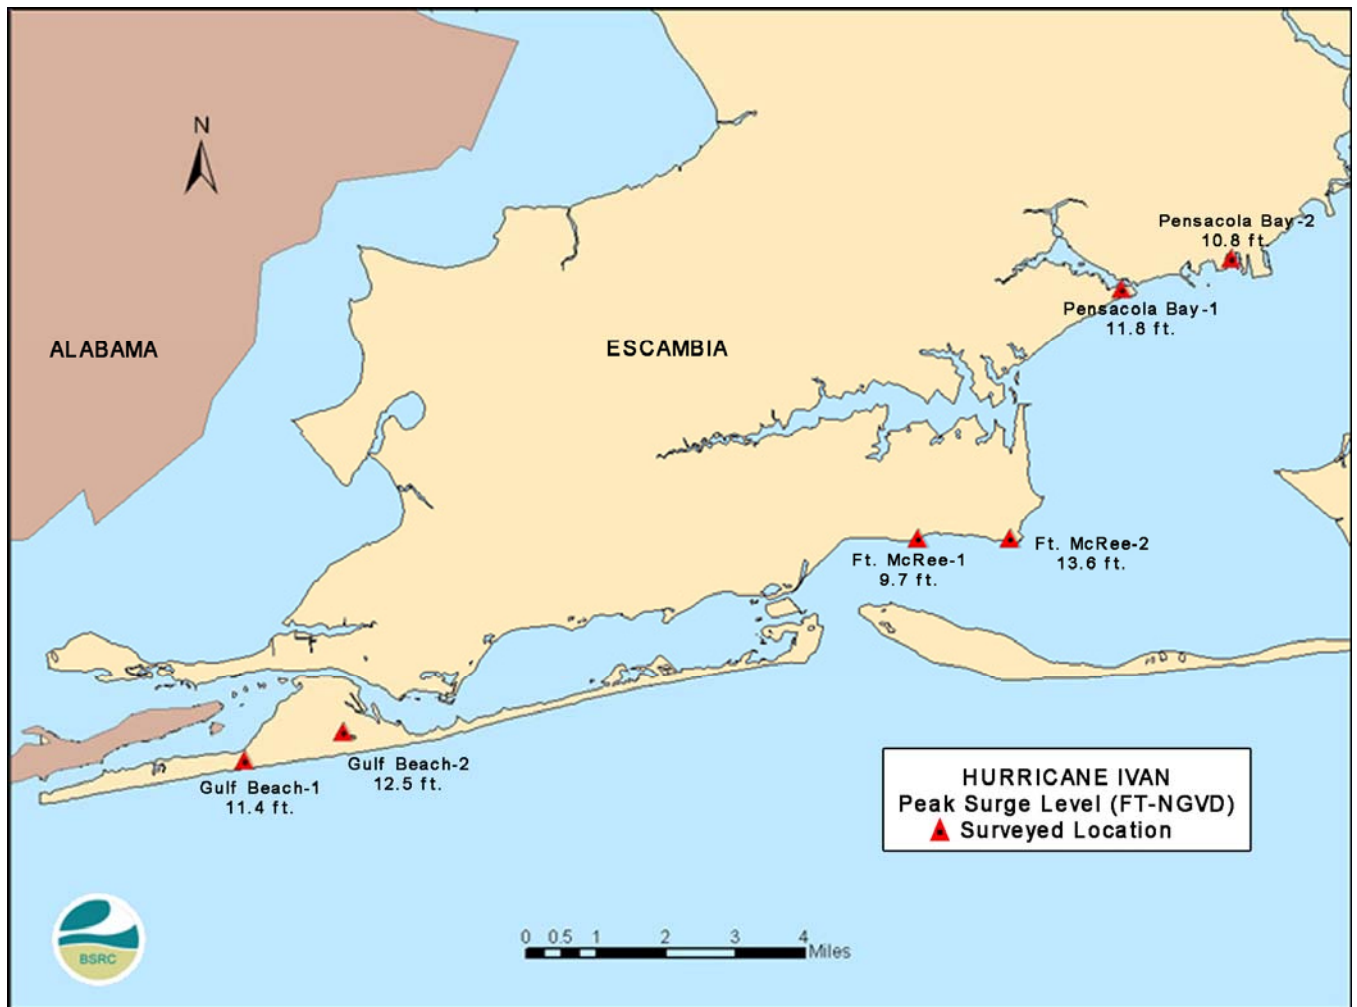
Figure 7. Surveyed Peak Surge Levels in the west Escambia County area for Hurricane Ivan.

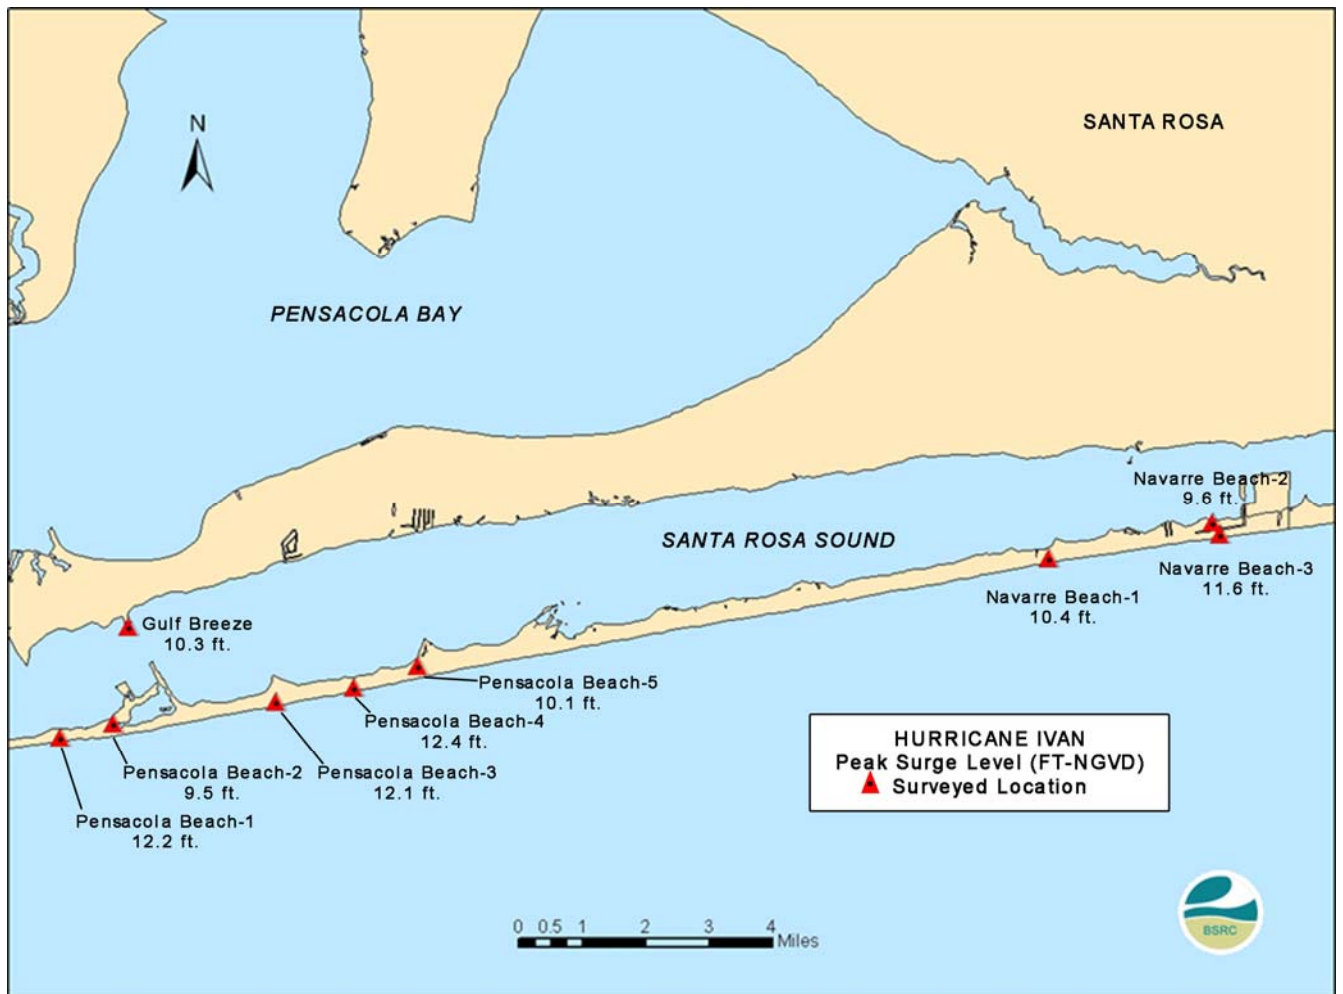
Figure 8. Surveyed Peak Surge Levels in the east Escambia County area for Hurricane Ivan.

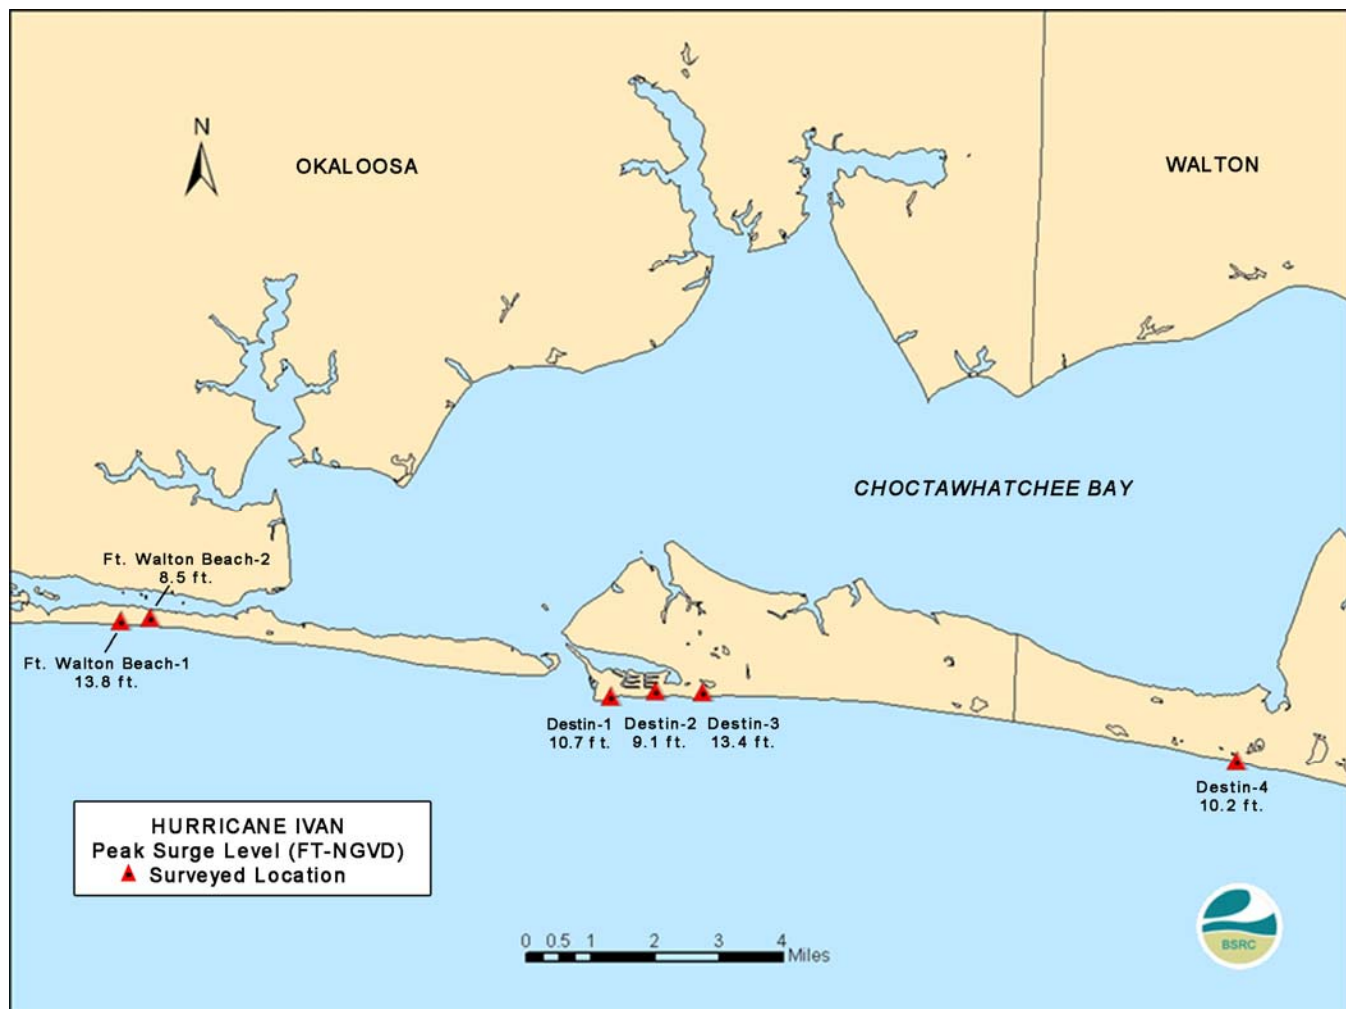
Figure 9. Surveyed Peak Surge Levels in the Okaloosa County area for Hurricane Ivan.

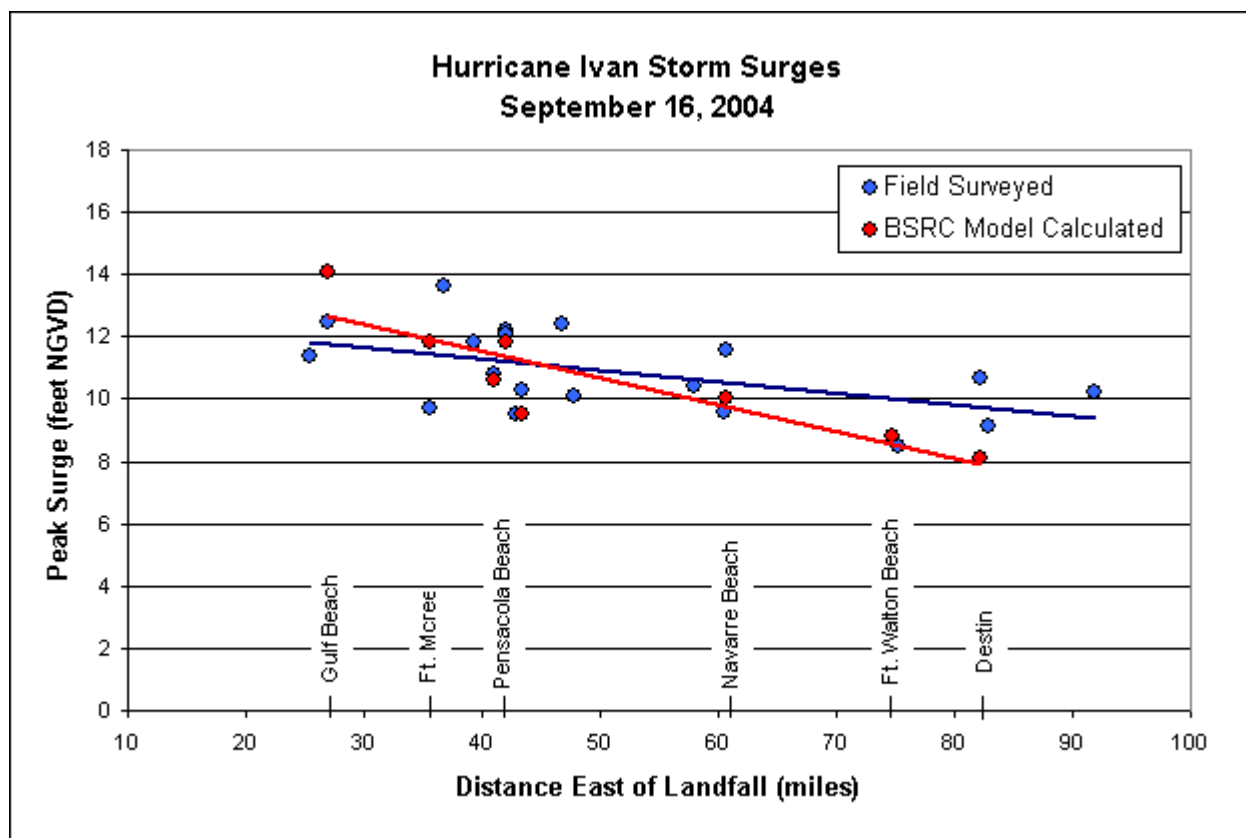
Figure 10. Comparison of Surveyed and BSRC Model Calculated Peak Surge Levels for Hurricane Ivan.

same locations as the HWM data listed in Table 1. Figure 10 and Table 2 display the result of model calculated total storm tide and a comparison with the surveyed HWM data.

Figure 10 and Table 2 show that the BSRC Model calculated Total Storm Tide by Hurricane Ivan agrees closely with the Surveyed HWM data. The BSRC model results are validated herein, hence the CCCL study values can be used to show the storm tide return periods for the HWM data of Hurricane Ivan.

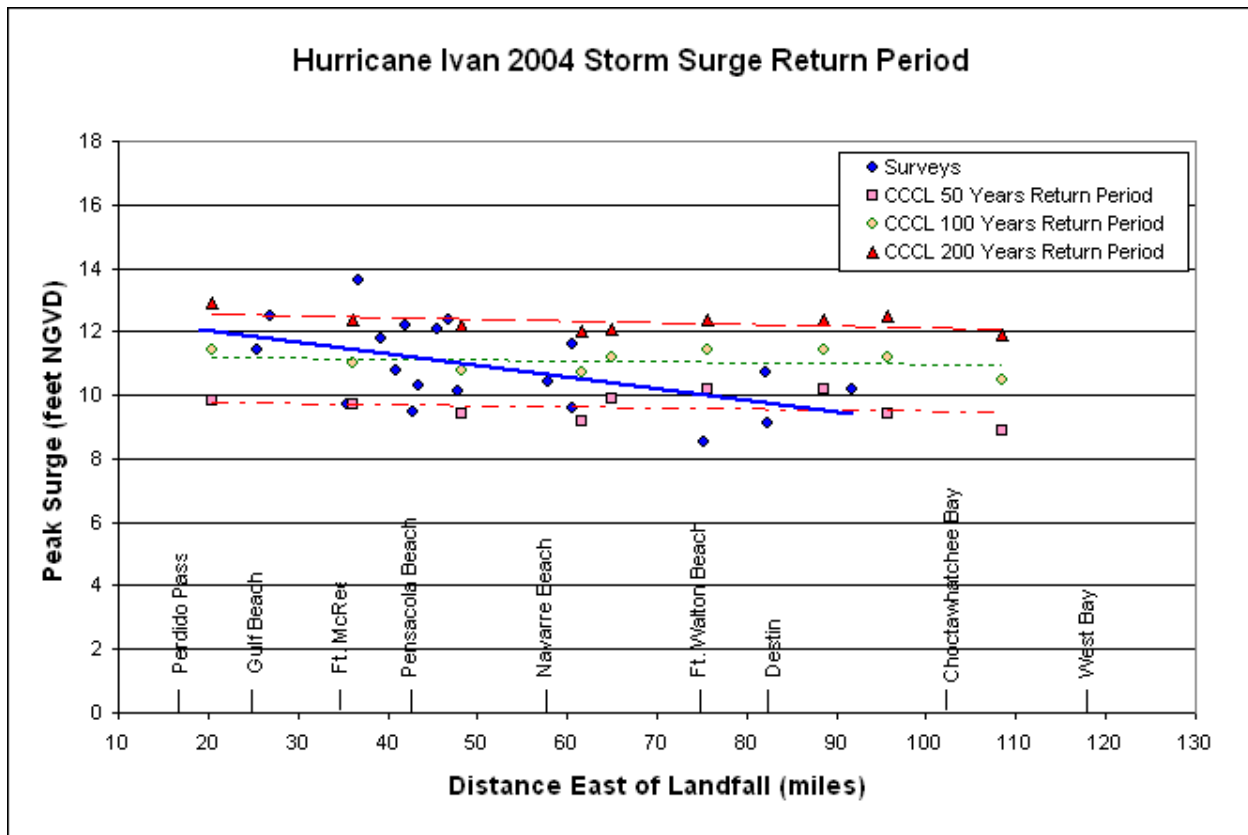
Figure 11. Hurricane Ivan Storm Tide Return Period.

A total of 27 total storm tides in 9 profile transect lines from the CCCL studies for Escambia, Okaloosa and Walton Counties were selected to generate return periods of 50, 100 and 200 years. Figure 11 depicts a comparison between the surveyed HWM data and the CCCL's total storm tide for various return periods. Most HWM data are located within the 50 and 200 years return periods from Gulf Beach to Destin areas. By comparing the downward trend line of the HWM data to the return period range, Hurricane Ivan is estimated to have generated a 100 year storm tide for the Pensacola Beach area and a 50 year storm tide for the Destin area as shown in Figure 11.
